Report on the investigation of  
the grounding at high speed of the RIB

***Sooty***

Calve Island, Isle of Mull

**Report No 22/2009**  
**October 2009**

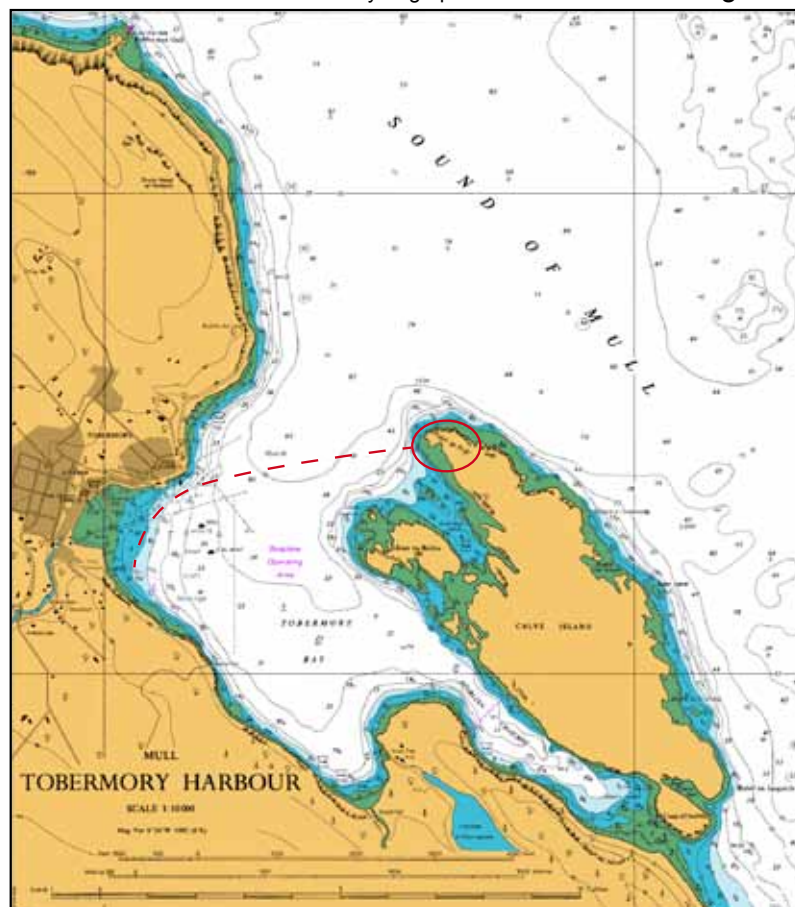
Figure 5

When clear of the fairway the coxswain increased power to get *Sooty* onto the plane<sup>2</sup>. About 1 to 2 minutes later there was a very loud bang, and the craft hit the rocks and stopped on the shore at Rubh' an Rìgh on the northern tip of Calve Island (Figures 5 and 6).

The probable route taken by *Sooty*

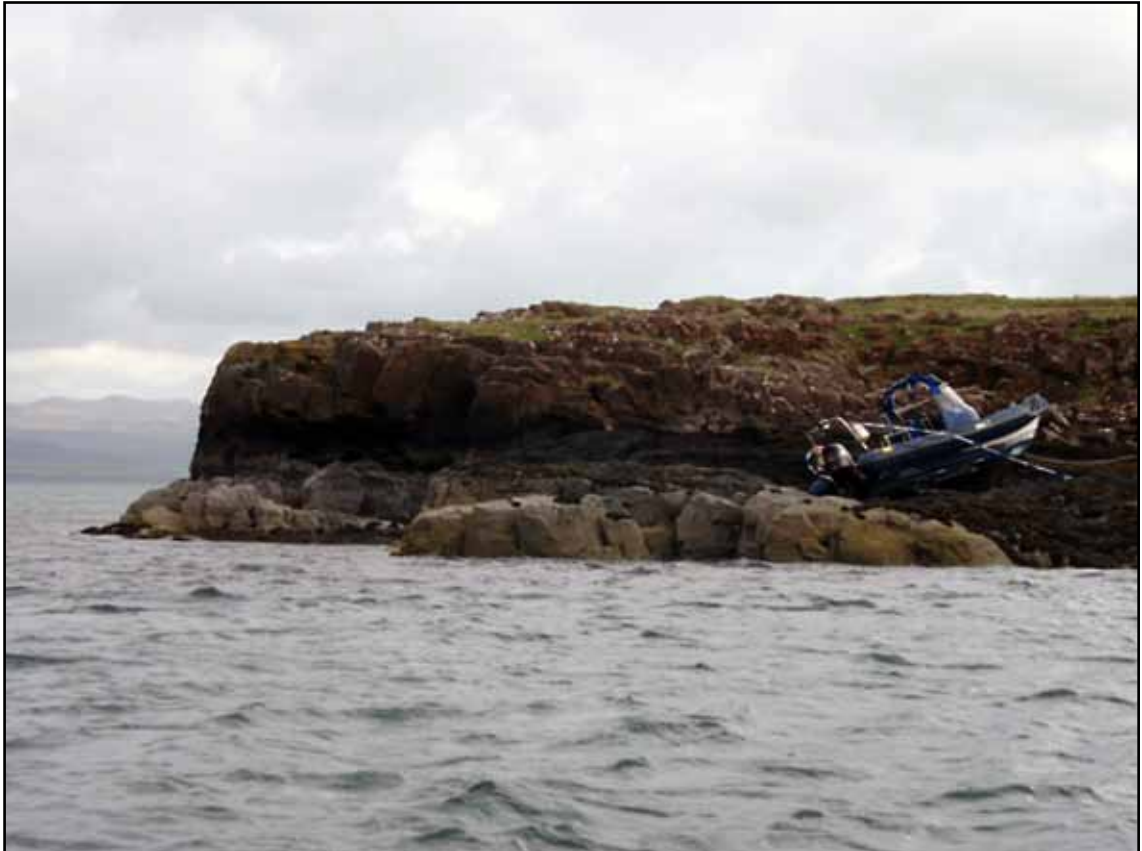
Resting place after the grounding

The points of contact identified on various rock faces above and below sea level and the damage to *Sooty* indicate that the RIB was heading approximately east north east at a speed of about 20 knots when it struck the steep rock outcrop at Rubh' an Righ on Calve Island. On impact, the RIB was projected into the air and came to rest 11m further up the shallow rocky gradient, with its engine stopped. The boat's crew were thrown forward as it suddenly came to rest. Gary Henaghan was ejected from the boat onto the rocks with sufficient force to inflict fatal head injuries. The seated occupants were thrown into the RIB's visor and console, sustaining injuries consistent with the damage later identified.

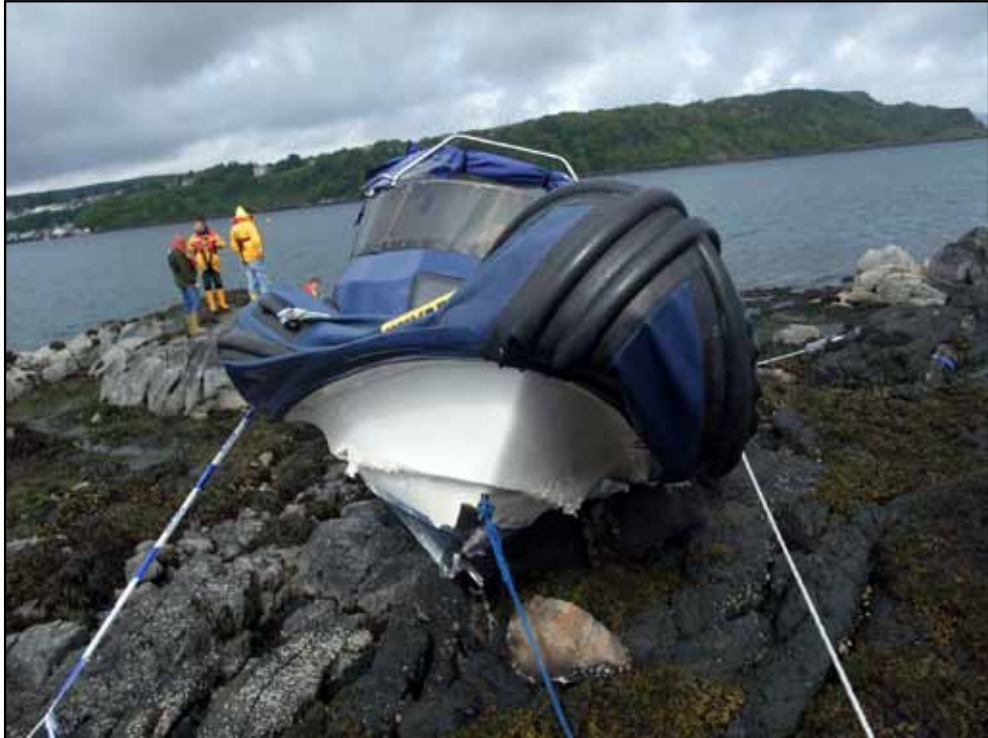
Figure 9

- The port and starboard bow section showed signs of impact damage. Sections of gel coating had been removed, and loose strands of grp matting were visible (**Figure 9**). Superficial damage to the gel coating was observed along the lines of the hull from forward to aft.
- The forward buoyancy tube, incorporating port and starboard bow sections, was deflated.
- All three propeller blades had been damaged (**Figure 10**).

Damage to hull and forward buoyancy tube

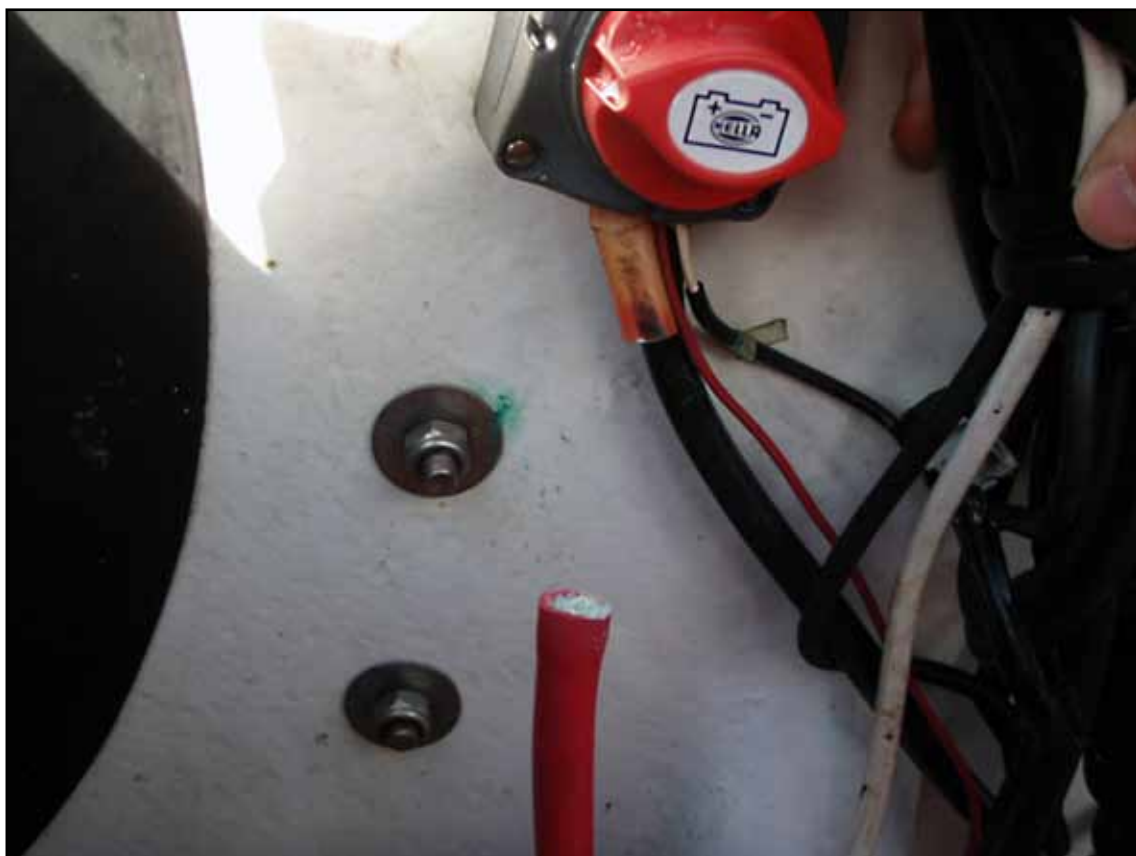
Figure 12

- The battery, housed in an unsecured plastic container, had both positive and negative leads attached. The positive lead had been pulled from the battery isolation switch which was secured to the transom. The crimped connection was corroded (**Figure 12**).

Positive battery lead pulled from the isolation switch

The total loss of electrical power, which resulted in the crew being unable to use the VHF radio after the grounding, was attributable to the battery not being properly secured. This allowed it to be thrown forward on impact, causing the corroded positive terminal to be ripped from the main power supply switch. The position in which the rocker switches were later found must be treated with caution, given that three of the crew were thrown into the instrument panel, and that the coxswain might have disturbed the rocker switches when attempting to use the VHF radio to alert the coastguard.

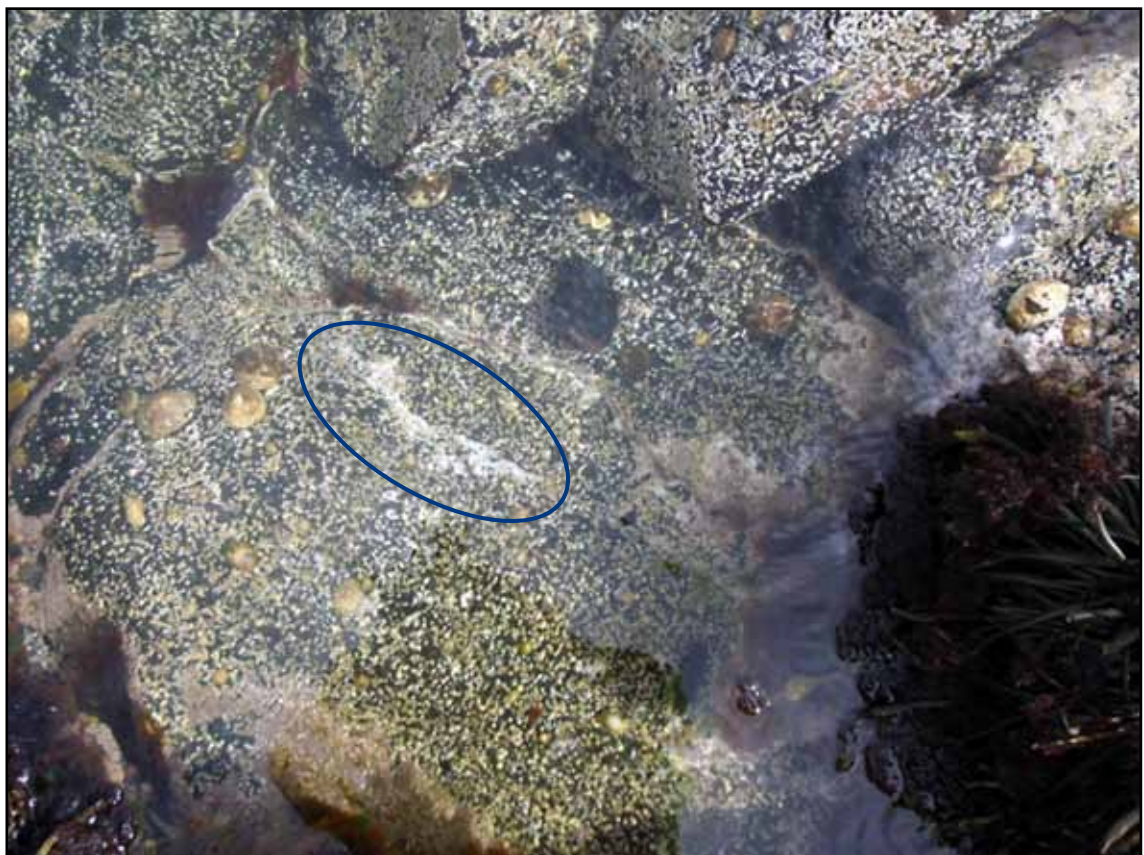
Figure 14

- White gel coat was observed on a rock face to starboard (**Figure 13**).
- Blue anti-foul paint from the underwater section of the hull was observed on several rock faces; directly on the line of approach.
- An underwater scar on a flat rock face, directly on the line of approach (**Figure 14**).

Impact point of outboard motor leg

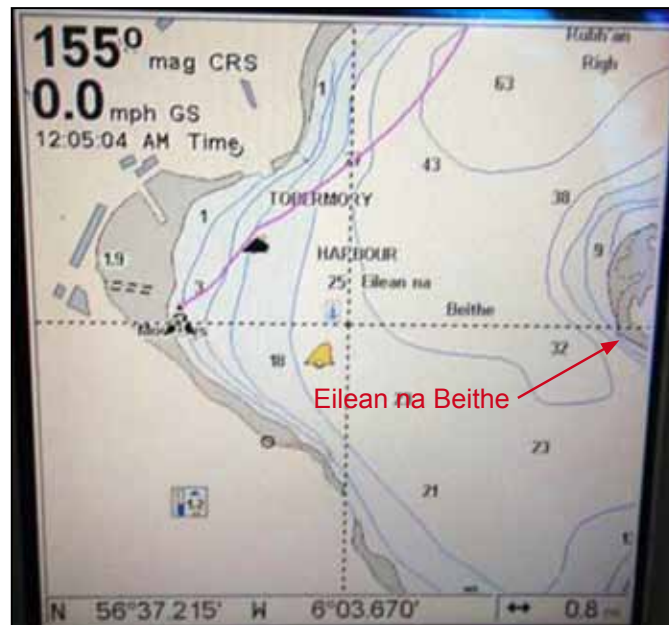
Figure 17

Assuming the GPS mapper was switched on, a map of the area would have been displayed. Positional awareness can be significantly influenced by the range scale of electronic chart displays. Depending on the range scale to which the unit defaulted, it is possible that when the coxswain glanced at the GPS display, he assumed the western tip of Eilean na Beithe, an island lying 2 cables south east of the accident site to be the western extremity of Calve Island (Figures 5, 17 and 18). This might have caused him to believe that Sooty was heading safely into the Sound of Mull when the RIB was actually heading directly towards the island.

Simulated picture (off centre) showing nearest headland

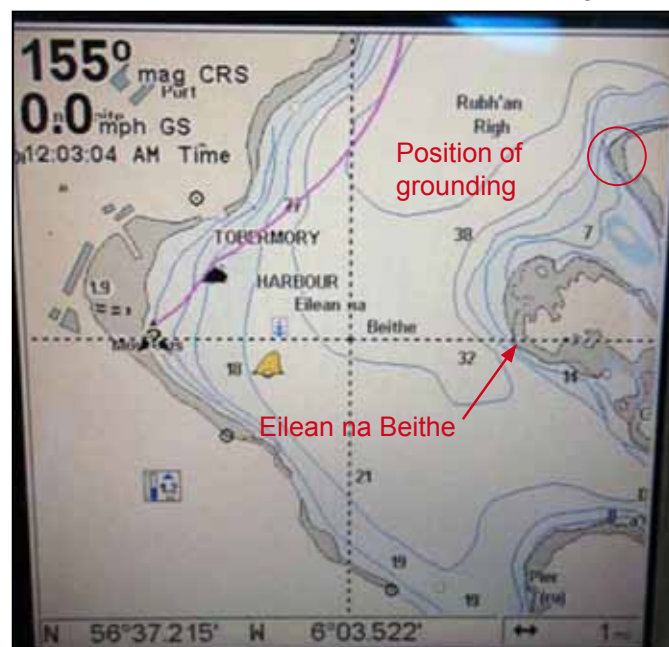
Figure 18

Simulated picture showing Calve Island just behind
