Report on the investigation of
the grounding at high speed of the RIB

Sooty

Calve Island, Isle of Mull

Report No 22/2009
October 2009

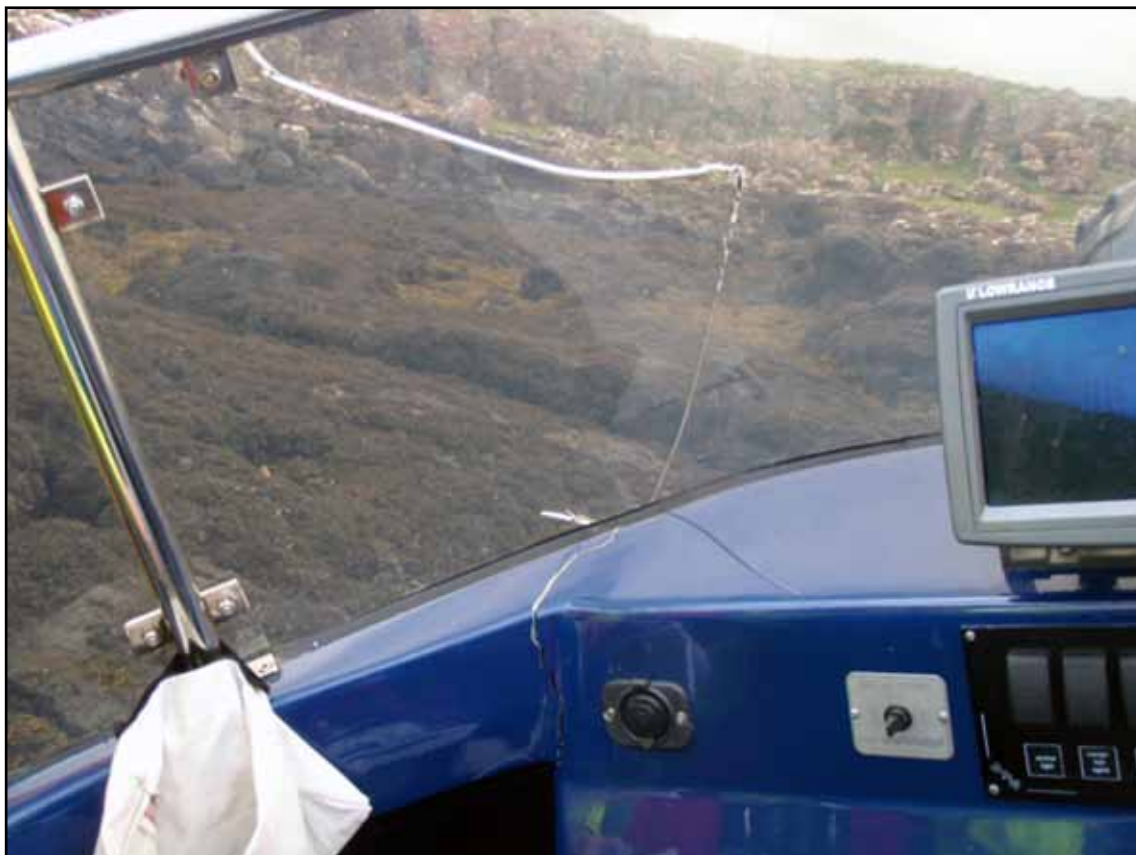
Figure 11

- A 20cm crack was identified inside the anchor chain locker.
- The tinted visor was cracked, the line of the crack continued into the main grp console (**Figure 11**).
- The magnetic compass on the top right hand side of the instrument panel had been dislodged.

Damage to tinted visor and the console
