Report on the investigation of
the grounding at high speed of the RIB

Sooty

Calve Island, Isle of Mull

Report No 22/2009
October 2009

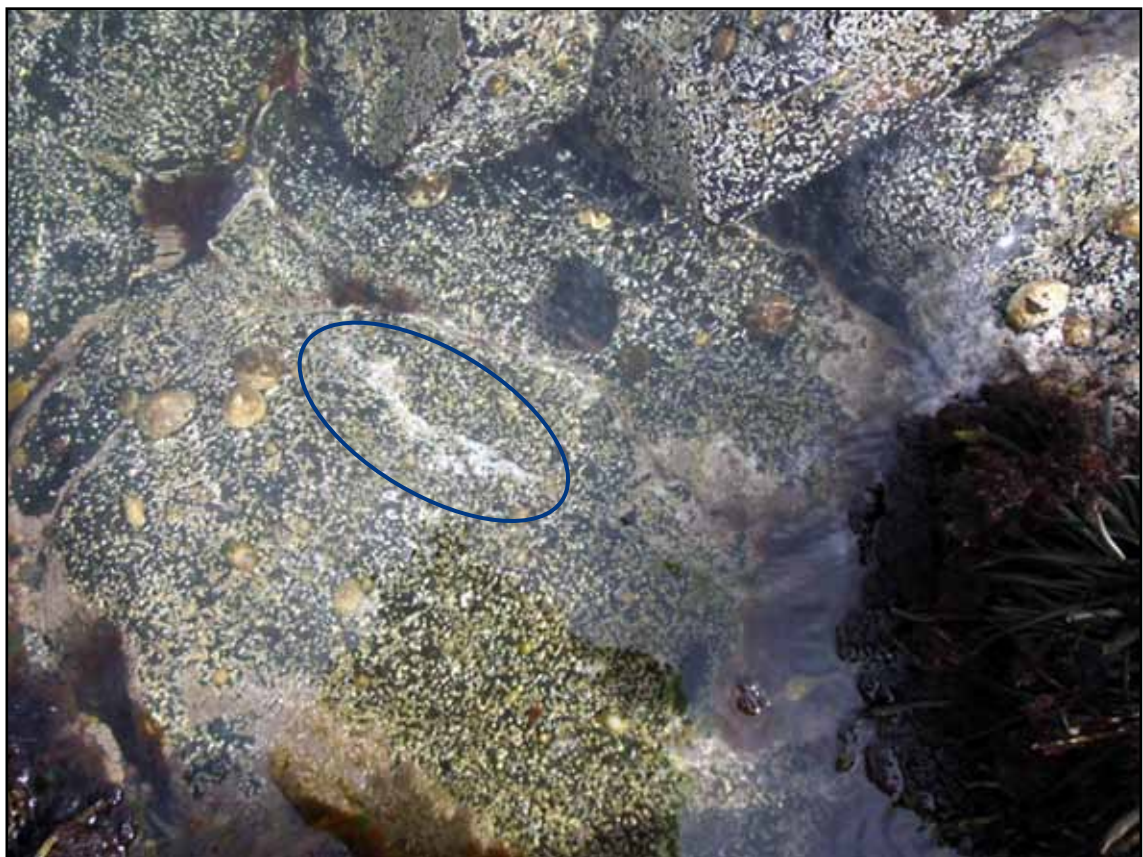
Figure 14

- White gel coat was observed on a rock face to starboard (**Figure 13**).
- Blue anti-foul paint from the underwater section of the hull was observed on several rock faces; directly on the line of approach.
- An underwater scar on a flat rock face, directly on the line of approach (**Figure 14**).

Impact point of outboard motor leg
