Report on the investigation of  
the grounding at high speed of the RIB

***Sooty***

Calve Island, Isle of Mull

**Report No 22/2009**  
**October 2009**

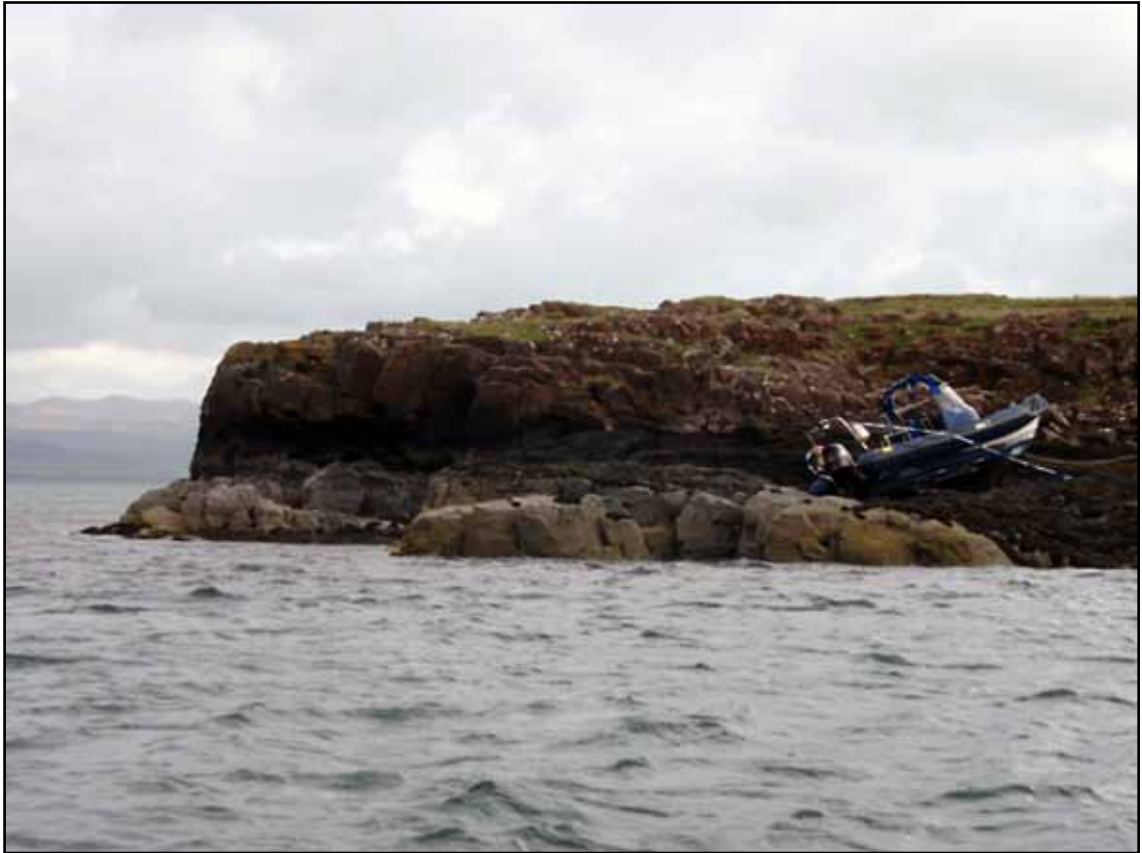
When clear of the fairway the coxswain increased power to get *Sooty* onto the plane<sup>2</sup>. About 1 to 2 minutes later there was a very loud bang, and the craft hit the rocks and stopped on the shore at Rubh' an Rìgh on the northern tip of Calve Island (Figures 5 and 6).

Resting place after the grounding

The points of contact identified on various rock faces above and below sea level and the damage to *Sooty* indicate that the RIB was heading approximately east north east at a speed of about 20 knots when it struck the steep rock outcrop at Rubh' an Righ on Calve Island. On impact, the RIB was projected into the air and came to rest 11m further up the shallow rocky gradient, with its engine stopped. The boat's crew were thrown forward as it suddenly came to rest. Gary Henaghan was ejected from the boat onto the rocks with sufficient force to inflict fatal head injuries. The seated occupants were thrown into the RIB's visor and console, sustaining injuries consistent with the damage later identified.

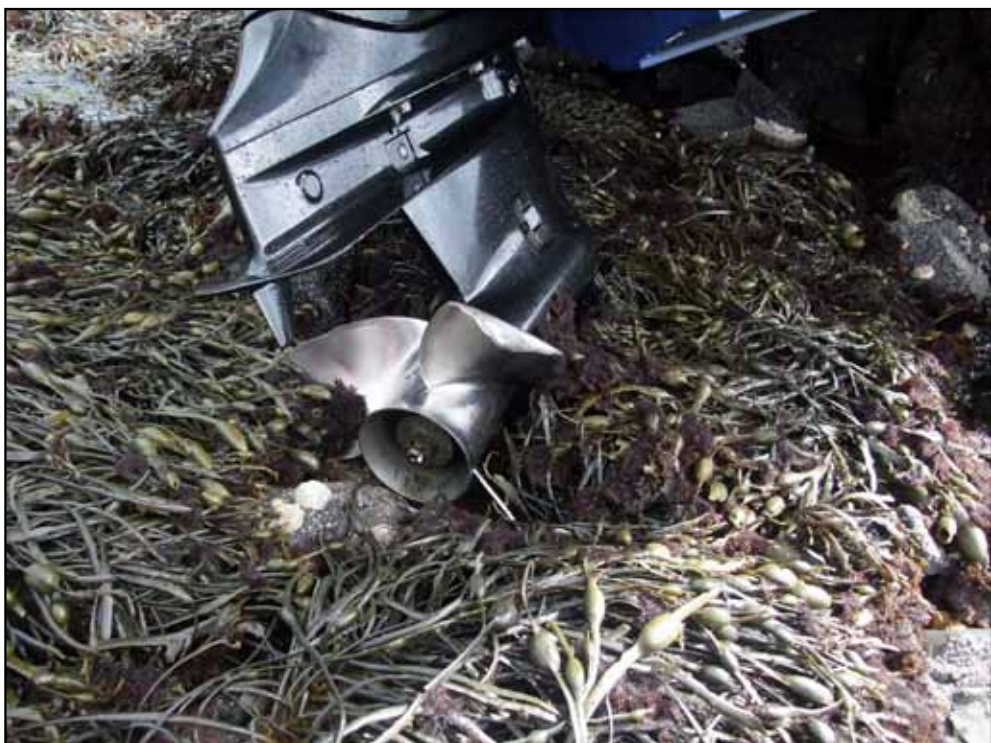
Figure 10

- The port and starboard bow section showed signs of impact damage. Sections of gel coating had been removed, and loose strands of grp matting were visible (**Figure 9**). Superficial damage to the gel coating was observed along the lines of the hull from forward to aft.
- The forward buoyancy tube, incorporating port and starboard bow sections, was deflated.
- All three propeller blades had been damaged (**Figure 10**).

Damage to propeller blades

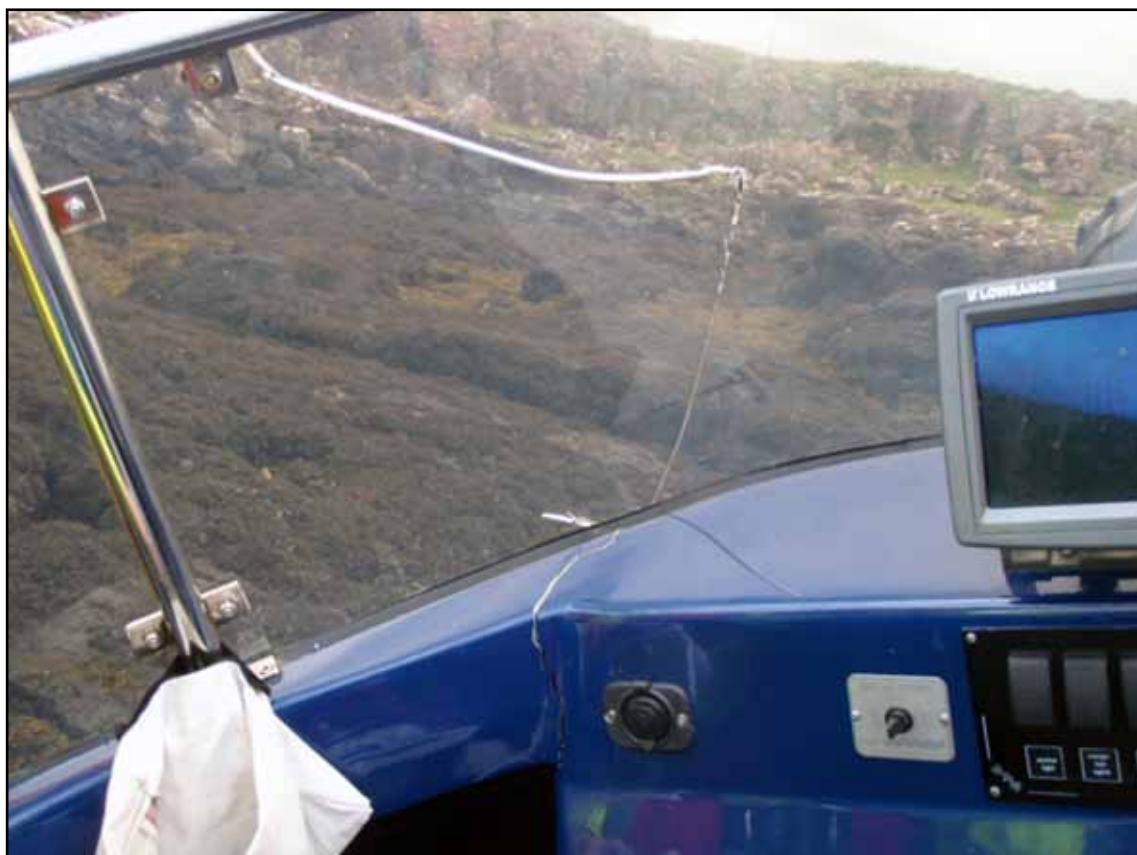
Figure 11

- A 20cm crack was identified inside the anchor chain locker.
- The tinted visor was cracked, the line of the crack continued into the main grp console (**Figure 11**).
- The magnetic compass on the top right hand side of the instrument panel had been dislodged.

Damage to tinted visor and the console

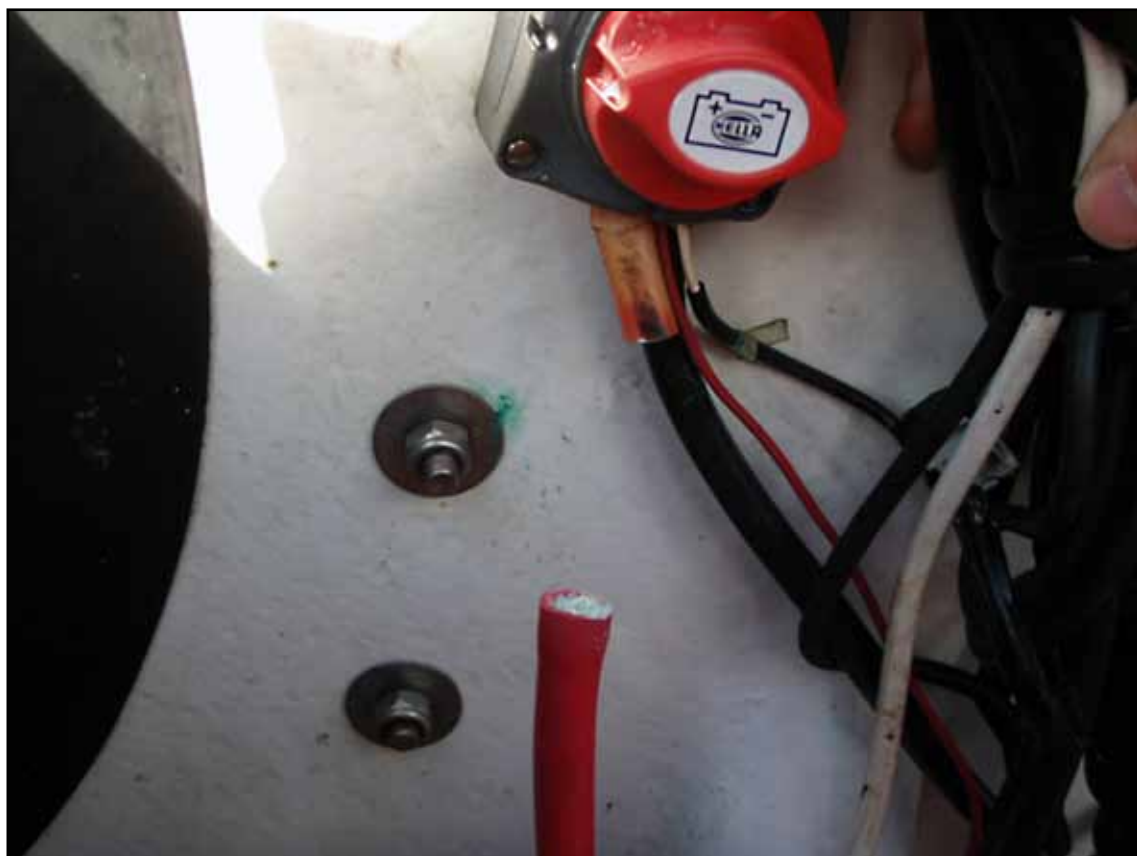
Figure 12

- The battery, housed in an unsecured plastic container, had both positive and negative leads attached. The positive lead had been pulled from the battery isolation switch which was secured to the transom. The crimped connection was corroded (**Figure 12**).

Positive battery lead pulled from the isolation switch

The total loss of electrical power, which resulted in the crew being unable to use the VHF radio after the grounding, was attributable to the battery not being properly secured. This allowed it to be thrown forward on impact, causing the corroded positive terminal to be ripped from the main power supply switch. The position in which the rocker switches were later found must be treated with caution, given that three of the crew were thrown into the instrument panel, and that the coxswain might have disturbed the rocker switches when attempting to use the VHF radio to alert the coastguard.

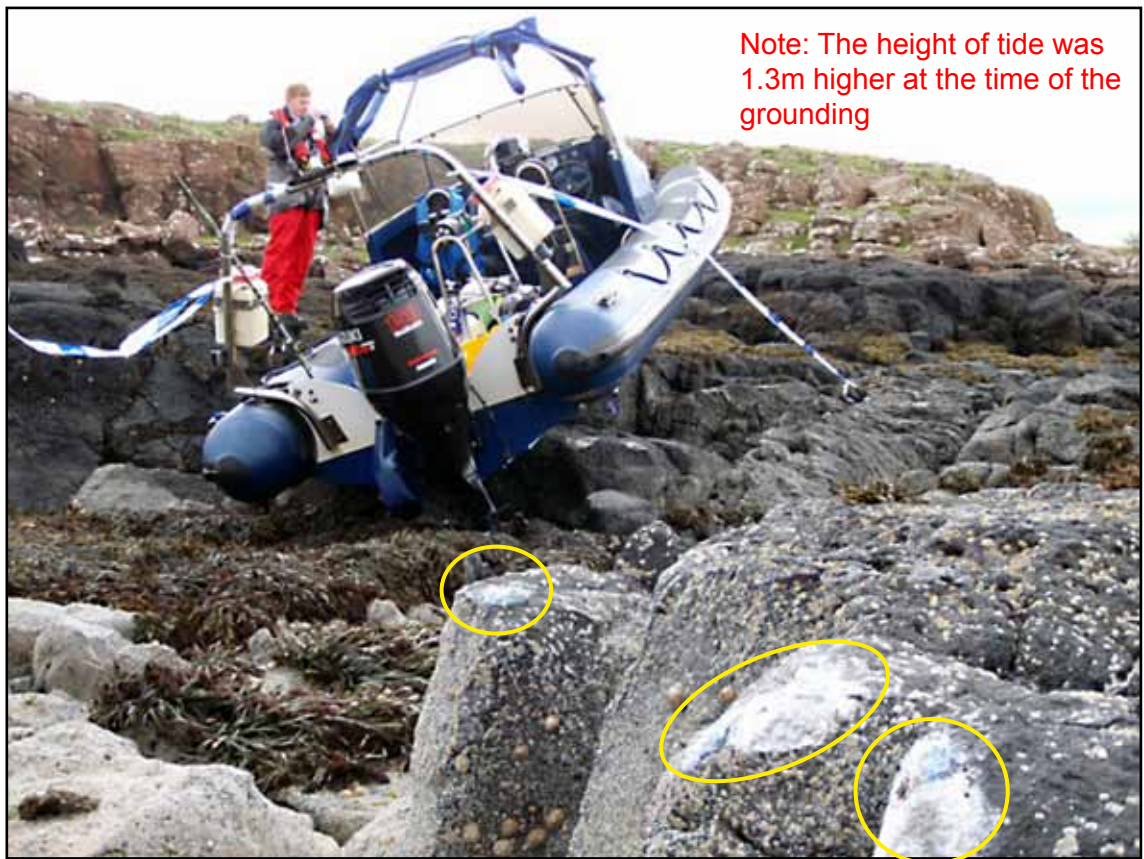
Figure 13

- White gel coat was observed on a rock face to starboard (**Figure 13**).
- Blue anti-foul paint from the underwater section of the hull was observed on several rock faces; directly on the line of approach.
- An underwater scar on a flat rock face, directly on the line of approach (**Figure 14**).

Evidence of gel coat to starboard

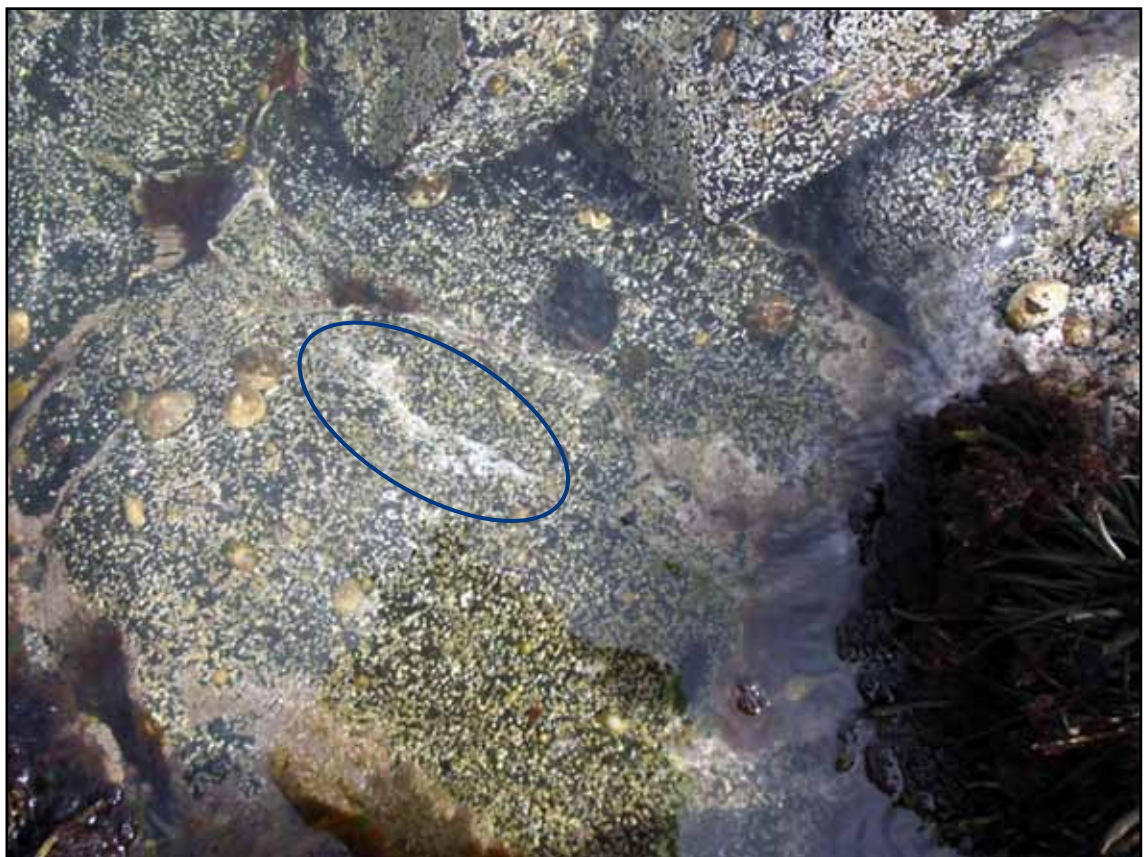
Figure 14

Impact point of outboard motor leg
