Report on the investigation of
the catastrophic failure of a windlass hydraulic motor
on board

Stellar Voyager

off Tees Bay
resulting in a major injury on
23 March 2009

Report No 25/2009
December 2009

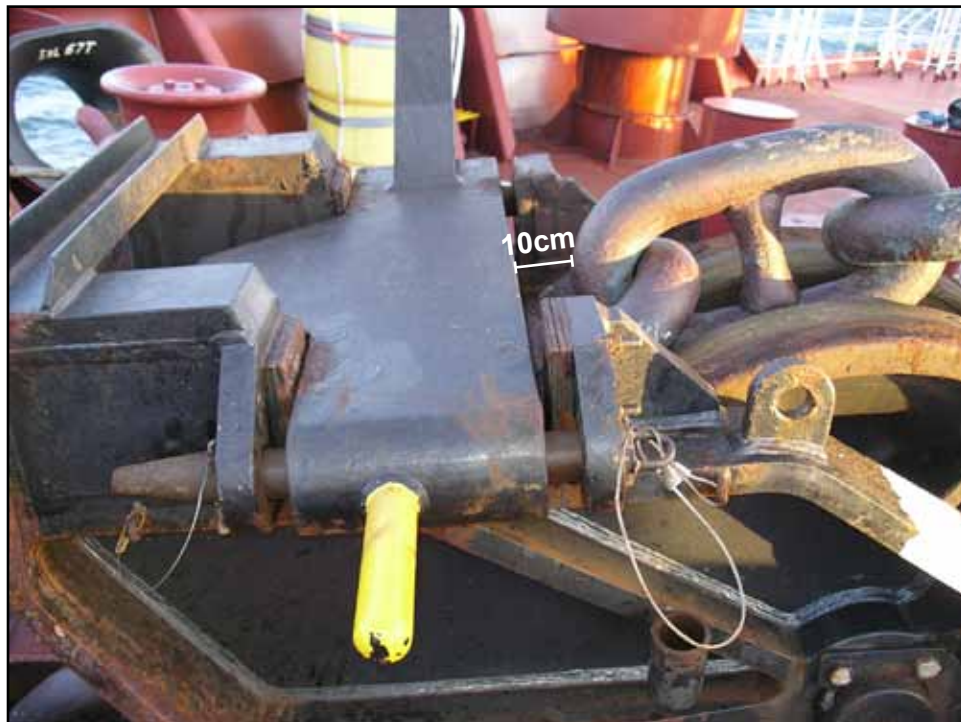
Figure 2

At 2230, the duty AB heard the chain cable suddenly tension on the windlass. On investigation, he found that the gap between the chain stopper and the link had closed, and immediately informed the bridge. The second officer checked that the vessel was not dragging her anchor and also alerted the master. The master arrived on the bridge at 2240 and ordered the duty AB to start the windlass hydraulic system; he also called anchor stations.

Gap between chain link and stopper

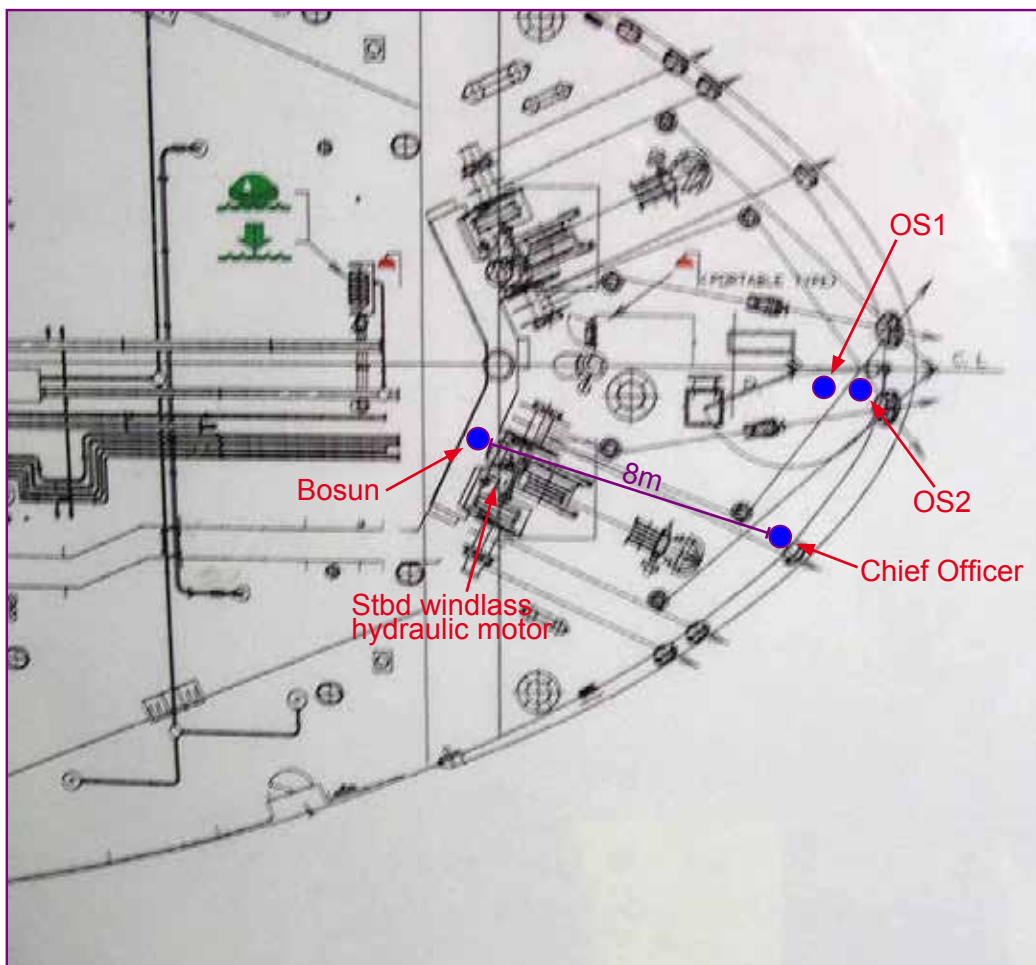
Figure 3

The chief officer soon joined the AB on the focsle, which was well lit, and told him to engage the windlass gear. The bosun and two ordinary seamen (OS) also arrived on the focsle. Communication between the master and the chief officer was via UHF radio but, because the master had difficulty hearing the chief officer due to the background noise caused by the wind, he often repeated what he had heard and asked the chief officer to confirm its accuracy. The positions of the anchor party on the focsle are shown in **Figure 3**.

Positions of crew members at the time of the accident

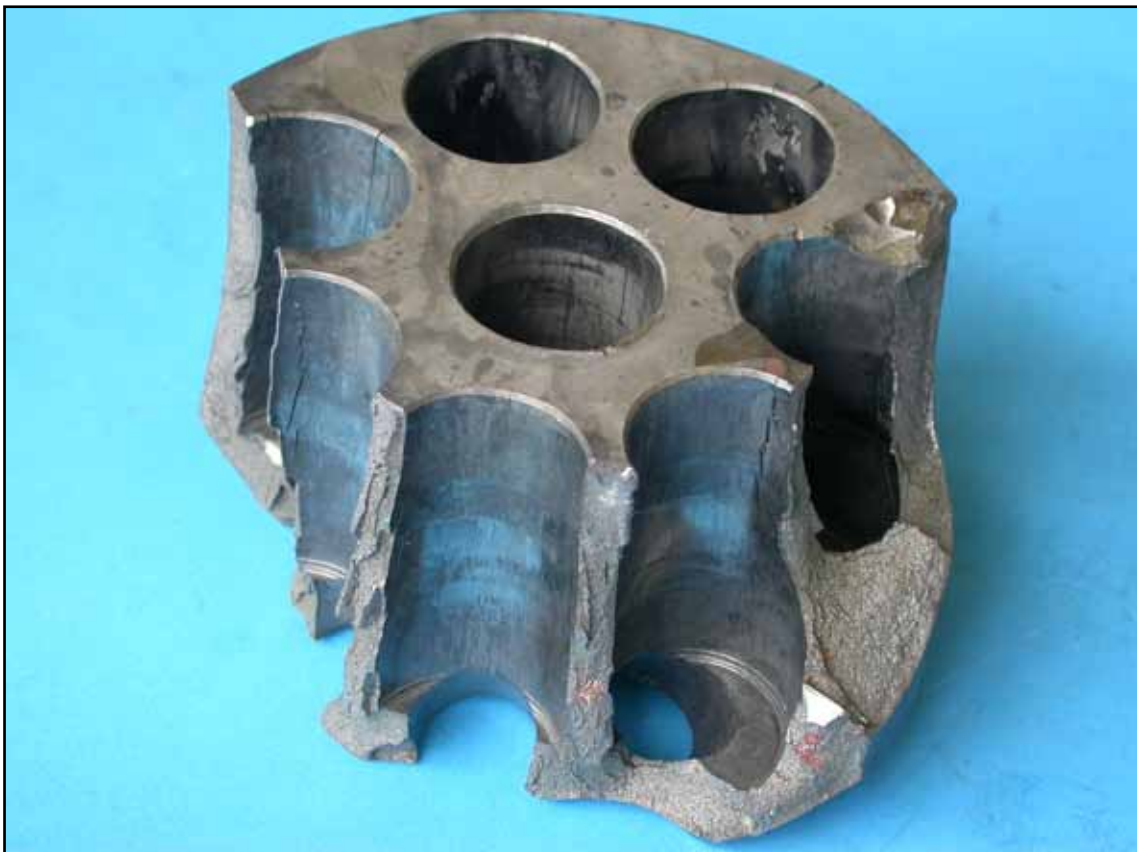
Figure 10

Preliminary onboard examination of the damaged hydraulic motor revealed very little evidence of torsional failure of its components. The majority of the damage was local to the hydraulic motor and its casing. The centre drive pin had sheared at its mid point where its bore increased substantially and, although three of the seven pistons were found intact, the remaining four were missing. The three pistons showed signs of hard contact between the ball heads and drive shaft, and the bodies of the pistons showed what appeared to be incipient service wear or spalling type damage (**Annex B, Figure 42**). Of the seven bores in the cylinder block, five adjacent bores had disintegrated (**Figure 10**). Except for the damage to the first roller bearing on the motor output shaft, a seized drive gear on the planetary gear train and overheating of the disc brake plates, no other damage was observed beyond the hydraulic motor.

Cylinder block

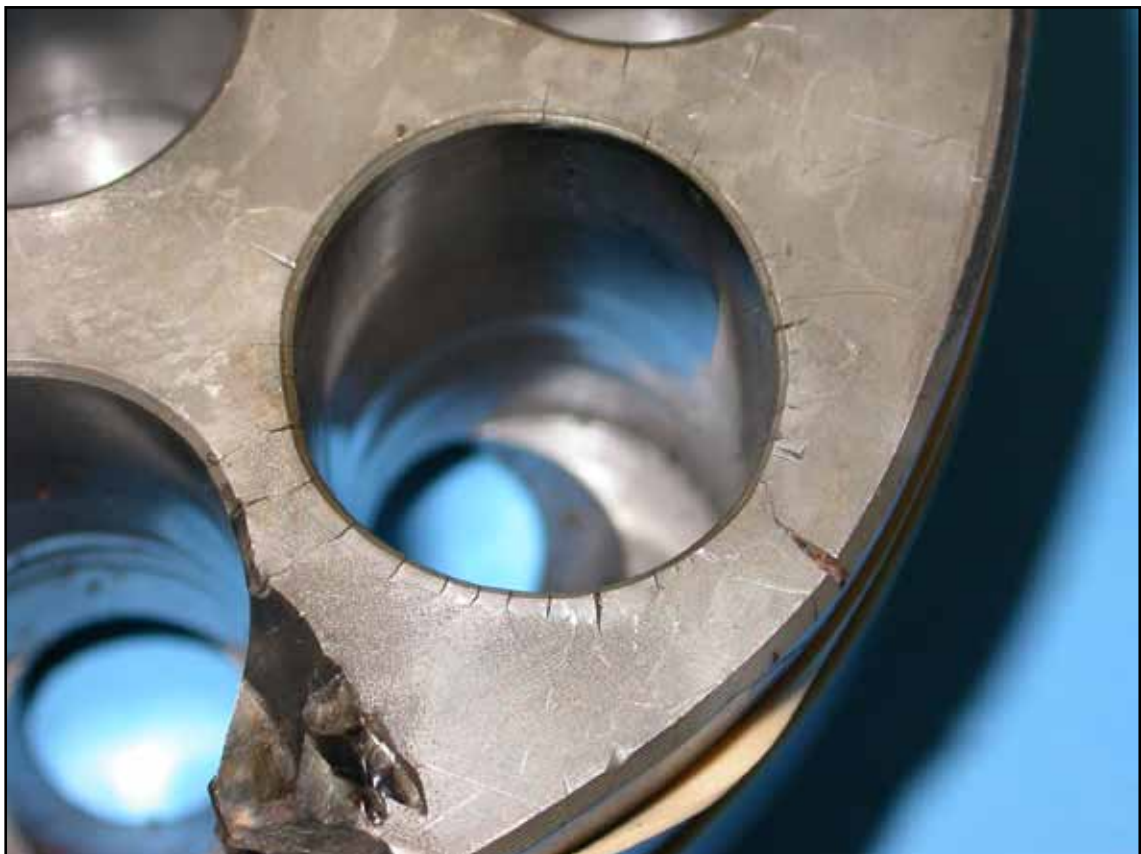
Figure 11

The findings of the metallurgy tests (paragraph 1.6.3 and **Annex B**) conclude that the explosion of the windlass hydraulic motor was the result of the brittle fracture of the motor cylinder caused by its over-pressurisation. As the results of the tensile test carried out on an undamaged section of the cylinder block ruled out material degradation leading to embrittlement, the load applied to the cylinder block must have been so rapid that the steel reached its yield point without plastic deformation, eventually surpassing its UTS and leading to fracture. The almost instantaneous nature of the fracture, the failure of the cylinder block along its longitudinal axis, and the secondary cracking on the cylinder bores (**Figure 11**) indicates that the cylinder block was subject to a very high hoop stress caused by the rapid and uncontrolled rise of pressure in the system. This is further supported by the predominant damage to one side of the cylinder (**Figure 12**), which was most likely to have been the pressurised side.

Secondary cracks on a cylinder bore

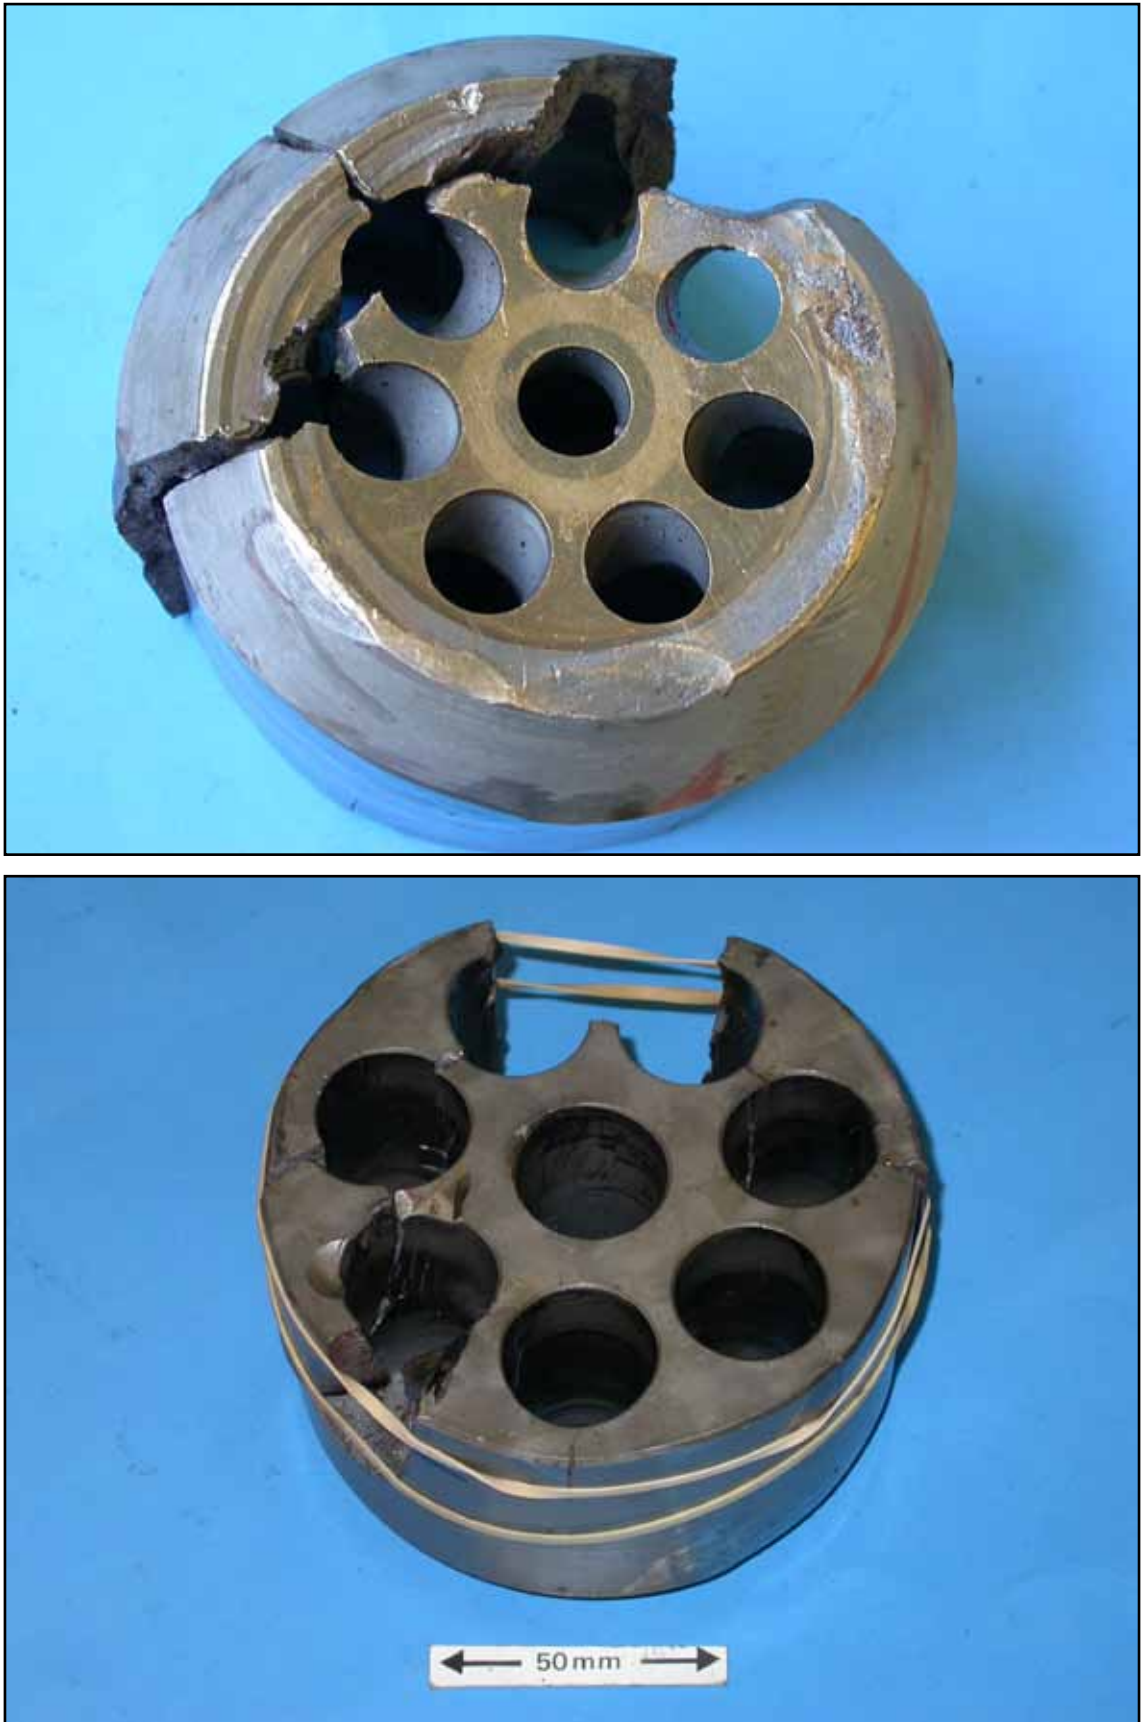
Figure 12

Predominant damage on one side of the cylinder housing

The over-pressurisation of the motor was possibly due to the ineffectiveness of the pressure relief valve. As the cable rendered, the flow of oil into the heaving line resulting from the motor turning in the opposite direction to that intended would have caused the motor to act as a positive displacement pump. With the operating lever set to maximum displacement, the position of the lens plate would have caused the pumping action to deliver the maximum throughput possible. Consequently, the pressure developed must have exceeded the 245 bars produced by the power pack, otherwise the motor would have stopped turning.

As the relief valve was only capable of relieving instantaneous peaks of pressure, it would not have been capable of handling the rapid and continuous pressure rise in the system which became a closed loop when the motor reversed. Together with the severely constricted pipes on the outlet side of the relief valve, which would have further hampered the flow of oil, and continuous supply of fresh oil through the replenishment circuit, this would have led to a very rapid rise of pressure in the motor, sufficient to cause its catastrophic failure.
