Survey Report
no. 091909

According to the commissioning by **[REDACTED]**, company of Zeppelin Baumaschinen GmbH, on April 14, 2009, the cause which led to the destruction of a hydraulic motor shall be examined.

Hydraulic drive for a combined windlass and mooring winch:

**EXAMINATION OF A FRACTURED
AXIAL DISPLACEMENT
HYDRAULIC MOTOR CYLINDER
BLOCK AND ASSOCIATED
ITEMS FROM THE ANCHOR
WINDLASS OF
*MT STELLAR VOYAGER***

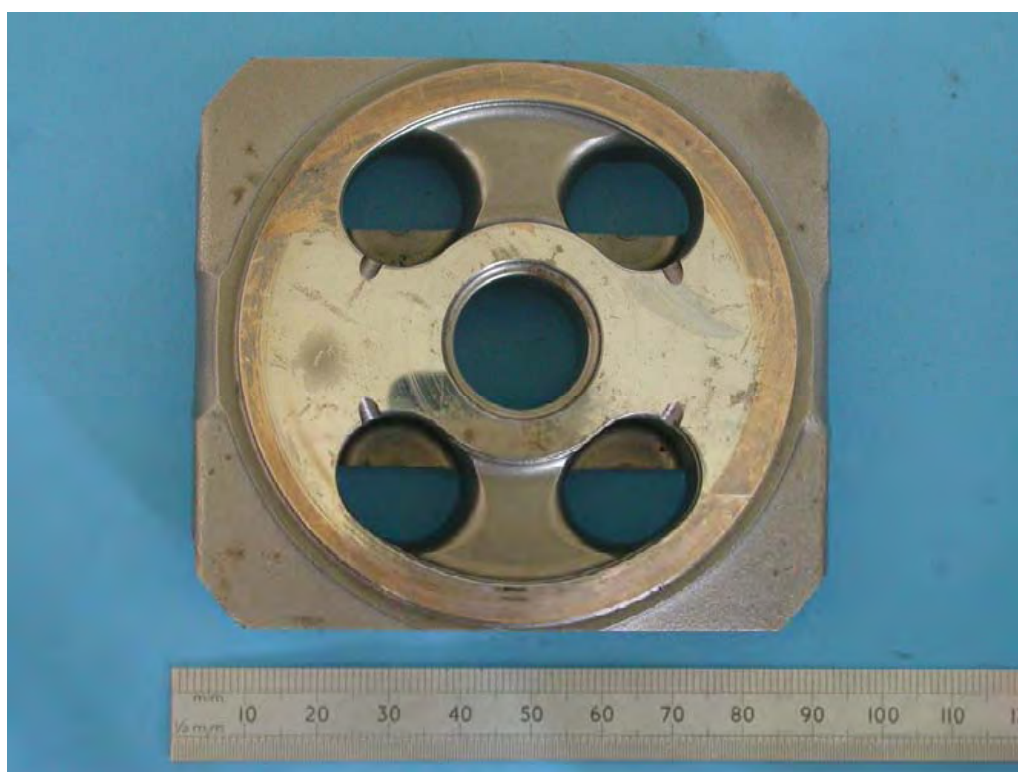
Figure 1: Rear side of the control lens.

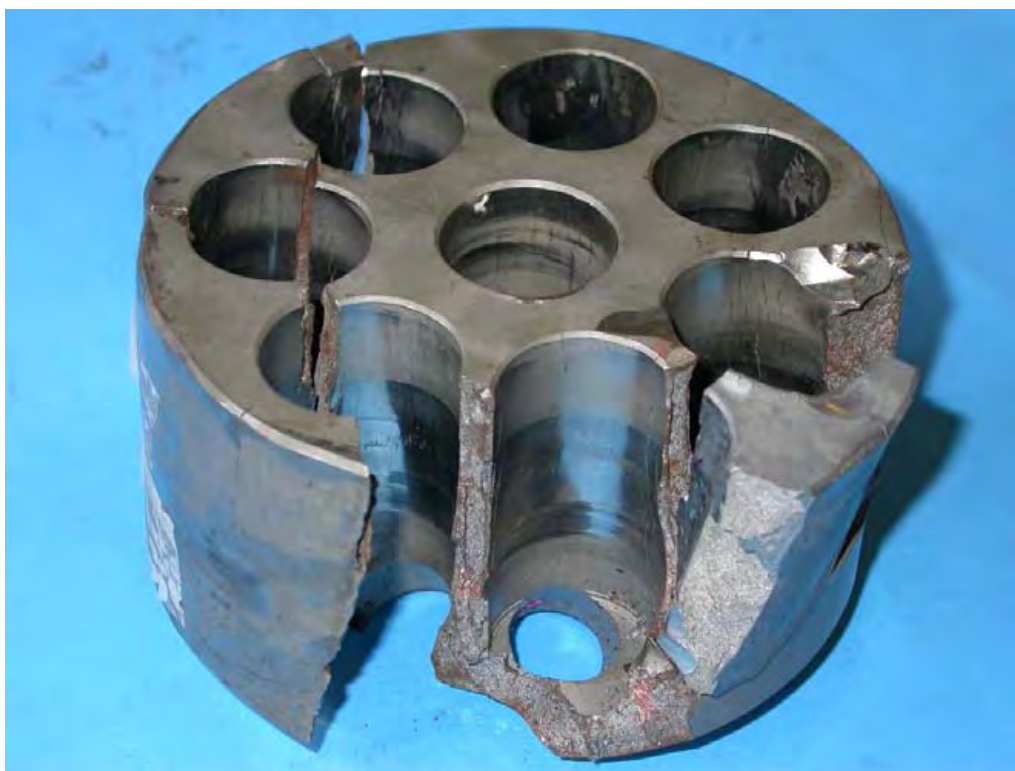
The hydraulic motors control lense appeared free from visually apparent cracking and damage (Figures 1 and 2). The cylinder block facing side at the lense (Figure 2) exhibited some service rubbing wear, none of which, however, appeared significant or material in respect of the motors failure. No evidence of cracking was apparent in any of the four inlet and outlet ports.

Figure 2: Cylinder block facing side of the control lens, showing evidence of only light non critical service rubbing wear.

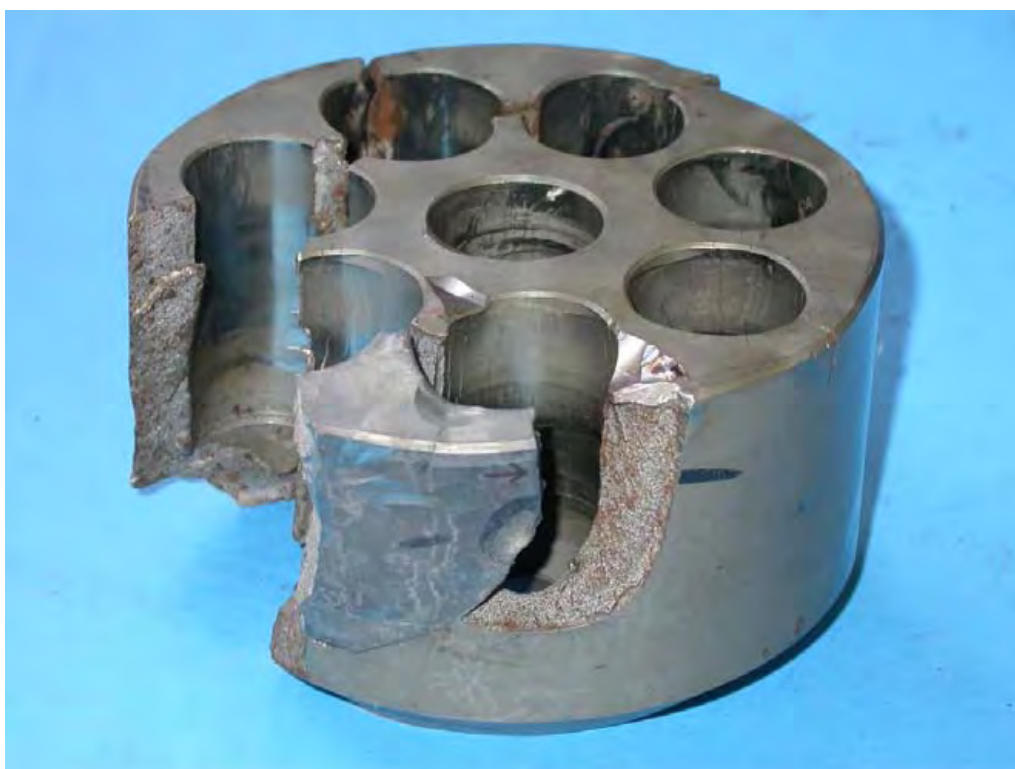
The cylinder block had comprised seven equally spaced cylinder holes on a pitch circle diameter of approximately 70mm, and a single centre pin hole. The block had fractured into a number of pieces, of which four had been recovered for examination (Figures 3, 4 and 5). The piece or pieces not recovered for examination comprised the outer and inter wall parts of two adjacent cylinders (Figure 6).

Figure 3: Fractured cylinder block, showing recovered pieces mated together.

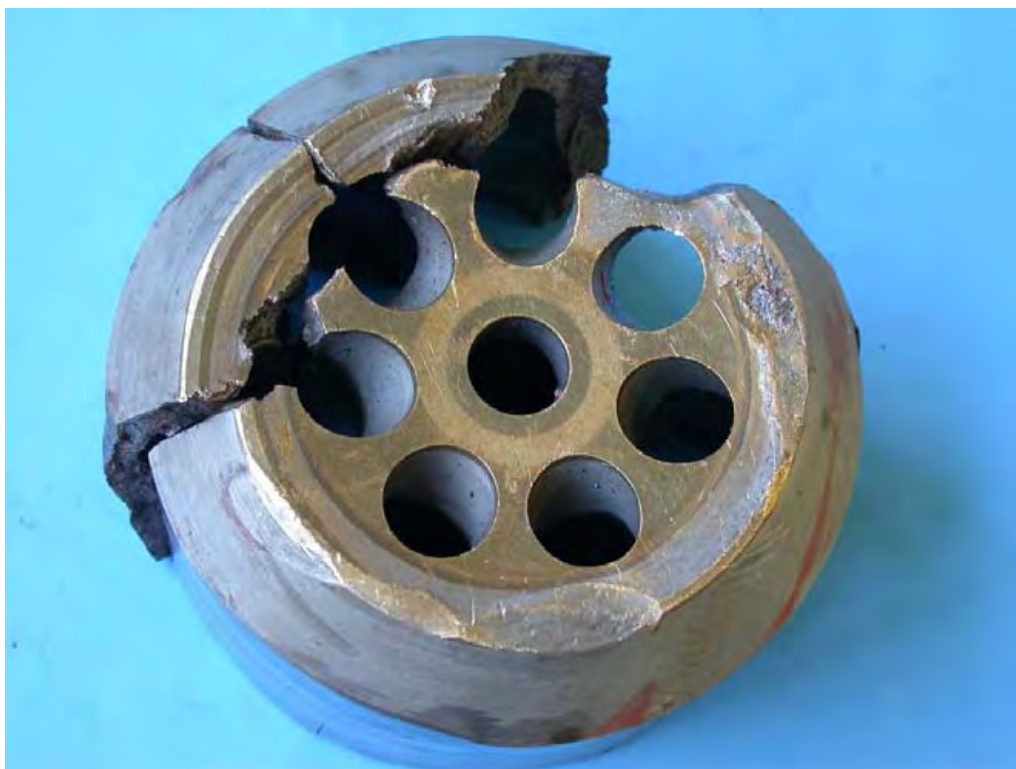
The cylinder blocks control lense mating face exhibited evidence of light service rubbing wear and what appeared to be extensive post fracture mechanical impact type damage (Figure 5).

Figure 4: As above, viewed from a different camera angle.

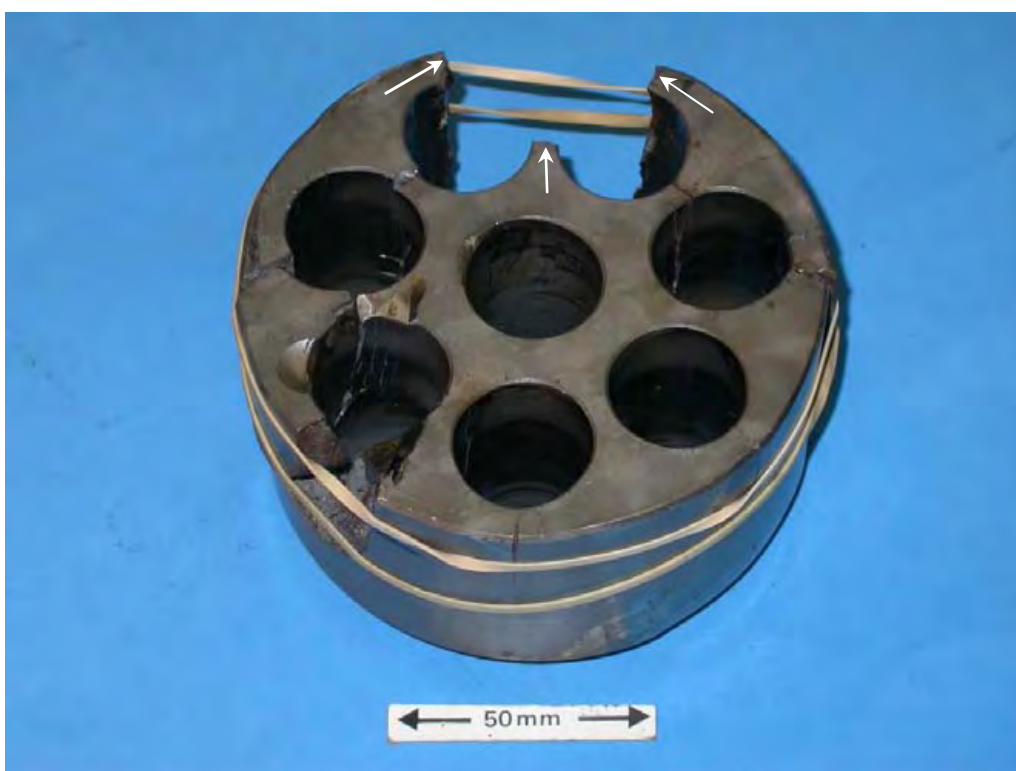
Figure 5: Fractured cylinder block, showing recovered pieces mated together and viewed from the control lens mating face.

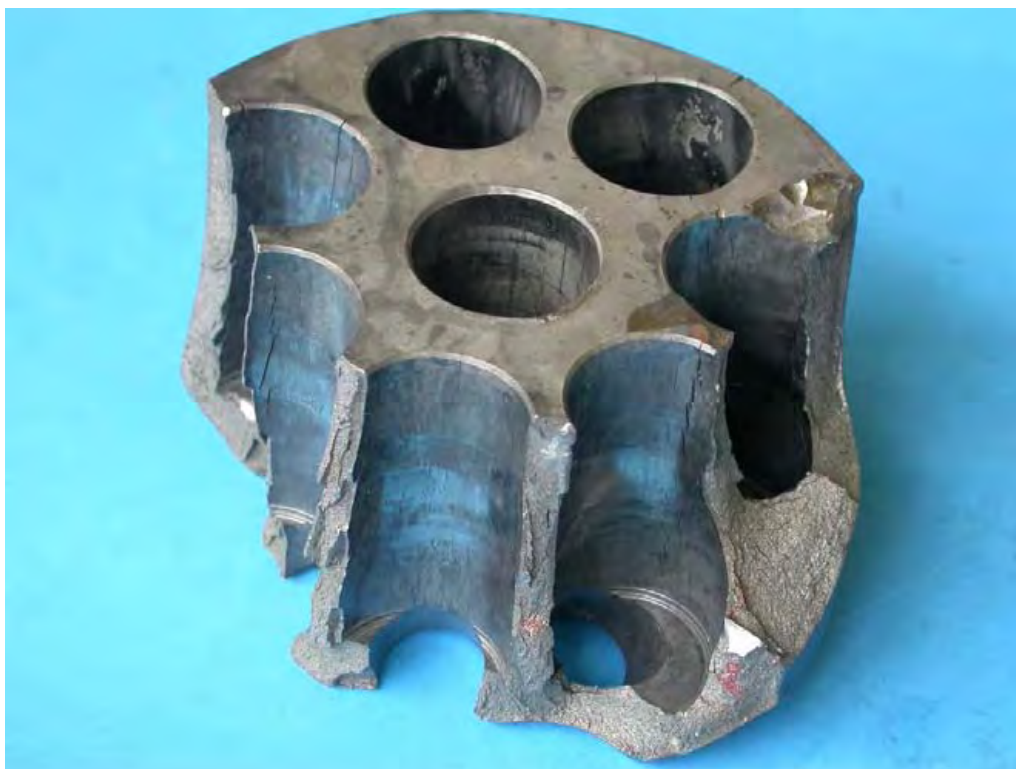
The fractures were consistently oriented in a generally longitudinal direction. They were located in both the ligaments between the cylinders and the blocks outer diameter, and at a number of inter cylinder ligament locations (Figures 7, 8, 9 and 10). The pieces exhibited evidence of multiple random post fracture impact marks, which were apparent at both the pieces fracture surfaces and the blocks outer diameter (Figures 11 and 12). No evidence of pre-casualty fatigue type cracking was apparent at any of the fracture surfaces.

Figure 6: Fractured cylinder block, showing the location of the unrecovered fractured piece or pieces (between arrows).

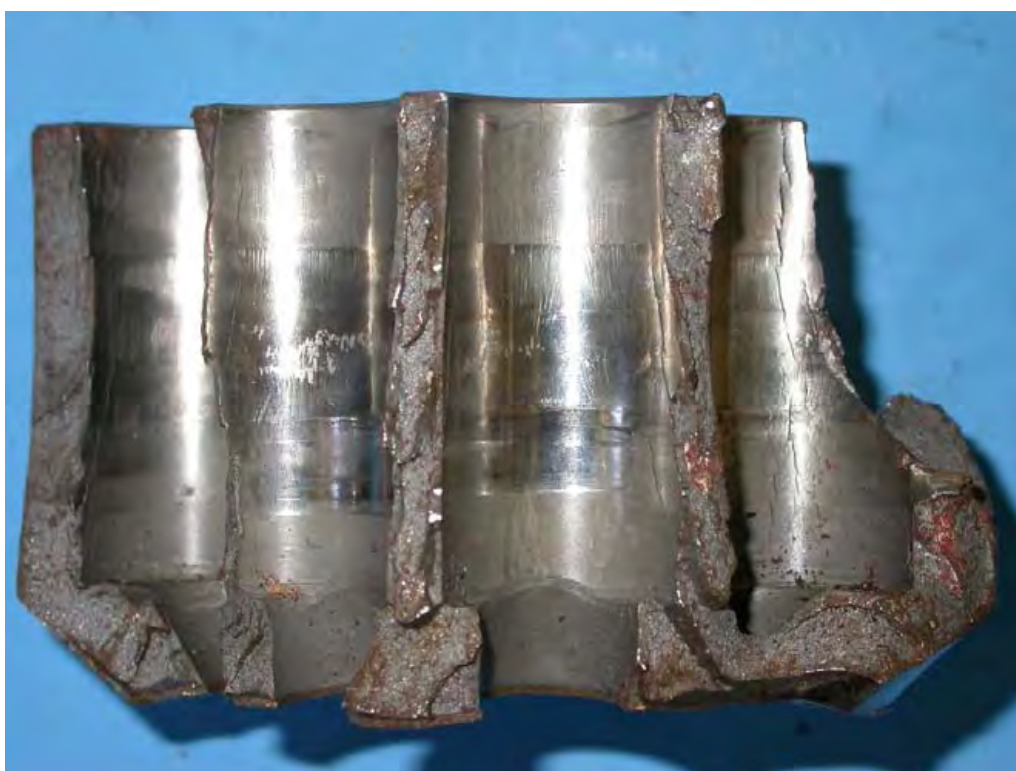
Figure 7: Largest of the recovered cylinder block pieces, showing the orientation and locations of the fracture sites (post fracture impact damage noted).

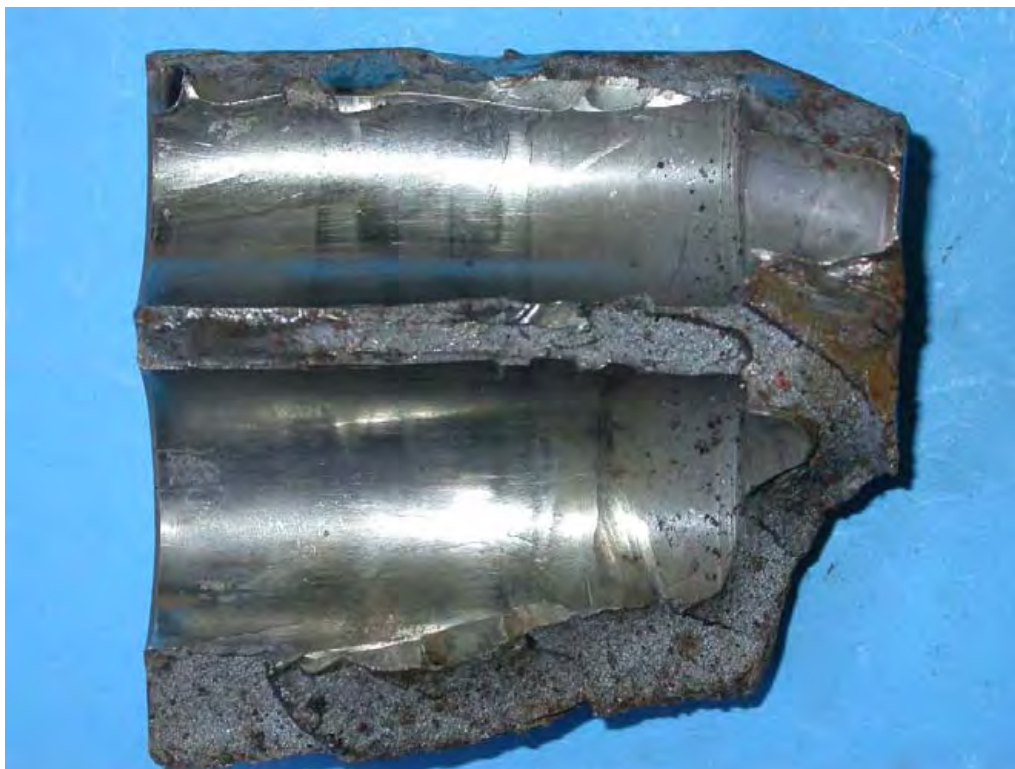
Figure 8: Second of the recovered cylinder block pieces, showing the orientation and locations of the fracture sites (post fracture impact damage noted).

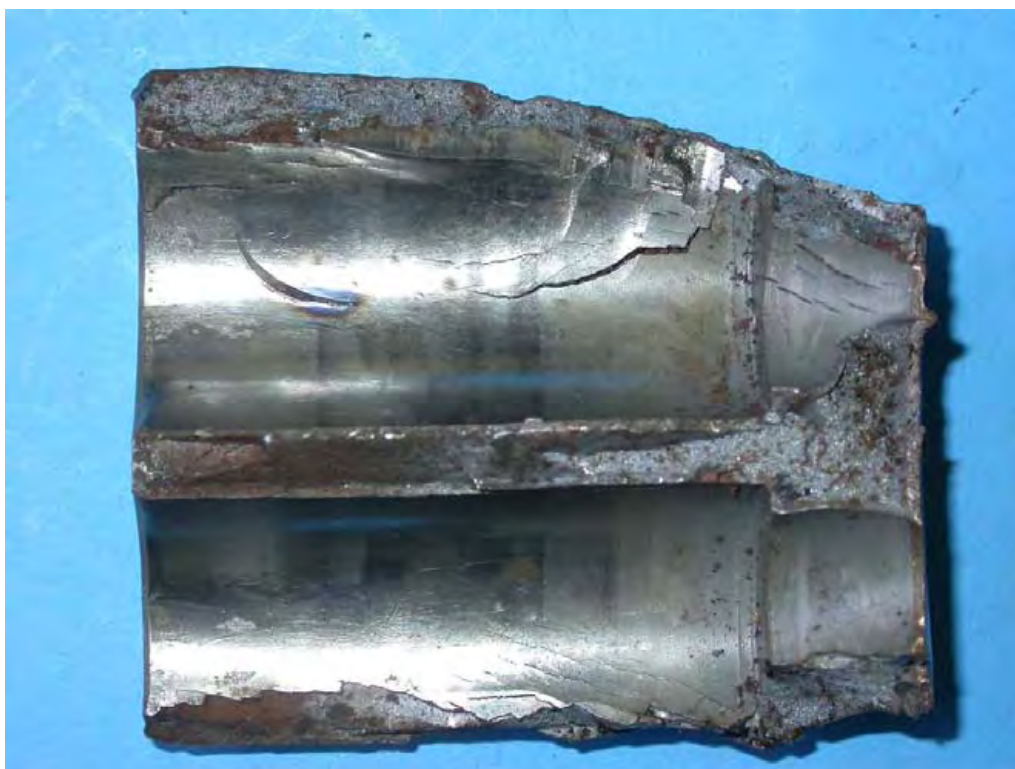
Figure 9: Third of the recovered cylinder block pieces, showing the orientation and locations of the fracture sites (post fracture impact damage noted).

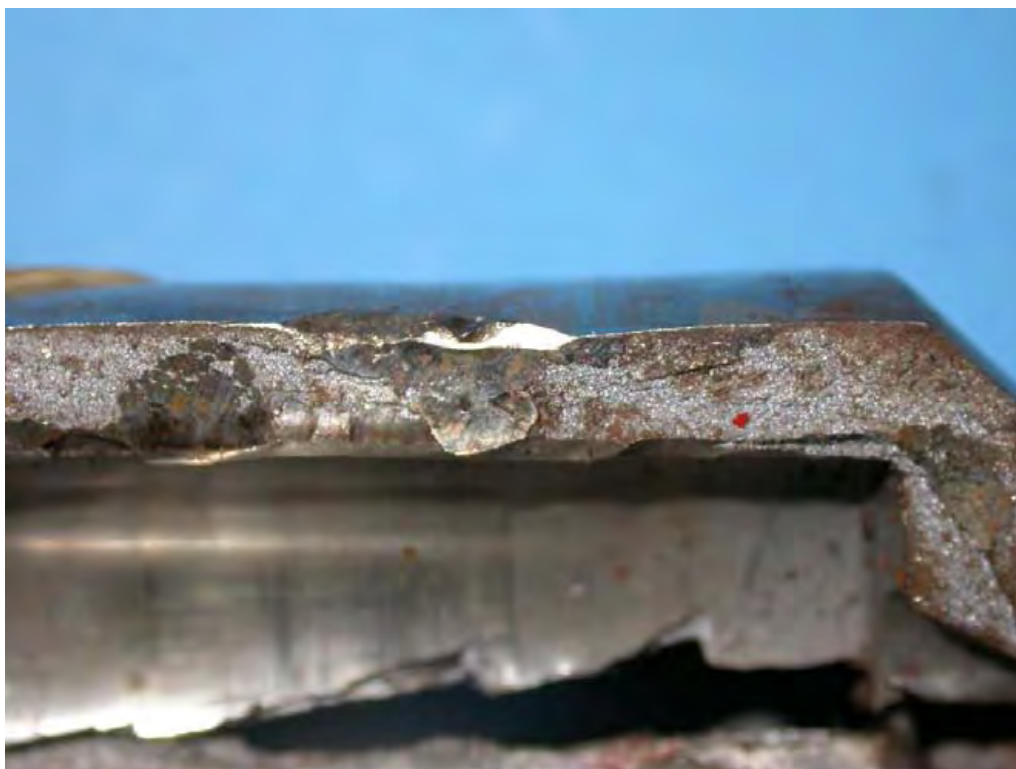
Figure 10: Fourth of the recovered cylinder block pieces, showing the orientation and locations of the fracture sites (post fracture impact damage noted).

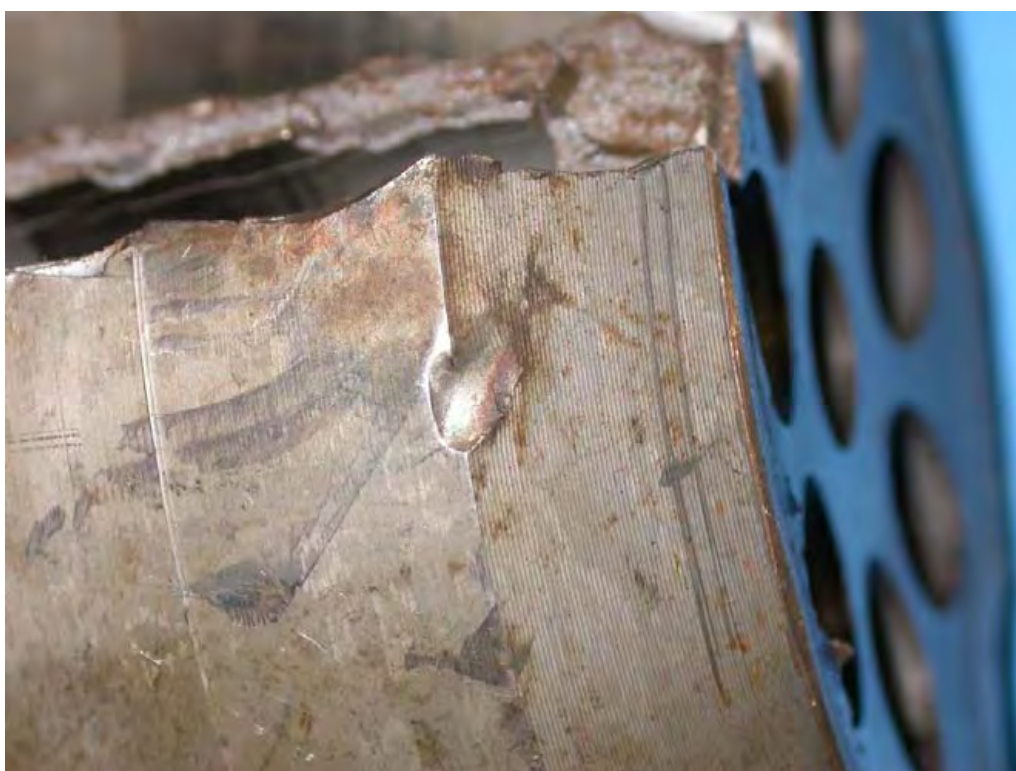
Figure 11: Typical sites of post fracture impact damage.

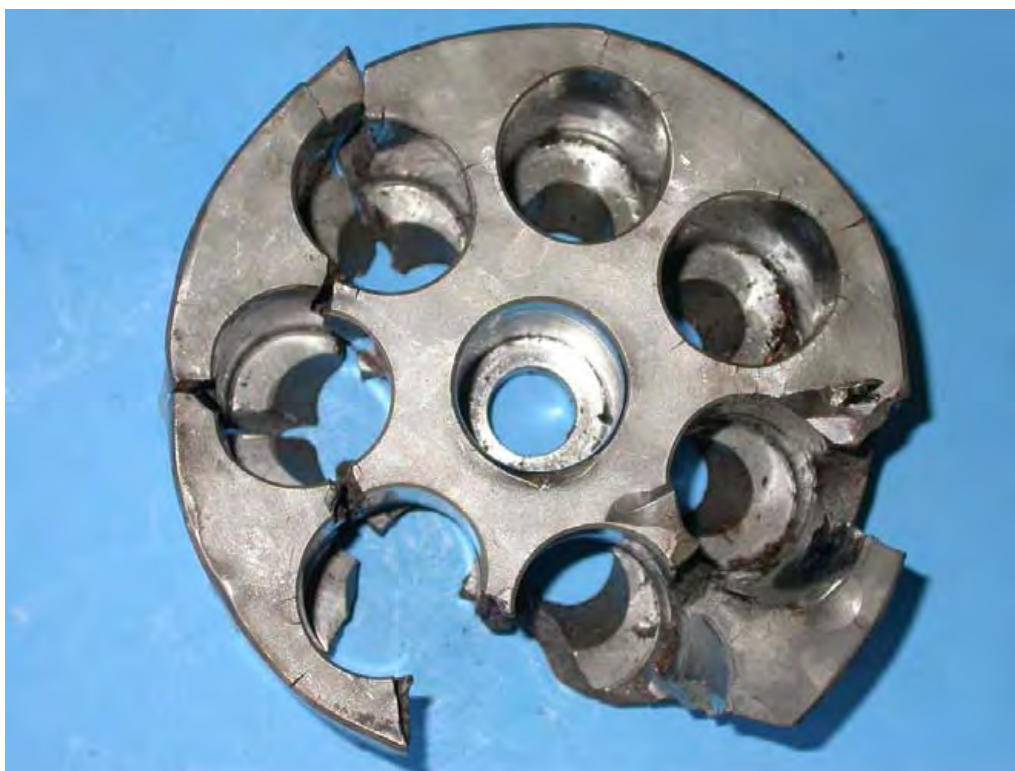
Figure 12: Typical post fracture impact damage at the cylinder clocks outer diameter.

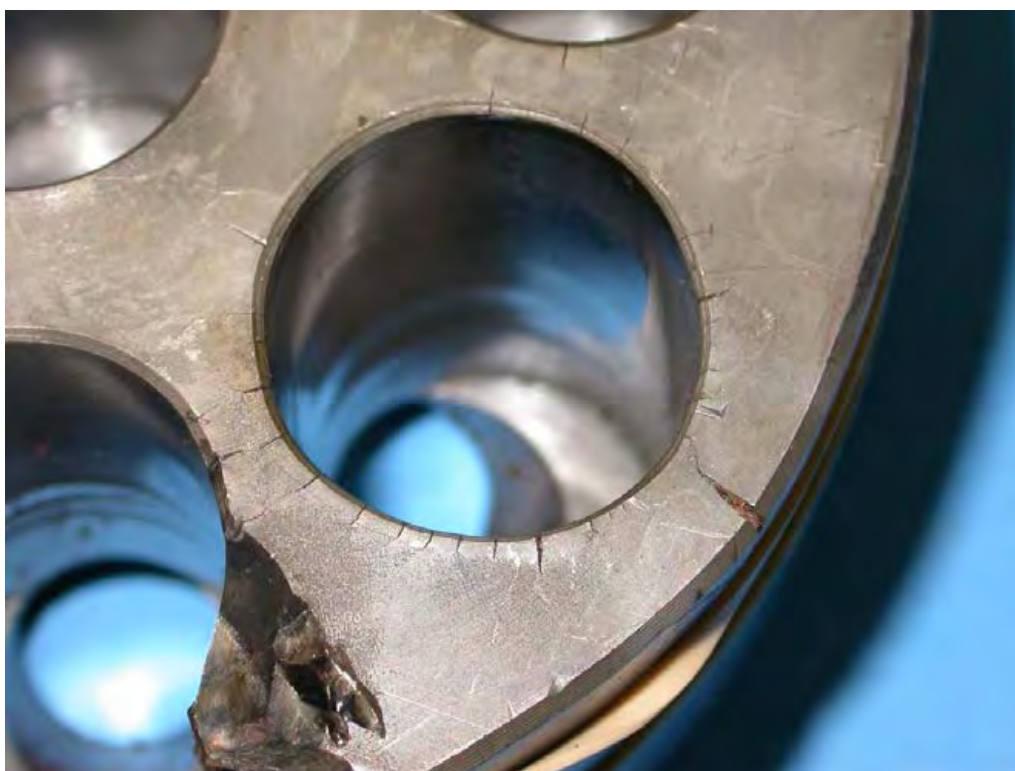
Cylinder holes at the blocks output end exhibited evidence of extensive secondary radial cracks, which were apparent both at the blocks end (Figures 13, 14 and 15) and along individual cylinder walls (Figures 16 and 17). The cracking was noted to be at its most severe adjacent to the fracture sites, and appeared to have resulted from a post yield hoop stress acting upon the cylinder walls.

Figure 13: Secondary radial cracks, which were apparent at the cylinder blocks output end.

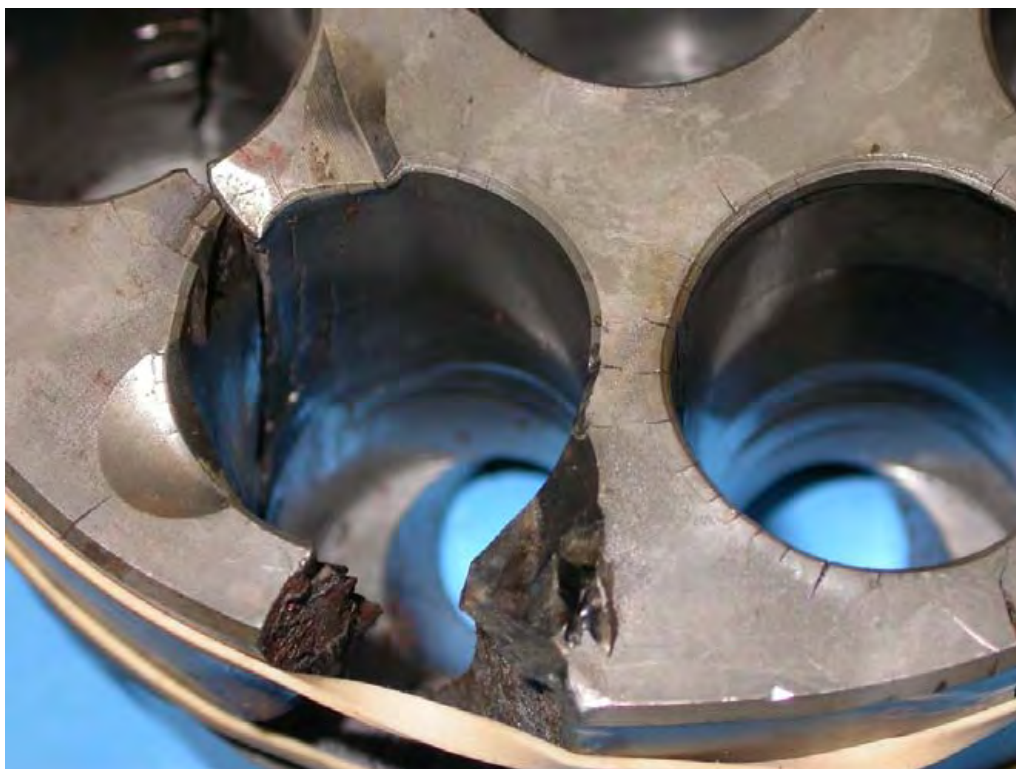
Figure 14: Detail of the output end secondary radial cracks around an individual cylinder.

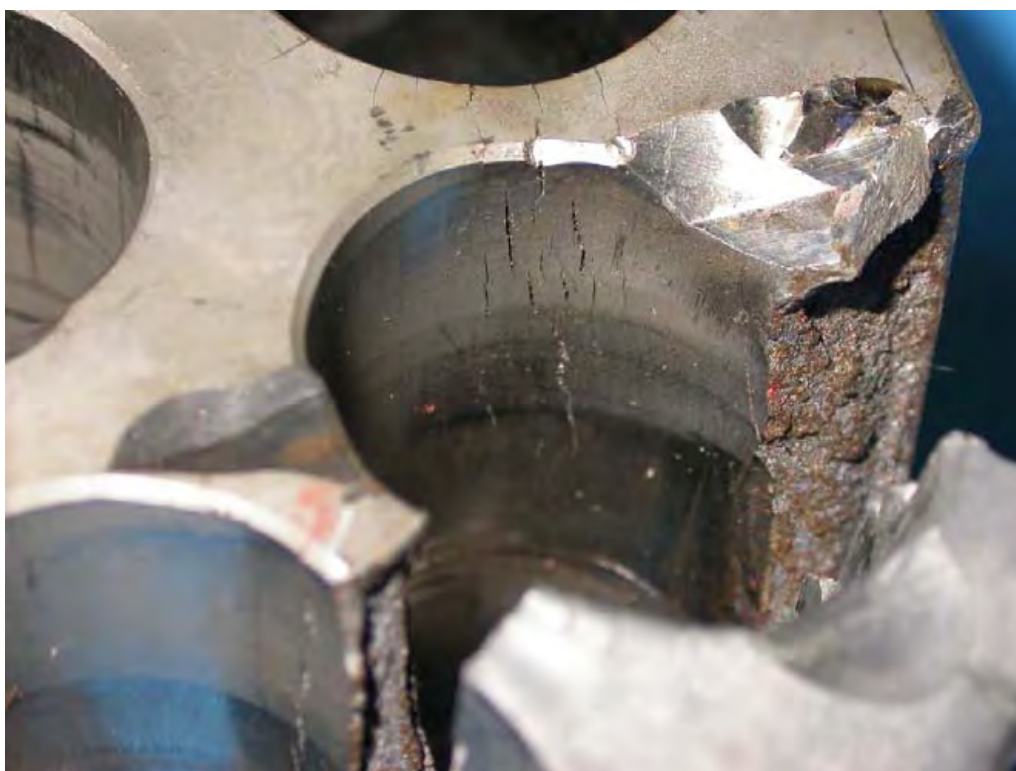
Figure 15: Detail of output end secondary radial cracks at two further adjacent cylinder sites

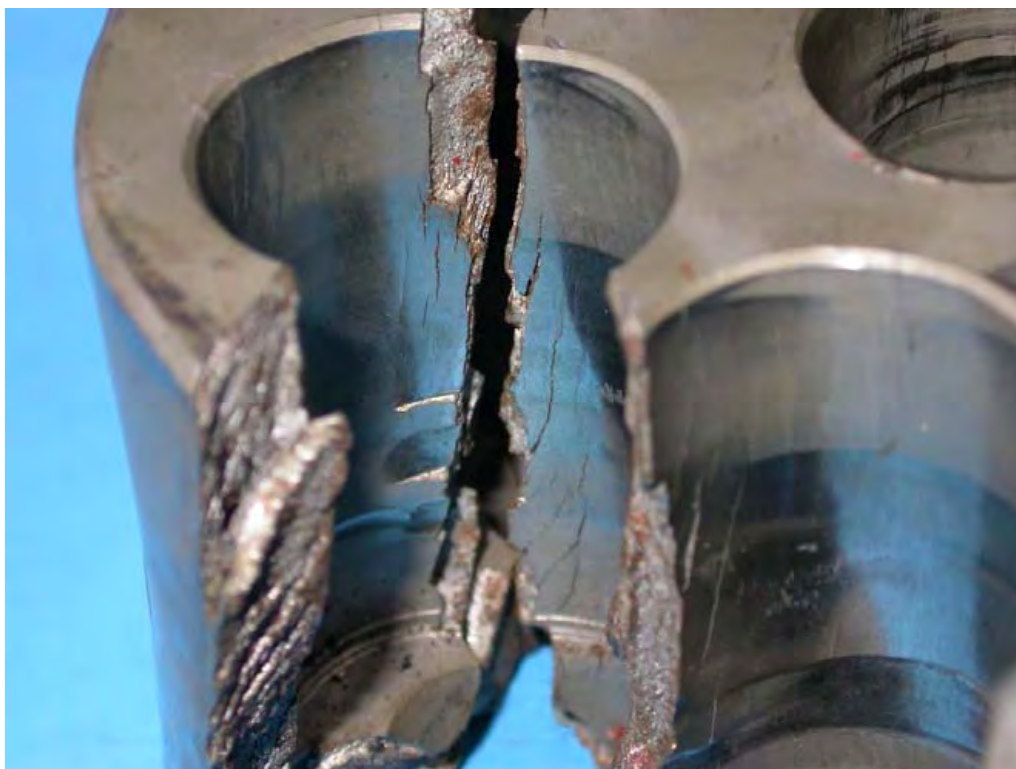
Figure 16: Secondary radial cracks, originating from the cylinder bore surface.

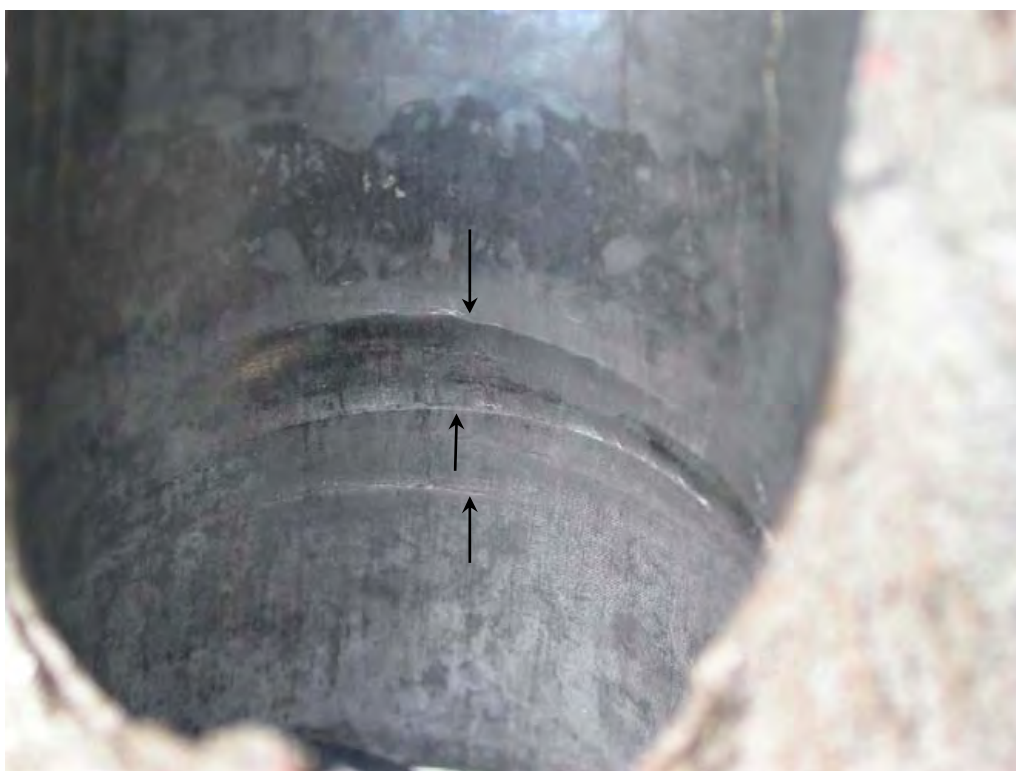
Figure 17: Detail of secondary radial cracks in two further cylinder bores.

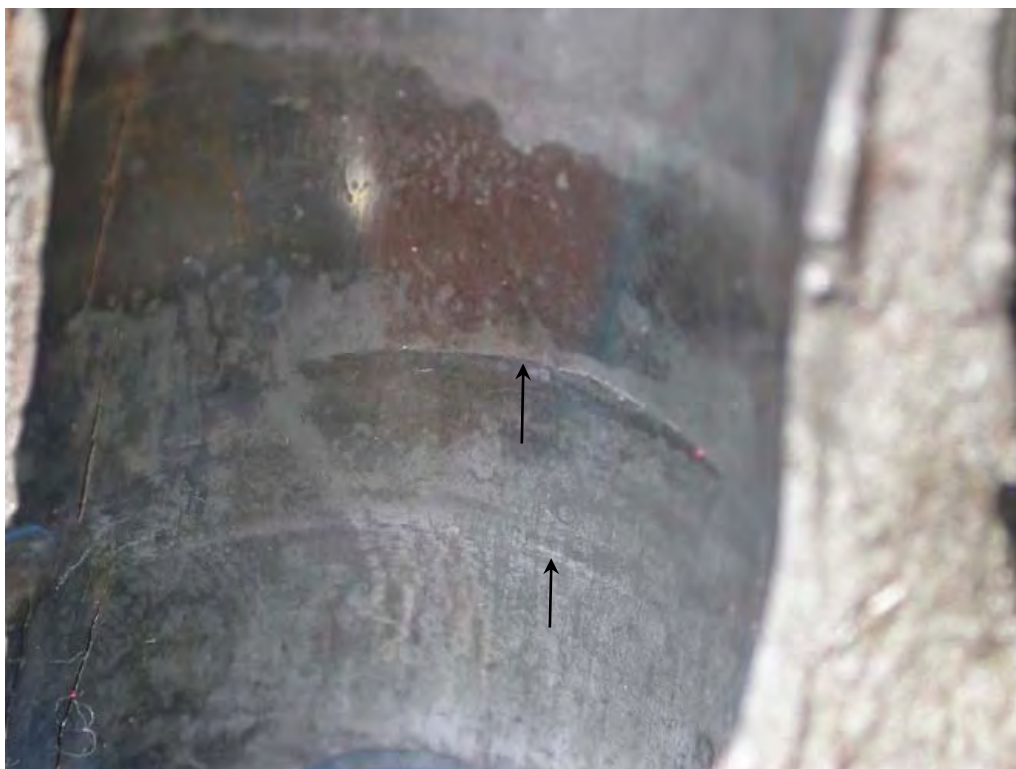
A number of the individual cylinder walls at the blocks fractured side exhibited evidence of piston mechanical indenting damage (Figures 18,

19 and 20), which appeared to be consistent with immediately pre-fracture yielding and deformation of the respective cylinder bores.

Figure 18: Piston mechanical indenting damage (arrowed) at the walls of a cylinder.

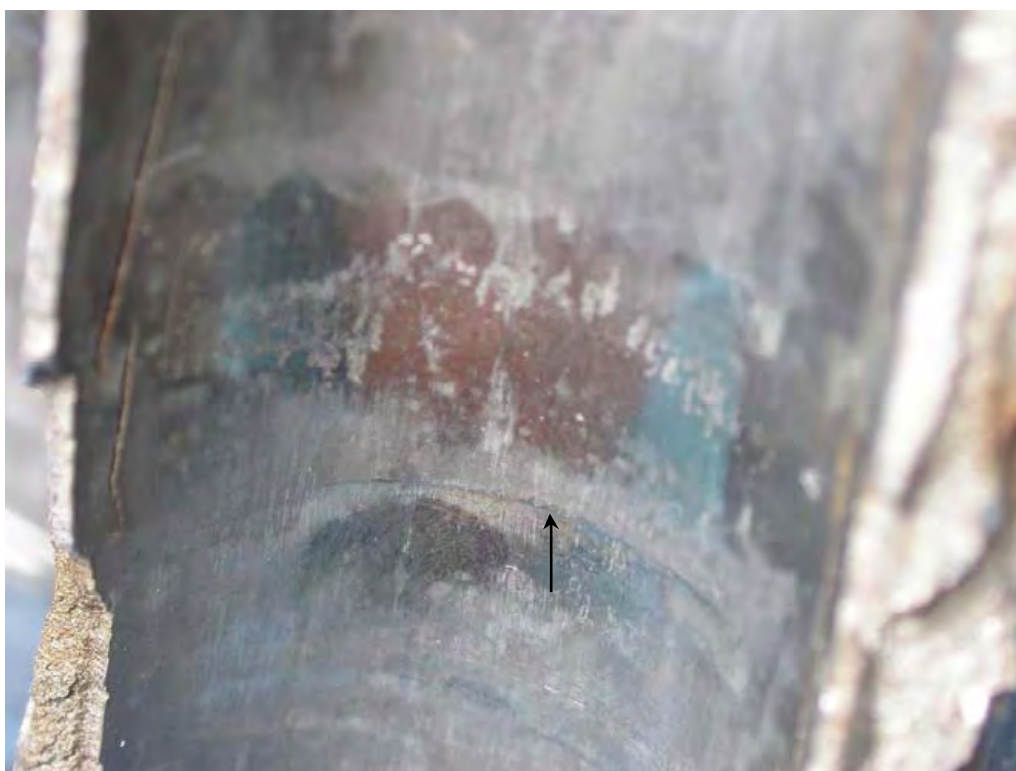
Figure 19: Detail of piston mechanical indenting damage (arrowed) at the walls of a second cylinder.

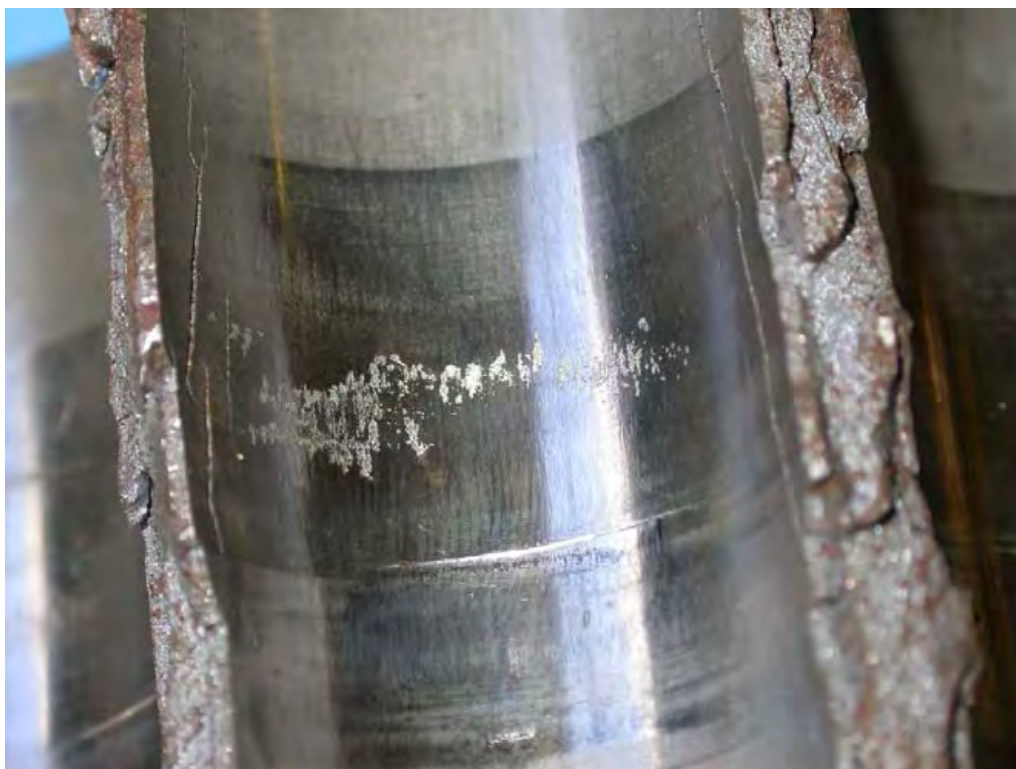
Figure 20: Detail of piston mechanical indenting damage (arrowed) at the walls of a third cylinder.

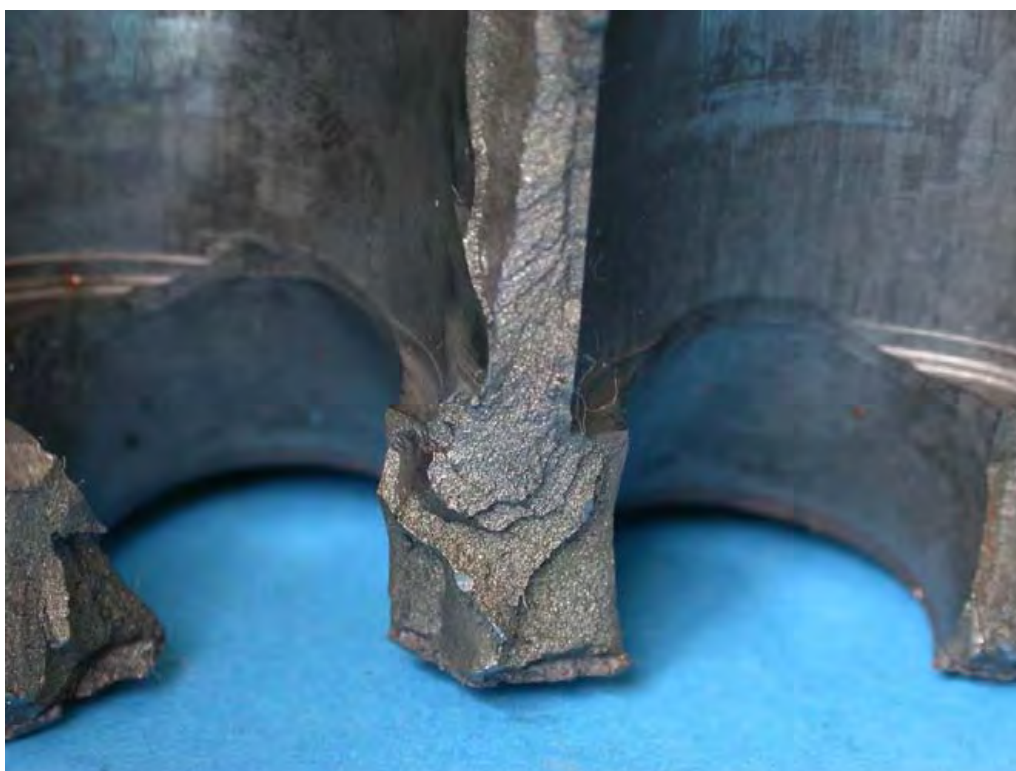
Though not apparently causative or related to the fracture process, a number of the cylinder bores exhibited evidence of incipient service wear or spalling type damage (Figure 21).

Figure 21: Incipient cylinder bore wear or spalling type damage.

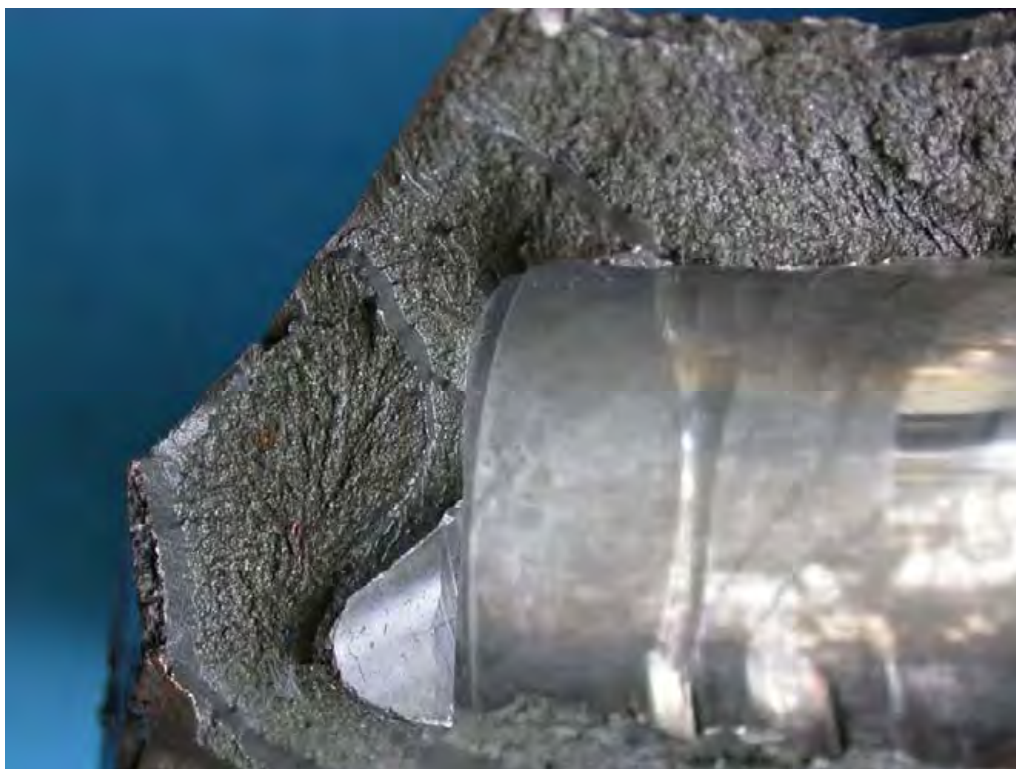
The cleaned fracture surfaces were seen to comprise what appeared to be a coincident series of fast brittle fractures (Figures 22, 23, 24, 25, 26 and 27), as exemplified by the widespread evidence of both brittle and chevron type fracture markings. Though the fracture surfaces were seen to exhibit numerous sites of post fracture impact type damage, the more detailed examination identified no evidence of pre-existing manufacturing defects or fatigue cracking.

Figure 22: Region of the cylinder block fracture surface, showing features consistent with a single event brittle fracture (post fracture mechanical damage noted).

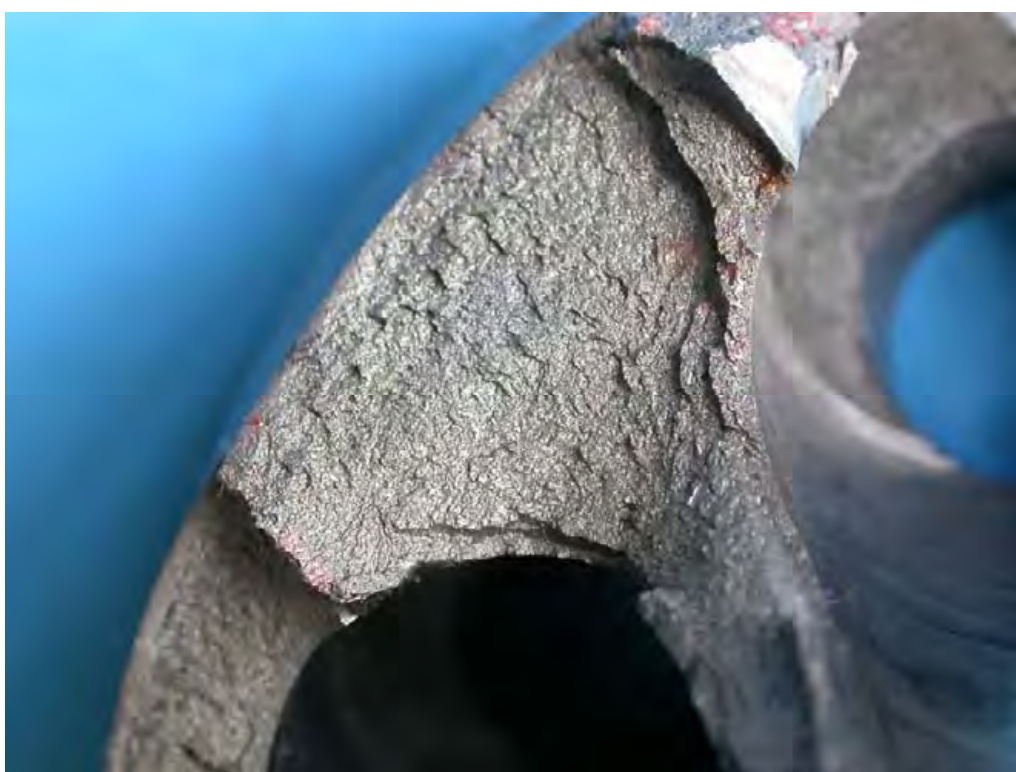
Figure 23: Second region of the cylinder block fracture surface, showing features consistent with a single event brittle fracture (post fracture mechanical damage noted).

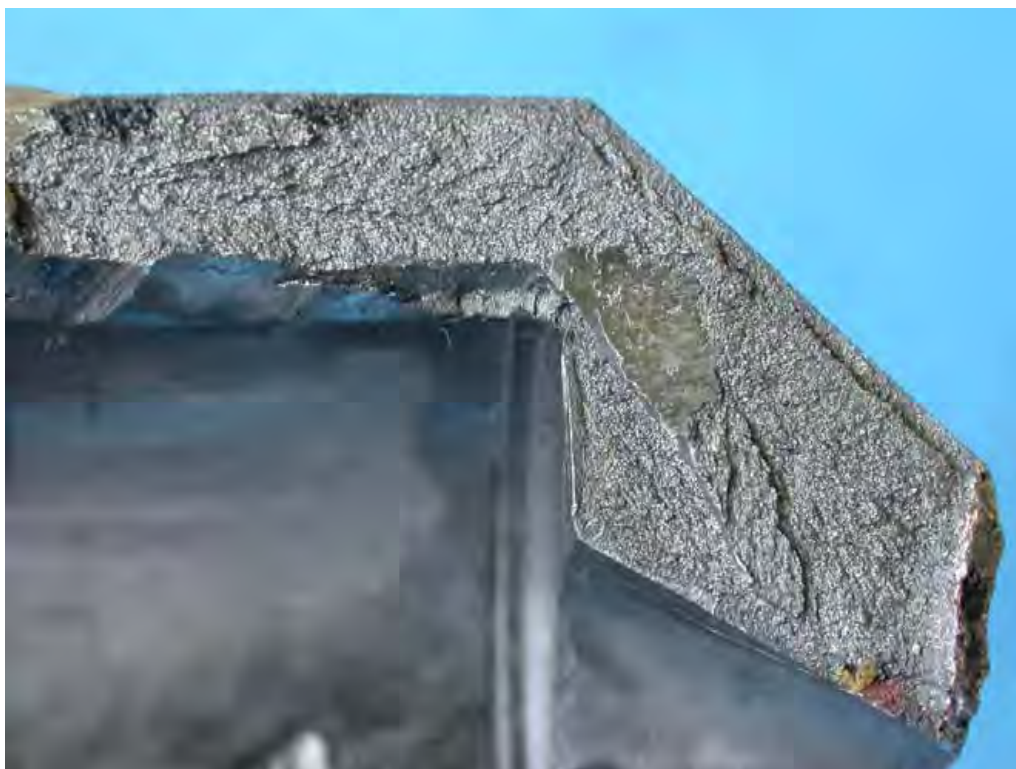
Figure 24: Third region of the cylinder block fracture surface, showing features consistent with a single event brittle fracture (post fracture mechanical damage noted).

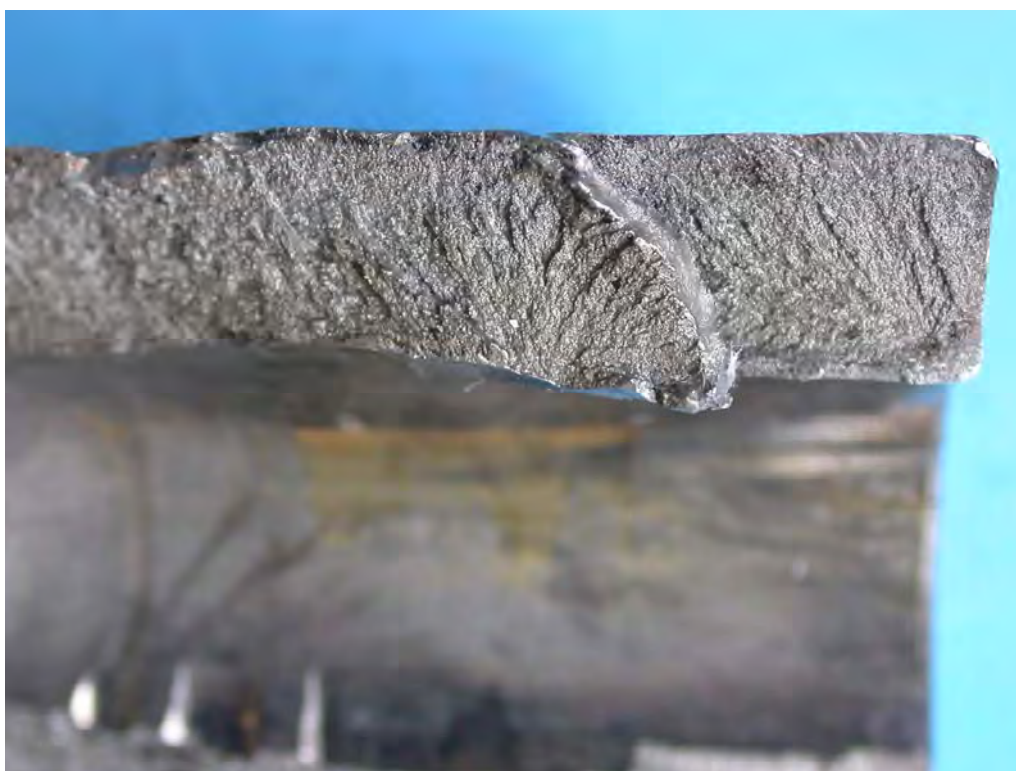
Figure 25: Fourth region of the cylinder block fracture surface, showing features consistent with a single event brittle fracture (post fracture mechanical damage noted).

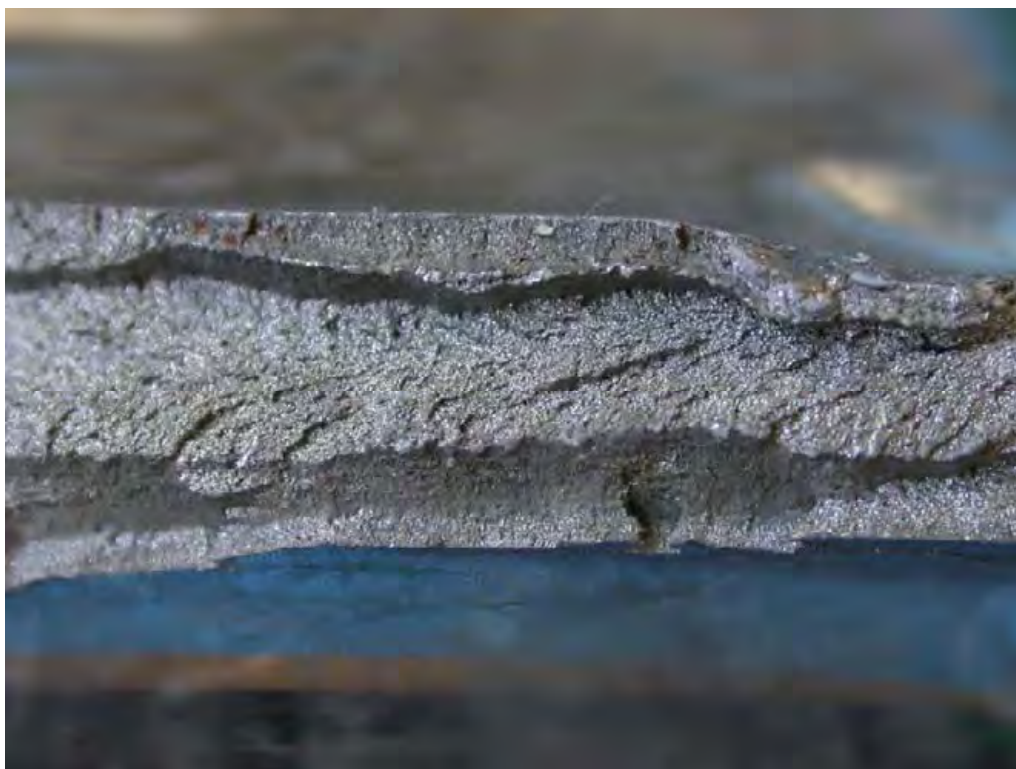
Figure 26: Fifth region of the cylinder block fracture surface, showing features consistent with a single event brittle fracture (post fracture mechanical damage noted).

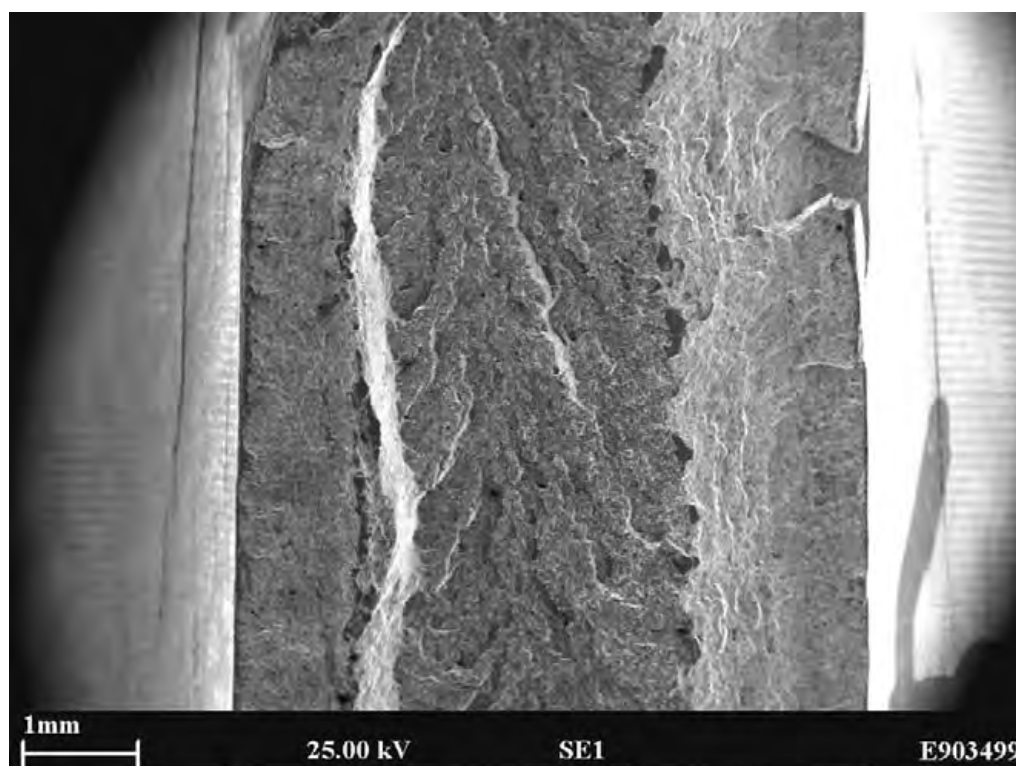
Figure 27: Sixth region of the cylinder block fracture surface, showing features consistent with a single event brittle fracture (post fracture mechanical damage noted).
