Survey Report
no. 091909

According to the commissioning by **[REDACTED]**, company of Zeppelin Baumaschinen GmbH, on April 14, 2009, the cause which led to the destruction of a hydraulic motor shall be examined.

Hydraulic drive for a combined windlass and mooring winch:

**EXAMINATION OF A FRACTURED
AXIAL DISPLACEMENT
HYDRAULIC MOTOR CYLINDER
BLOCK AND ASSOCIATED
ITEMS FROM THE ANCHOR
WINDLASS OF
*MT STELLAR VOYAGER***

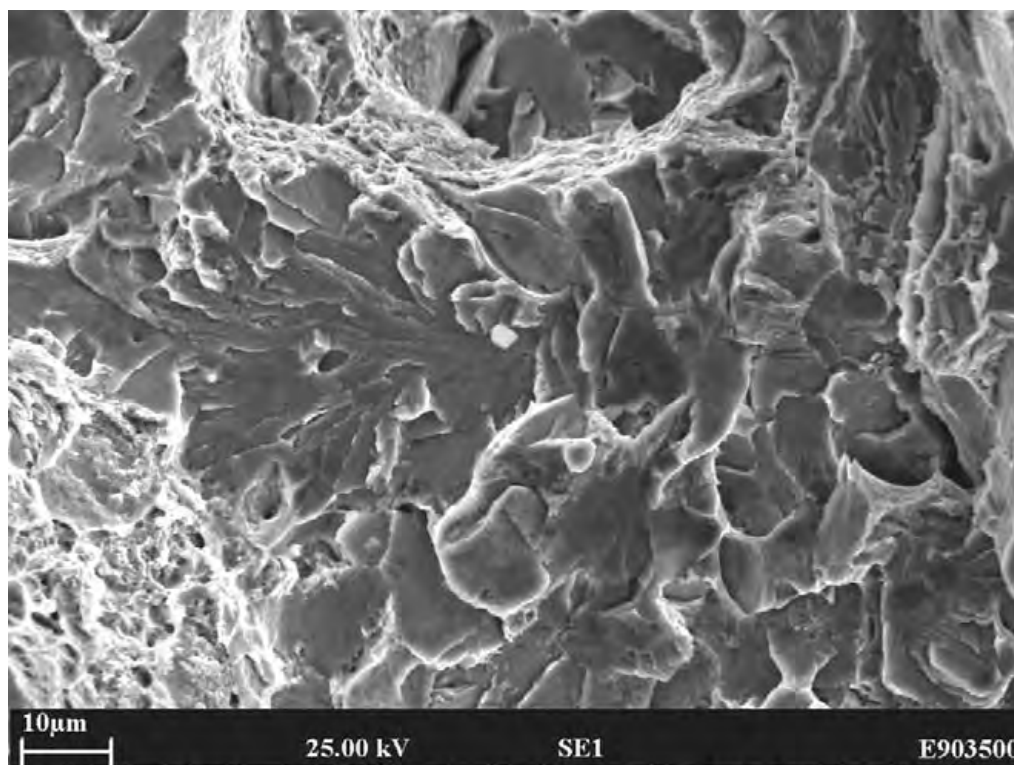
The detailed SEM examination of the cylinder block fracture surfaces confirmed the fracture mode to be one of brittle transgranular cleavage (Figures 28, 29 and 30). Examination of the incipient cylinder wall damage (Figure 31) appeared less definitive (Figure 32) and could have resulted from either local micro cracking of the hard chromium plating, or more likely, sliding contact fatigue type surface spalling.

Figure 28: SEM fractograph, showing a typical cylinder block fracture surface field and one characterised by fast fracture "chevron" type markings.

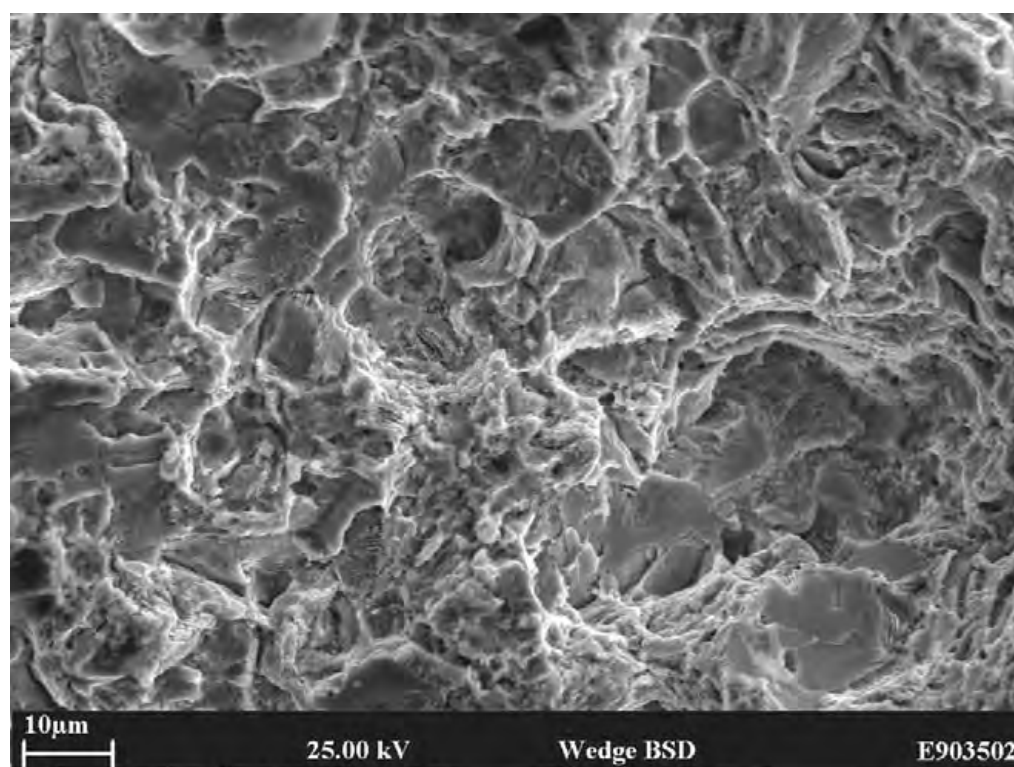
Figure 29: SEM fractograph, showing detail of cleavage fracture apparent at the right hand hole edge of figure 28.

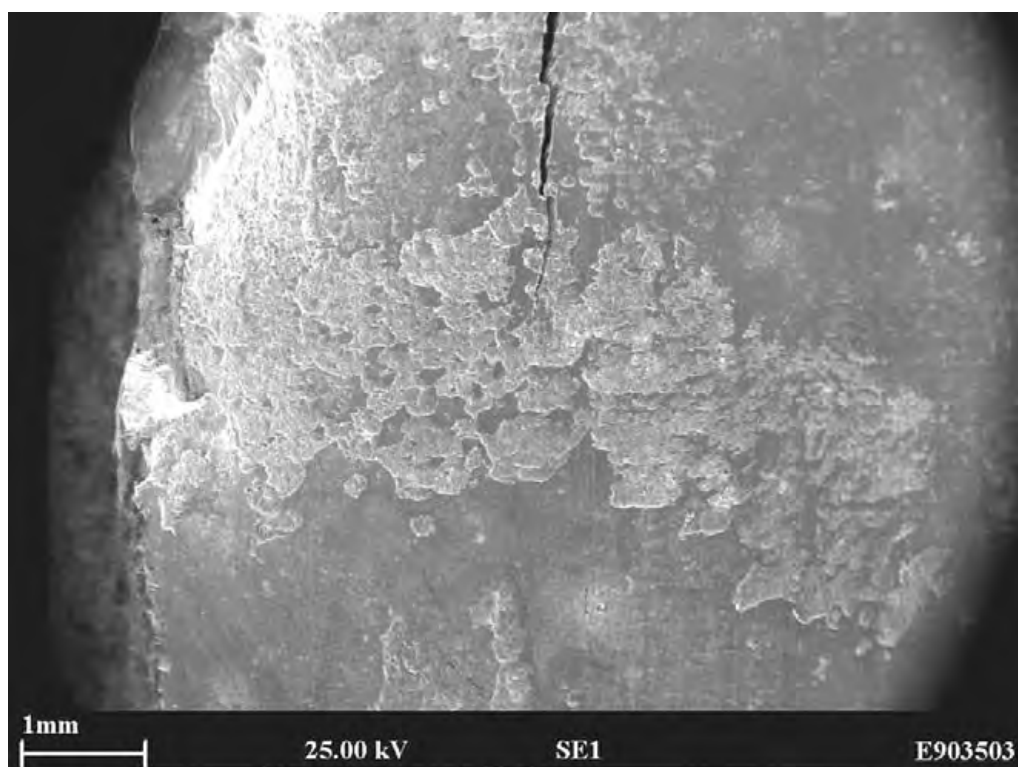
Figure 30: SEM fractograph, showing cleavage fracture apparent at the left hand hole edge of figure 28.

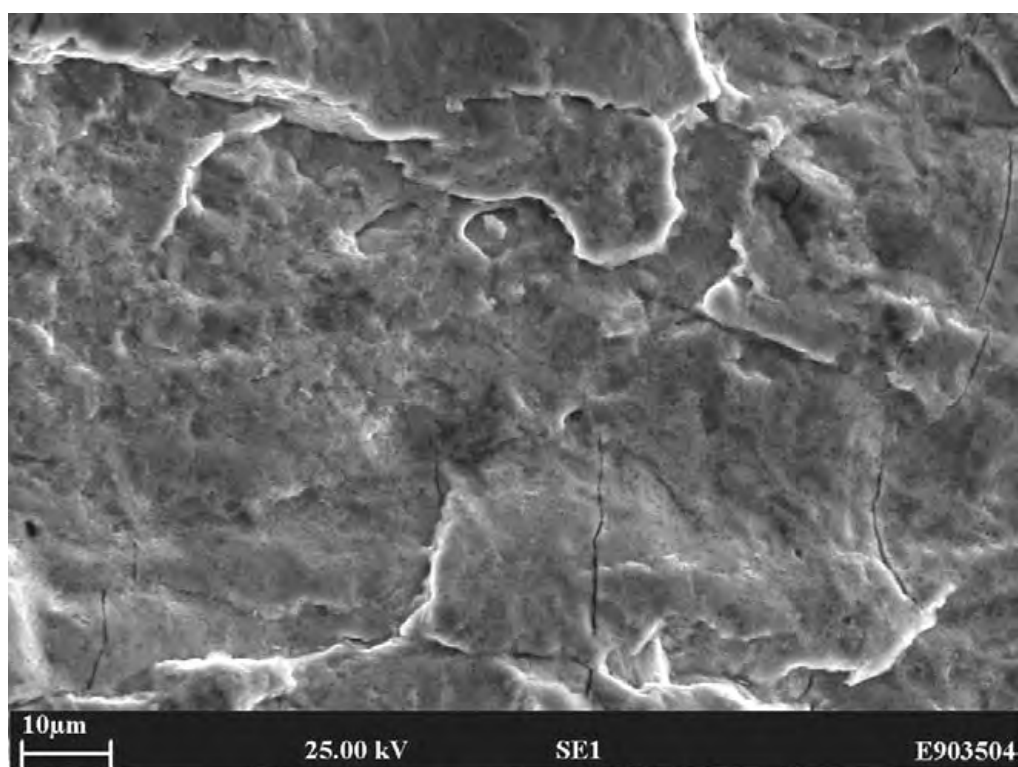
Figure 31: SEM fractograph, showing a local site of incipient cylinder bore wear or damage (secondary radial crack noted at top centre field).

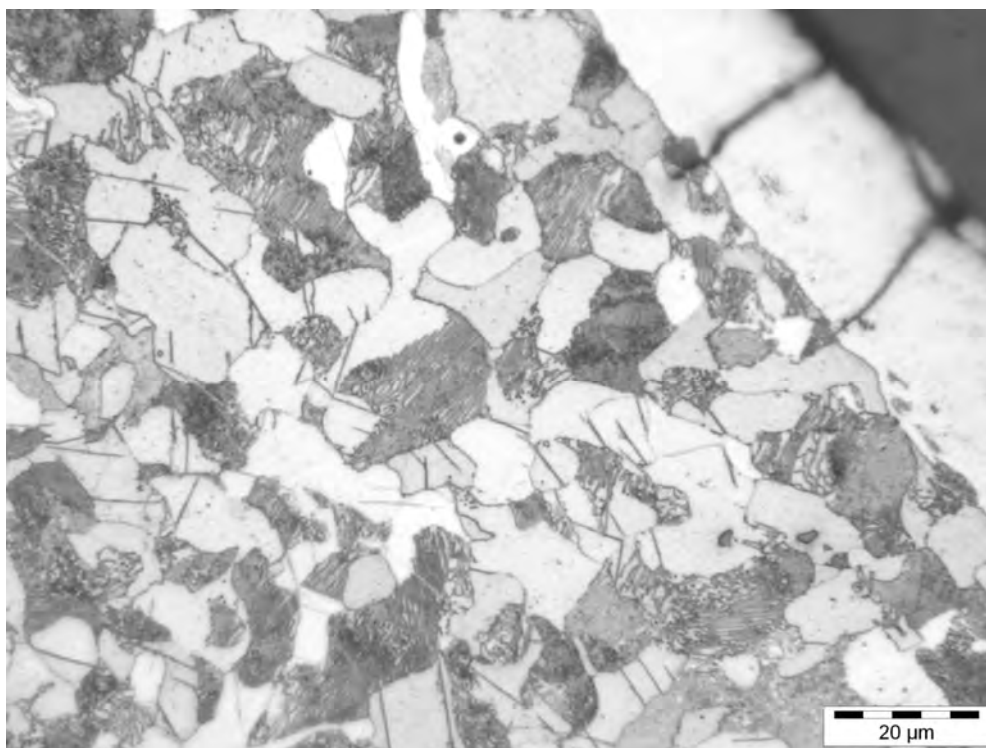
The prepared specimens included three fracture sites (Figure 34), all of which exhibited similar features. The fracture sites were accompanied by extensive evidence of secondary radial cracking of the cylinder walls (Figures 35 and 36), and the fracture process appeared to be essentially brittle (Figure 37).

Figure 37: Micrograph (original image captured at X500), specimen etched in Nital. Detail of one of the fractured cylinder block walls, showing evidence of an essentially brittle fracture mechanism.

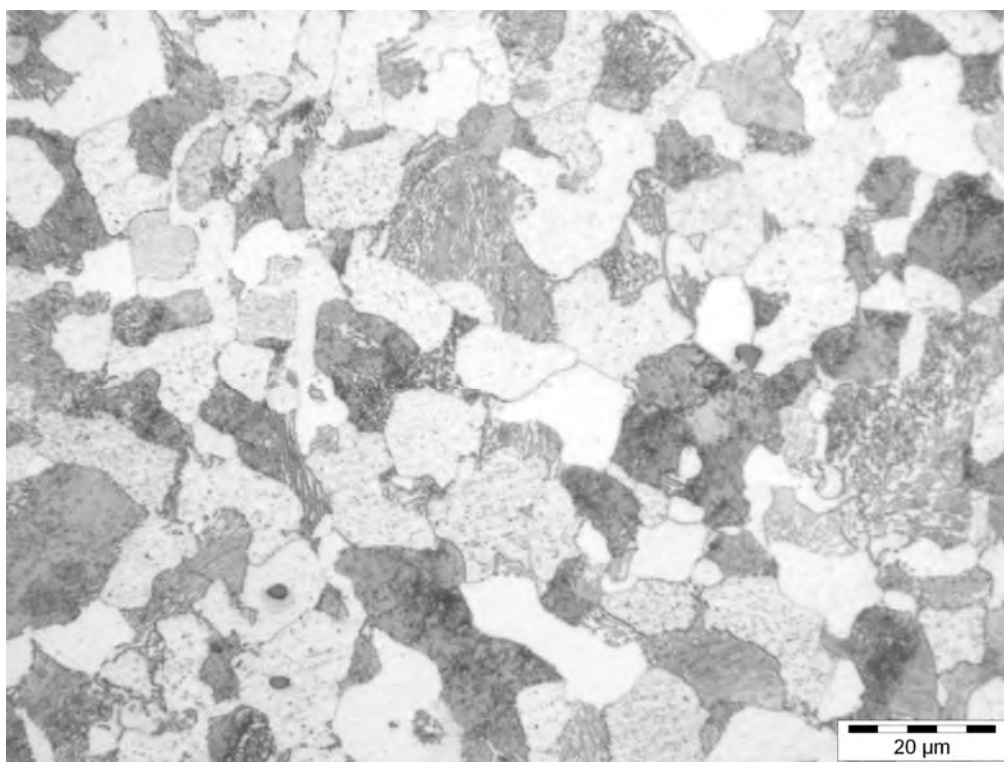
The cylinder bores were seen to have been hard chromium plated, and near surface regions of the steel block substrate exhibited very widespread evidence of sub grain strain induced twinning (Figure 38). Widespread evidence of cracking was also apparent in the chromium plating (Figure 38), which coupled with the near surface sub grain strain damage suggested that extensive hoop stress type yielding of the cylinder bores had occurred immediately prior to the terminal fracture.

Figure 38: Micrograph (original image captured at X1000), specimen etched in Nital. A field adjacent to a cylinder bore, showing extensive post yield sub-grain twinning and cracking in the chromium plating.

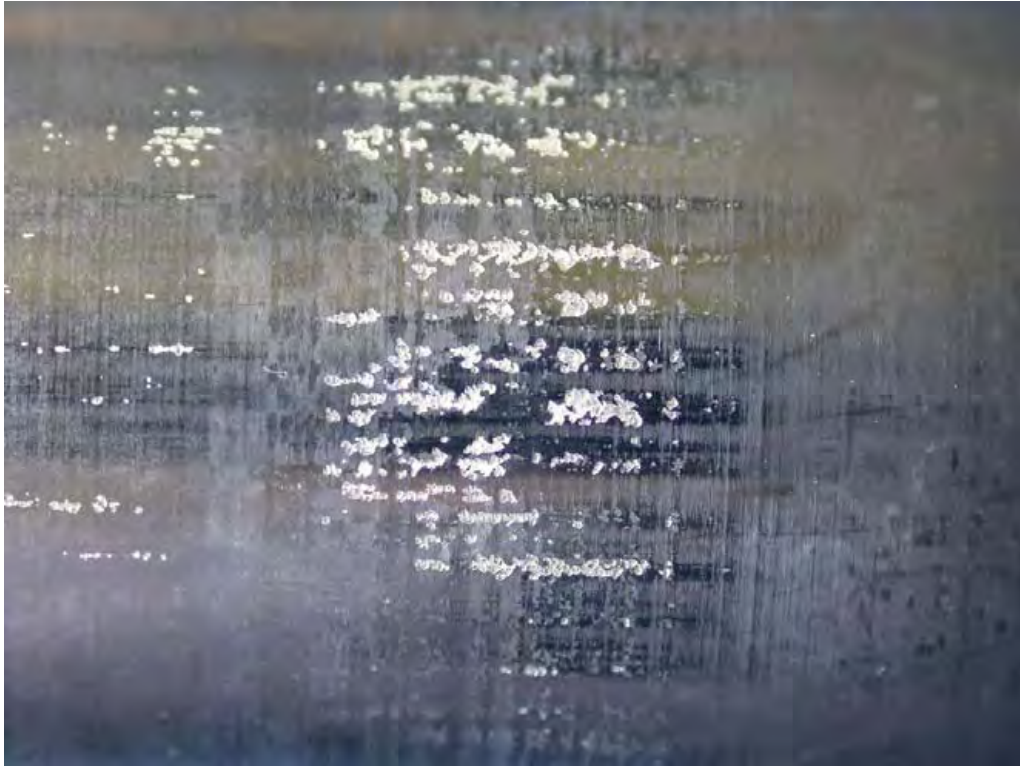
Figure 42: Incipient service wear or spalling type damage (damage sites arrowed).

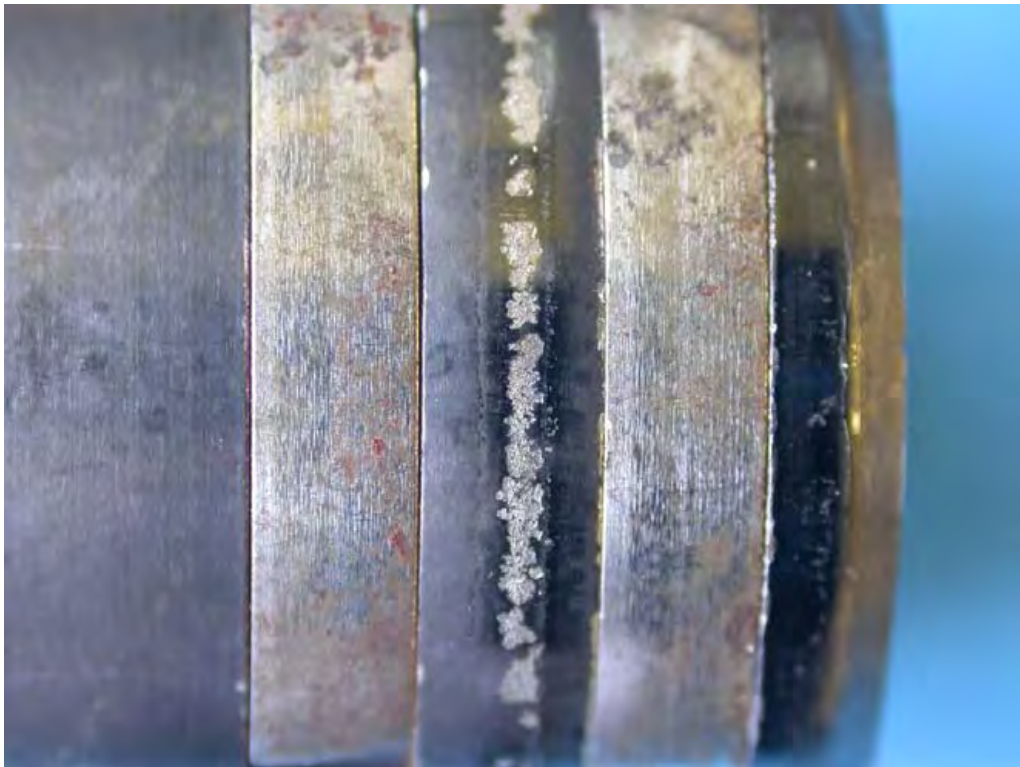
Figure 43: Detail of figure 42, showing wear or spalling of the main body region.

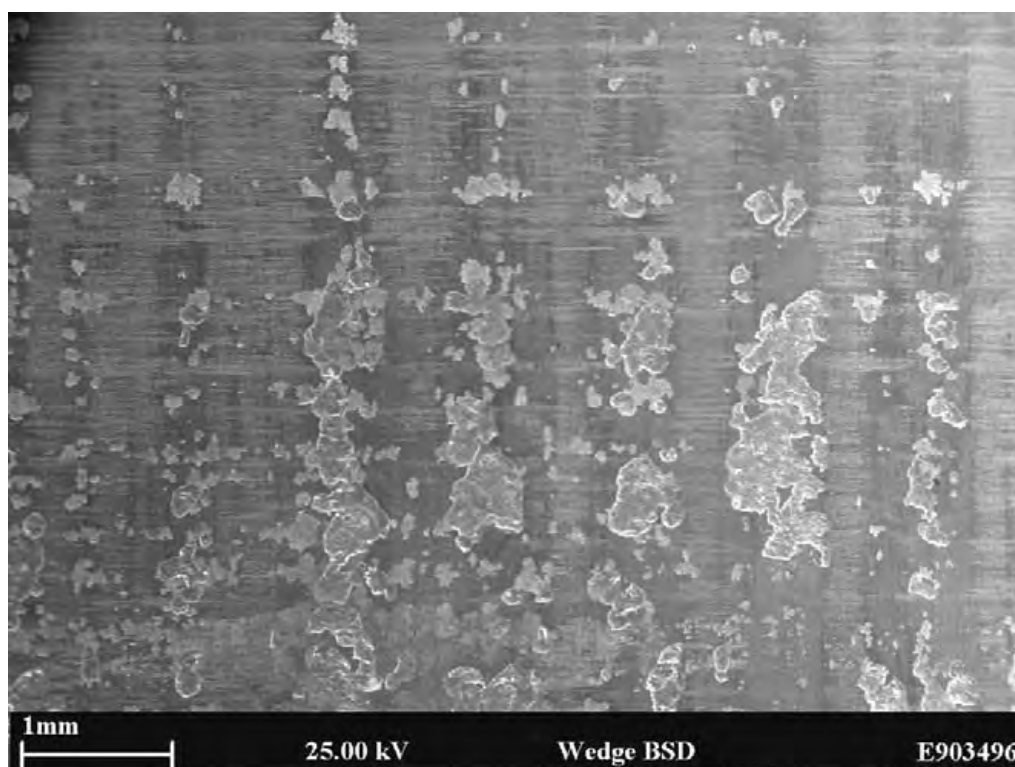
Figure 44: Detail of figure 42, showing wear or spalling of the region between the two piston rings.

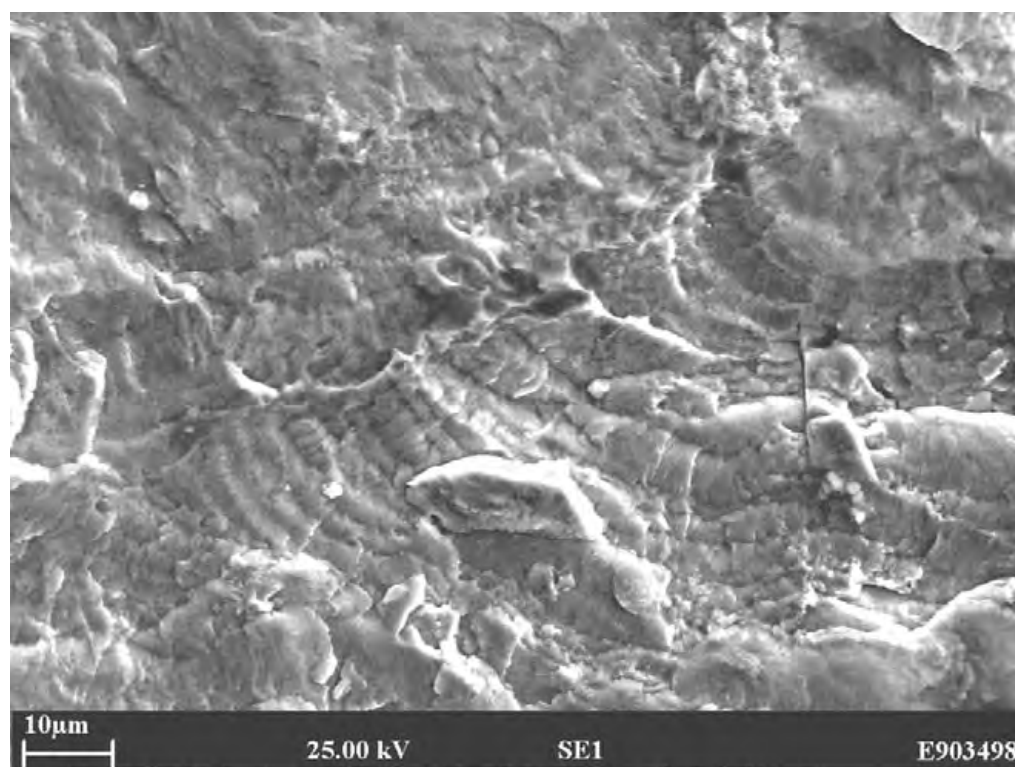
Figure 45: SEM fractograph, showing surface spalling type damage in the pistons main body region.

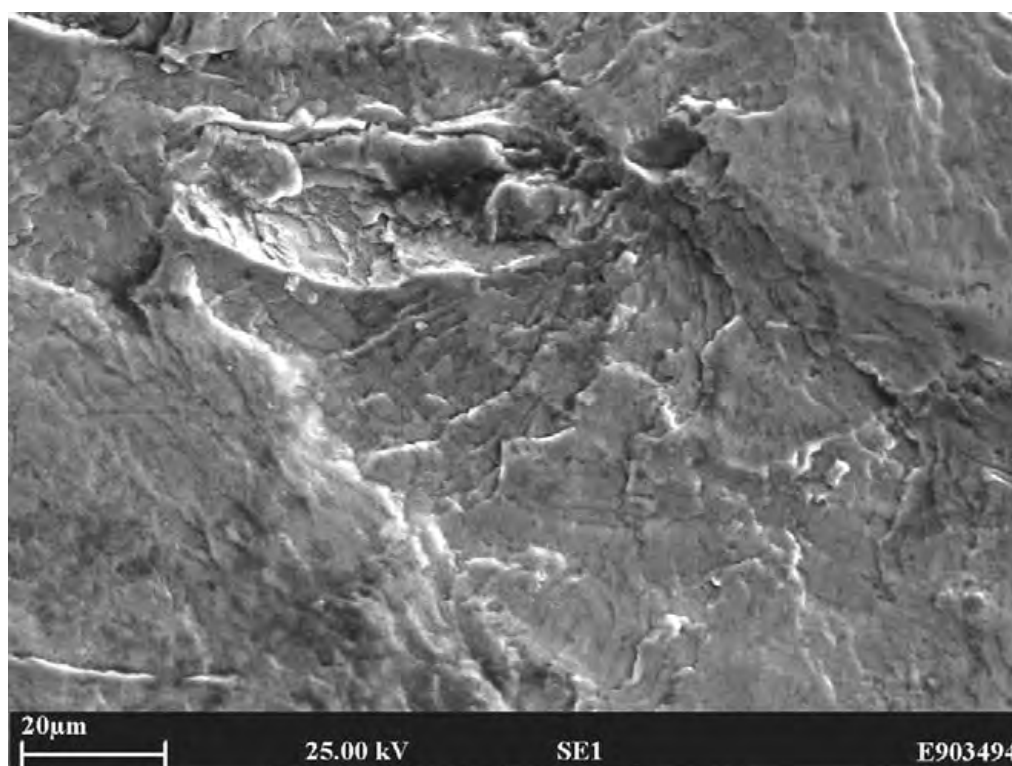
Figure 47: SEM fractograph, showing surface spalling type damage between the two pistons rings.

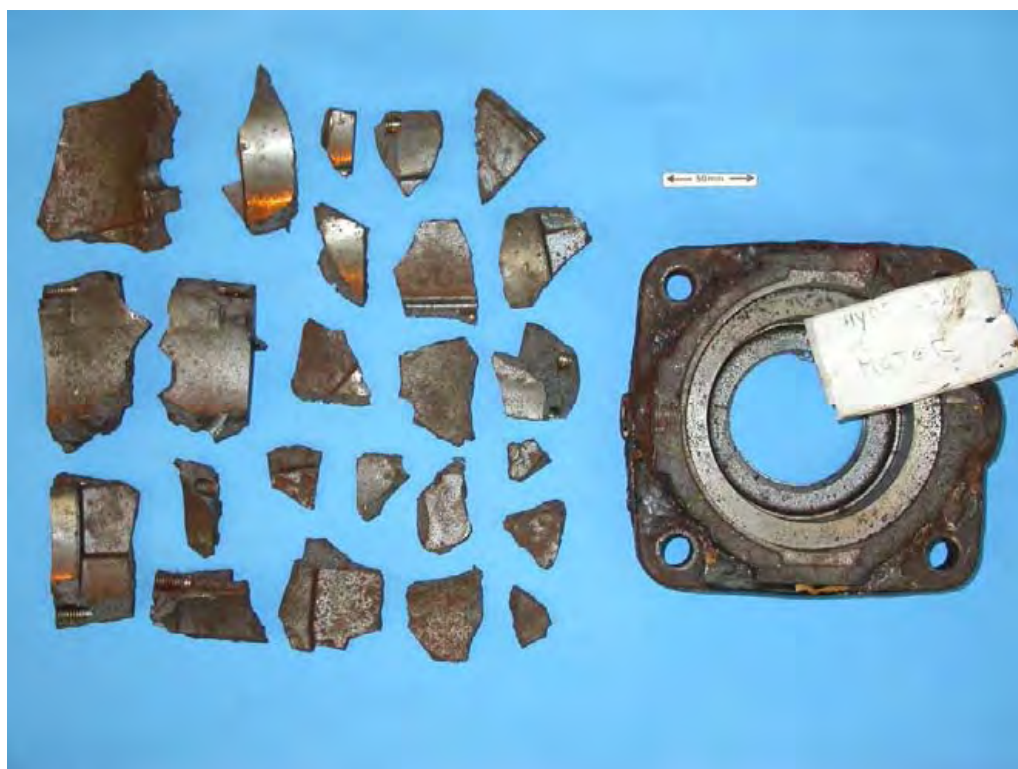
Figure 56: Recovered pieces from the extensively fractured cast iron motor casing.

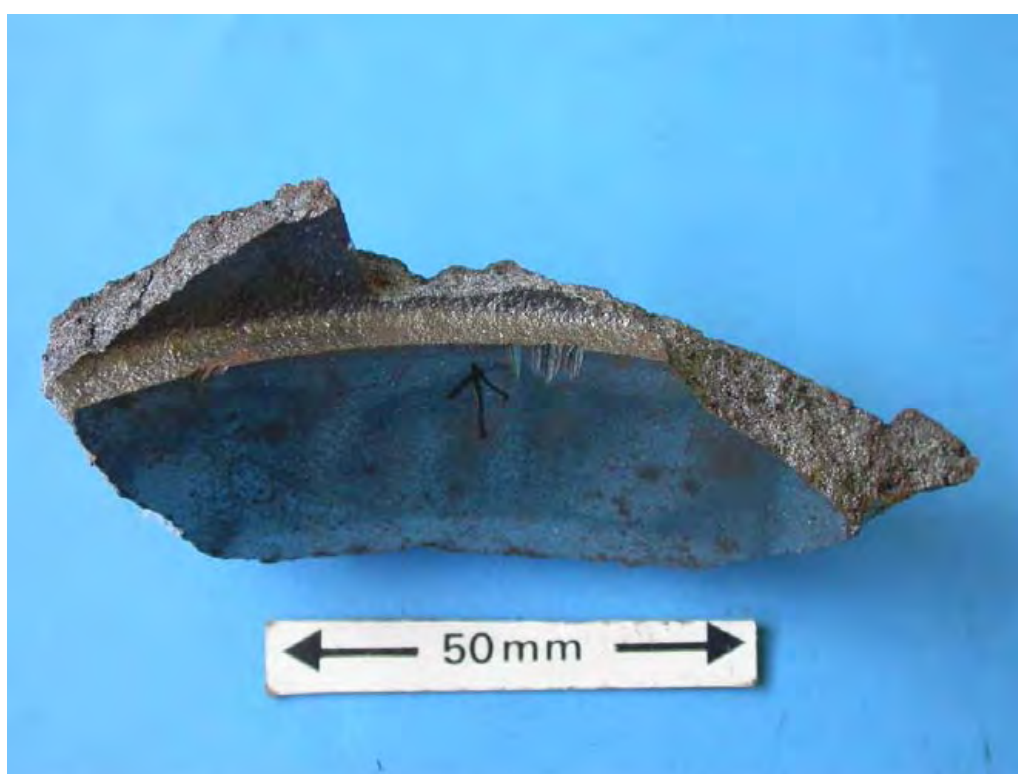
Figure 57: Recovered pieces from the extensively fractured cast iron motor casing, viewed from their opposite sides.

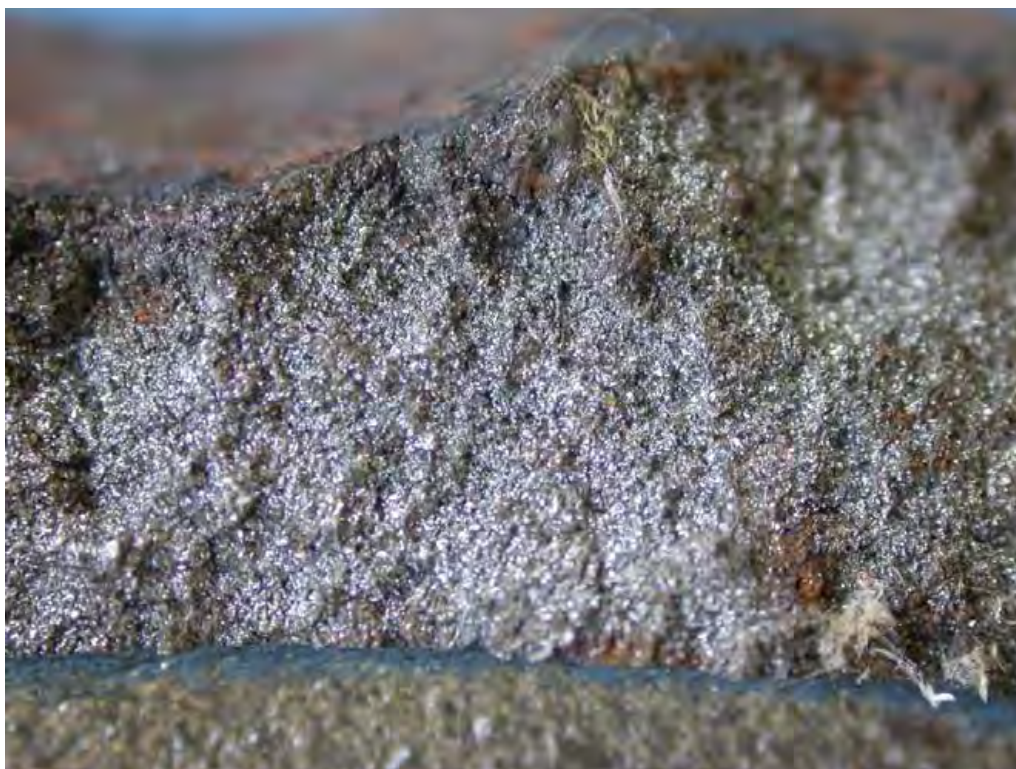
Figure 58: fractured piece from the motor casing, which exhibited fracture surfaces indicative of a cast iron (piece subsequently examined fractographically and metallographically).

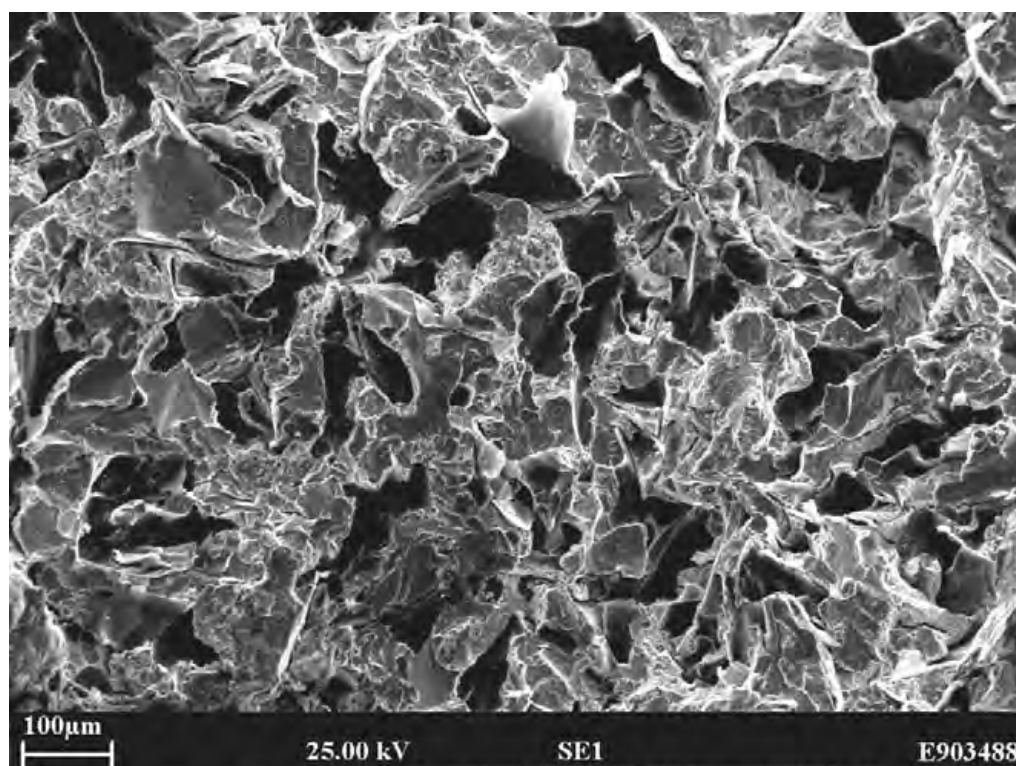
Figure 59: Detail of figure 58, showing fracture surface features consistent with a cast iron.

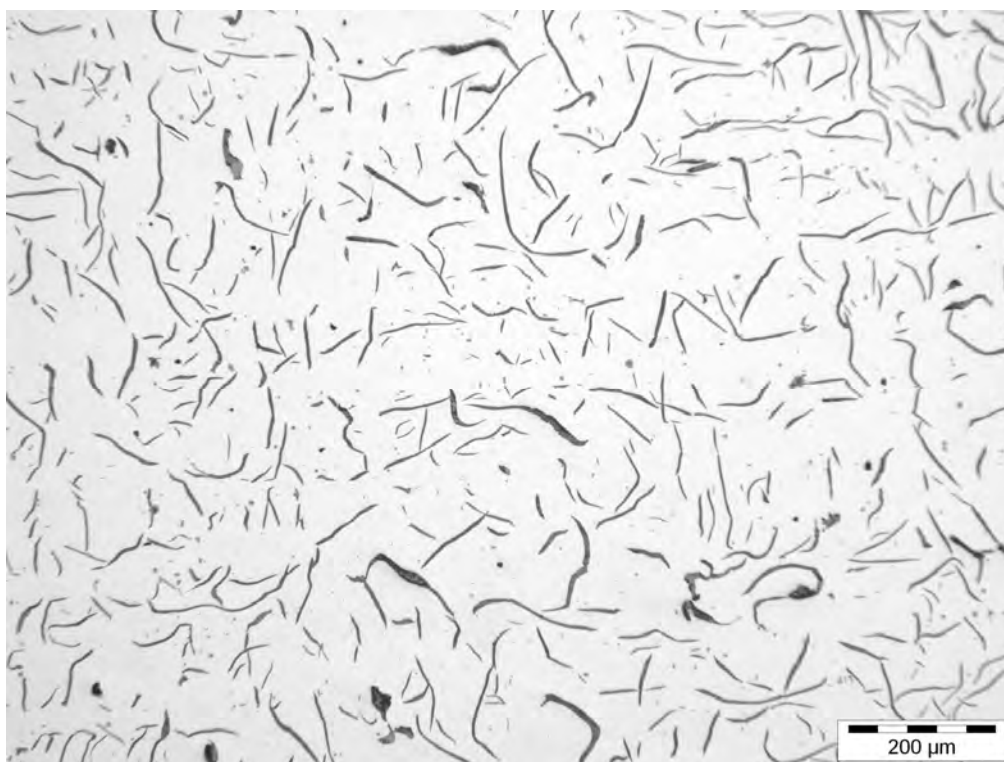
Figure 60: SEM fractograph, showing fractographic detail of the piece shown in figure 58 and comprising graphite flakes (black) in a brittle cleavage fractured iron matrix (grey).

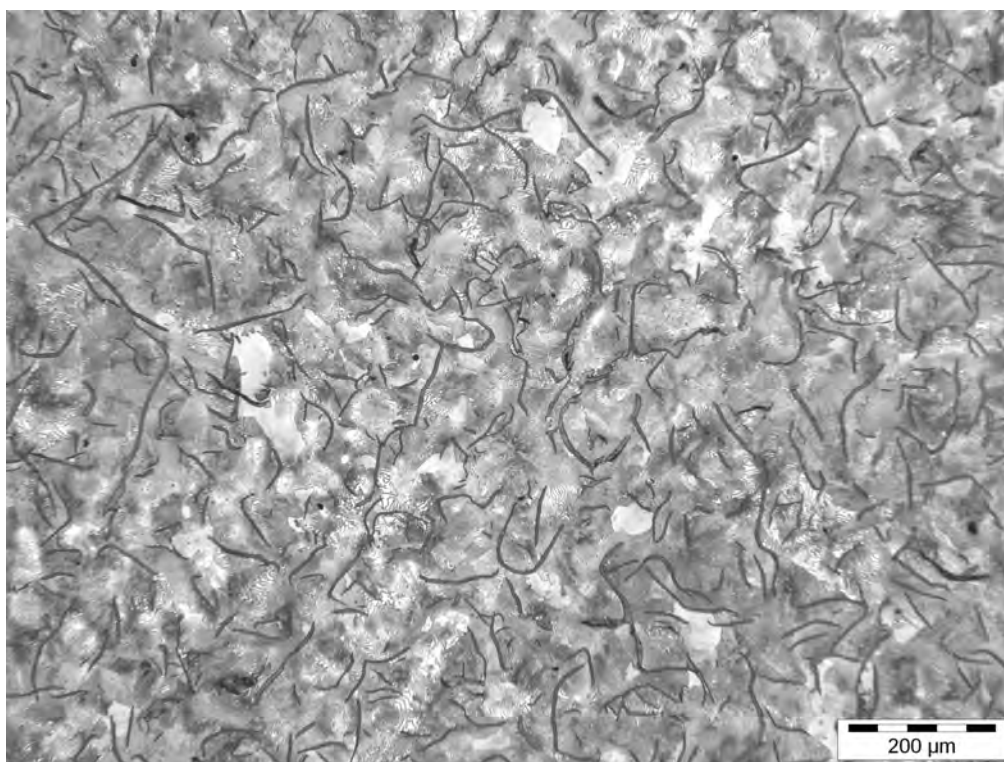
Figure 61: Micrograph (original image captured at X100), specimen unetched. Section from the fractured motor case piece illustrated in figure 58, and showing a flake graphite type morphology typical of a grey cast iron.
