**MAIB SAFETY BULLETIN 1/2009**

Catastrophic Failure of High Pressure  
Hydraulic Anchor Windlasses

## MAIB SAFETY BULLETIN 1/2009

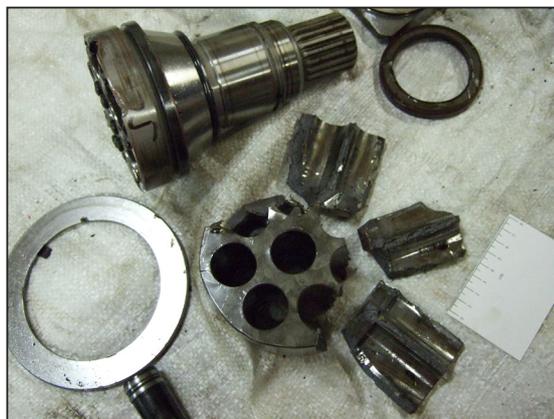
- On 23 March 2009, the hydraulic motor of the TTS Kocks high pressure windlass on board the Bahamas registered crude oil tanker *Stellar Voyager* exploded as the vessel attempted to weigh anchor in Tees Bay, UK. With the wind gusting up to 30 knots and a 2m swell, the anchor chain was under considerable tension. The windlass motor was in the 'heave' position but the anchor chain had started to render or pay out. When the windlass motor casing shattered, the windlass operator was seriously injured by debris, some of which was thrown as far as 40m. This accident is being investigated by the MAIB and the Bahamas Maritime Authority.

Preliminary findings of metallurgical examination of the failed components recovered from *Stellar Voyager* have identified:

- There is no evidence of damage caused by fatigue, metallurgical defects or impact.
- The toughened steel cylinder and pistons of the axial piston displacement motor had been subjected to extremely high internal pressures.
- Signs that the outer cast iron casing had fractured under extreme internal pressure and on impact with broken components of the hydraulic motor.

**2009/140S            Identify the technical reasons for the catastrophic failures of its windlass motors and determine engineering and design solutions to prevent similar accidents on board vessels fitted with its equipment.**
