Report on the investigation of
the fatality of a chief officer in a ballast tank
on board the container ship

Ville de Mars

in the Gulf of Oman

Report No 20/2009
September 2009

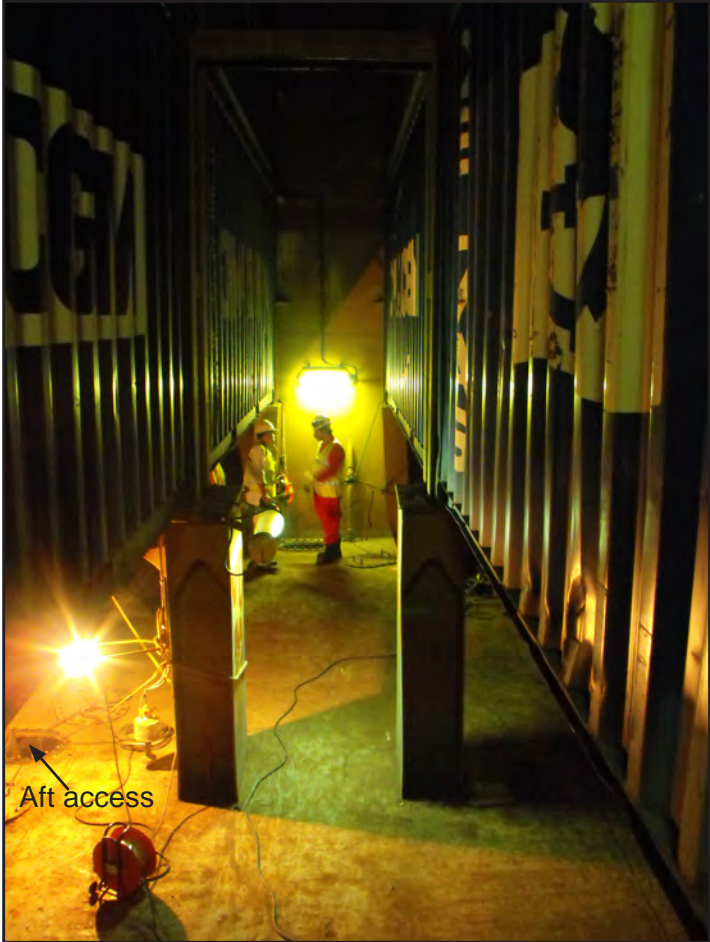
Figure 1

The party entered cargo hold No 1 and made their way to the forward access of WBT 1F (**Figure 1**). At 1030, the chief officer informed the third officer, who was the officer of the watch on the bridge, that he was about to enter the tank. He then took a reading of the tank's atmosphere by kneeling and reaching inside the access hatch with the gas analyser. The oxygen content was 20.9%¹. He put the analyser back in his boiler suit pocket and descended through the open manhole into the darkened tank, holding the lit torch in one hand. The bosun stood at the tank access monitoring the chief officer's progress; the AB stood about 0.5m behind the bosun.

Access to WBT 1F in cargo hold No 1
