Stena Voyager

Report on the condition of the failed lashings and the cause of failure

Investigation to establish the causes of vehicle lashing failures involved in an accident on board a passenger and freight ferry.

Shift of cargo on board HSS *Stena Voyager*

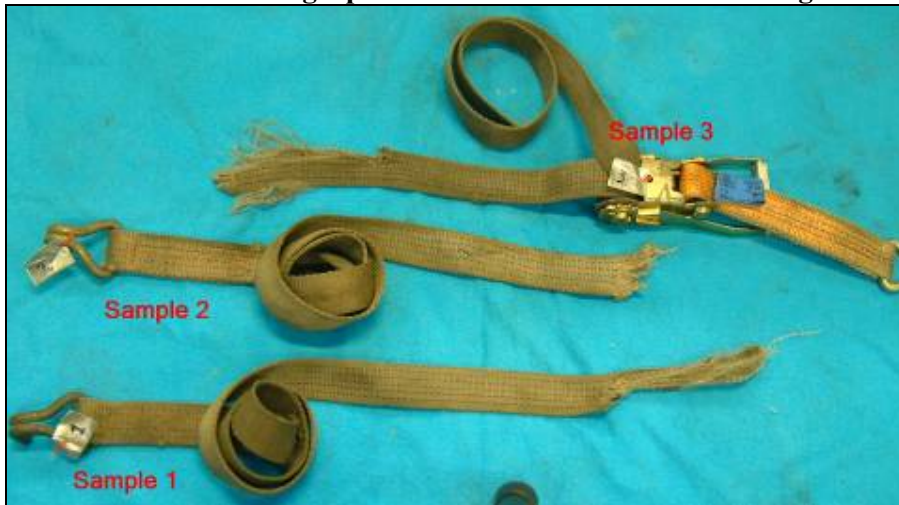
Photograph 1 General view of failed lashings

Photograph 1 is a general view of the three failures received by TTI Testing

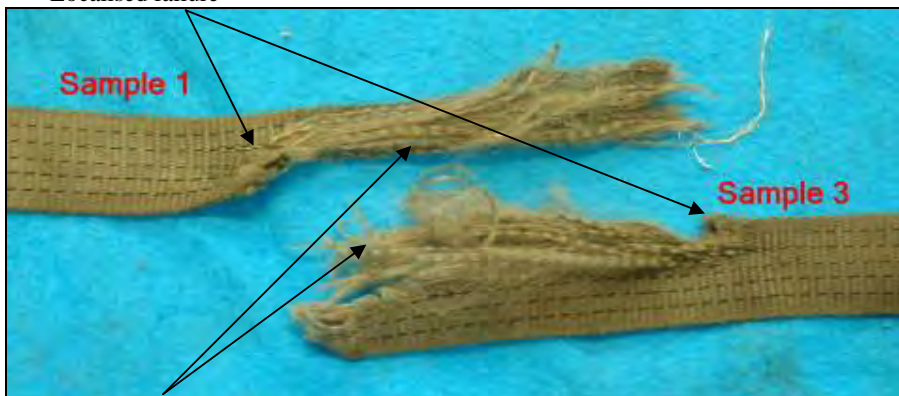
Photograph 2

The general appearance of failures 1 and 3 suggest they are the two halves of one failed lashing, as shown in photograph 2. The failure is characterised by a partial localised failure across the lashing width, the remainder appearing to be tensile failure.

Localised failure

Tensile failure

An additional possibility for the failure could be that a small cut at the region of localised failures, as shown in photograph 2, could have precipitated the failure. Previous webbing failure investigations by TTI have found this to be a cause of failure. However, close examination under the optical microscope, as well as the evidence from the SEM investigation does not reveal any clear evidence of this having been a contributory factor the failure in this case.

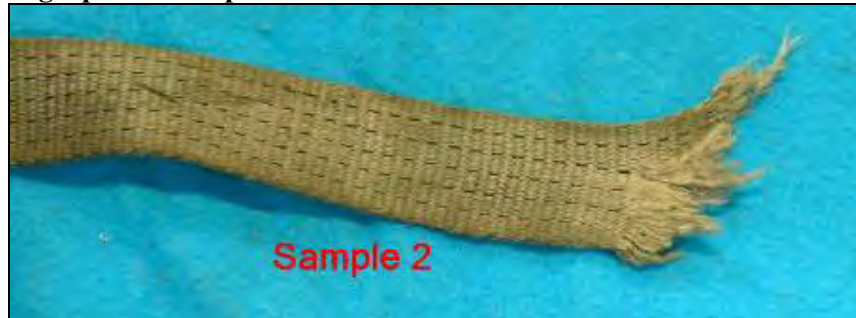
Photograph 3 Sample 2

Sample 2 is shown in photograph 3. This has the appearance of a tensile failure

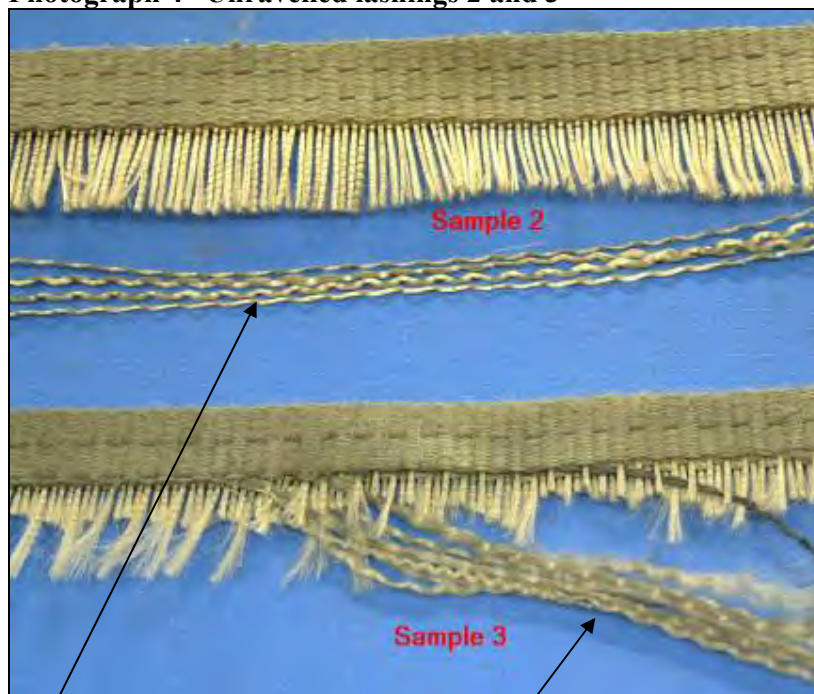
Photograph 4 Unravelled lashings 2 and 3

Photograph 4 shows the unravelled lashings 2 and 3.

350 tex warp yarn from sample 2

260 tex warp yarn from sample 3

Nevertheless, it can be seen that there is a variation in the warp yarn density and tex, particularly the ‘thick’ yarns, of the different lashings, and that lashings 2 and 3 appear to be of a different construction to the reference lashing. It is not likely that the differences in tex values can be explained by loss of yarn material due to abrasion damage.

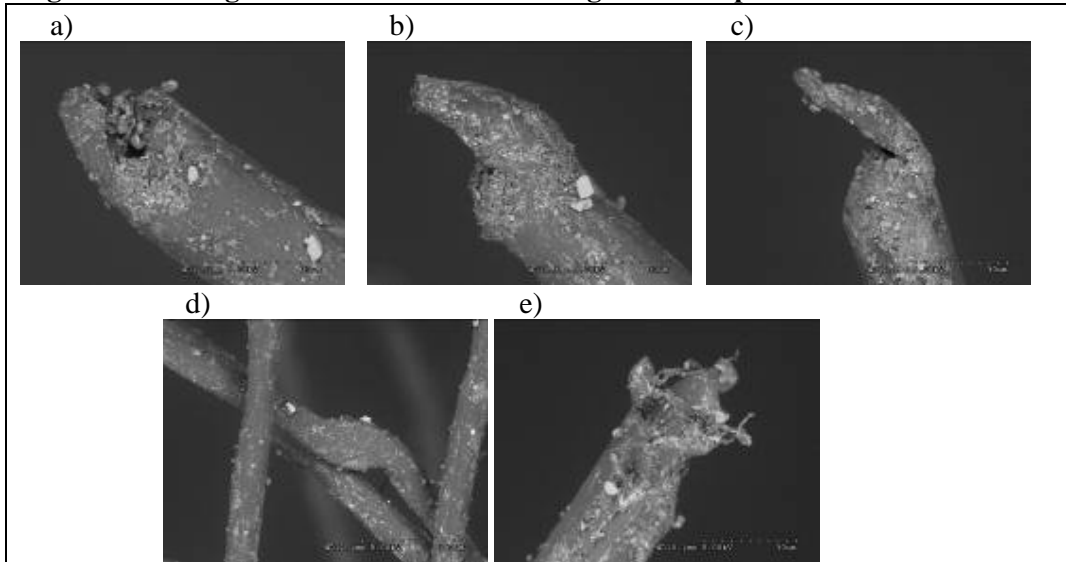
Figure 1 Images from the tensile failed region of sample 1

Images 1a to 1c are typical of failure caused by tensile fatigue, whilst 1d shows some flattening due to pressure. 1e shows evidence of both flattening and tensile fatigue. The degree of contamination across the failed diameter of some of the images suggests filament failure could have occurred some time before the final failure incident itself

The above images of figures 1 and 2 do not show any evidence of cut or abrasion damage, but evidence of crushing and tensile fatigue is seen.

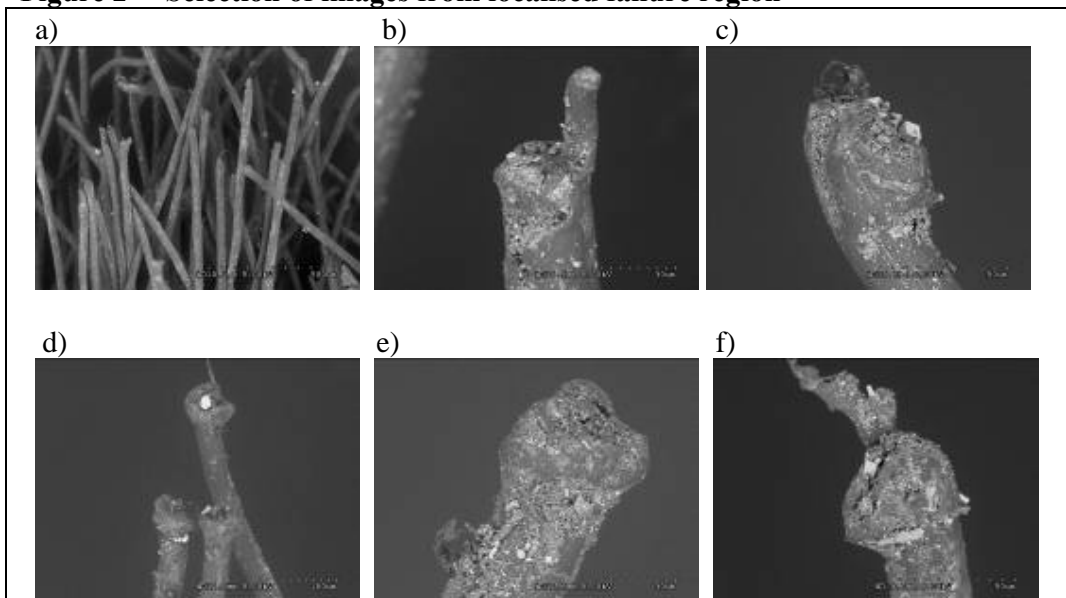
Figure 2 Selection of images from localised failure region

2a is a general view where some filament crushing can be seen. Tensile fatigue is seen in 2b and 2f, whilst the bulbous ends to filaments in 2d suggest a higher energy

fail where the filament has recoiled upon itself. Interestingly, salt crystals can be seen embedded in the failed filament ends of 2c and 2d, suggesting that the filament material has recoiled and enveloped the salt crystals during the failure.

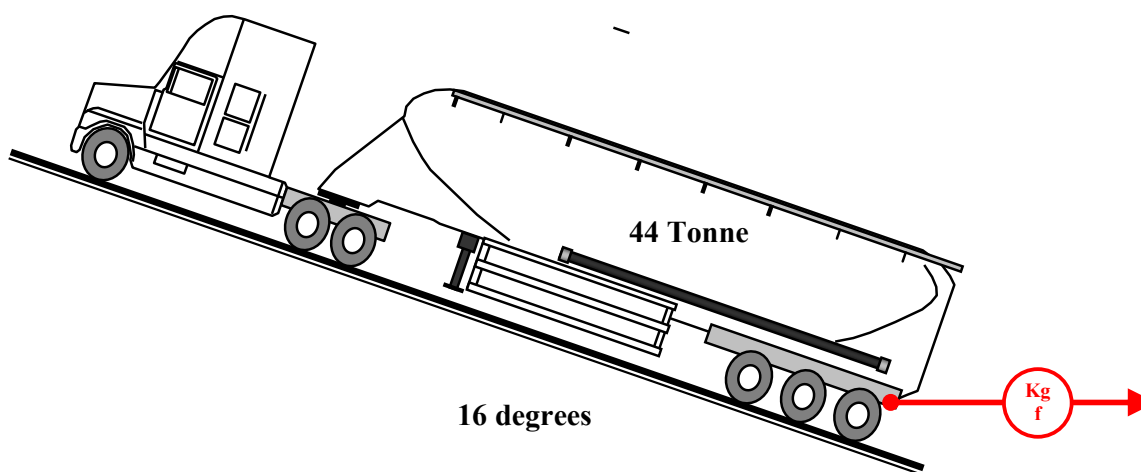
Test 6 – Vehicle on 16 degree slope.

Test No.	Chock Type	No. off Chocks	Chock Position	Force (T)			Comments
				1 st	2 nd	3 rd	
5	2	2	Centre				No.2 chocks failed to hold the weight of the vehicle on the slope, therefore this test was not progressed any further.

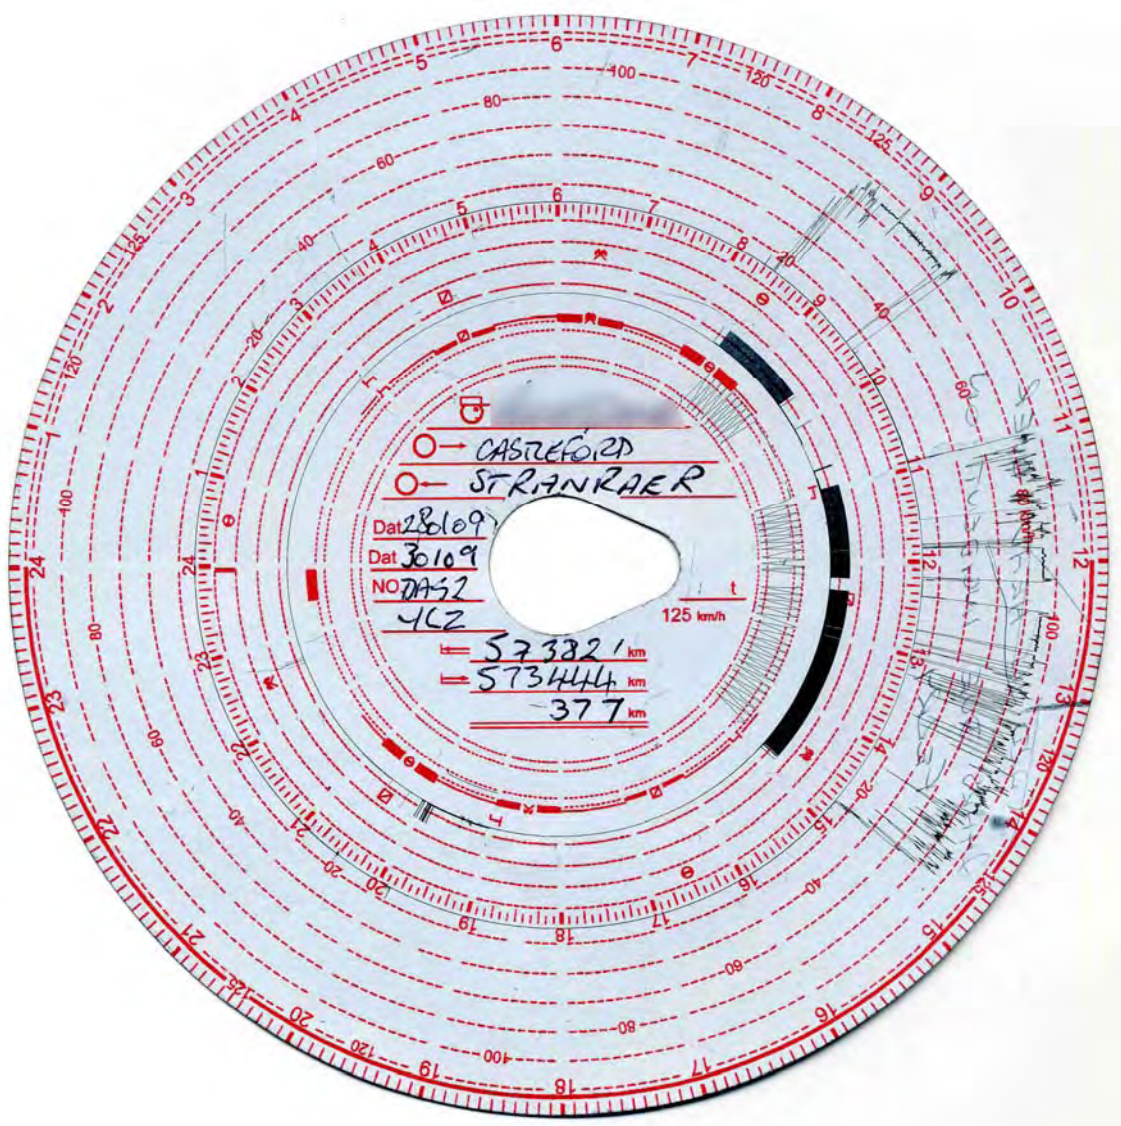
Figure 1

2. An enlarged copy of the face of the tachograph chart is shown at Figure 1.

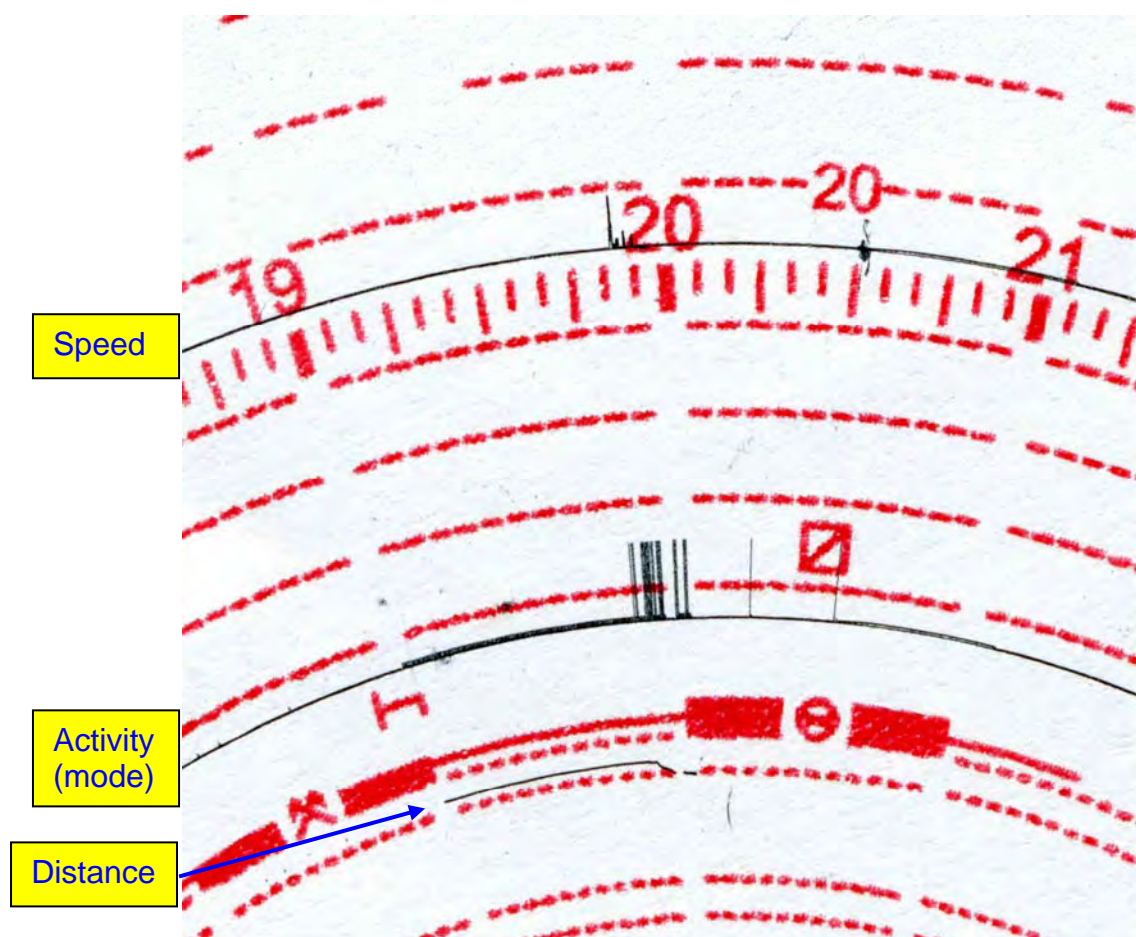
Figure 2

- The short movement recorded at about 20:13 hours chart time would have been around the time that the ferry departed from the port.
- The movement and 'impact' recorded at about 20:31 hours chart time would have been when the vehicle crashed into/through the ferry doors.

11. An enlargement of the tachograph chart recording around 19:00-21:00 hours is shown at Figure 2.
