Report on the investigation of
a person overboard during a passenger transfer from

HMS Westminster to Princess Rose

on the River Thames

Report 16/2009
July 2009

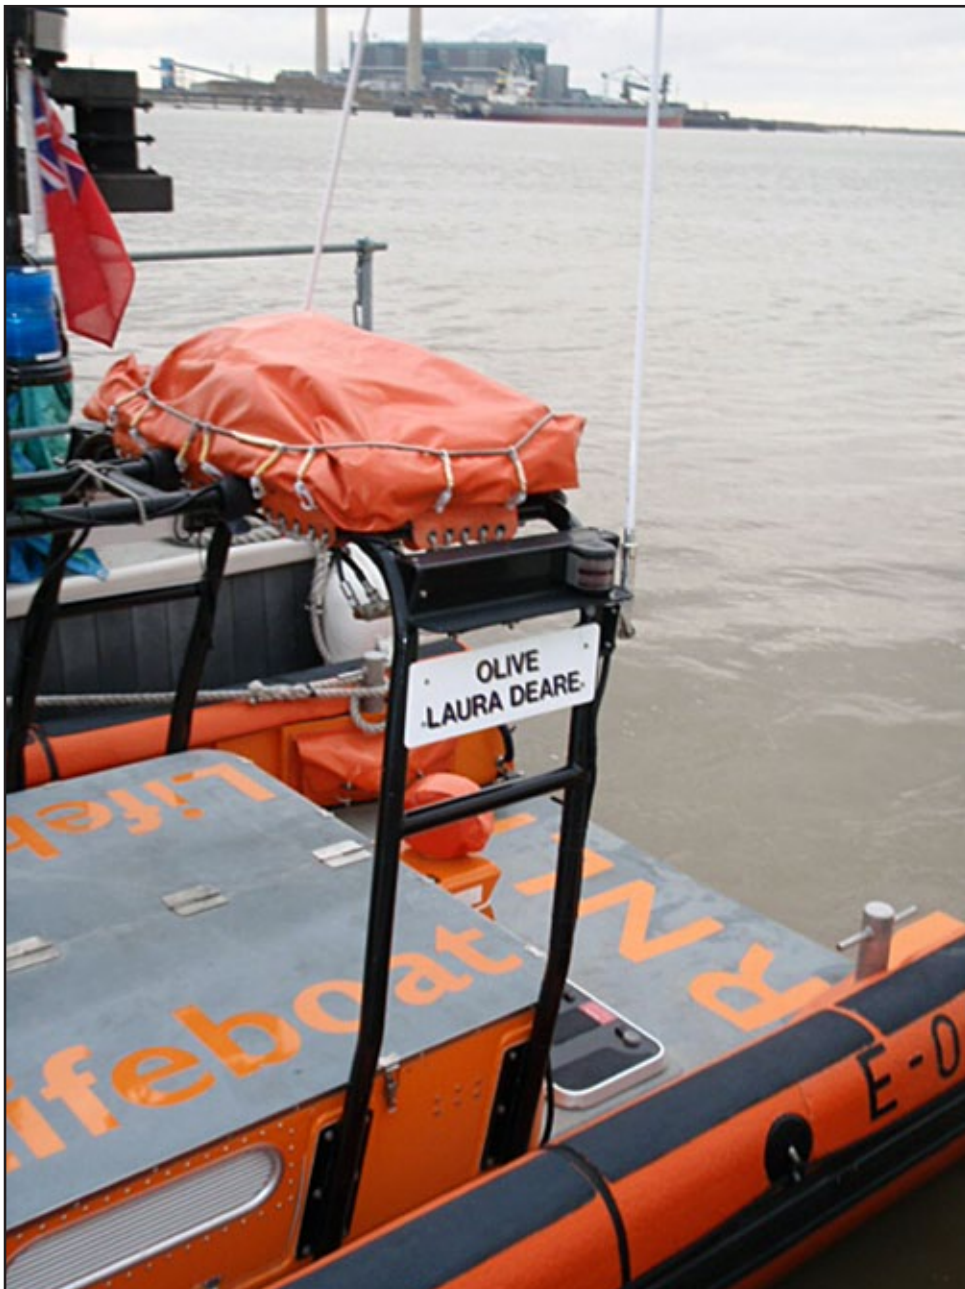
Figure 5

Manoverboard recovery procedures were immediately initiated by both vessels, and the coxswain of the lifeboat astern saw the accident and stopped his vessel adjacent to the DRNLO. The lifeboat crew were unable to lift her over the inflatable tube on the port bow and had to move her to the vessel's low stern transom (**Figure 5**), where they pulled her on board. The lifeboat took the DRNLO to the Royal Terrace Pier, where she was collected by an ambulance alerted by the Thames Vessel Traffic Service (VTS). She was then taken to the Gravesend lifeboat station where paramedics attended to her. The DRNLO was not required to be taken to hospital.

Low transom of RNLI lifeboat used to recover the casualty from the water
