Report on the investigation of  
a person overboard during a passenger transfer from

***HMS Westminster to Princess Rose***

on the River Thames

**Report 16/2009**  
**July 2009**

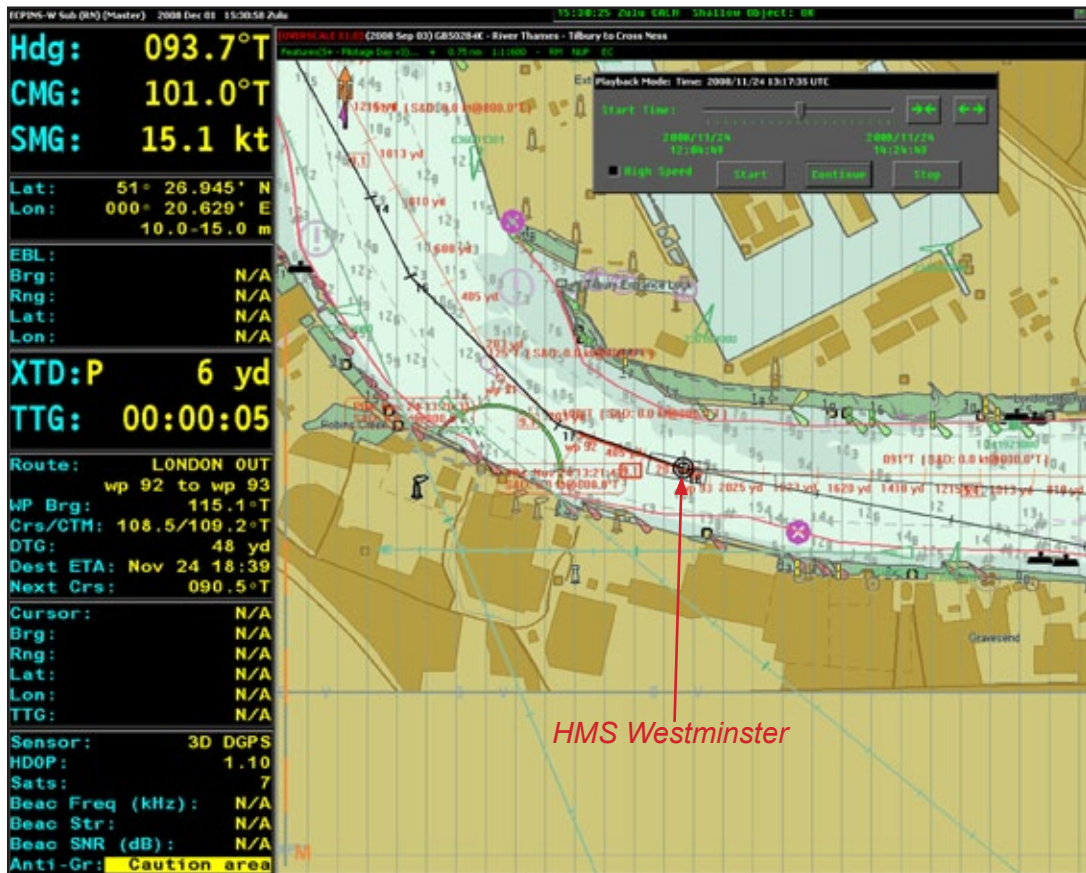
At 1317, while the fenders were prepared, the frigate started to reduce speed from 15 knots to 7 knots over the ground (**Figure 2**). Her heading had also been adjusted to 093°, which provided a lee on her starboard side from the brisk wind blowing over the port bow. During this period, the Gravesend 'E class' inshore lifeboat took up a position about 200m astern of *HMS Westminster* to act as a safety boat during the passenger transfer. The Thames pilot boat was also in close proximity astern, ready to disembark the pilot on completion of the boat transfer.

WECDIS download - HMS Westminster entering Gravesend Reach

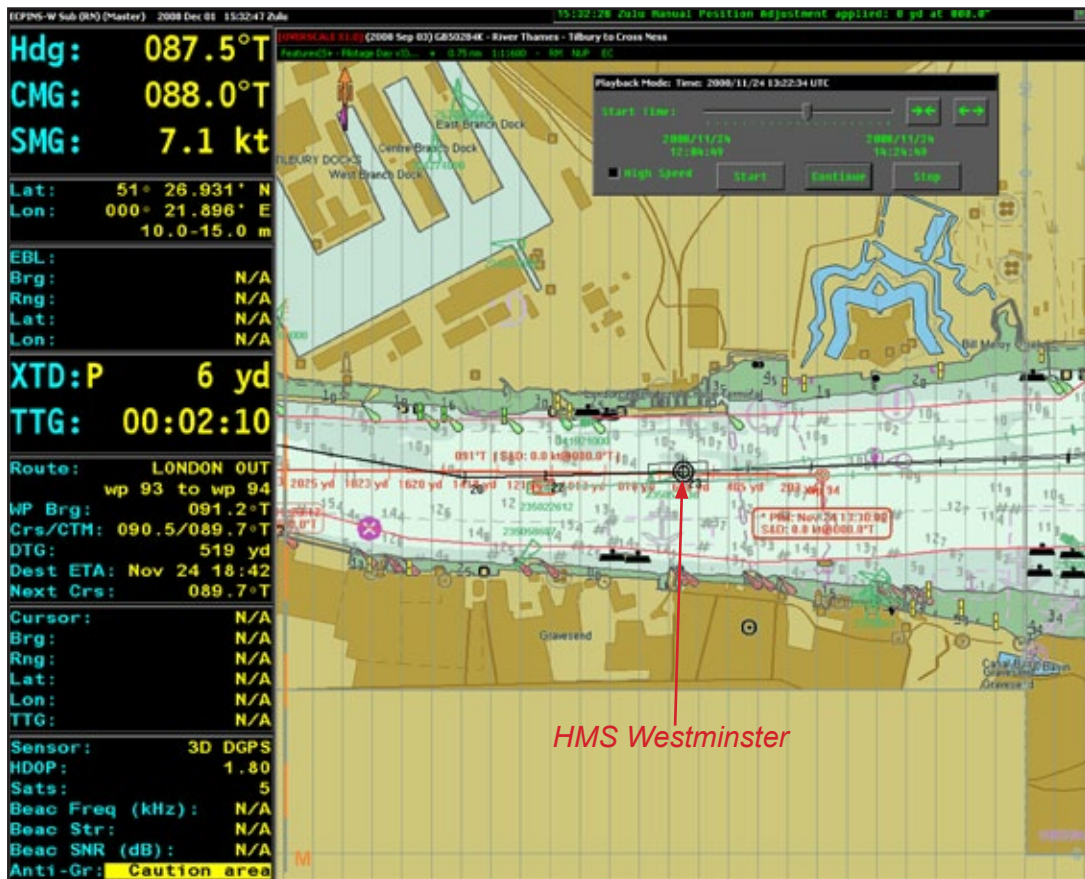
At approximately 1321 (**Figure 3**), HMS Westminster's executive officer and OOW assessed from the starboard bridge wing that the river conditions were 'well within limits for transfer'. With the ship's speed now at 5 knots through the water and with the fenders in position, the executive officer gave approval for the boat transfer to commence. The fenders were not tied to the vessel's guardrails; they were being tended by hand.

WECDIS download - immediately before passenger transfer

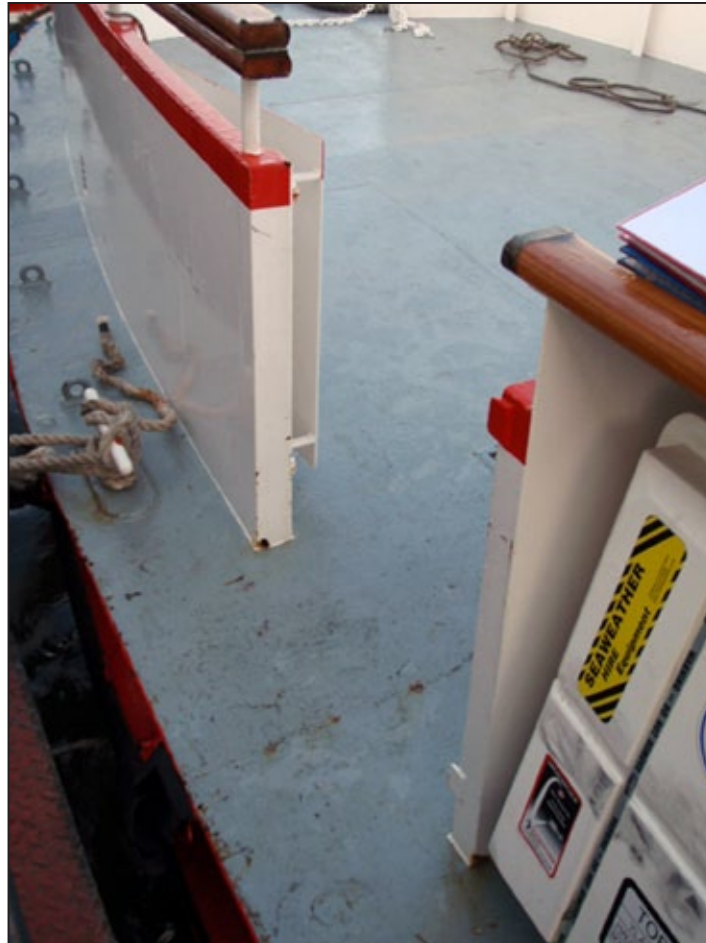
Figure 4

*Princess Rose* boarding gate

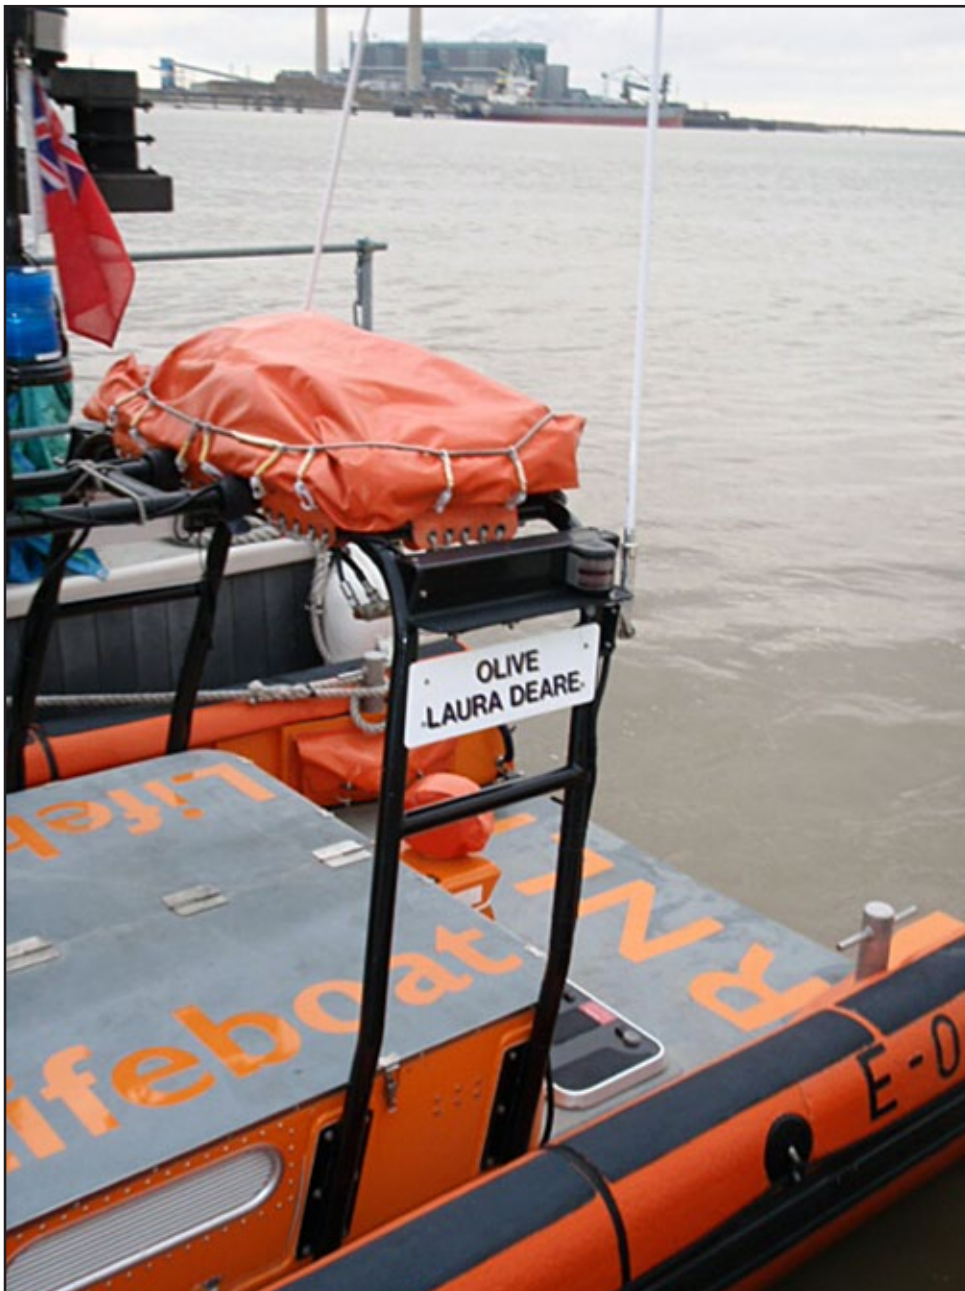
Figure 5

Manoverboard recovery procedures were immediately initiated by both vessels, and the coxswain of the lifeboat astern saw the accident and stopped his vessel adjacent to the DRNLO. The lifeboat crew were unable to lift her over the inflatable tube on the port bow and had to move her to the vessel's low stern transom (**Figure 5**), where they pulled her on board. The lifeboat took the DRNLO to the Royal Terrace Pier, where she was collected by an ambulance alerted by the Thames Vessel Traffic Service (VTS). She was then taken to the Gravesend lifeboat station where paramedics attended to her. The DRNLO was not required to be taken to hospital.

Low transom of RNLI lifeboat used to recover the casualty from the water

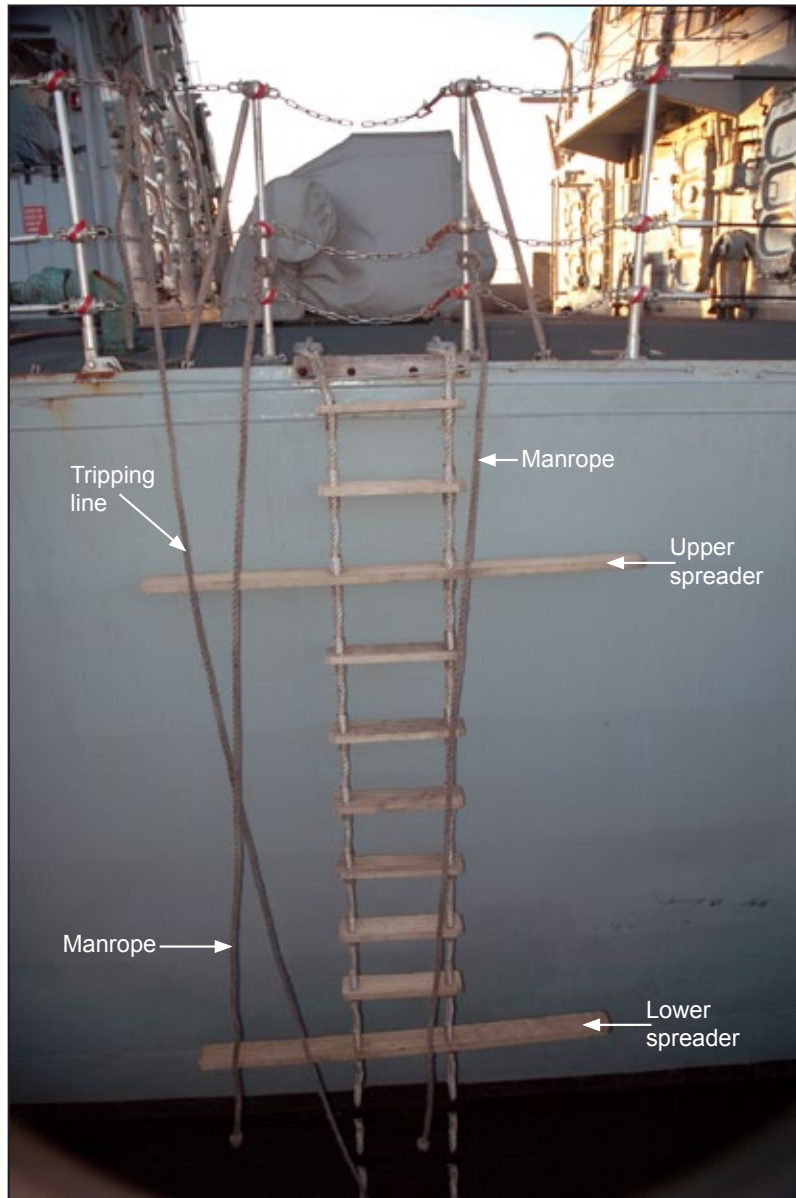
Figure 7

The equipment comprised a pilot ladder secured to deck eye pads using spring hooks, two 24mm polypropylene manropes, and a hook line. The pilot ladder was fitted with two anti-twist spreader bars and its bottom four steps were made of moulded rubber. A tripping line was attached to the bottom rung of the ladder to assist with its deployment and recovery (**Figure 7**). There was no rescue strop provided in the area of disembarkation. VHF radio communication was available between the deck and the bridge.

Pilot ladder as rigged at the time of the accident

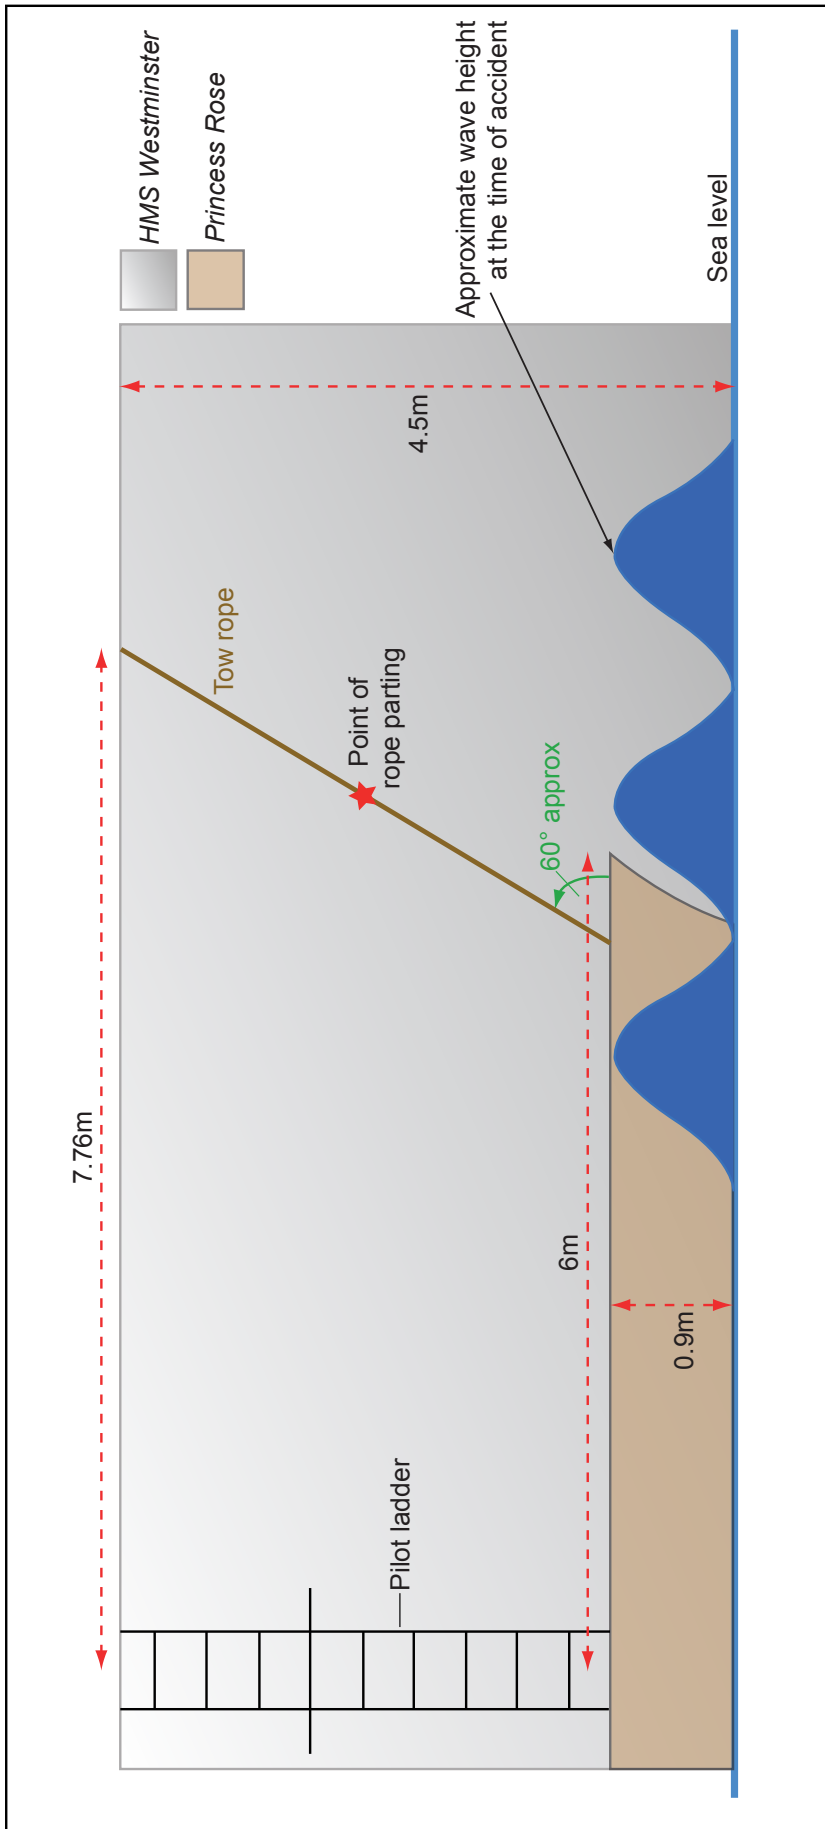
Figure 8

In this case, the angle of the painter was relatively steep (**Figure 8**), and when *Princess Rose* began to pitch as the sea conditions worsened, the resultant vertical movement of the vessel's bow induced a shock loading and caused the polypropylene rope to part. It is likely this could have been avoided had a longer painter been provided and attached further forward on board *HMS Westminster*. It is also likely that the movement of *Princess Rose* in relation to the transfer position following the failure of the painter would have been controlled more quickly if one of the crew had remained in the wheelhouse. Although the use of a painter reduced the need for frequent engine and helm movements, the need to be able to manoeuvre immediately is very important, particularly when transferring people.

Relative position of Princess Rose and the pilot ladder while alongside HMS Westminster

1. The angle of the painter was relatively steep, and when *Princess Rose* began to pitch as the sea conditions worsened, the resultant vertical movement of the vessel's bow induced a shock loading and caused the polypropylene rope to part. [2.3.1]
