Report on the investigation of

the collision between

Scot Isles

Wadi Halfa

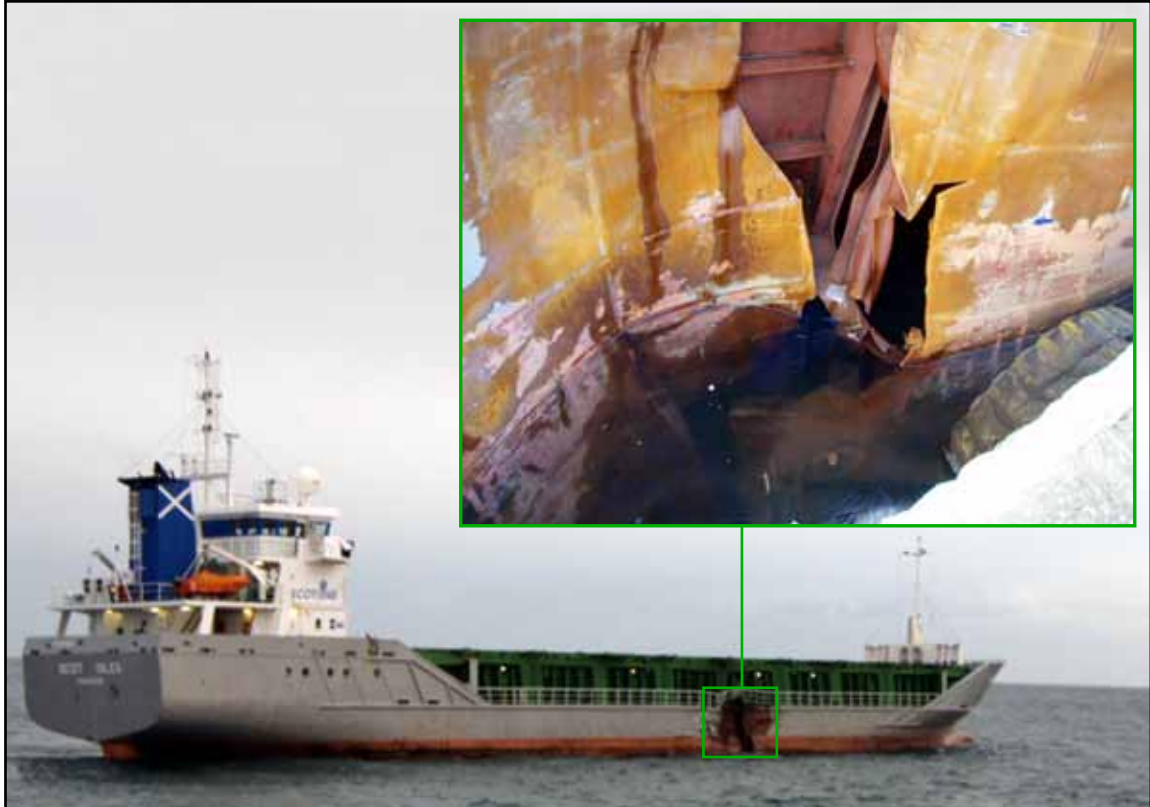
The master then sent the second officer and an AB to carry out a full inspection of the main deck and hold. They reported that the bulkhead in the hold was buckled, but intact, in way of the damage and that there was no water ingress.

At twilight, about 0645, the master saw evidence of oil in the water beside the vessel, emanating from number two starboard wing fuel tank, which had been ruptured by the collision. He then instructed the engineers to list the vessel to port and to transfer oil from the damaged tank into another fuel tank to prevent further pollution.

Scot Isles - damage overview

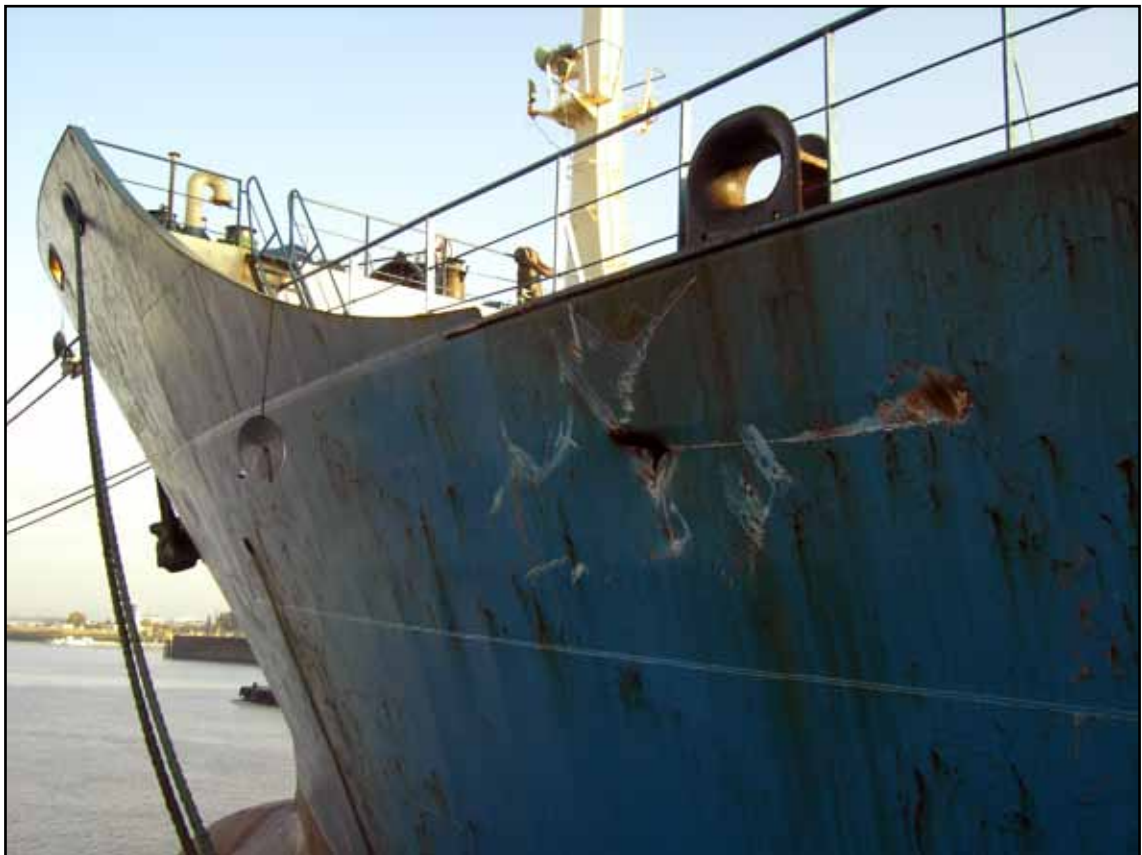
Figure 8

The chief officer returned to the bridge and told the master that the only apparent damage to *Wadi Halfa* was a small hole in number one port wing ballast tank, approximately 25cm long and about 50cm below the main deck level (**Figure 8**).

Wadi Halfa - shell plate damage to number one port wing ballast tank
