Report on the investigation of the fatal injury of a crew member  
and the serious injury of a second crew member  
in heavy weather on board the UK registered container ship

***Maersk Kithira***

23 September 2008

**Report No 9/2009**  
**April 2009**

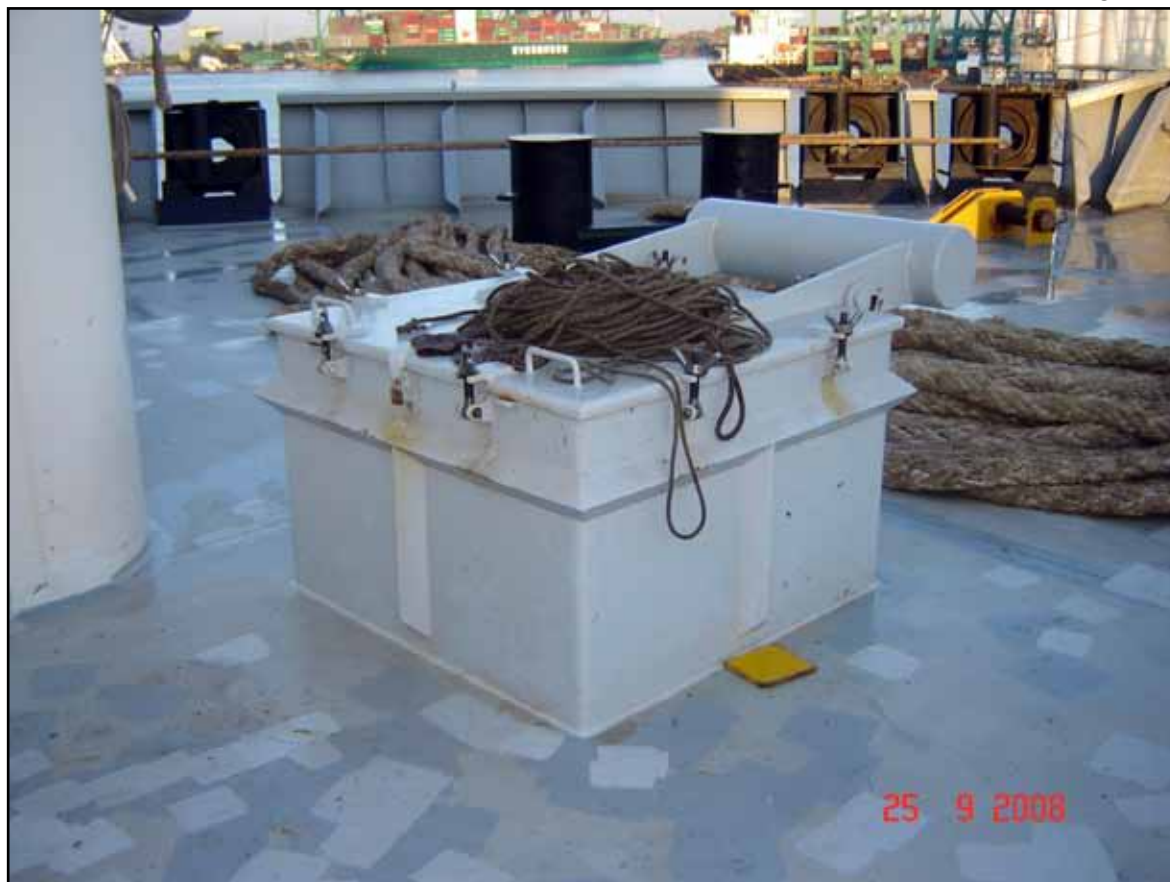
Figure 2

The master, chief engineer and chief officer jointly agreed that it would be necessary to tighten the dogs securing the forecastle stores hatch (**Figure 2**) to prevent further water from entering the space. The third officer switched on the foredeck floodlights, and the chief officer and chief engineer waited briefly at the top of the access to the upper deck for the master to give permission for them to proceed. At 2010, permission was given, and the two men went onto the upper deck. Ship movement was such that neither found it difficult to stand. They made their way initially to the access port in the breakwater (**Figure 3**), and stood in the shelter of the breakwater to assess the motion of the ship, and gauge the amount of water being shipped on the deck. Noting that the only water coming onto the deck was spray coming up through the hawse pipe, they decided that it was safe to go onto the forecastle, and at 2011, informed the master by UHF radio of what they were doing.

The forecastle stores hatch
