Report on the investigation of
injury to a passenger on board the RIB

Celtic Pioneer

26 August 2008

Report No 11/2009
May 2009

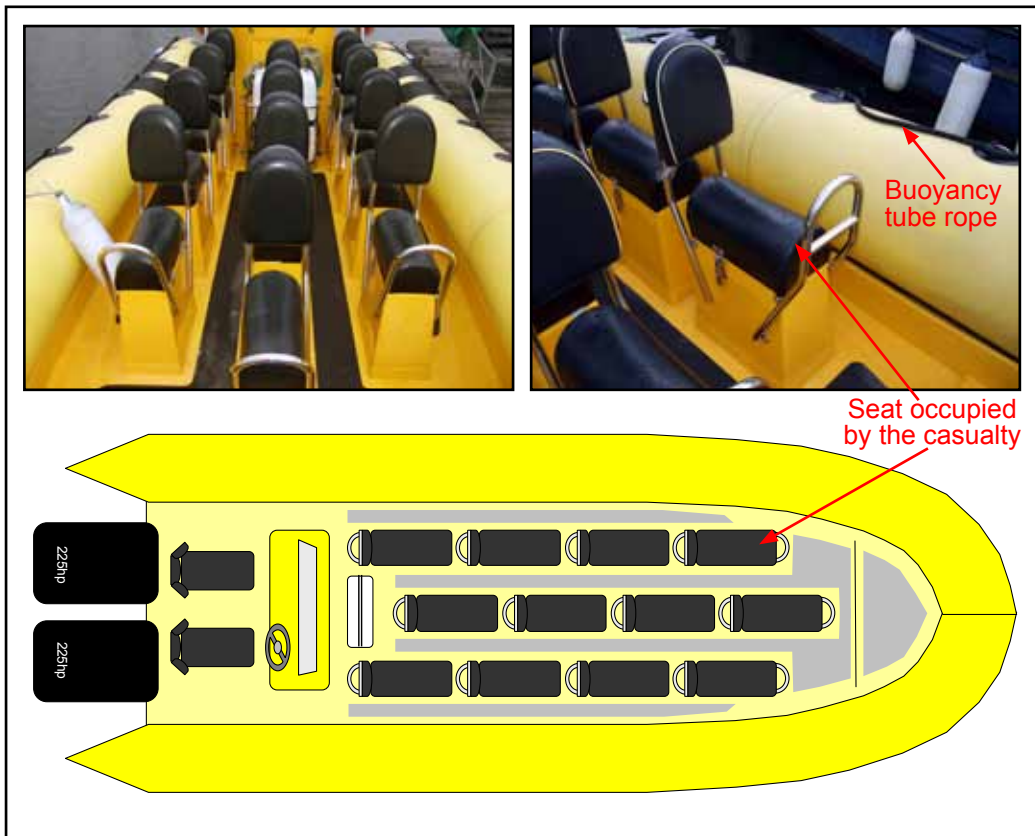
Figure 2

Celtic Pioneer seating positions

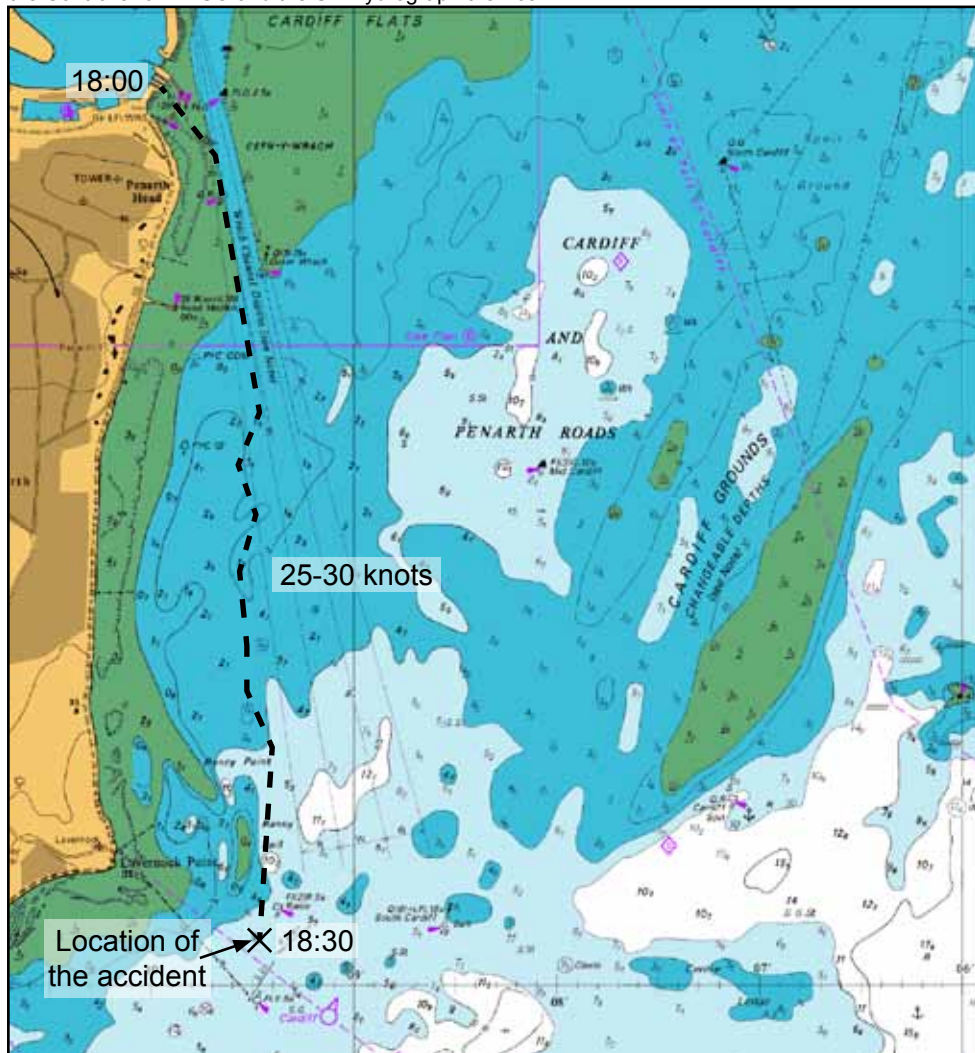
Figure 4

Extract of chart BA 1182 - passage and accident location

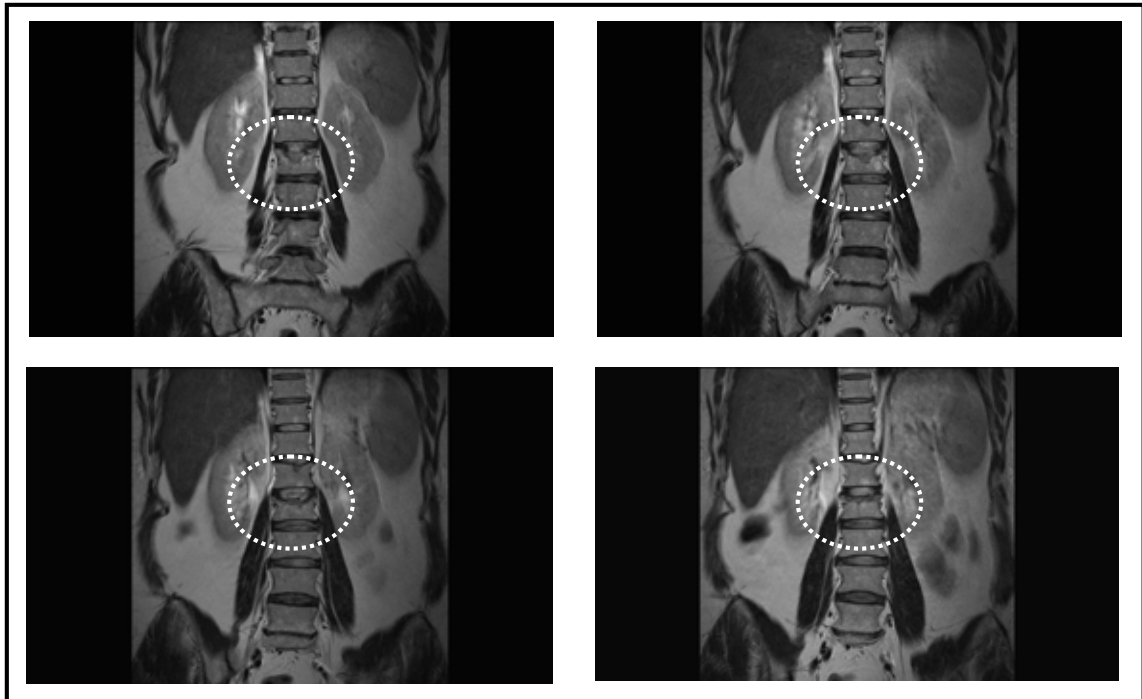
The injured passenger suffered '*a compression fracture of the second lumbar vertebra (L2) with compression of the superior (upper) end plate*' (**Figure 5**). The moderately high energy fracture resulted in the separation of a fragment of vertebral body which had the potential to cause neurological damage (**Annex E**).

Scans of injury suffered

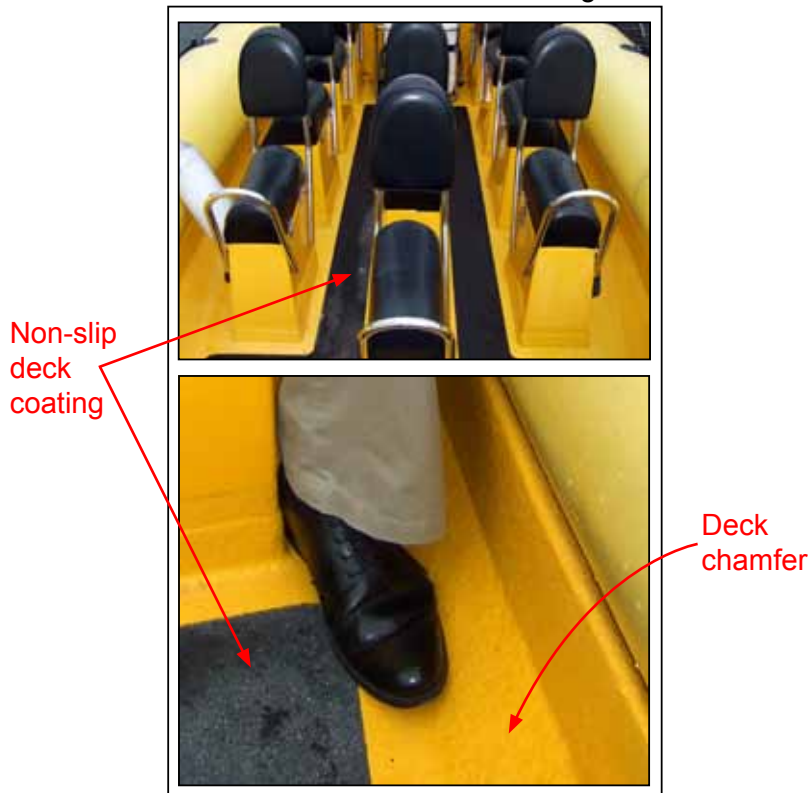
Figure 9

Careful consideration of human factors engineering issues during the design stage for high speed craft can significantly reduce the levels and effect of shock and vibration. Bay Island Voyages had invested in new, well built RIBs from an established manufacturer, which were designed specifically for this type of activity. However, a number of design features have been identified that adversely affected the casualty's ability to sustain the required posture and therefore increased the likelihood of her suffering a spinal compression fracture.

Celtic Pioneer deck design factors

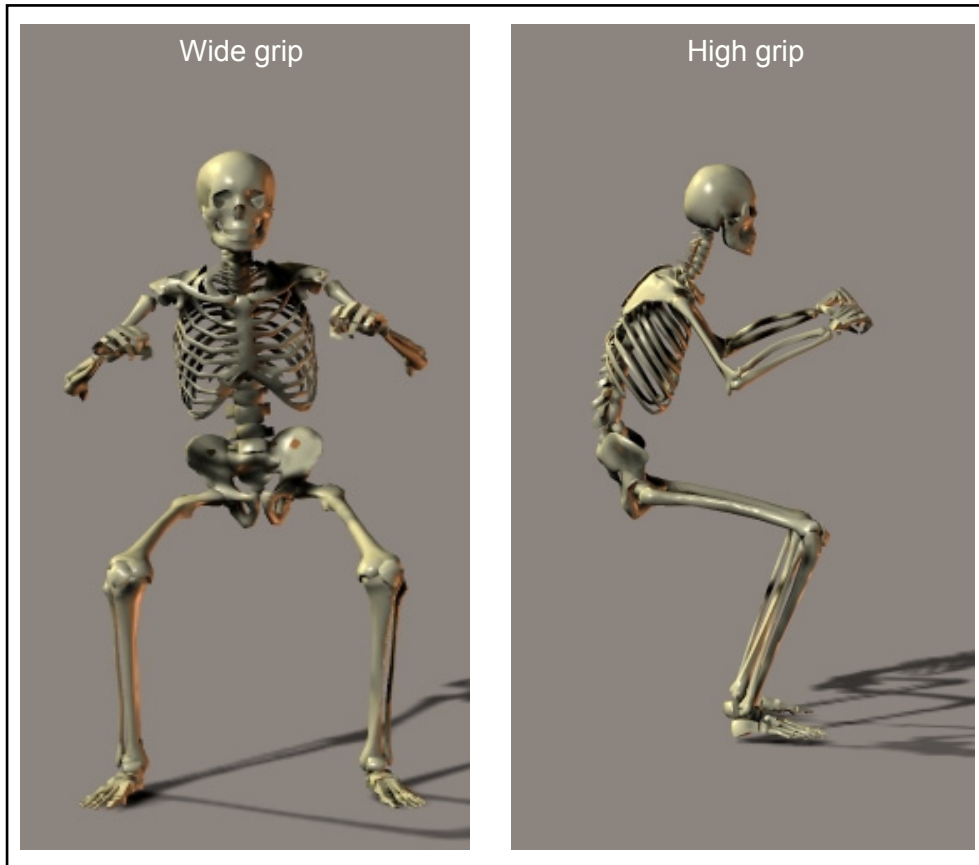
Handrails or handgrips, particularly when affording a high and wide grip, allow passengers to support themselves against impacts during high speed manoeuvring or while dodging waves (**Figure 11**). The position of the handrail on the front row of seats on board *Celtic Pioneer* was lower than those provided on the seats behind. The reduced height of this rail would have made it difficult for the injured passenger to stop herself being thrown forward on impact with the sea. It would also have caused her to assume a more stooped posture while underway (**Figure 12**). Furthermore, the relatively narrow handrail is likely to have offered the injured passenger limited lateral support against impacts with the water during a turn. The handrails on the front row of seats were also open to the elements, exposing the hands of the occupants to the effects of wind chill and sea spray. It was probably a combination of these factors which contributed to the injured passenger's decision to hold onto the buoyancy tube rope with her left hand. Bay Island Voyages' advertising leaflet (**Annex A**) shows a passenger, occupying the corresponding seat on board *Celtic Ranger*, taking similar action. The resulting posture is likely to have introduced a degree of bending and twisting to the casualty's lower back as *Celtic Pioneer* dodged the waves. This would have significantly increased the risk of her suffering a wedge compression fracture (**Figure 13**).

The effects of handgrip or handrail design on passenger posture and stability

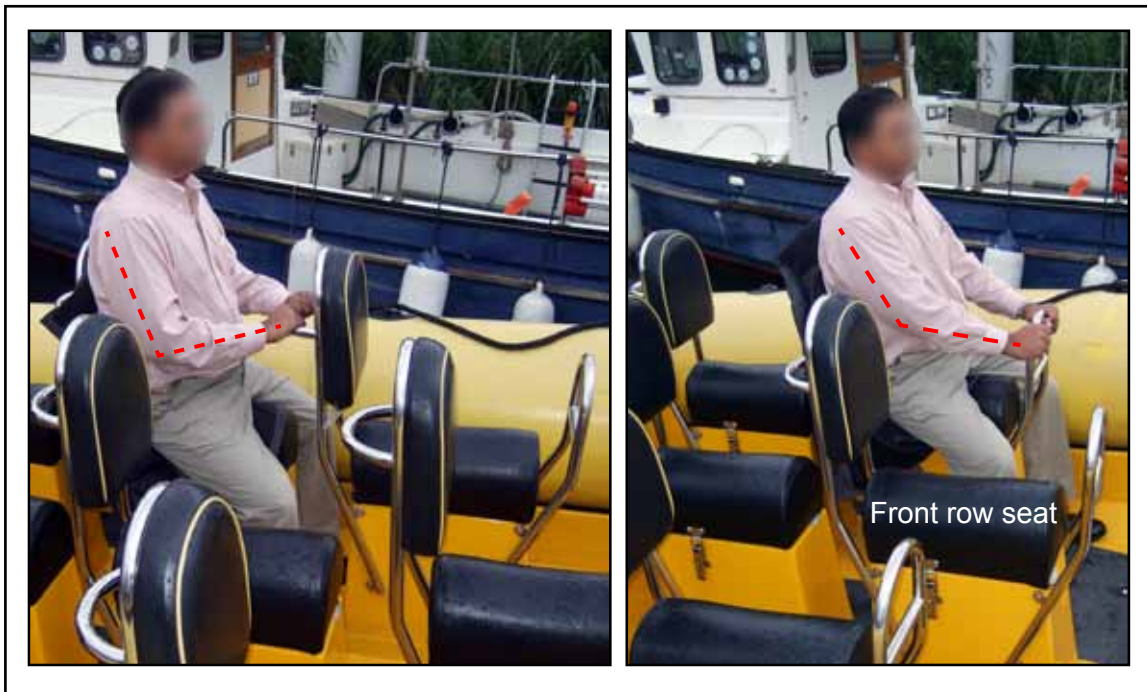
Posture factors associated with the casualty's seat

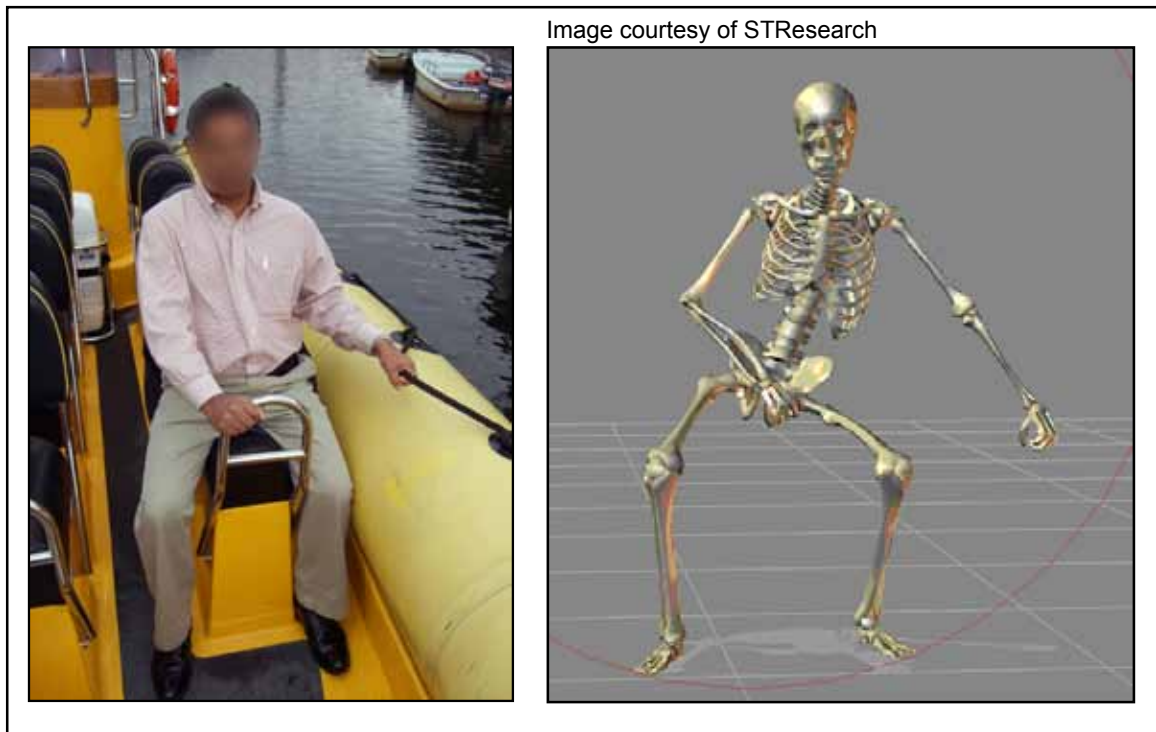
Illustration of the probable spinal alignment of the casualty at the time of the accident
