Report on the investigation of
injury to a passenger on board the RIB

Celtic Pioneer

26 August 2008

Report No 11/2009
May 2009

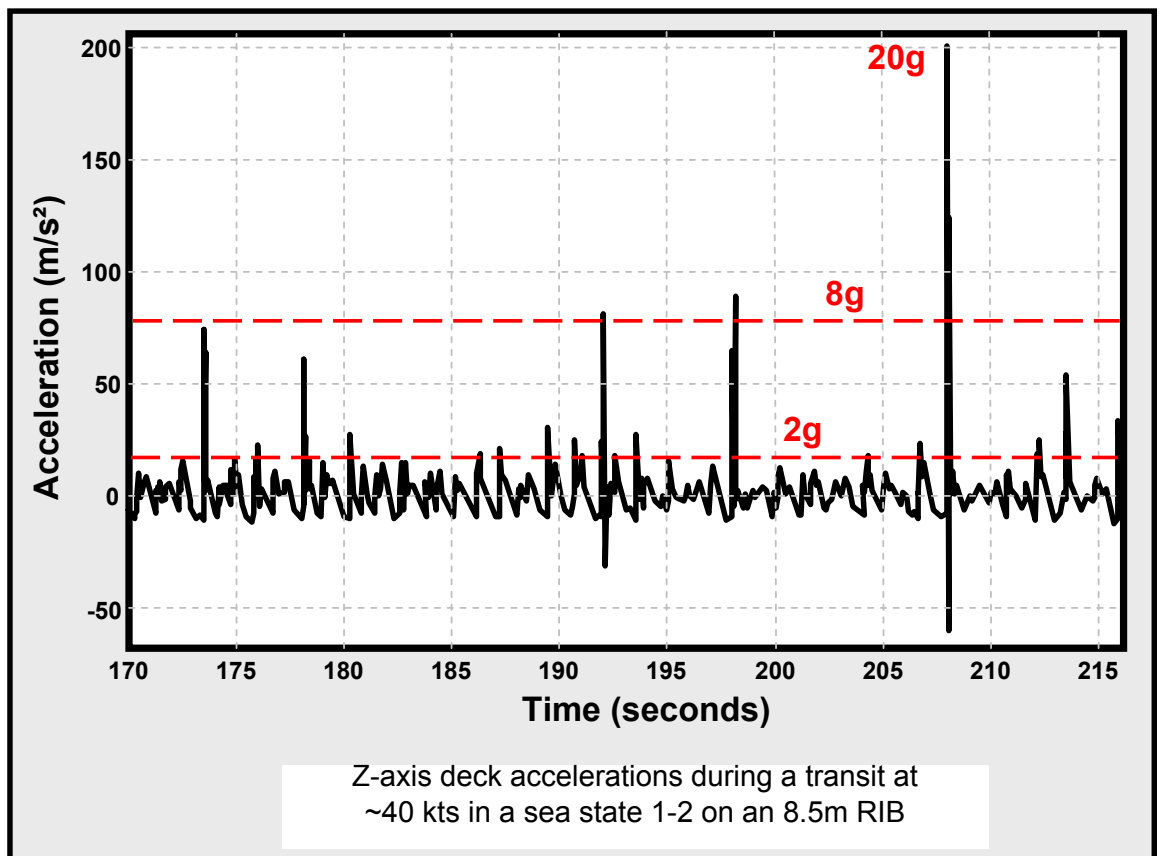
Figure 7

Not only did the trials demonstrate that the repeated shocks expected during high speed operations can occasionally be of sufficient magnitude to cause impact injuries, but they also clearly justify the requirement for fast boat operators to conduct a shock and WBV risk assessment and take the appropriate steps listed in the Vibration Regulations to reduce the risk of chronic and acute injuries to employees to as low as reasonably practicable. A person exposed to the shock and vibration levels shown in **Figure 7** exceeds the 8 hour WBV EAV within 15 minutes. **Figure 8** illustrates that after 1 hour, the level of exposure is up to 7.5 times the EAV and 3 times the ELV allowed maxima.

Magnitude and frequency measurements for shock recorded on board an 8.5m RIB

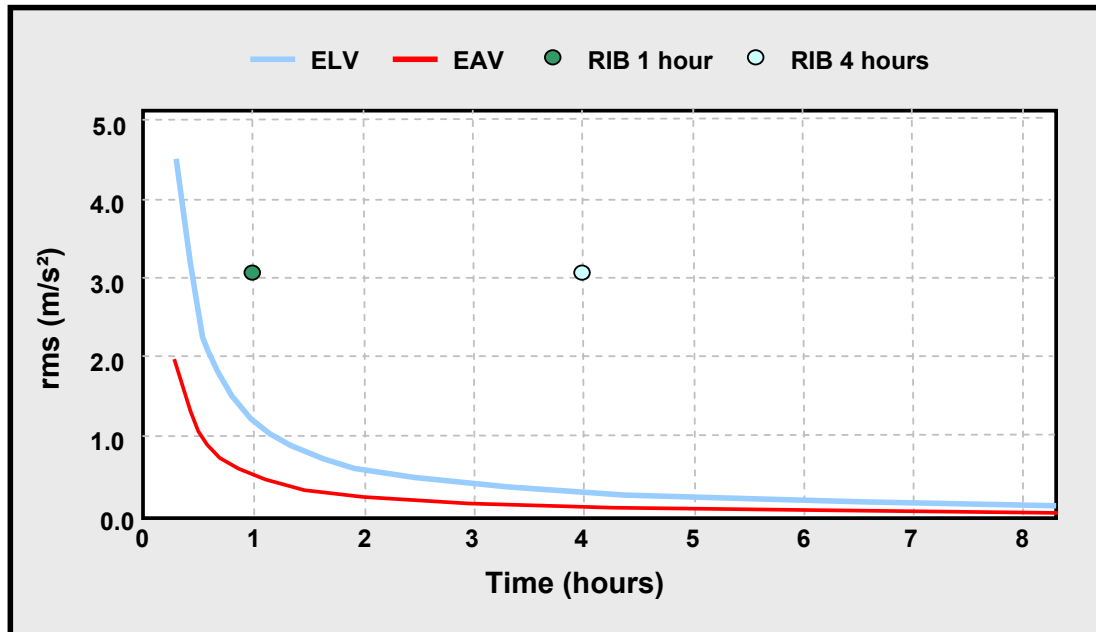
Figure 8

An example of how a RIB travelling at ~40 kts in a sea state 2 will exceed the EU WBV Exposure Action and Limit Values

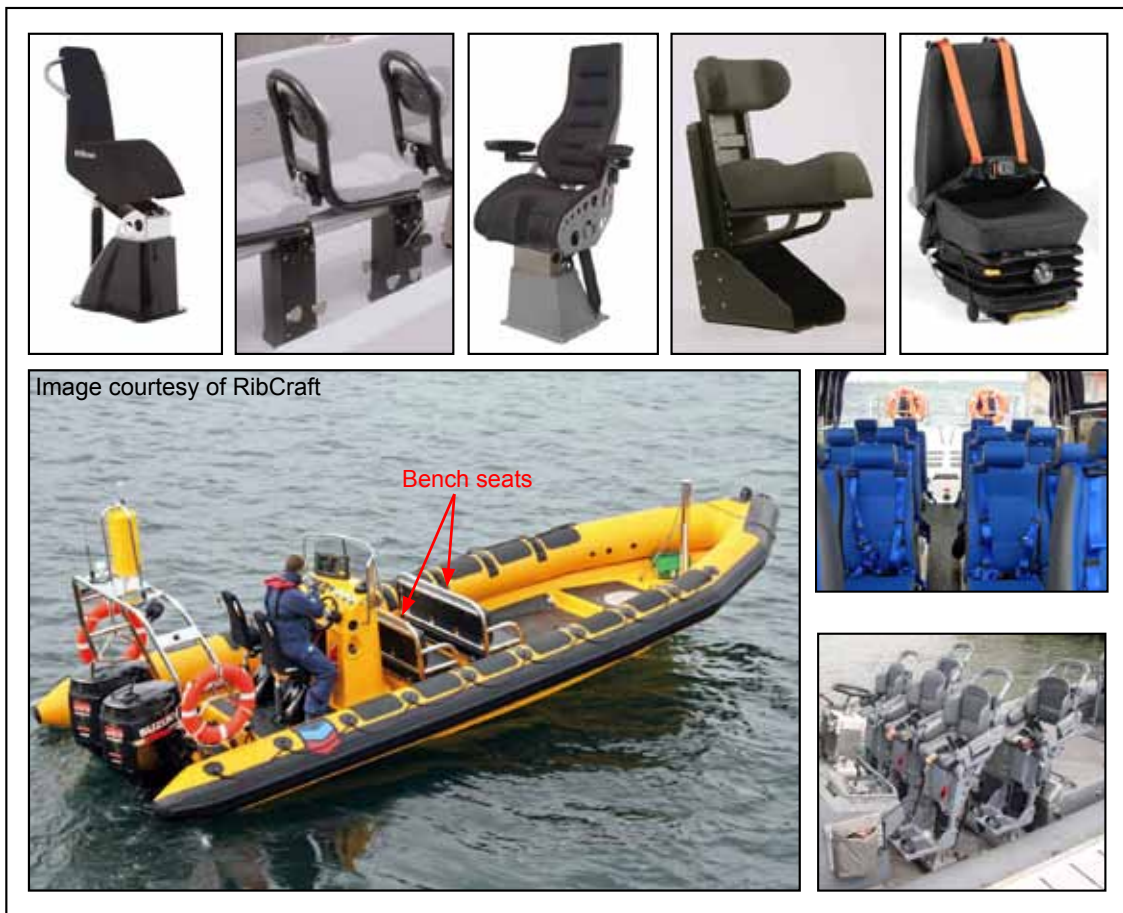
Figure 10

Seats are available for use on high speed craft, which are designed to dampen the transmission of shock and vibration and improve the occupant's posture and spinal alignment. Some of the most commonly adopted designs include shock absorption systems, restraint harnesses, and adjustable features to allow for people of differing sizes (**Figure 10**).

Examples of seats used on board high speed craft
