Report on the investigation of
injury to a passenger on board the RIB

Celtic Pioneer

26 August 2008

Report No 11/2009
May 2009

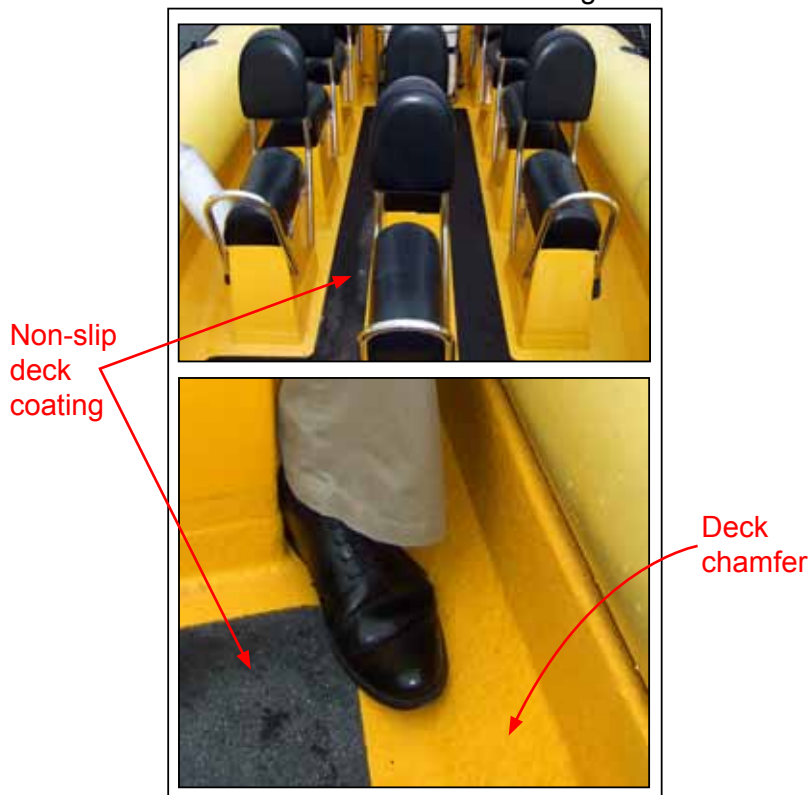
Figure 9

Careful consideration of human factors engineering issues during the design stage for high speed craft can significantly reduce the levels and effect of shock and vibration. Bay Island Voyages had invested in new, well built RIBs from an established manufacturer, which were designed specifically for this type of activity. However, a number of design features have been identified that adversely affected the casualty's ability to sustain the required posture and therefore increased the likelihood of her suffering a spinal compression fracture.

Celtic Pioneer deck design factors
