Report on the investigation of
injury to a passenger on board the RIB

Celtic Pioneer

26 August 2008

Report No 11/2009
May 2009

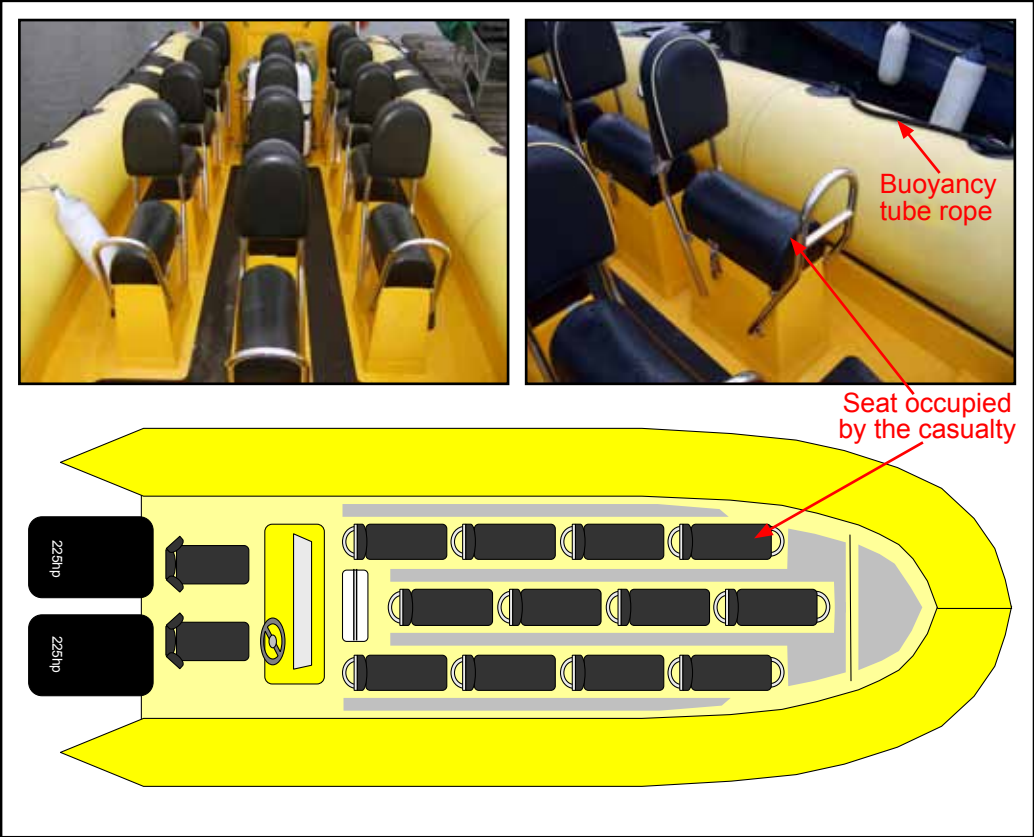
Figure 2

Celtic Pioneer seating positions

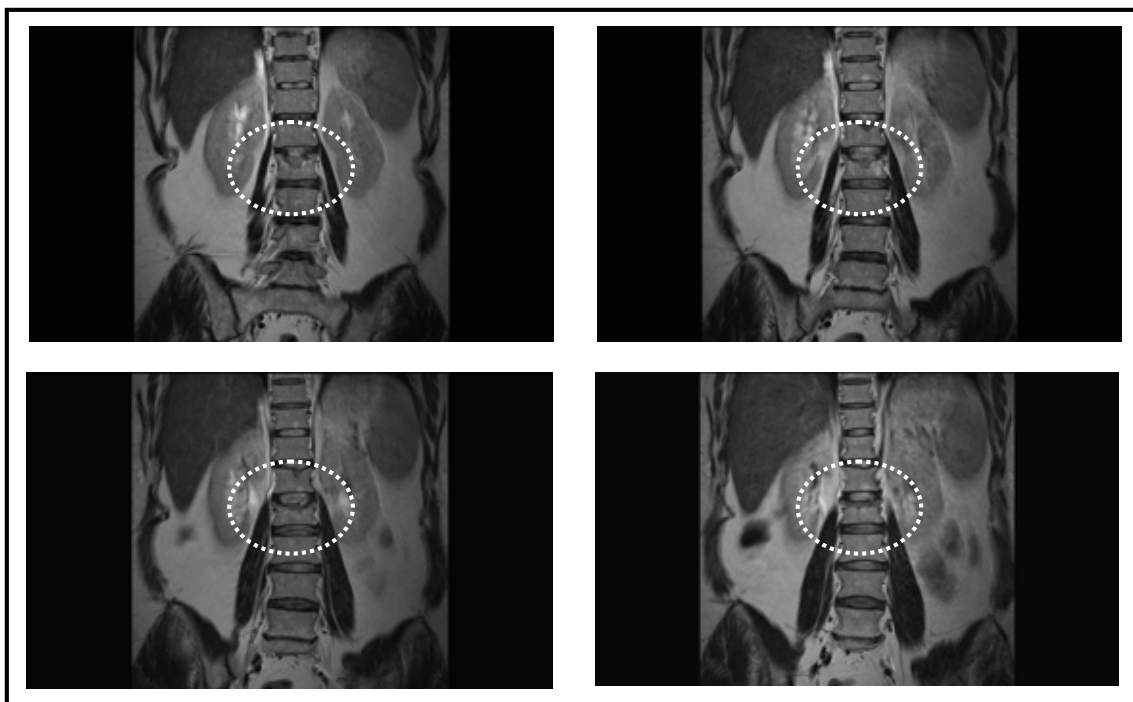
The injured passenger suffered '*a compression fracture of the second lumbar vertebra (L2) with compression of the superior (upper) end plate*' (**Figure 5**). The moderately high energy fracture resulted in the separation of a fragment of vertebral body which had the potential to cause neurological damage (**Annex E**).

Scans of injury suffered

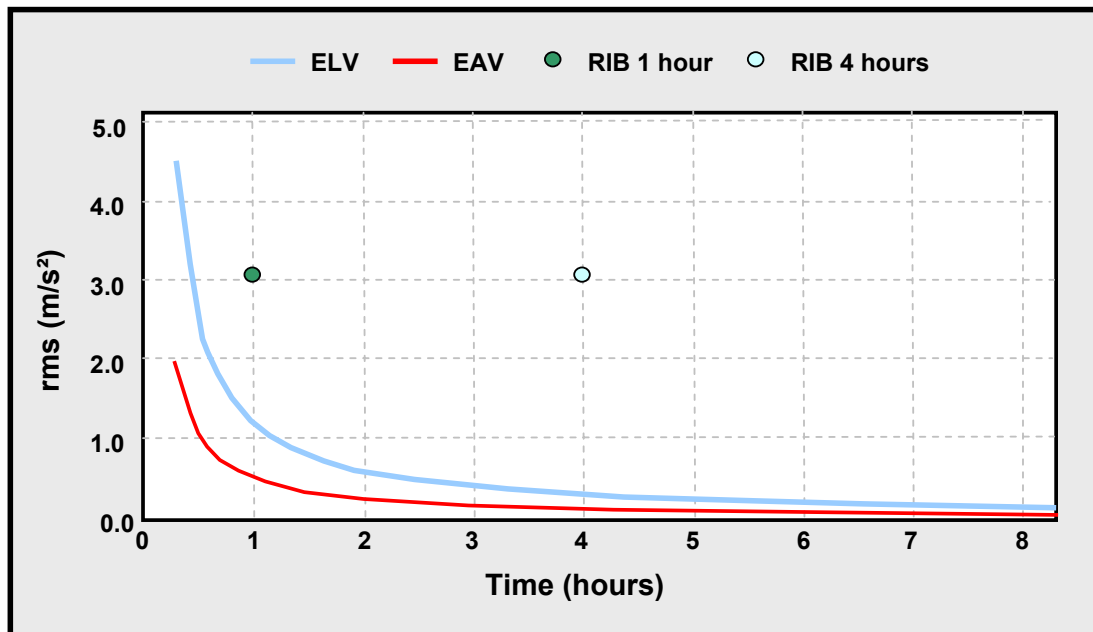
Figure 8

An example of how a RIB travelling at ~40 kts in a sea state 2 will exceed the EU WBV Exposure Action and Limit Values

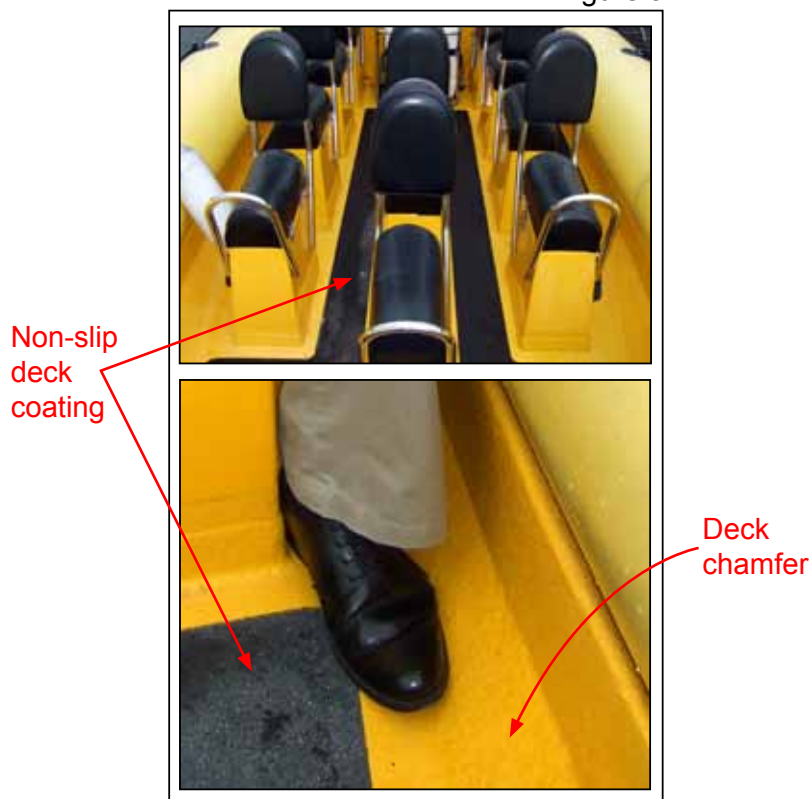
Figure 9

Careful consideration of human factors engineering issues during the design stage for high speed craft can significantly reduce the levels and effect of shock and vibration. Bay Island Voyages had invested in new, well built RIBs from an established manufacturer, which were designed specifically for this type of activity. However, a number of design features have been identified that adversely affected the casualty's ability to sustain the required posture and therefore increased the likelihood of her suffering a spinal compression fracture.

Celtic Pioneer deck design factors

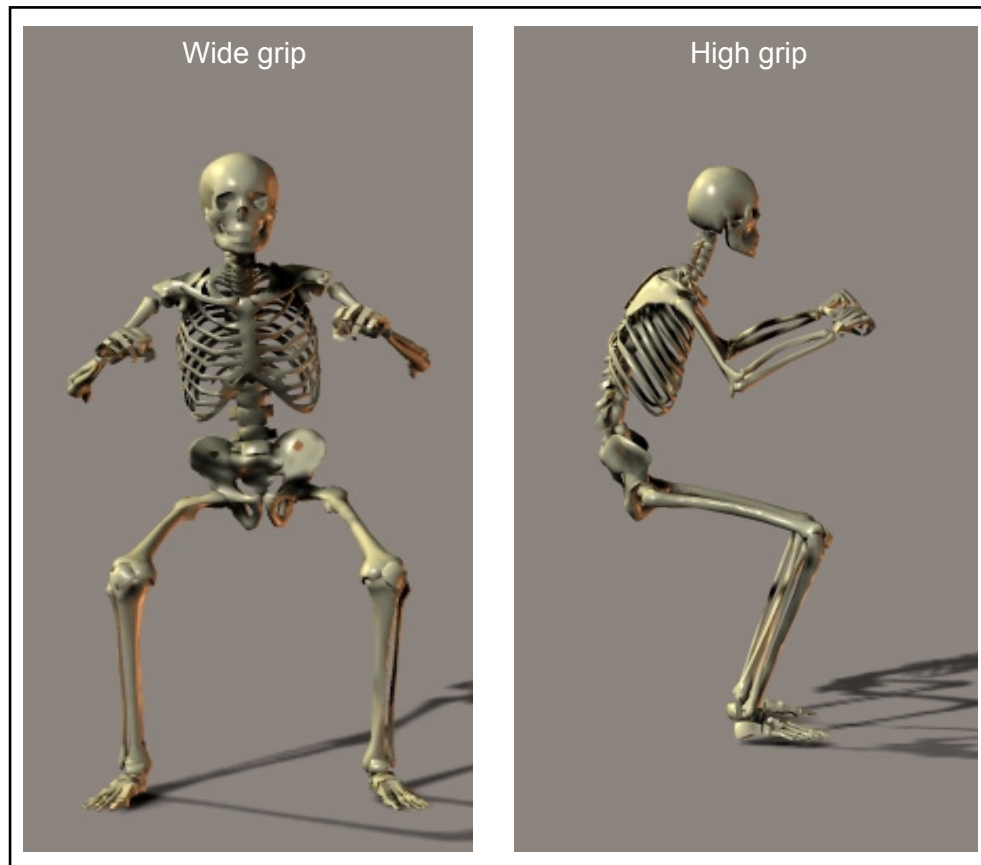
The effects of handgrip or handrail design on passenger posture and stability

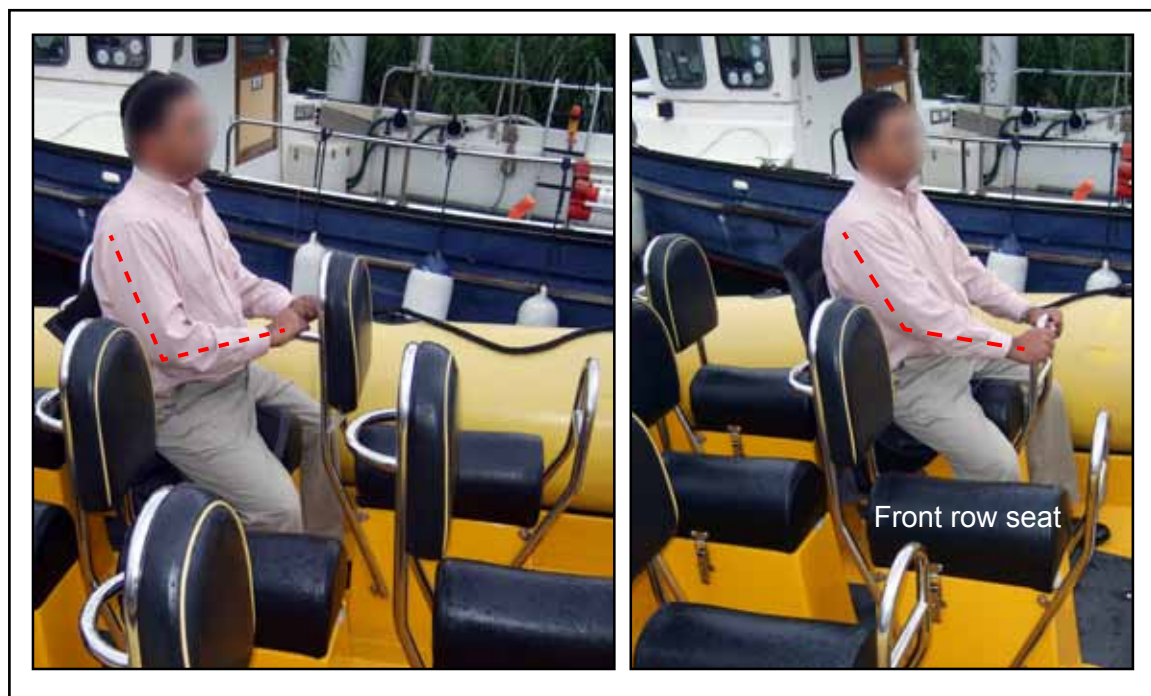
Handrails or handgrips, particularly when affording a high and wide grip, allow passengers to support themselves against impacts during high speed manoeuvring or while dodging waves (**Figure 11**). The position of the handrail on the front row of seats on board *Celtic Pioneer* was lower than those provided on the seats behind. The reduced height of this rail would have made it difficult for the injured passenger to stop herself being thrown forward on impact with the sea. It would also have caused her to assume a more stooped posture while underway (**Figure 12**). Furthermore, the relatively narrow handrail is likely to have offered the injured passenger limited lateral support against impacts with the water during a turn. The handrails on the front row of seats were also open to the elements, exposing the hands of the occupants to the effects of wind chill and sea spray. It was probably a combination of these factors which contributed to the injured passenger's decision to hold onto the buoyancy tube rope with her left hand. Bay Island Voyages' advertising leaflet (**Annex A**) shows a passenger, occupying the corresponding seat on board *Celtic Ranger*, taking similar action. The resulting posture is likely to have introduced a degree of bending and twisting to the casualty's lower back as *Celtic Pioneer* dodged the waves. This would have significantly increased the risk of her suffering a wedge compression fracture (**Figure 13**).

Posture factors associated with the casualty's seat
