Report on the investigation of  
the loss of a passenger overboard from

***Hurlingham***

at Westminster Pier, on the River Thames

**Report No 12/2009**  
**June 2009**

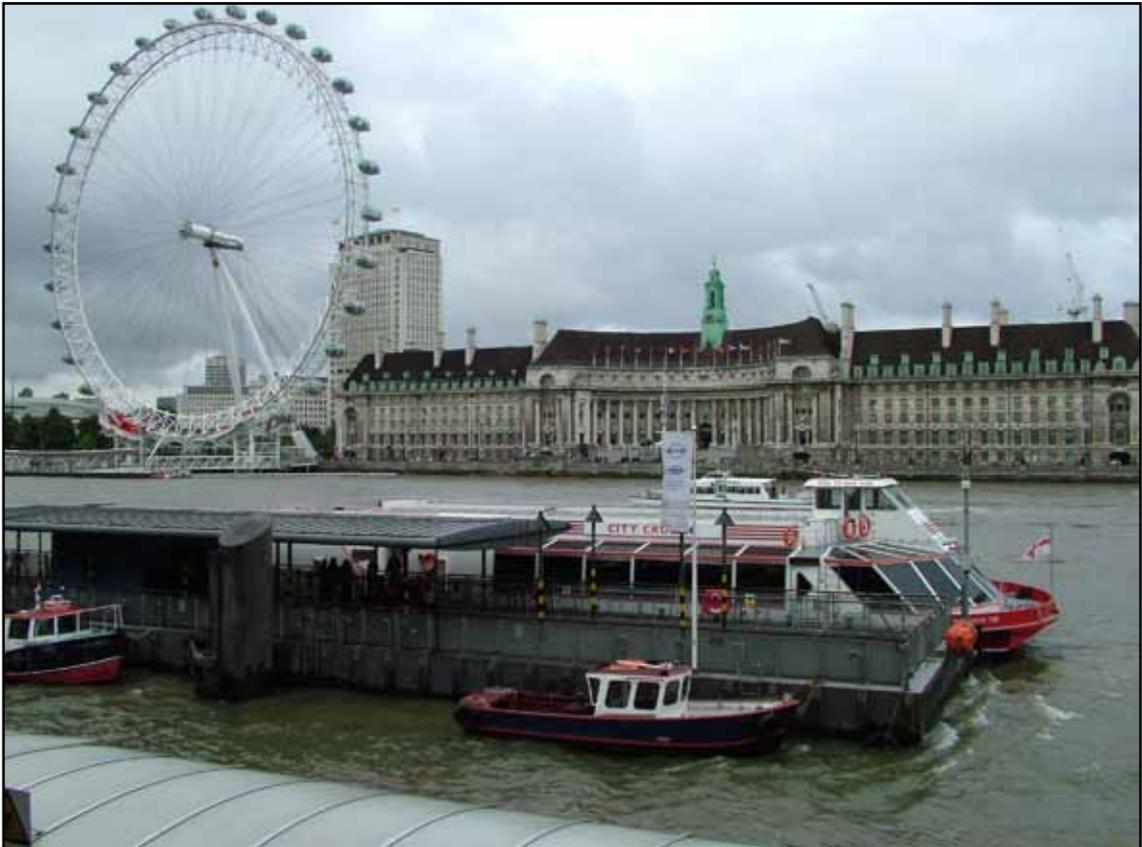
Figure 3

*Hurlingham* returned to Westminster Pier and the skipper began his own search around the inboard parts of the pier (**Figure 3**). He met up with the ILB crew, who confirmed that they had not been able to find the missing passenger on either side of the pier.

Westminster Pier viewed from the river bank

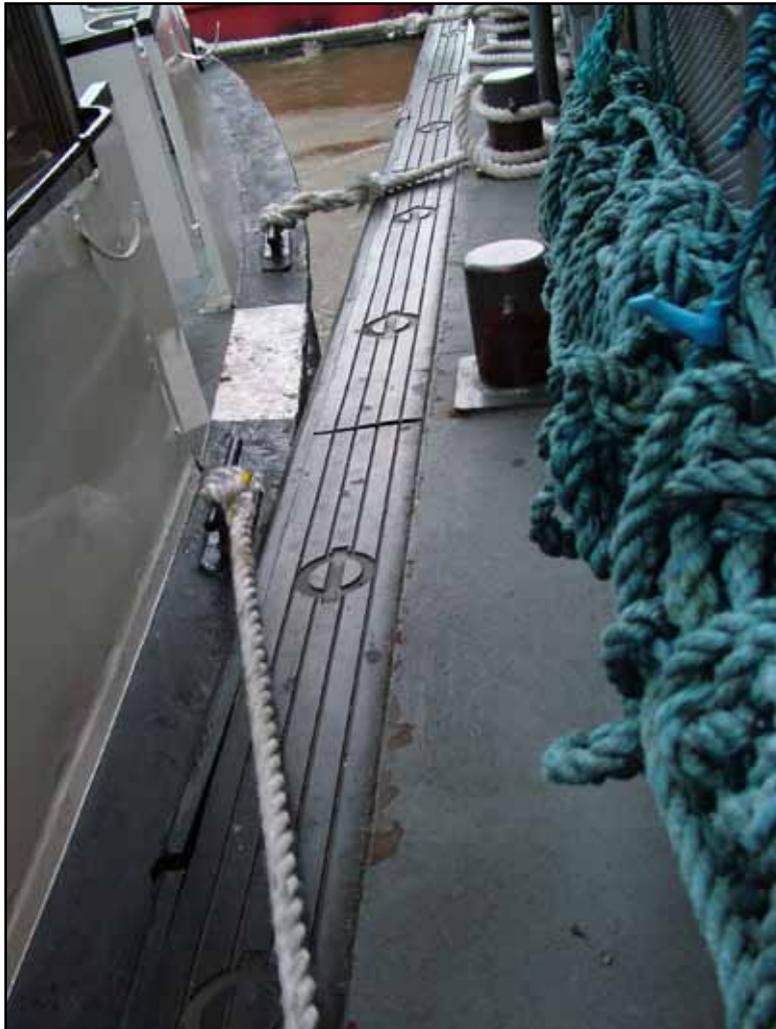
Figure 4

During the investigation, *Hurlingham* was brought alongside Westminster Pier to examine passenger access (**Figure 4**). It was found that by bringing the boat into the pier at a shallow angle, the deck edge at the forward boarding gate could be brought up against the pier, without leaving a gap. *Hurlingham's* deck was lower than the pier, requiring passengers to step up a distance of between 17 and 23cm depending on the number of people on board.

Possible means of access from *Hurlingham* to Westminster Pier

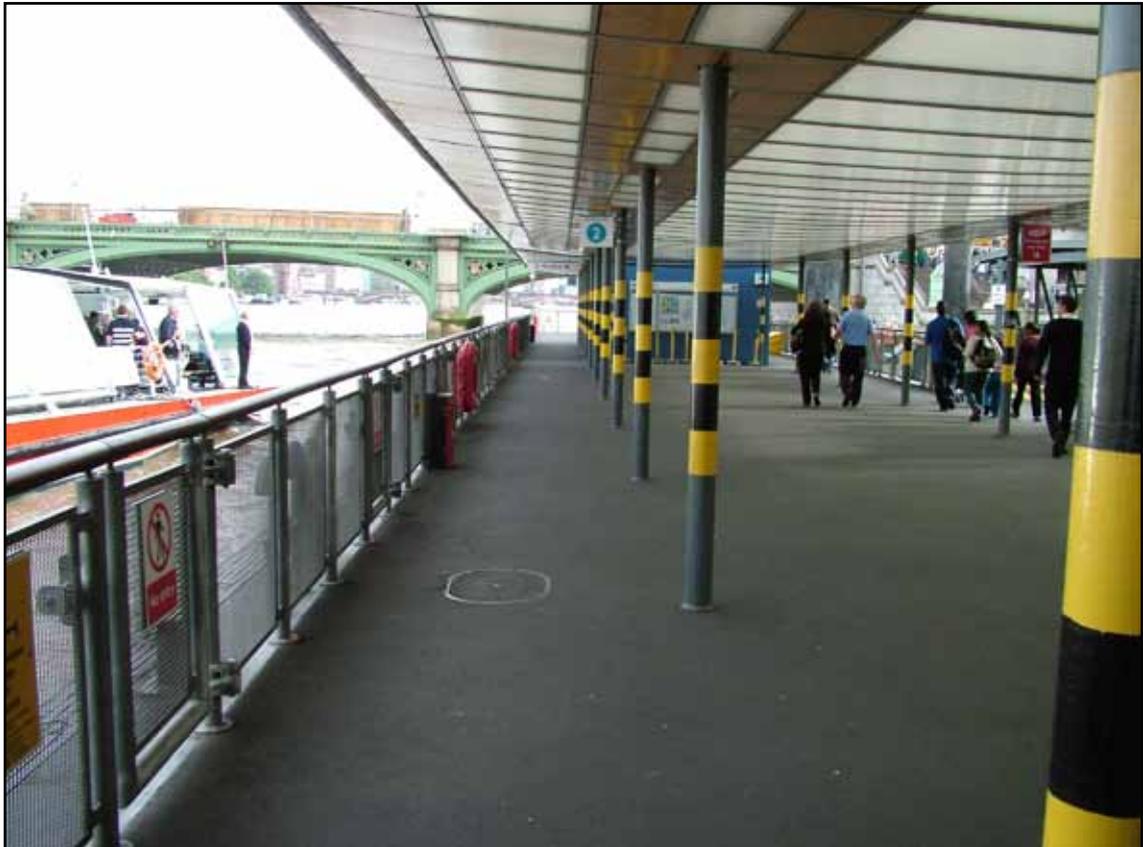
The fore deck disembarkation area was lit by background light from the accommodation of *Hurlingham* and from overhead lights on Westminster Pier. The combination provided general lighting but, on the evening of the accident, the immediate area of the gates on the boat and pier would have been in shadow (**Figure 5**). The deck edge of *Hurlingham* was painted white, and the fender material at the edge of the pier was black.

General arrangements on Westminster Pier
