Report on the investigation of

the grounding of

Antari

**Report No 7/2009
February 2009**

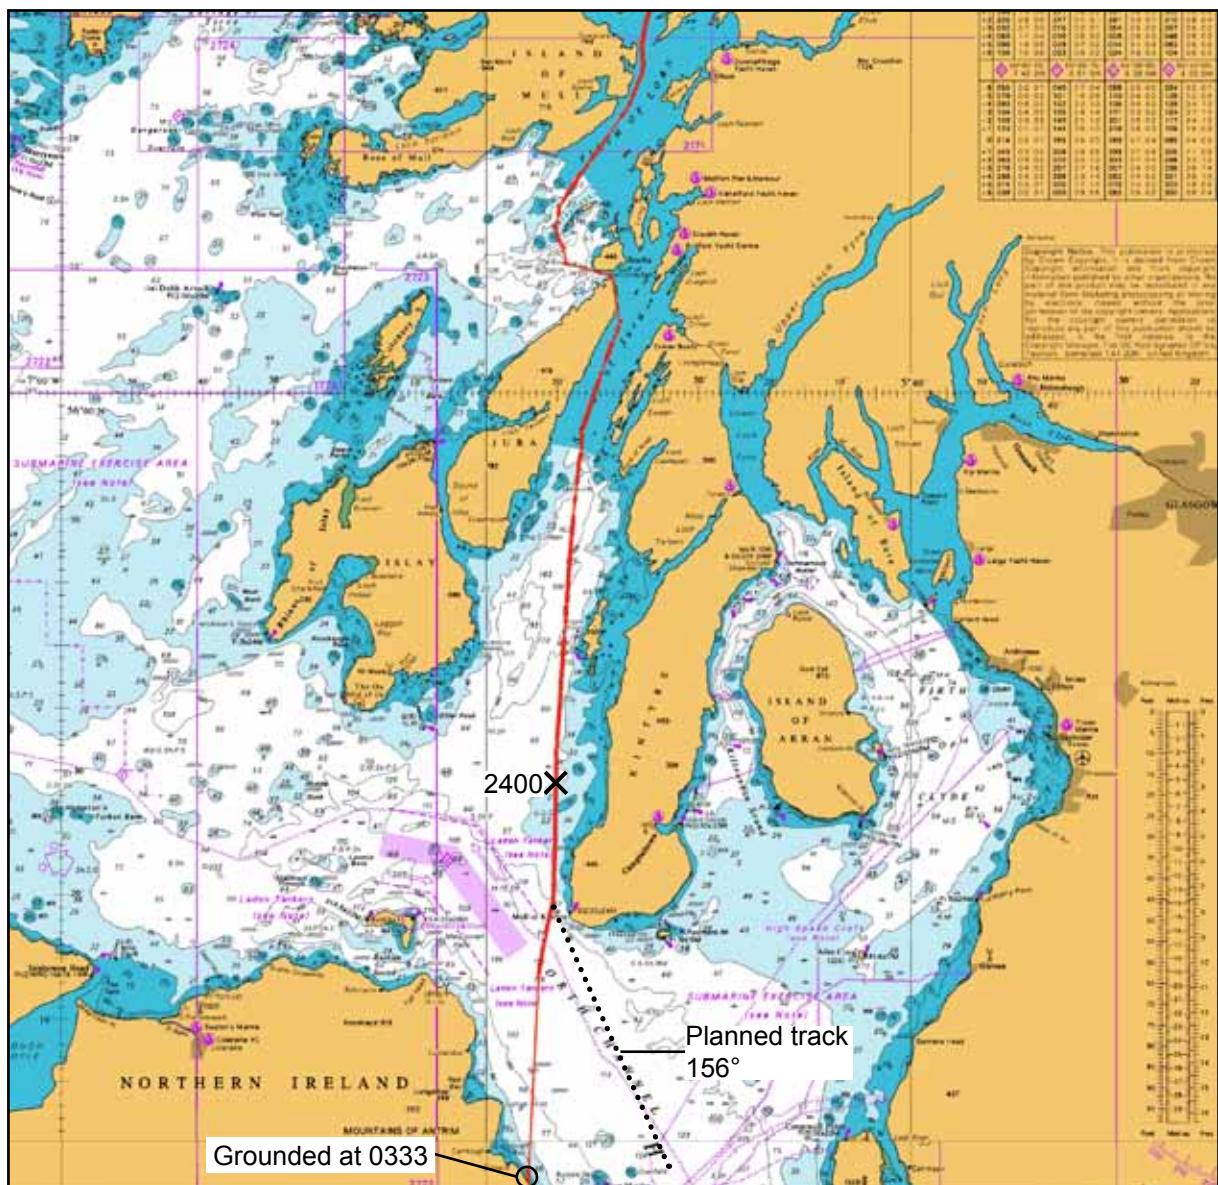
At 2000, with the master as the sole bridge watchkeeper, *Antari* transited the Gulf of Corryvreckan before heading south to run parallel with the west coast of the Kintyre peninsula (**Figure 1**).

BA Chart 2724, extract showing Antari's AIS track

At midnight, the vessel's course was 182° (T), speed 11 knots and she was about 11 miles from the next planned alteration of course position, which was due west of the Mull of Kintyre lighthouse.

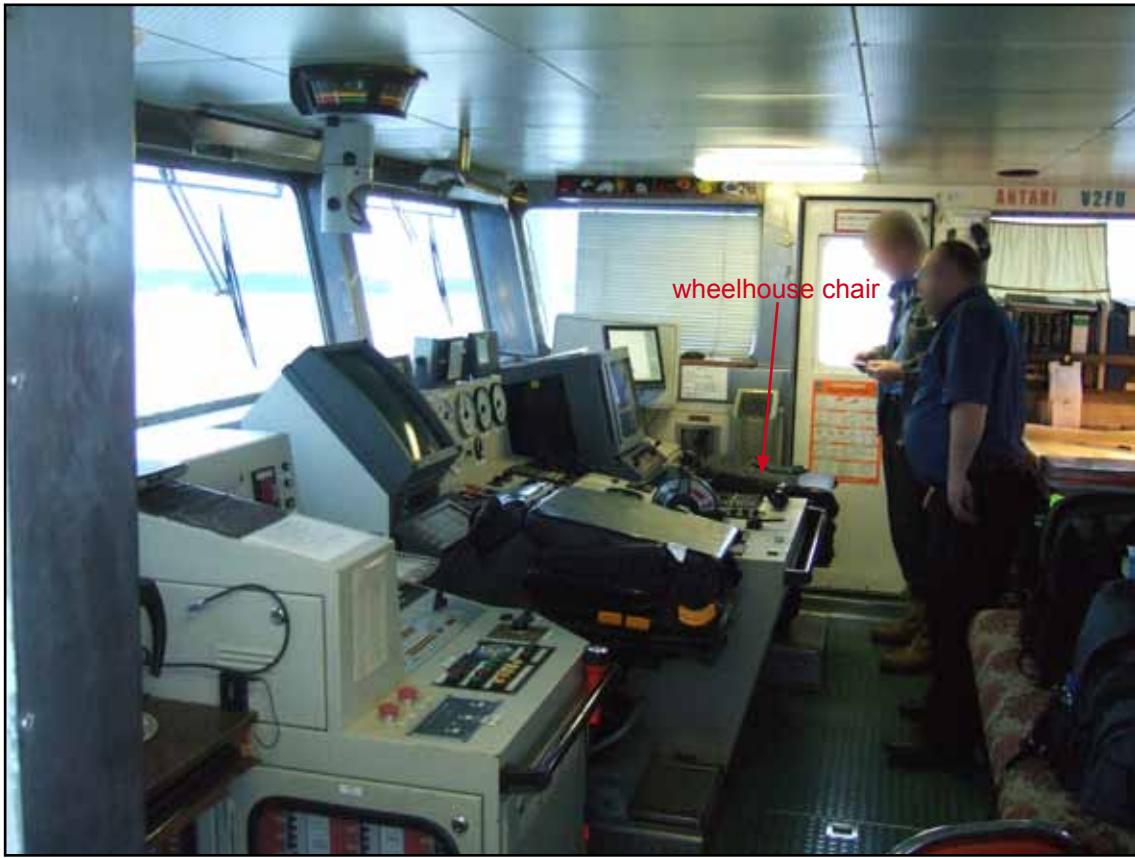
Figure 2

The chief officer was now the sole bridge watchkeeper. Both wheelhouse doors were closed, it was a clear, moonless night and the sea was calm with a slight westerly swell. He was sitting, as was his custom, in a chair on the starboard side of the wheelhouse, in front of one of the radar sets and the ECDIS unit (**Figure 2**). He fell asleep shortly after sitting down, and remained asleep until the vessel grounded at 0321.

Antari, wheelhouse chair in which chief officer fell asleep

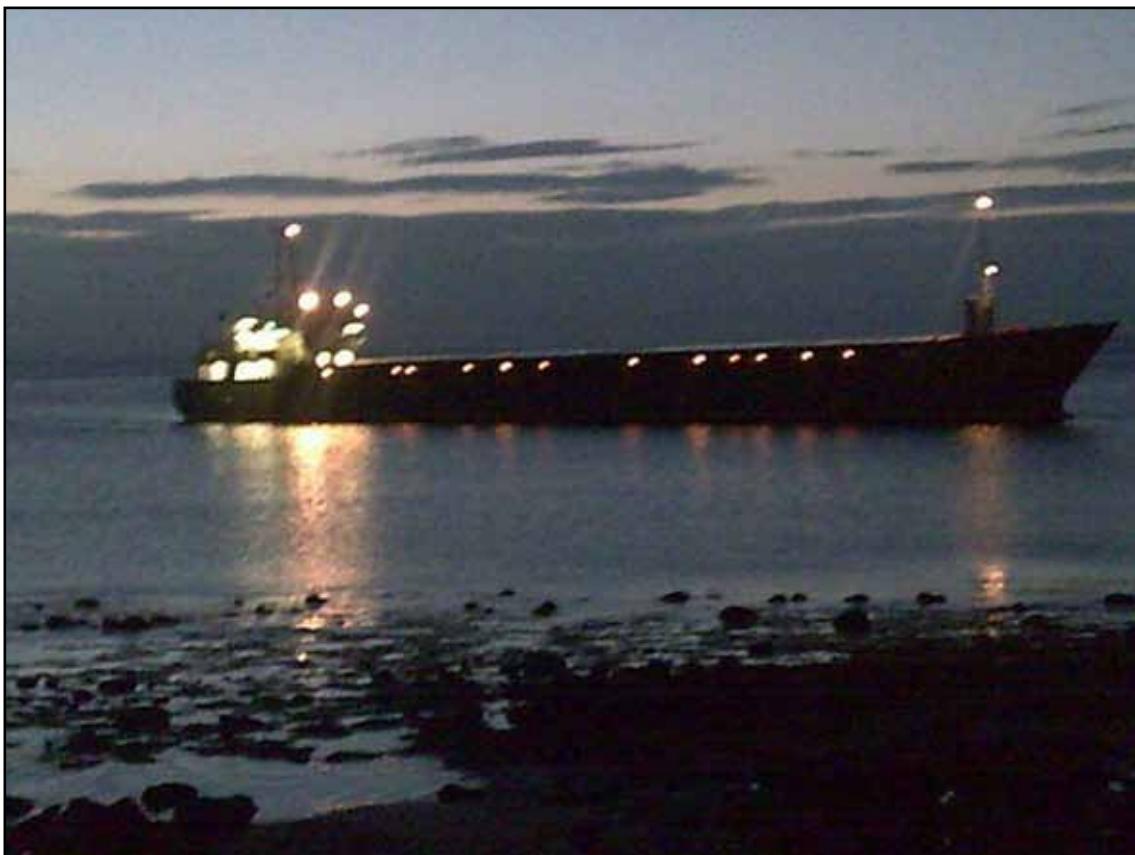
At 0407 a motorist driving along the coast road between Larne and Glenarm reported to Belfast coastguard that he could see a vessel aground on the beach, close to the road at St Drumnagreagh Port (**Figure 3**).

Antari aground on the Antrim coast

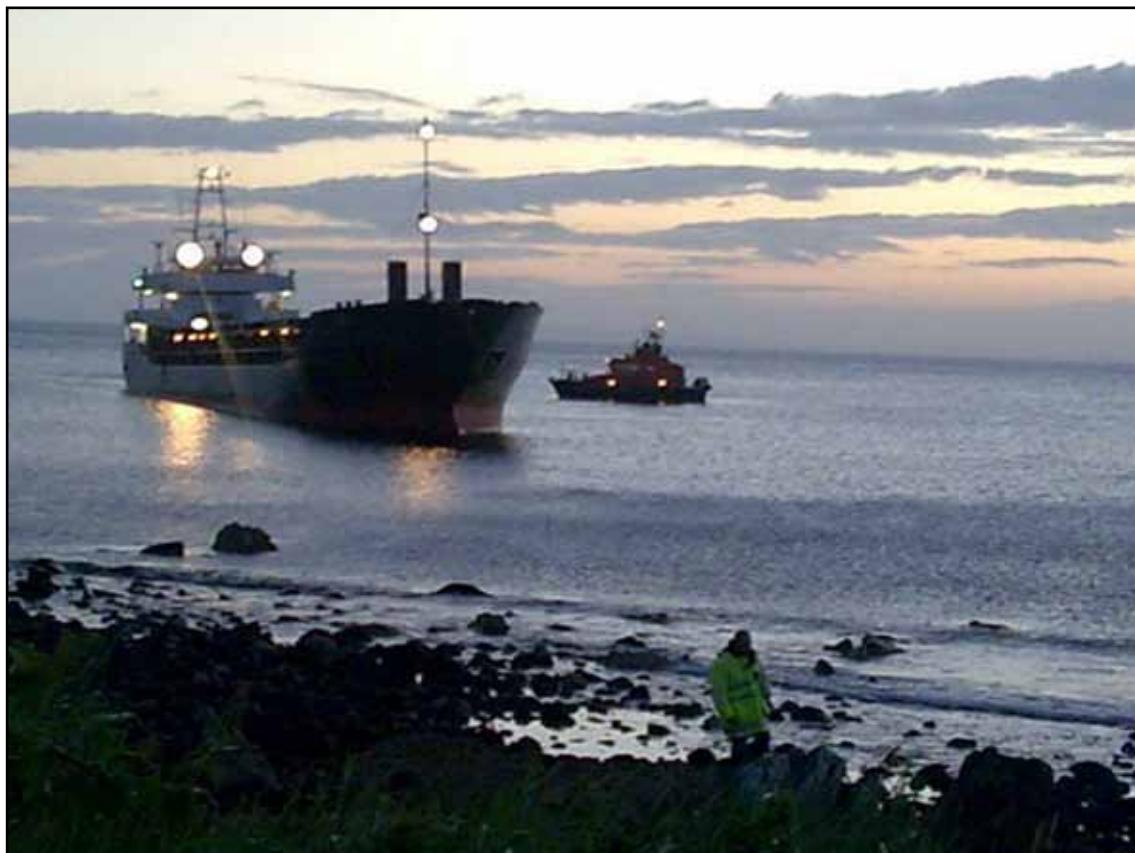
The Larne lifeboat arrived at 0512 and carried out a check, by searchlight, of the vessel for damage and pollution (**Figure 4**).

Larne lifeboat checks *Antari*'s hull for damage

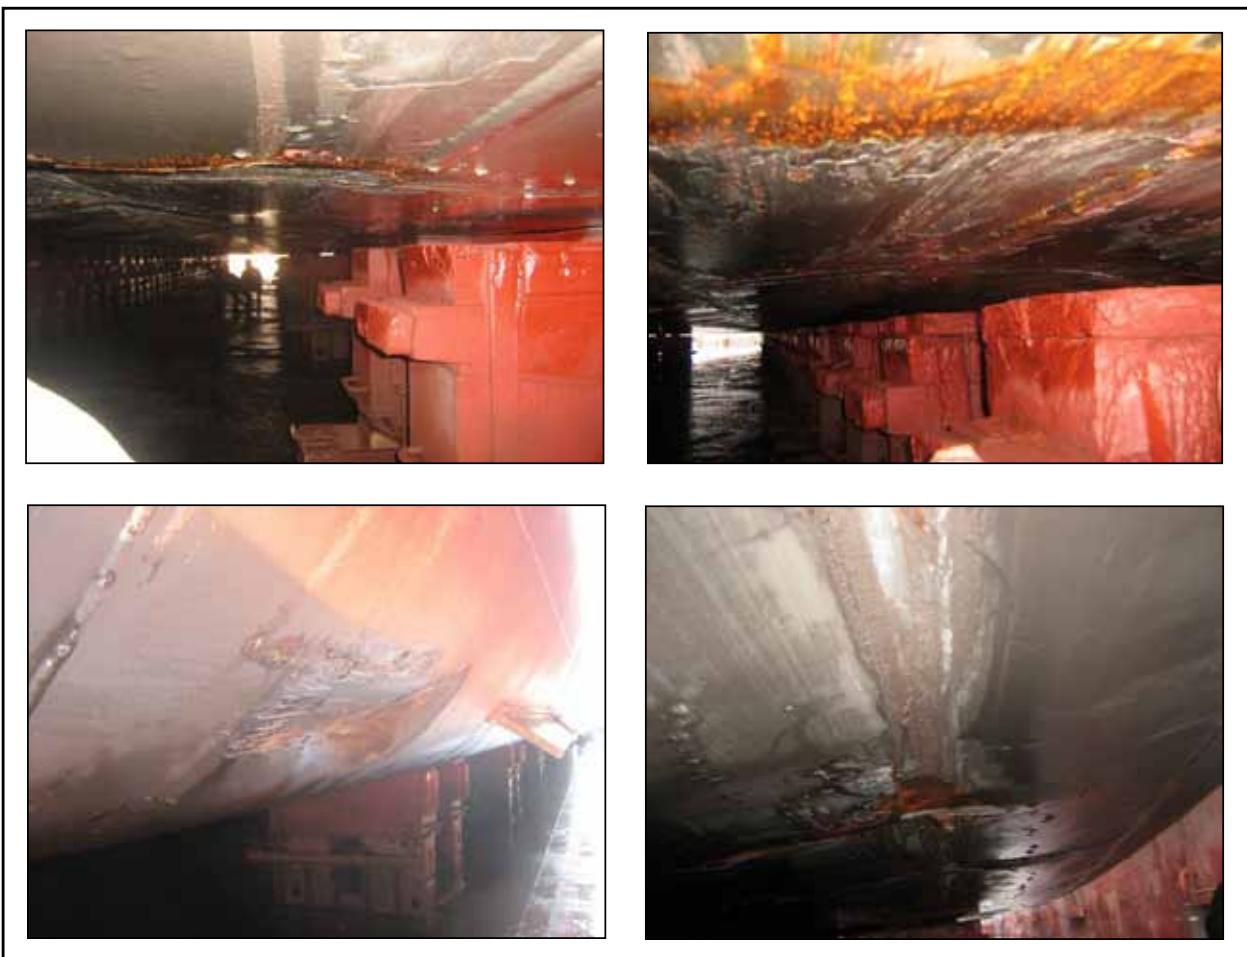
Figure 5

The results of the survey showed indentation damage to the bottom of the hull over 70% of the vessel's length from forward, and found that there was a small hole in number 3 double bottom ballast tank.

Damage to bottom

The vessel departed for Ghent later that day, where she arrived on 3 July. On completion of discharge of the cargo, she proceeded to Swinoujscie, Poland where permanent repairs, lasting several weeks and requiring 25 tonnes of new steelwork to the vessel's bottom (**Figure 5**), were carried out before she was able to resume service.

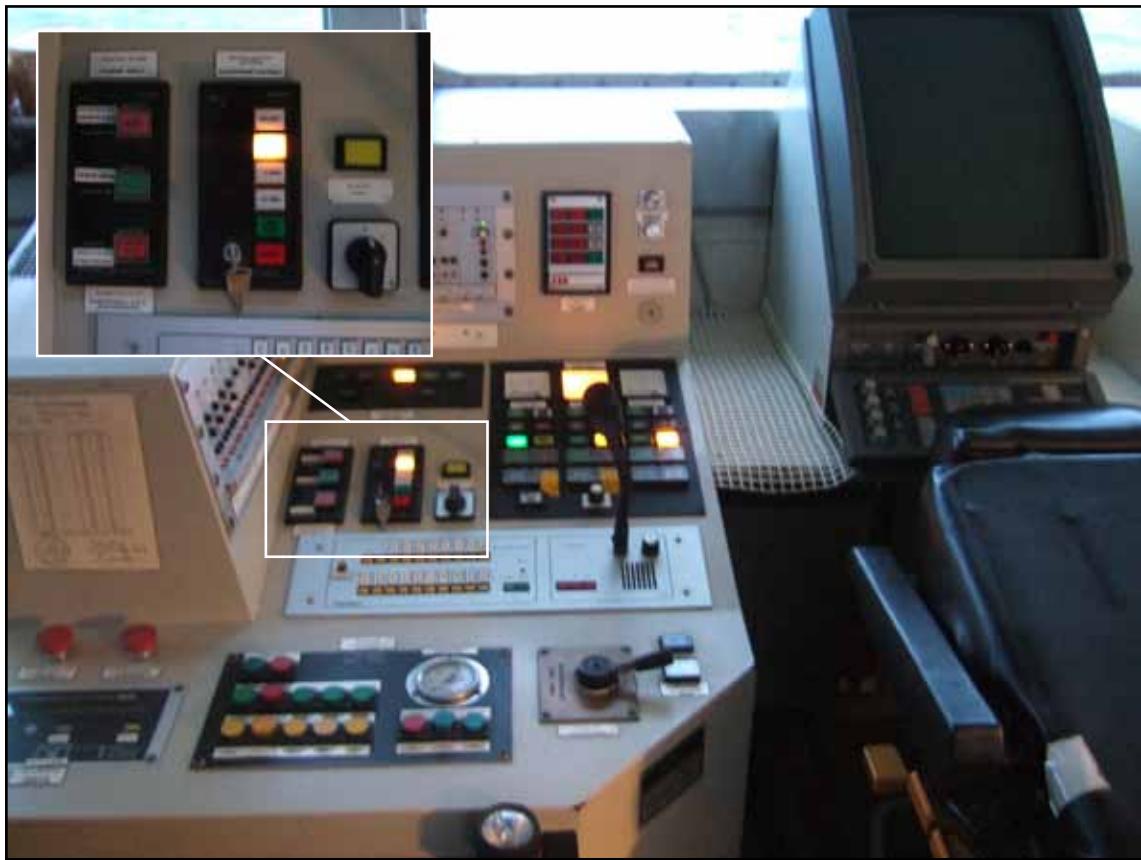
Figure 6

A watch alarm is an alarm system that is designed to alert the watchkeeper at predetermined intervals. The alarm sequence will usually consist of a flashing light, followed, after a period of time, by an audible alarm on the bridge, and thereafter, following a further delay, by the sounding of an alarm in the officers' cabins, or the general alarm. Once activated, the initial alarm is usually silenced by the watchkeeper pressing a button. Failure to cancel the alarm will result in the off watch officer(s) or, in some cases, the entire crew, being alerted to a potential problem on the bridge.

Watch alarm in wheelhouse

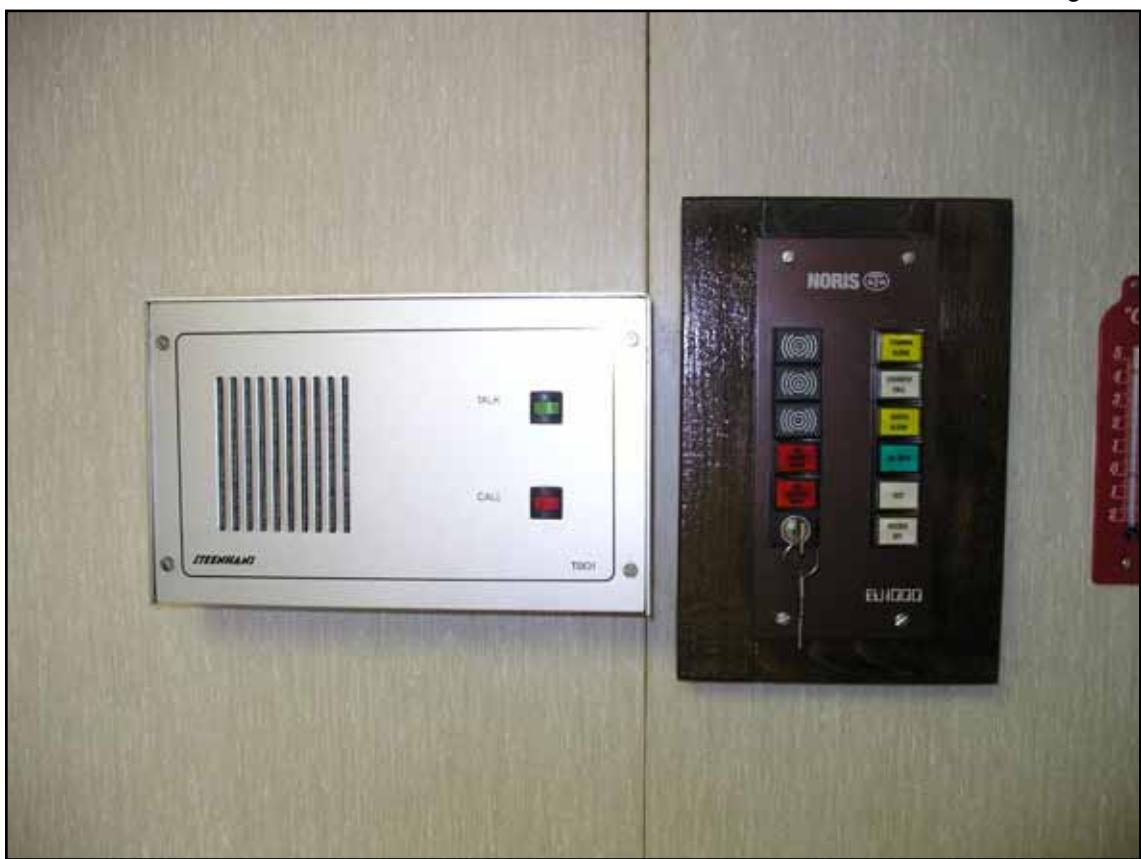
Figure 7

Watch alarm repeater in master's cabin
