Report on the investigation of
the fatality on board
passenger cruise ship

Saga Rose

on 11 June 2008

Report No 01/2009
January 2009

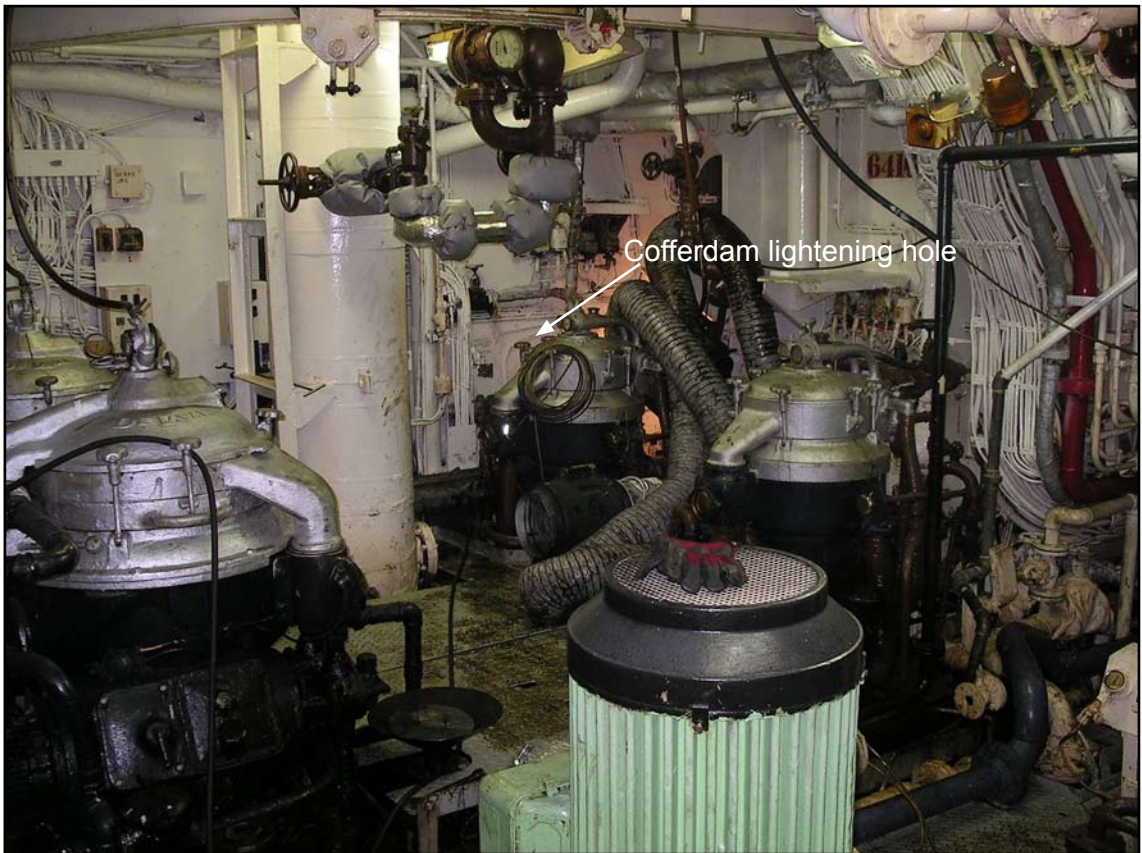
Figure 2

The purifier room

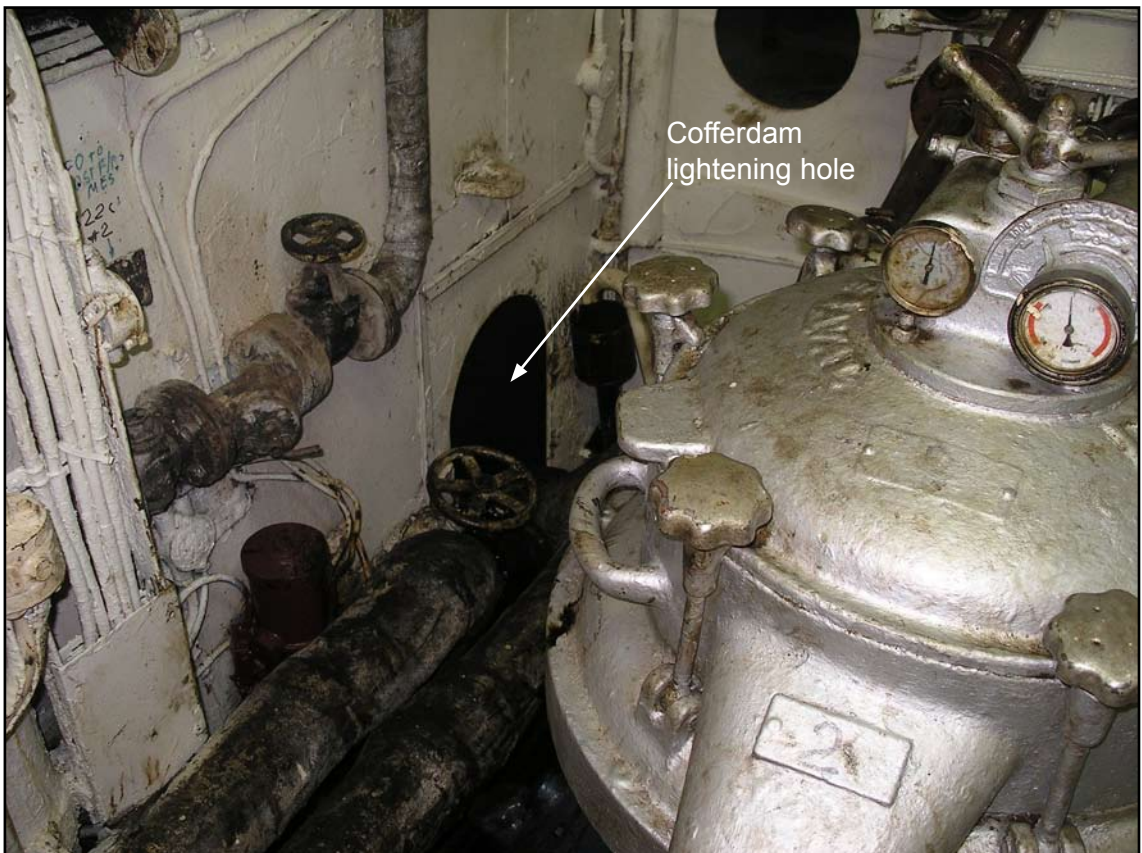
Figure 3

Entrance to the cofferdam (view from the purifier room)

The manhole was at the far end of a 5 metre open cofferdam (**Figure 5**) which was accessed through a lightening hole from the purifier room (**Figures 3 and 4**). The cofferdam was situated between two heated fuel oil service tanks and

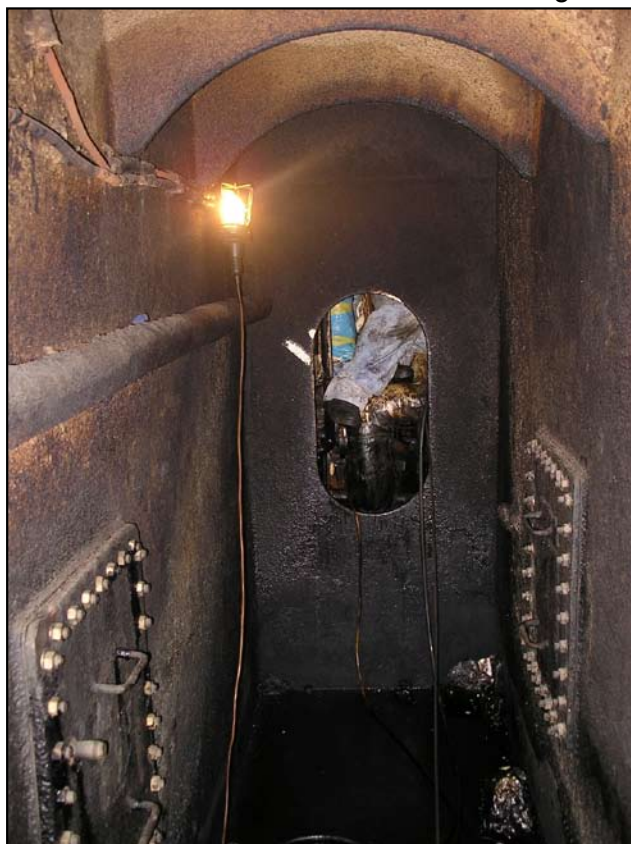
Figure 4

Entrance to the cofferdam (view from cofferdam)

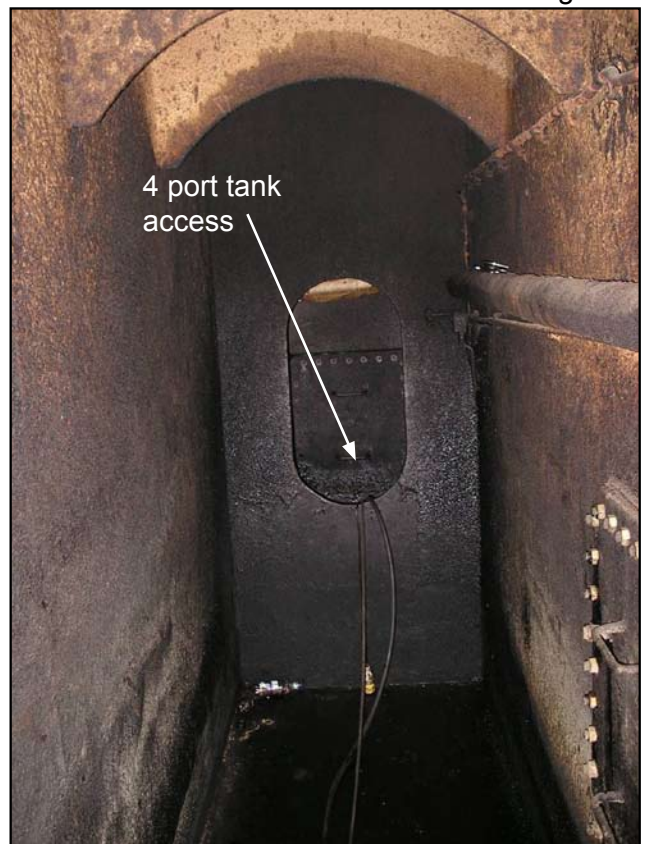
Figure 5

Cofferdam with tank access

the temperature in the cofferdam was between 40° and 50°C. Illumination was provided by a light with a wandering lead, and, other than for access to the double bottom tank, this space was not normally entered.

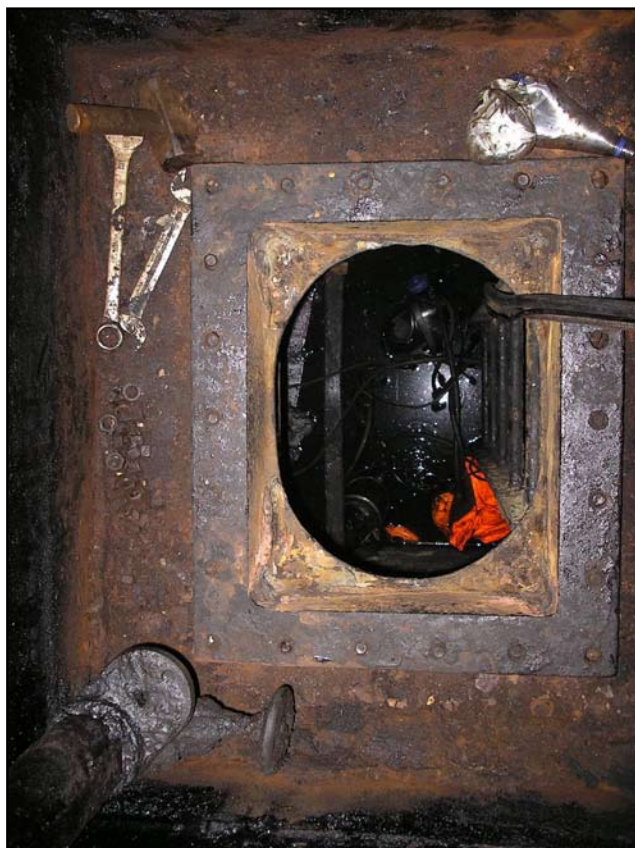
Figure 6

No.4 port outer double bottom tank manhole

No 4 port outer double bottom tank was 2.5m wide and 20m long with a maximum depth of 1.7m, and it had a capacity of 44 cubic metres. About 10cm of water covered the tank bottom. The tank was serviced by a vertical natural air vent to the ship's side, a suction/filling pipe sited in the engine room, which was blanked off, and a sounding pipe which was blocked. The tank's steel structure was coated with a preservative, but this had broken down and the structure was heavily corroded.

Access into the tank was through a single tank top manhole fitted with a steel cover secured by 22 nuts and bolts. The manhole access was oval shaped, but the steel cover was rectangular with dimensions of 800mm x 600mm (**Figure 6**). Following the accident, the manhole cover gasket was found lying in the tank bottom under the discarded breathing apparatus and airlines used during the rescue.

It is almost certain that the oxygen depleted atmosphere developed through the corrosion of the tank's steel structure. The tank had probably been empty since it was last inspected in April 2005, and the steel structure would have corroded in the following 3 years due to its exposure to moist air. The oxidising or rusting process would have consumed the oxygen within the tank and, as the tank was fitted with a single natural air vent, any mixing of fresh air with the tank's atmosphere would have been minimal.

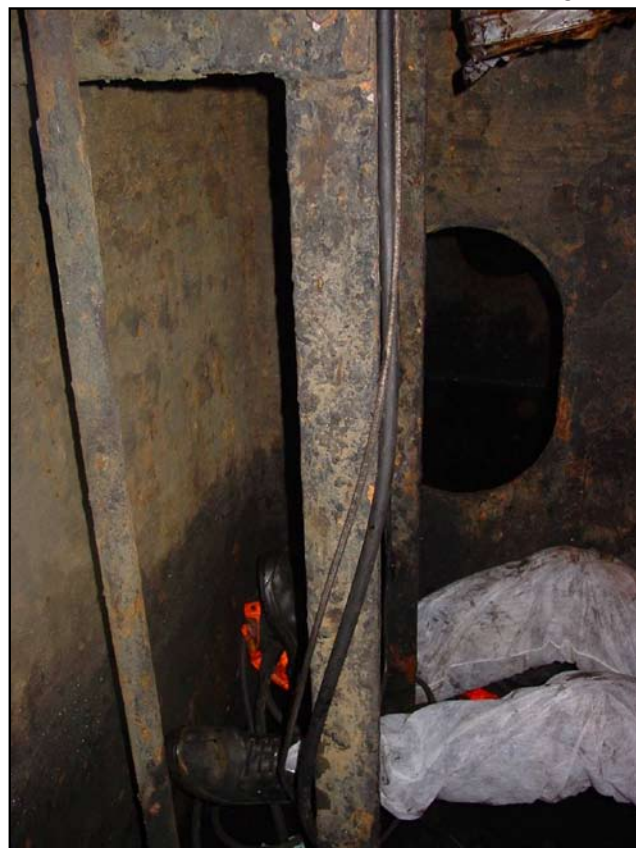
Figure 7

Reconstruction of the position of the second bosun

Although the postmortem report concluded that the bruising to the underside of the second boson's left arm supports the scenario of him reaching into the tank, sliding and tumbling in, this was unlikely in view of the extremely limited room available adjacent to the manhole (**Figures 5 and 6**). It is more plausible that he descended the ladder, and then reached towards the water at the tank bottom with his left hand while holding onto the ladder with his right hand. Once his head was inside the tank, he would have quickly lost consciousness and collapsed onto the protruding frame at the tank bottom (**Figure 6**), with his left arm extended. This scenario is also consistent with the position in which his body was found (**Figure 7**) and the absence of other injuries which would have been likely had he fallen 1.7m, head first into the tank.
