Report on the investigation of  
the fatality on board  
passenger cruise ship

***Saga Rose***

on 11 June 2008

**Report No 01/2009**  
**January 2009**

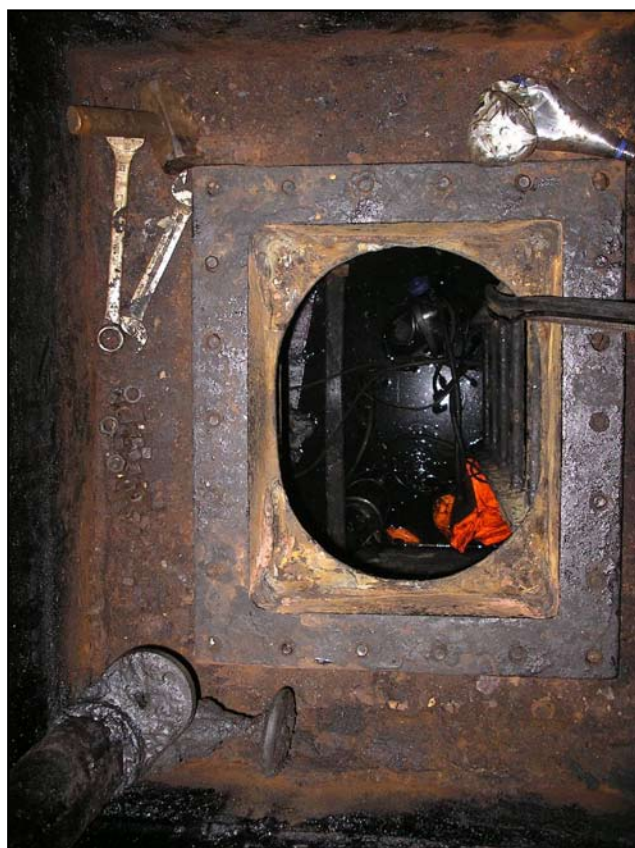
Figure 6

No.4 port outer double bottom tank manhole

Access into the tank was through a single tank top manhole fitted with a steel cover secured by 22 nuts and bolts. The manhole access was oval shaped, but the steel cover was rectangular with dimensions of 800mm x 600mm (**Figure 6**). Following the accident, the manhole cover gasket was found lying in the tank bottom under the discarded breathing apparatus and airlines used during the rescue.

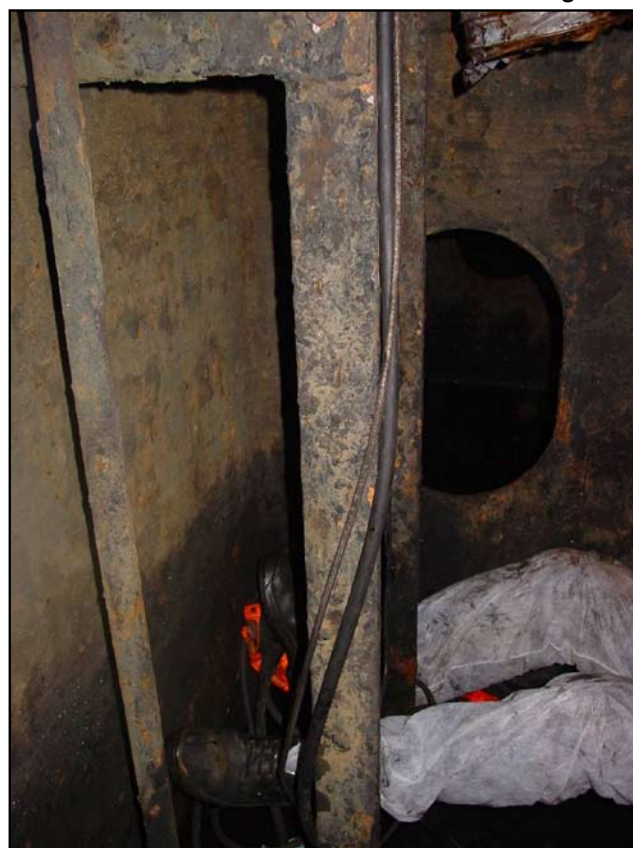
Figure 7

Reconstruction of the position of the second bosun
