Report on the investigation of  
the fatality on board  
passenger cruise ship

***Saga Rose***

on 11 June 2008

**Report No 01/2009**  
**January 2009**

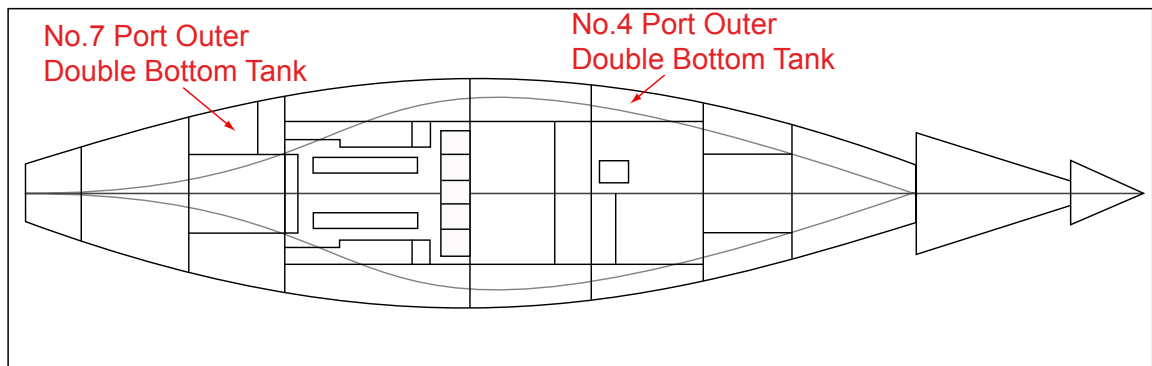
Figure 1

Extract of vessel's tank plan

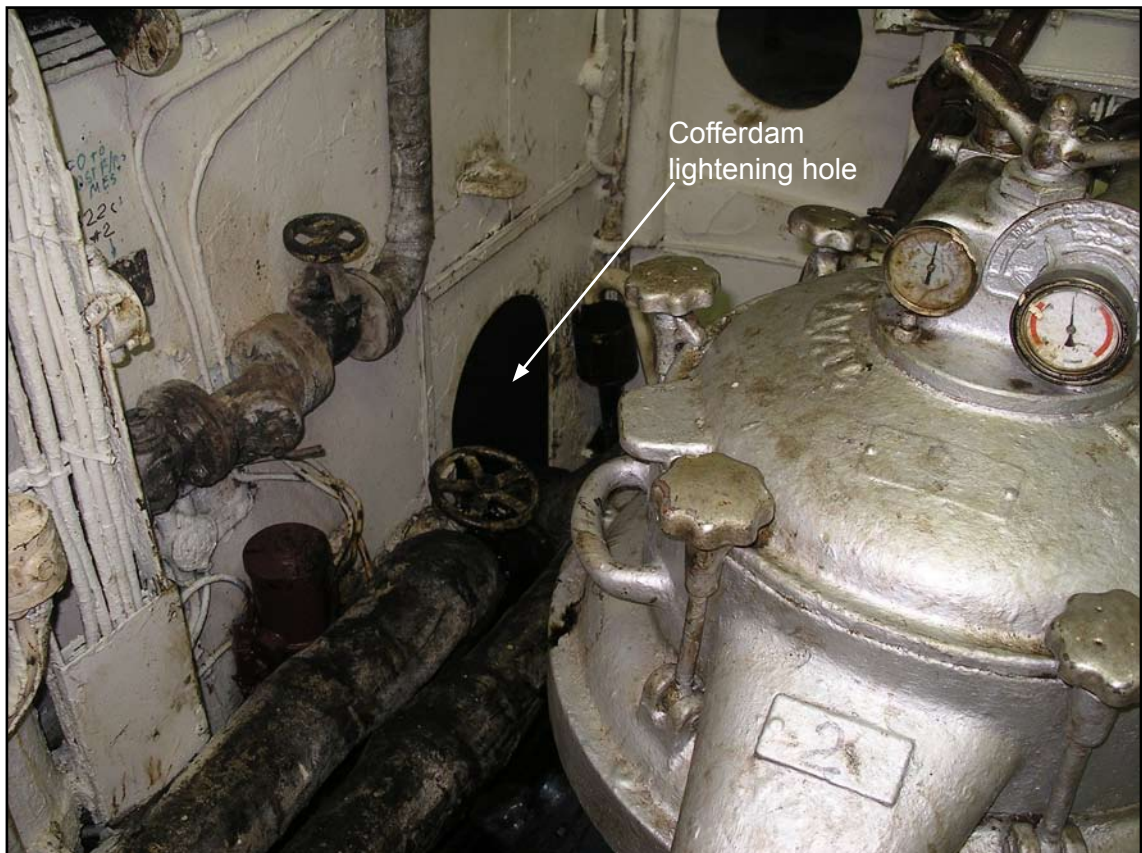
Figure 3

Entrance to the cofferdam (view from the purifier room)

The manhole was at the far end of a 5 metre open cofferdam (**Figure 5**) which was accessed through a lightening hole from the purifier room (**Figures 3 and 4**). The cofferdam was situated between two heated fuel oil service tanks and

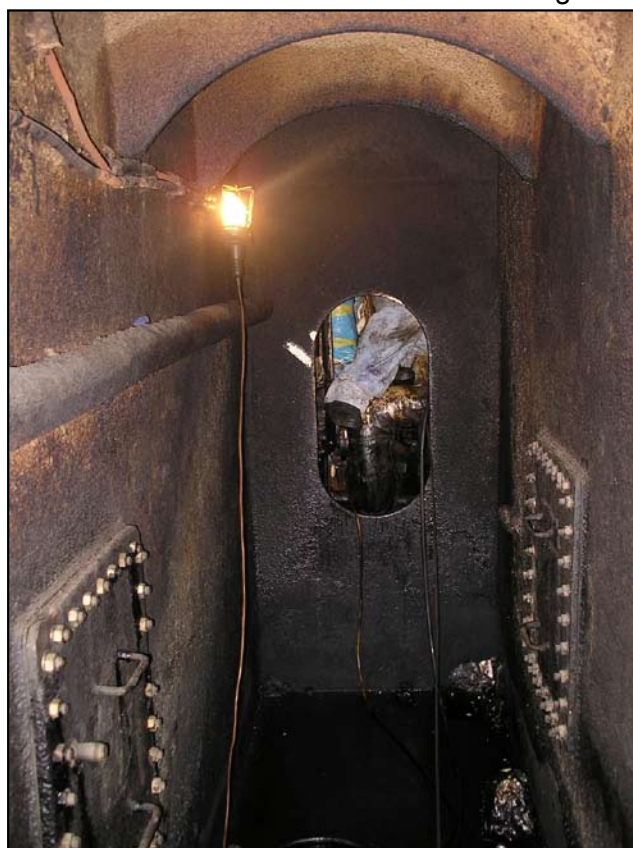
Figure 4

The motorman slid down into the cofferdam and looked down into the tank (**Figures 4, 5, and 6**). He saw the second bosun was unconscious at the foot of the ladder. He was lying face up, with one of his legs passing between two of the ladder’s lower rungs (**Figure 7**). The motorman immediately alerted the bosun, who ordered him to get out of the cofferdam. The bosun and the motorman then went to the engine control room from where the bosun informed the officer of the watch (OOW) on the bridge, by telephone, that the second bosun was unconscious in No 4 port outer tank.

Entrance to the cofferdam (view from cofferdam)

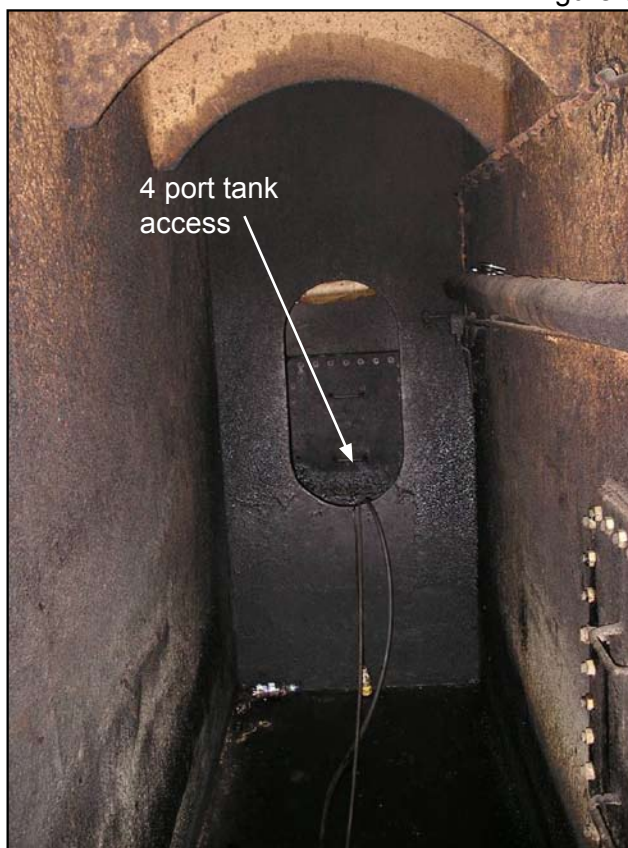
Figure 5

Cofferdam with tank access

the temperature in the cofferdam was between 40° and 50°C. Illumination was provided by a light with a wandering lead, and, other than for access to the double bottom tank, this space was not normally entered.

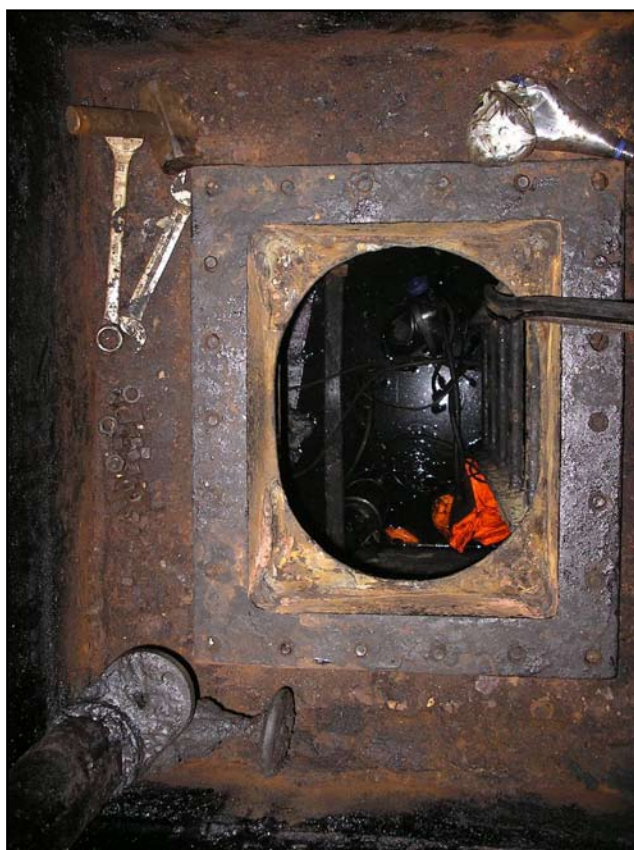
Figure 6

No.4 port outer double bottom tank manhole

No 4 port outer double bottom tank was 2.5m wide and 20m long with a maximum depth of 1.7m, and it had a capacity of 44 cubic metres. About 10cm of water covered the tank bottom. The tank was serviced by a vertical natural air vent to the ship's side, a suction/filling pipe sited in the engine room, which was blanked off, and a sounding pipe which was blocked. The tank's steel structure was coated with a preservative, but this had broken down and the structure was heavily corroded.

Access into the tank was through a single tank top manhole fitted with a steel cover secured by 22 nuts and bolts. The manhole access was oval shaped, but the steel cover was rectangular with dimensions of 800mm x 600mm (**Figure 6**). Following the accident, the manhole cover gasket was found lying in the tank bottom under the discarded breathing apparatus and airlines used during the rescue.

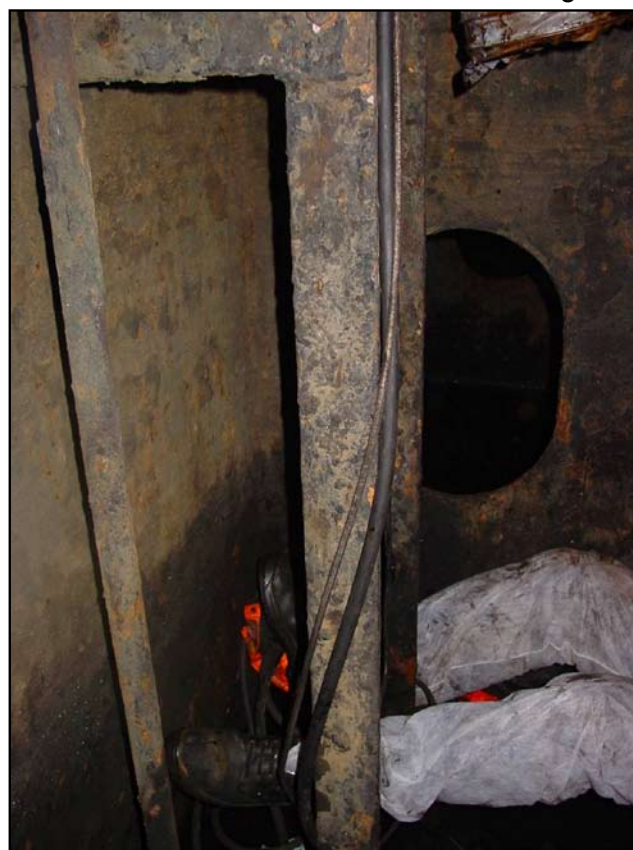
Figure 7

Reconstruction of the position of the second bosun

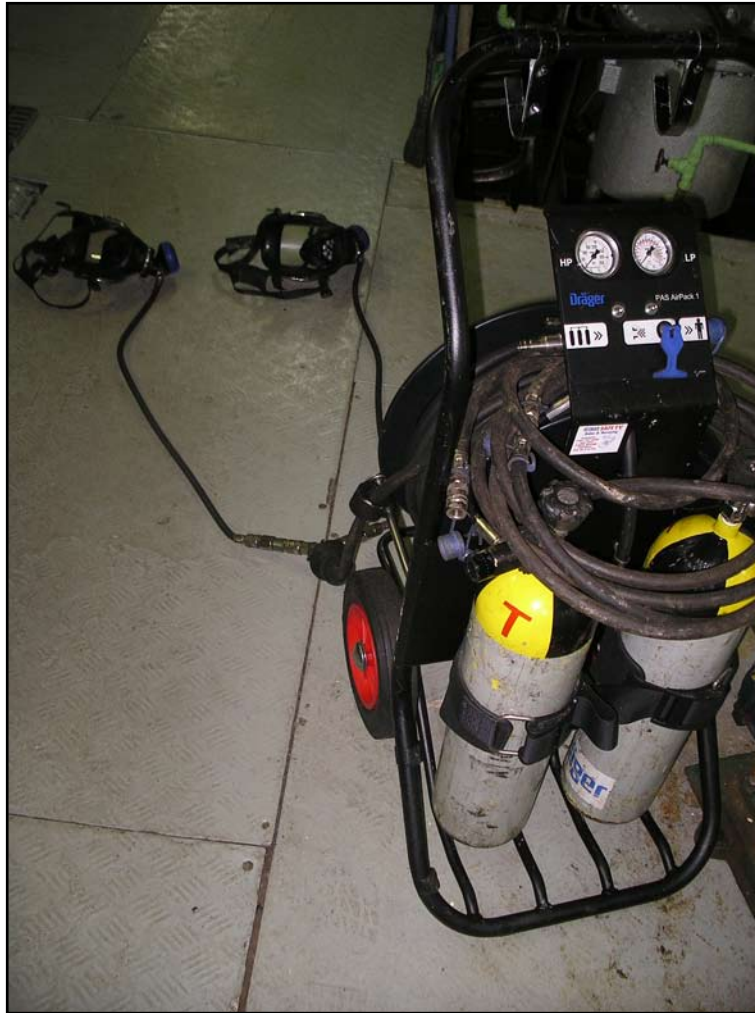
Figure 8

BA trolley set

The safety officer and the staff chief engineer slid down into the cofferdam and were then passed three SCBA sets and the two masks from the trolley set. The safety officer put on one of the trolley masks and the staff chief engineer an SCBA. They then crawled through the cofferdam, carrying the rest of the emergency equipment to the tank entrance.
