Report on the investigation of
the fatality on board
passenger cruise ship

Saga Rose

on 11 June 2008

Report No 01/2009
January 2009

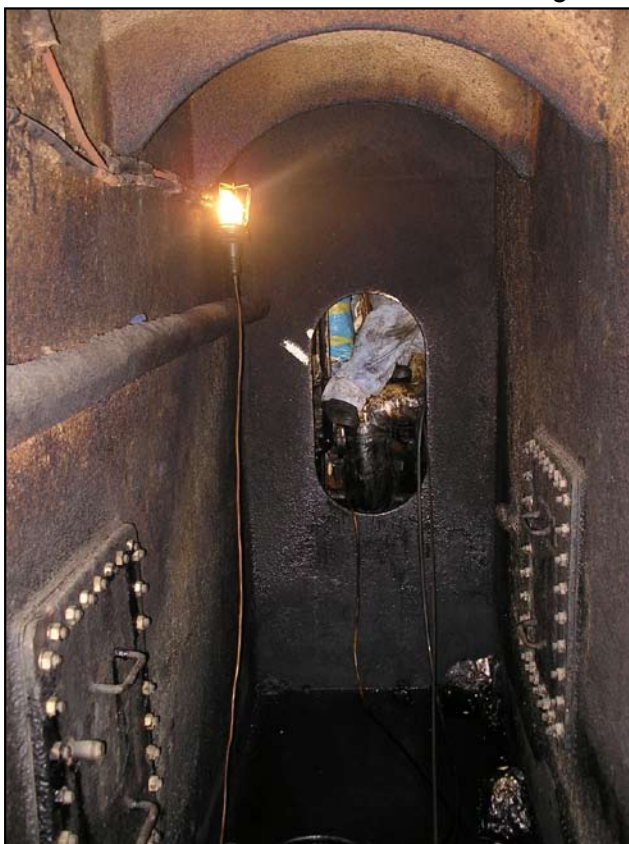
Figure 4

Entrance to the cofferdam (view from cofferdam)

The manhole was at the far end of a 5 metre open cofferdam (**Figure 5**) which was accessed through a lightening hole from the purifier room (**Figures 3 and 4**). The cofferdam was situated between two heated fuel oil service tanks and

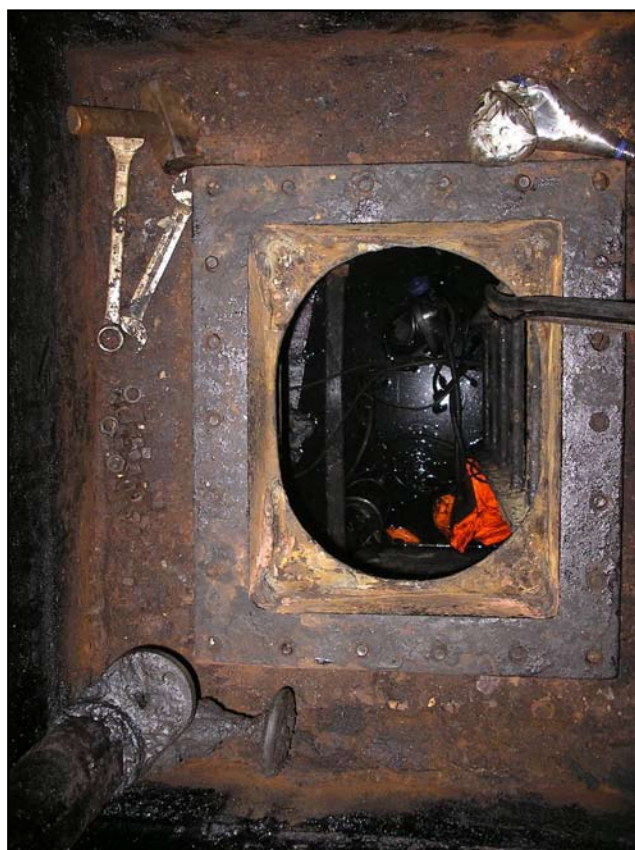
Figure 6

No.4 port outer double bottom tank manhole

Access into the tank was through a single tank top manhole fitted with a steel cover secured by 22 nuts and bolts. The manhole access was oval shaped, but the steel cover was rectangular with dimensions of 800mm x 600mm (**Figure 6**). Following the accident, the manhole cover gasket was found lying in the tank bottom under the discarded breathing apparatus and airlines used during the rescue.

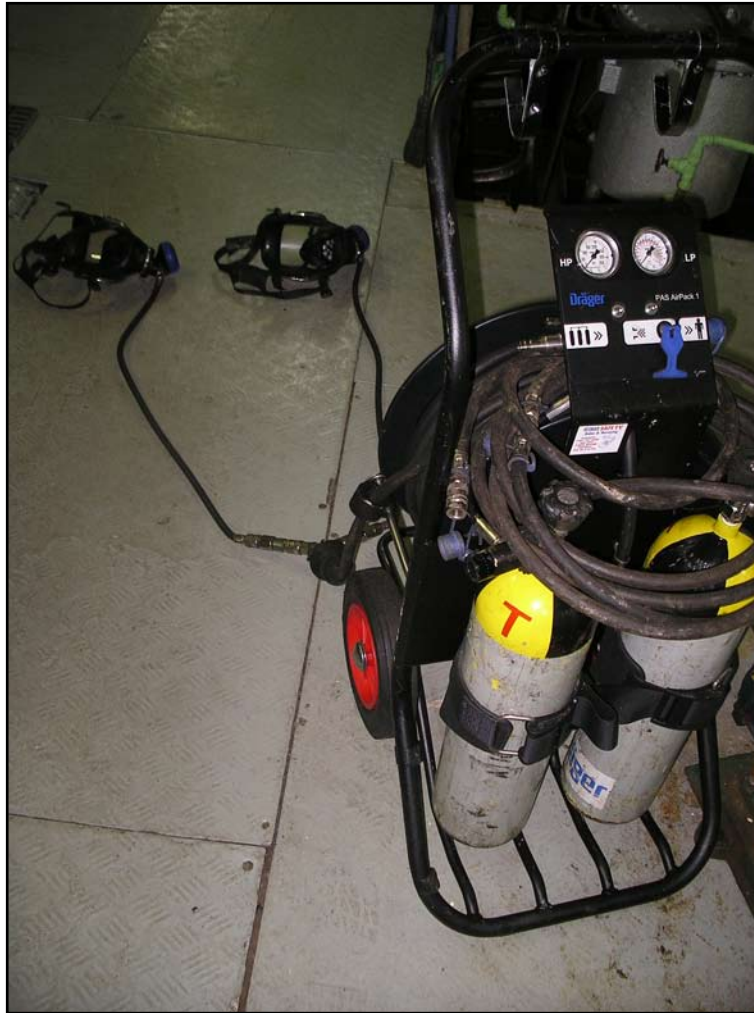
Figure 8

BA trolley set
