Report on the investigation of  
the grounding of

***CFL Performer***

Haisborough Sand

**Report No 21/2008  
December 2008**

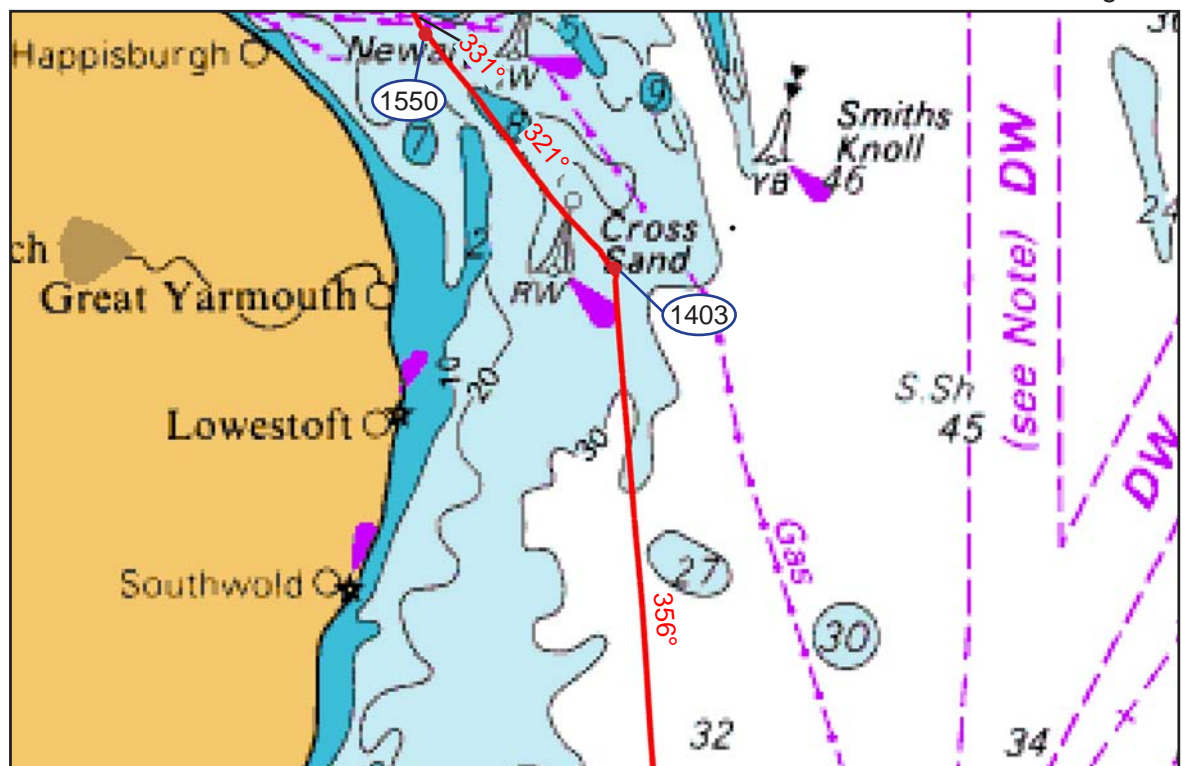
Figure 1

The vessel transited the Dover Strait Traffic Separation Scheme (TSS) on the evening of 11 May, and during the 1200-1600 watch the following day, the second officer was the officer of the watch (OOW). The vessel's position was monitored in relation to the voyage plan using the vessel's Electronic Chart Display Information System (ECDIS)<sup>1</sup>. To follow the plan, the vessel's course was adjusted at 1403 from 356° to 321° and again at 1550 to 331° (**Figure 1**). The vessel was in autopilot and her speed over the ground was about 9.5 knots.

Vessel's track recorded by AIS

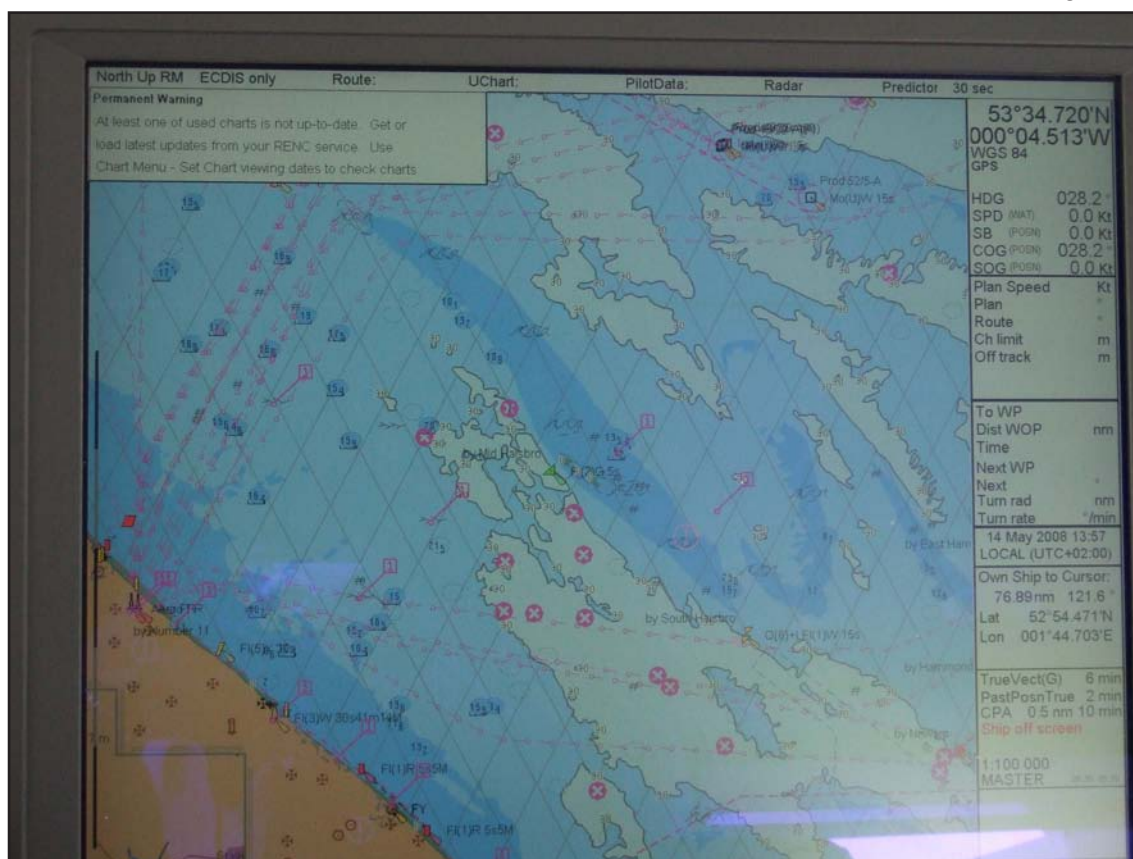
Figure 2

ECDIS display at 1:100000 scale

The scale selected was 1:100,000, which was the scale in use when the second officer relieved the master at 1200. The name of the plan and the intended track were displayed in red, and the channel limit was set to 185m. No watch

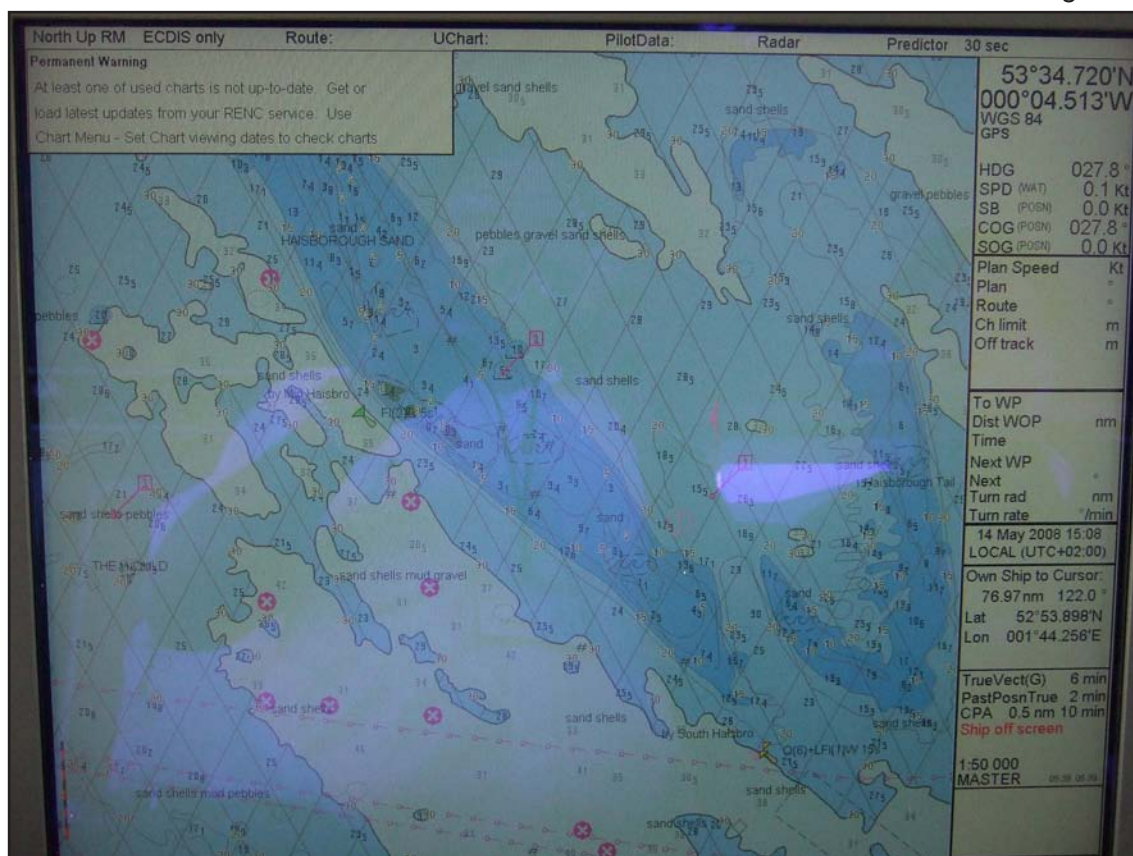
Figure 3

ECDIS display at 1:50000 scale

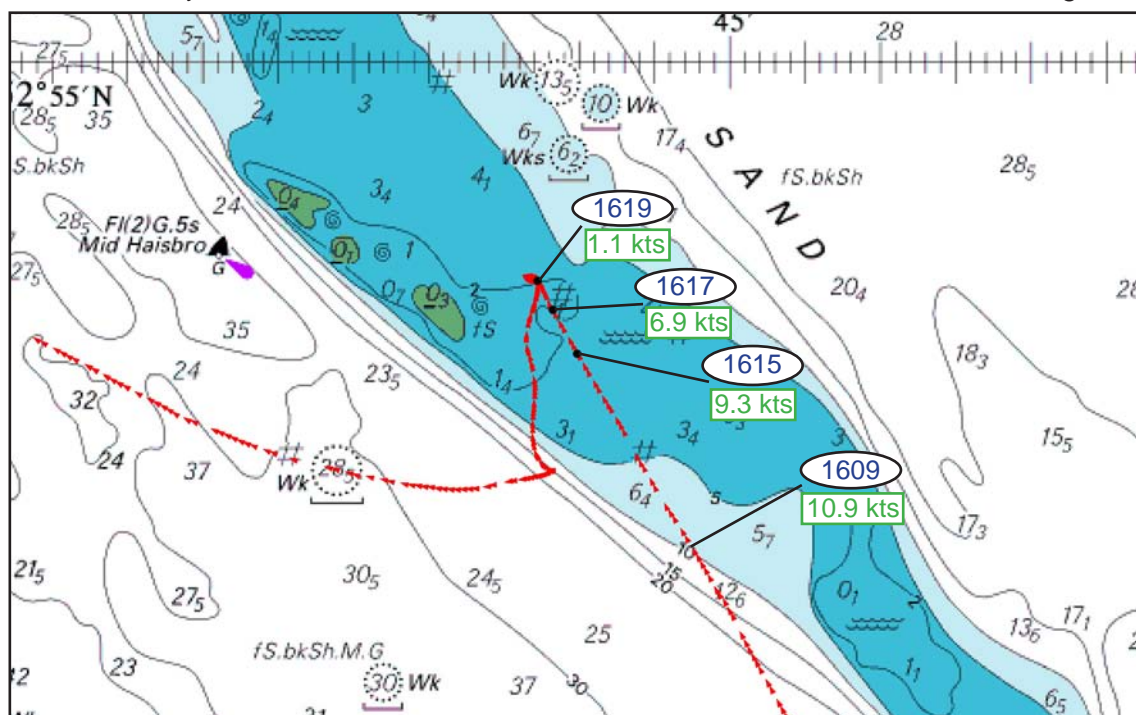
The reduction in the vessel's speed was detected by Yarmouth coastguard using the Automatic Identification System (AIS) (**Figure 4**). At 1634, the coastguard station called *CFL Performer* on VHF radio to establish if the vessel was aground and needed assistance. The master, who had quickly made his way to the bridge with the chief officer, informed the coastguard that the vessel was aground but did not require assistance. He then put the propeller pitch to full astern, and the vessel refloated without difficulty. The chief officer checked the soundings of the double bottom tanks and the chief engineer checked the temperatures of main and auxiliary machinery; no problems were found.

Vessel's AIS track over Haisborough Sand

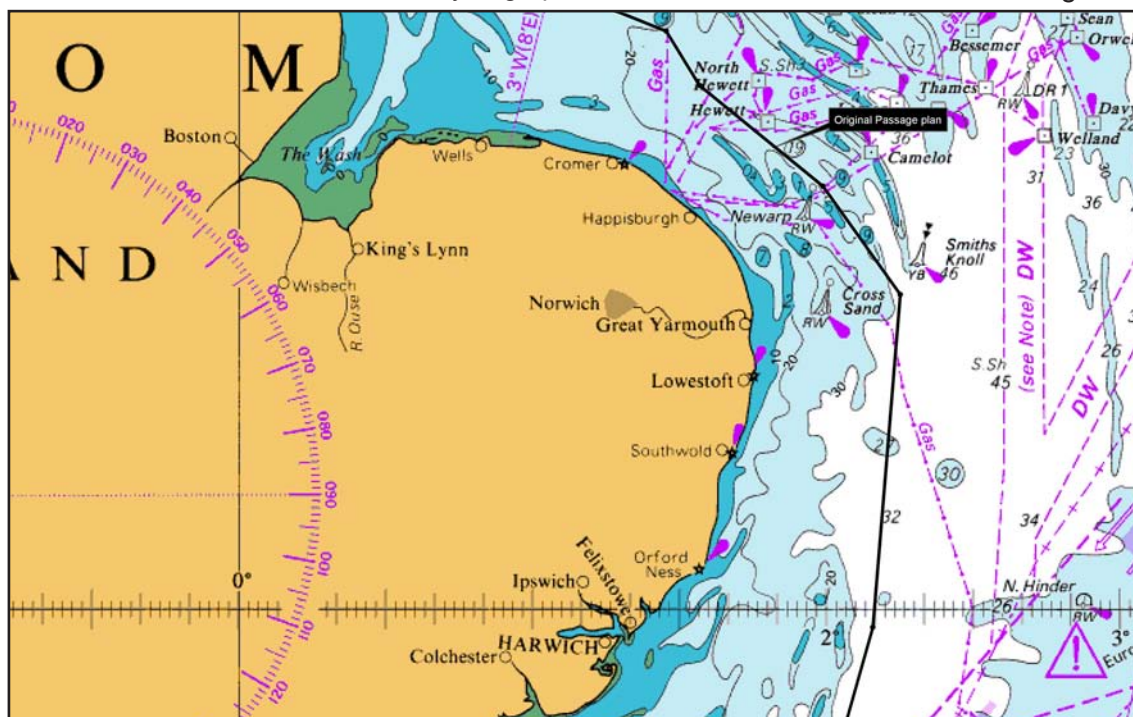
Figure 5

The voyage from Paramaribo to Grimsby was planned on the ECDIS by the chief officer before he was promoted. The plan was named *Paramaribo-Grimsby* and an extract is at **Figure 5**.

Extract of the original passage plan

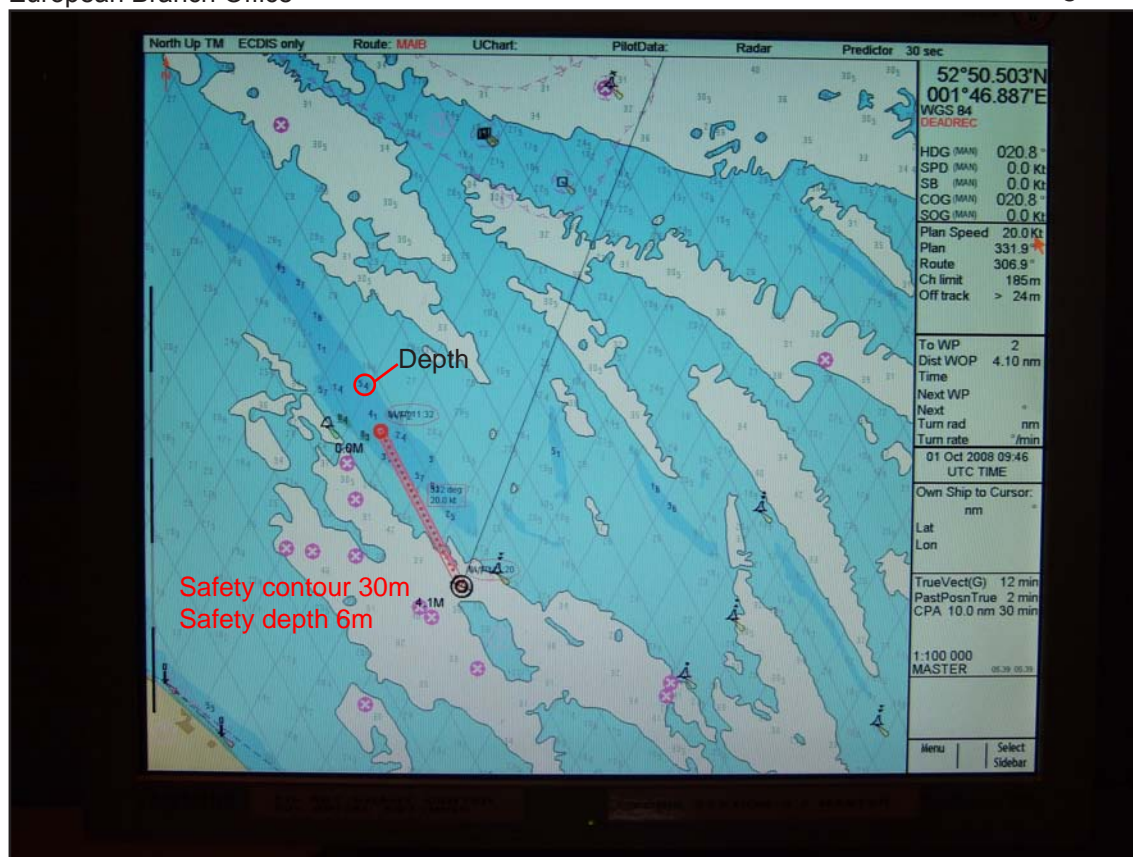
The safety depth applies to spot soundings, the depth of which is insufficient for a vessel to safely pass over. Spot soundings less than the safety depth are displayed in bold type to provide a more accurate representation of a vessel’s ‘no-go’ line than the safety contour (**Figure 6**).

Screen shot of ECDIS display showing depth and contour settings  
(taken at the Furuno European Branch Office)

safety contour alarm will not activate. When an un-checked plan is monitored, the name of the plan at the top of the ECDIS screen is displayed in red, as are the areas within the channel limits where the safety contour is crossed (**Figure 6**).

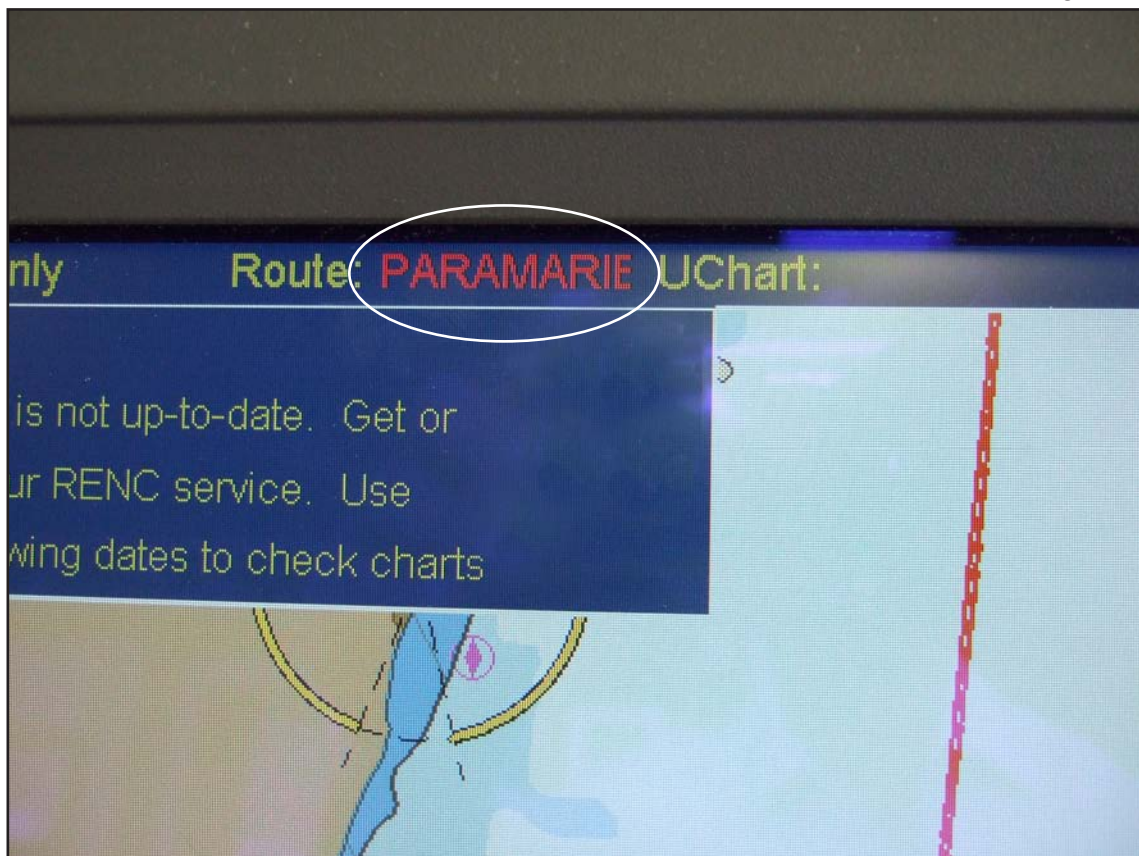
Figure 7

Screen shot showing title of original plan

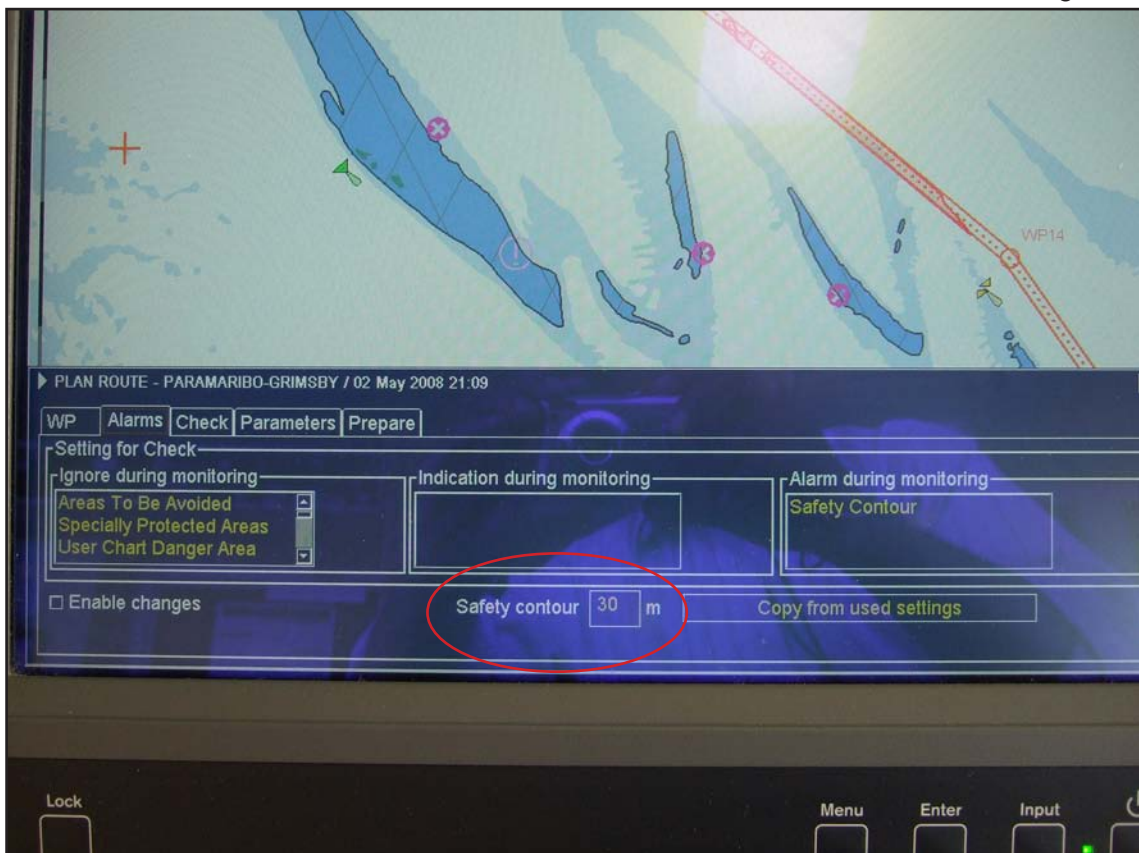
Figure 8

- The voyage plan in use at the time of the grounding had been deleted.
- The original passage plan from Paramaribo to Grimsby was saved as a file called "*Paramaribo-Grimsby*". The plan was created on 14 April and was last modified on 2 May. The title of the plan and the tracks were coloured red on the display (**Figure 7**).
- The safety contour used on the original passage plan was 30m (**Figure 8**).

Screen shot showing safety contour set in original plan

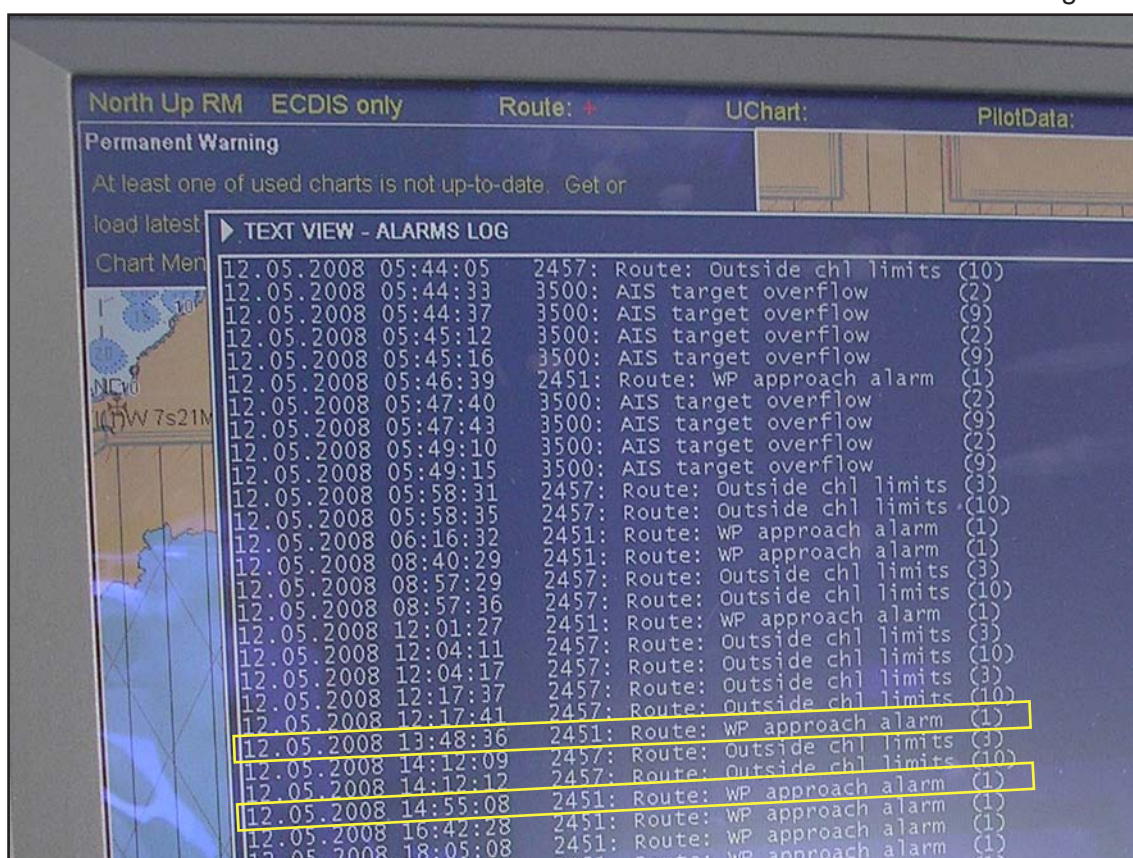
Figure 9

- The waypoint approach alarm activated immediately prior to the vessel's course alterations at 1403 and 1550 on 12 May 2008 (**Figures 1 and 9**).
- The safety contour alarm did not activate at any time during the voyage (**Figure 9**).
- The voyage log file did not record the name of the passage plan in use, but contained sufficient information to reconstruct the vessel's track.
- The chart usage file was deleted.
- All of the charts required for the vessel's passage to Grimsby were official ENC's.

Screen shot showing alarm log

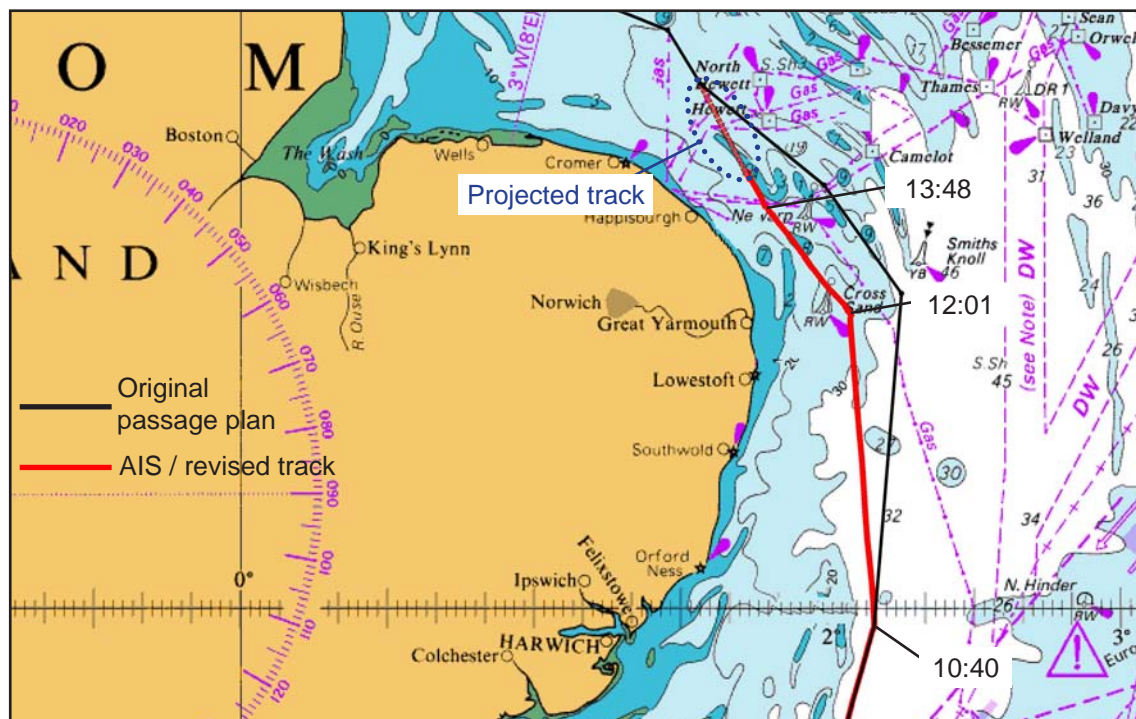
Figure 10

Vessel's original and revised planned routes

The route was planned and executed on the vessel's ECDIS, which had numerous in-built safeguards intended to prevent an accident of this nature. However, it is evident that on this occasion these safeguards were not utilised, and system warnings were not acted upon, either when the route was planned or when it was monitored. In particular:

- The system's check page was not used to check each leg of the route for navigational hazards.
- The plan was executed despite its title remaining red, indicating that the intended route crossed the safety contour set or other defined dangers.
- The safety contour alarm did not sound as the vessel approached the shallow because a watch vector had not been set.

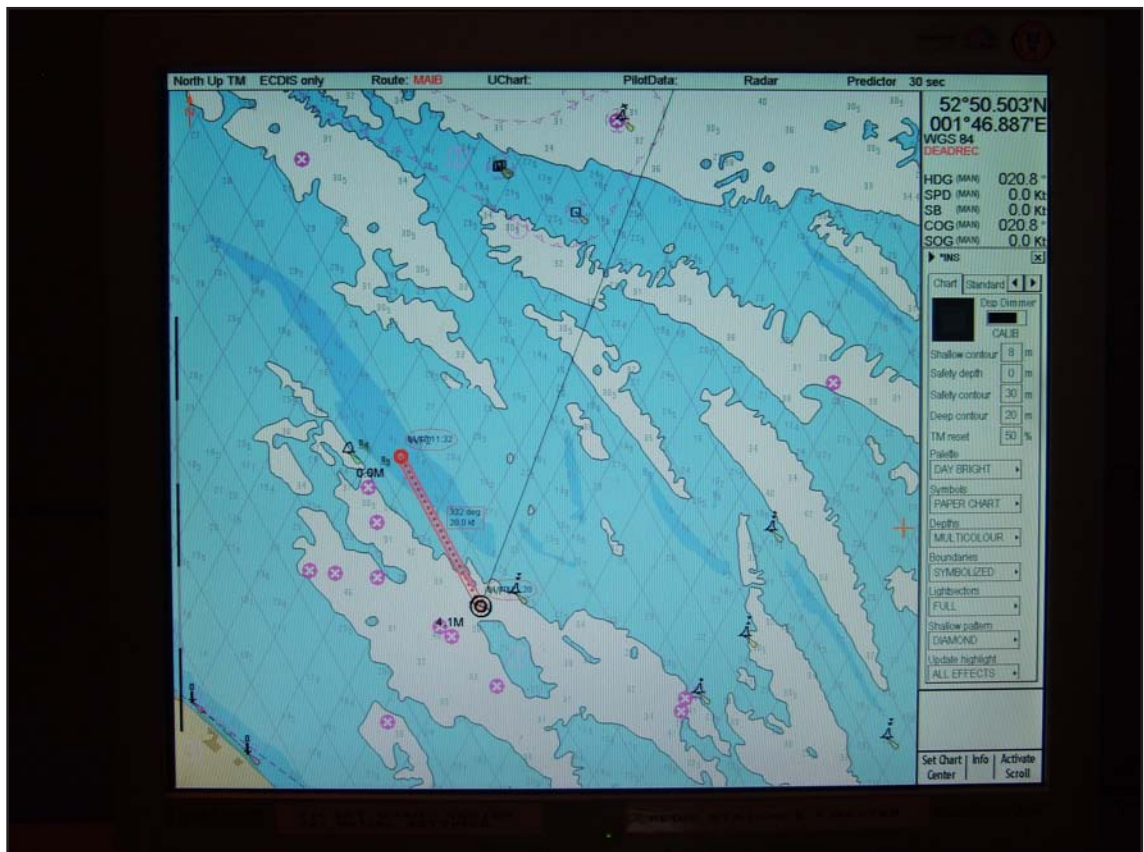
Figure 11

Screen shot showing display with 0 metres safety depth set  
(taken at the Furuno European Branch Office)

would have affected the officers' ability to see the shallows, the drying patches in the vicinity of the Mid Haisbro' buoy would have been visible regardless of the settings applied. As these were not seen when the route was planned, and as the vessel's intended track would have passed over dark blue shading and the diamond hatched markings, which are similar to the conventions used for marking shallows and 'no-go' areas on paper charts, it is evident that the planner's visual check was only cursory. It is also evident that the amended route was not cross-checked by the master.
