Report on the investigation of the
grounding of the cargo vessel

Sea Mithril

on the River Trent

Report No 16/2008
September 2008

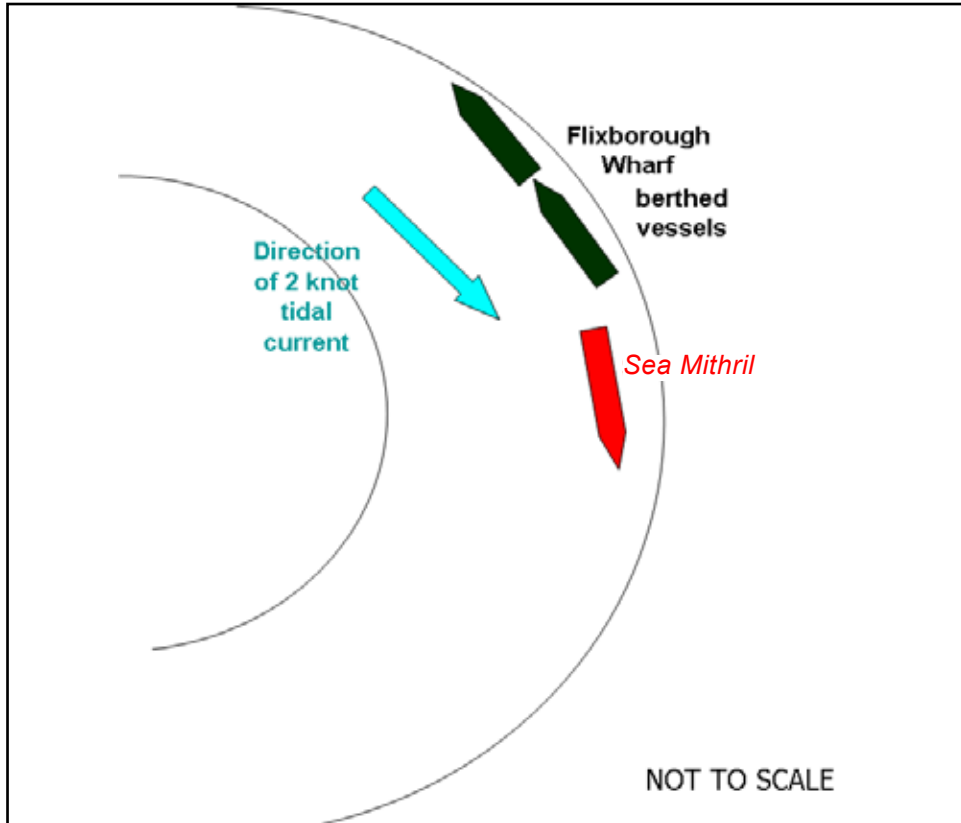
By the time *Sea Mithril* had cleared Flixborough Wharf, her speed had reduced to about 2.5 knots over the ground and she was being swept bodily towards the left-hand bank by the flood tide (**Figure 5**). The pilot advised the master to steer to starboard. When he noticed the vessel's speed from the radar display he immediately advised the master to "speed up" and "come more to starboard." Reed beds were then seen to port, and a few moments later the vessel momentarily touched the river bottom at her stern near the left-hand riverbank.

Diagram showing the position of *Sea Mithril* after passing Flixborough just prior to her touching bottom for the first time

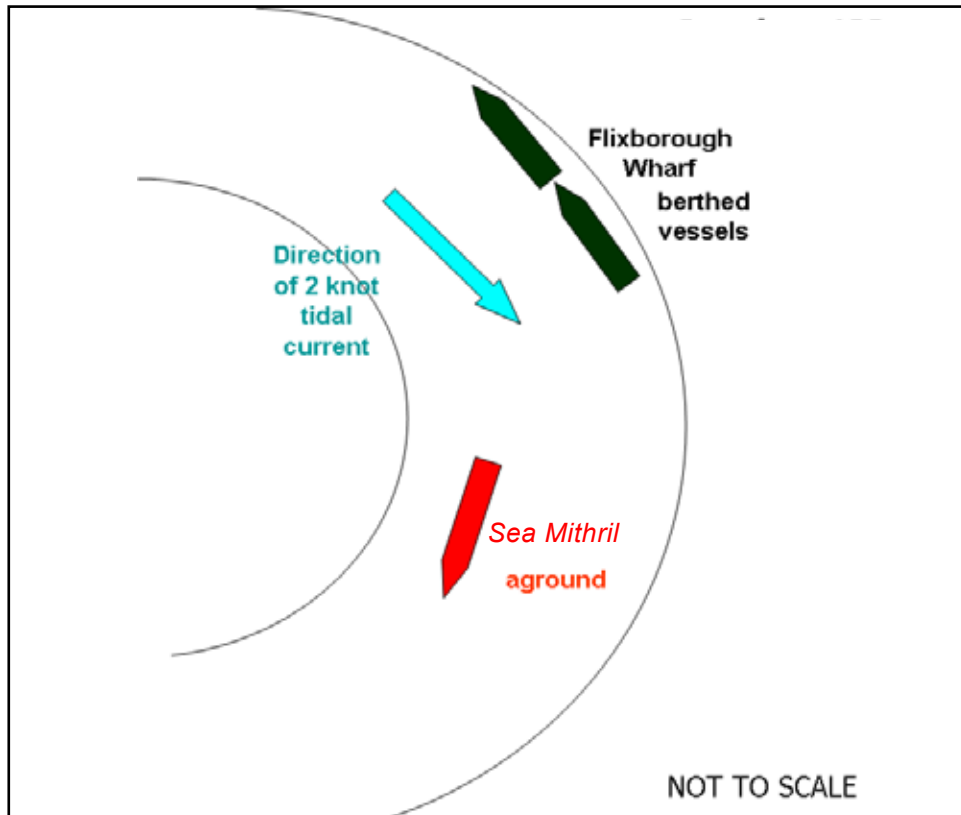
The master quickly put the azimuth controls to full ahead and to starboard. The vessel turned sharply and began to head across the river. The pilot realised *Sea Mithril* was now in danger of grounding in the shallows near the opposite bank and advised the master to turn back to port. Although the master put the engine controls to port, the vessel ran gently aground at 0425 (**Figure 6**).

Diagram showing the position of *Sea Mithril* when aground for the second time

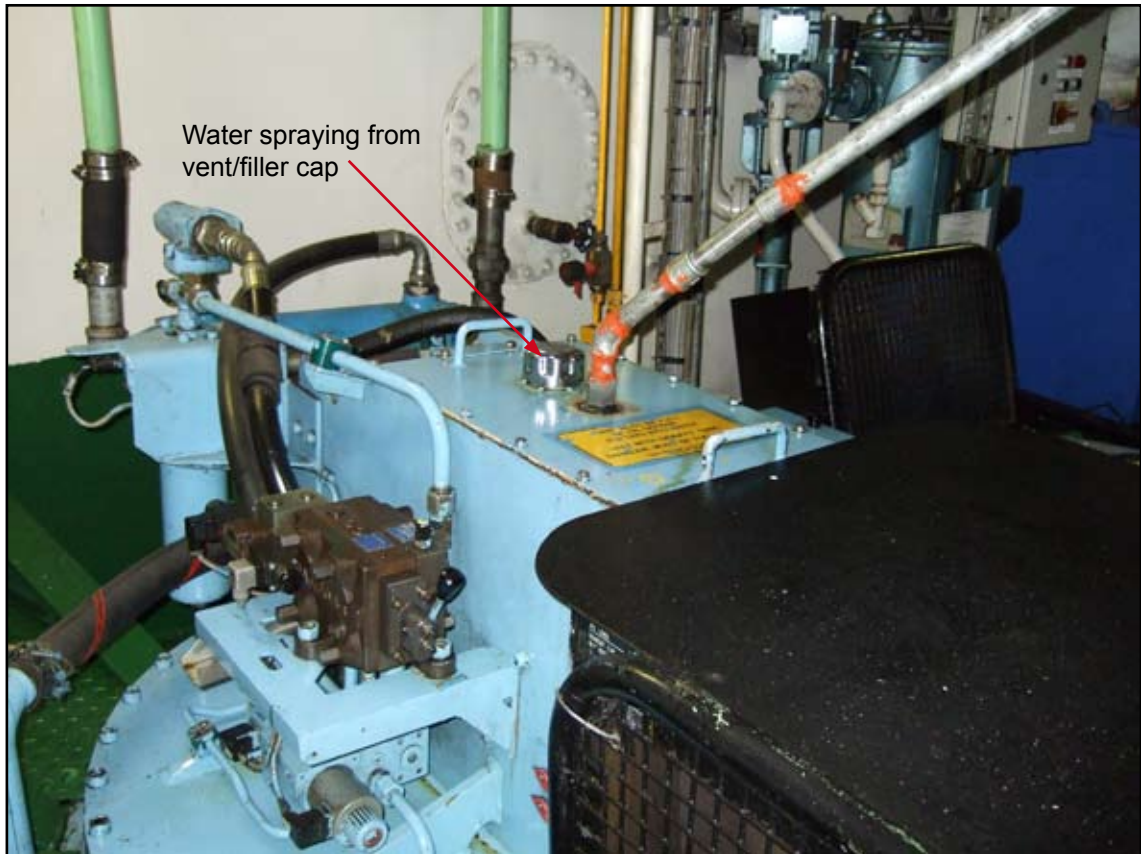
After several minutes, the engineer arrived on the bridge and told the master that water was spraying from the port azimuth oil vent in the engine room (**Figure 7**). The master replied that he wanted to continue running both engines until the vessel had re-floated and was safely alongside. This exchange was in Russian and the pilot was not made aware of the problem that had been reported. All empty spaces and the cargo holds were sounded, but no other water ingress was found.

Photograph showing position of water ingress

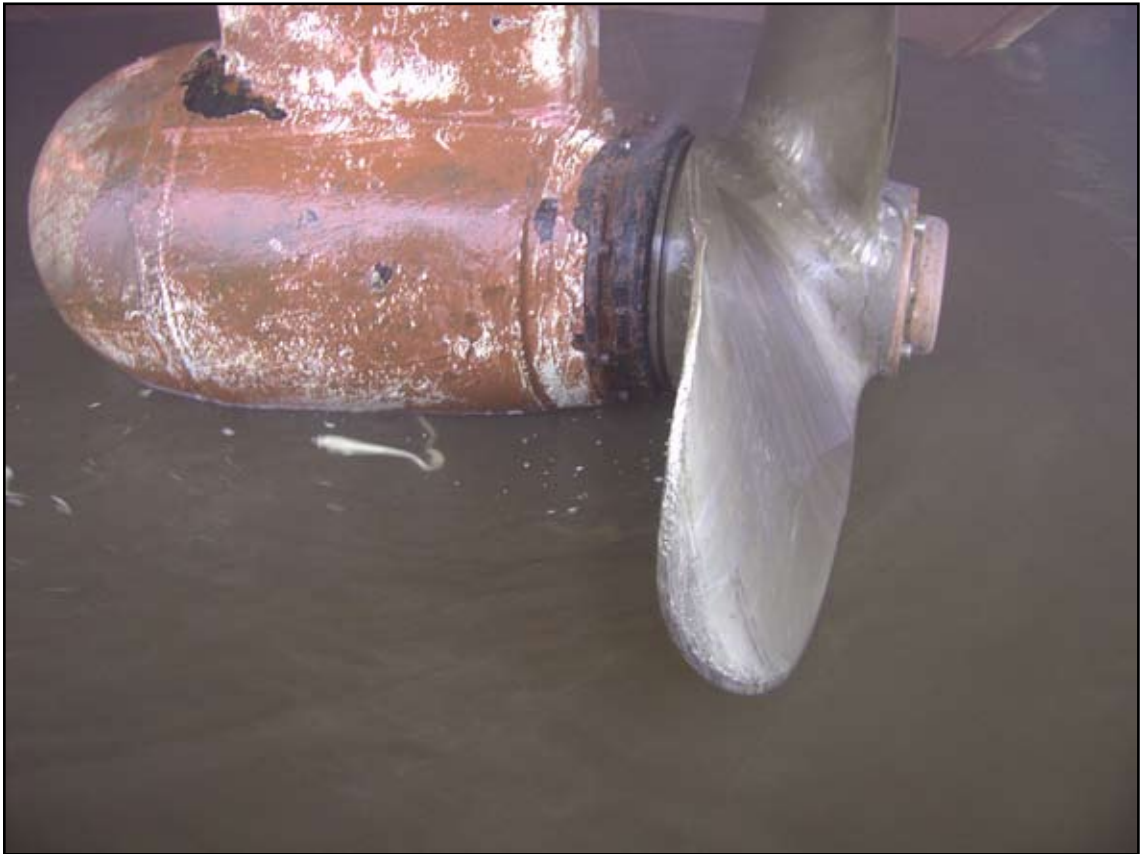
Figure 9

During an inspection at Grove Wharf on 19 February 2008, the vessel's port azimuth pod casing was found to be fractured and its propeller blades badly damaged (**Figure 9**). The vessel was given dispensation to sail to Leith, Scotland, for repairs. ABP Humber was informed of the vessel's condition but was not made aware that the damage had been caused during the groundings the previous day. *Sea Mithril* sailed from Grove Wharf on 19 February with a pilot embarked. She was escorted by a tug during her passage down the Trent and Humber and, at the request of the ship's manager she was closely monitored by the Coastguard during her passage to Leith, where she arrived the following day. When the vessel was later dry-docked it was established that, in addition to the damage already identified, the port azimuth drive shaft had to be replaced. There was also evidence of recent coating damage under the vessel's port quarter (**Figure 10**).

Port azimuth pod and damaged propeller

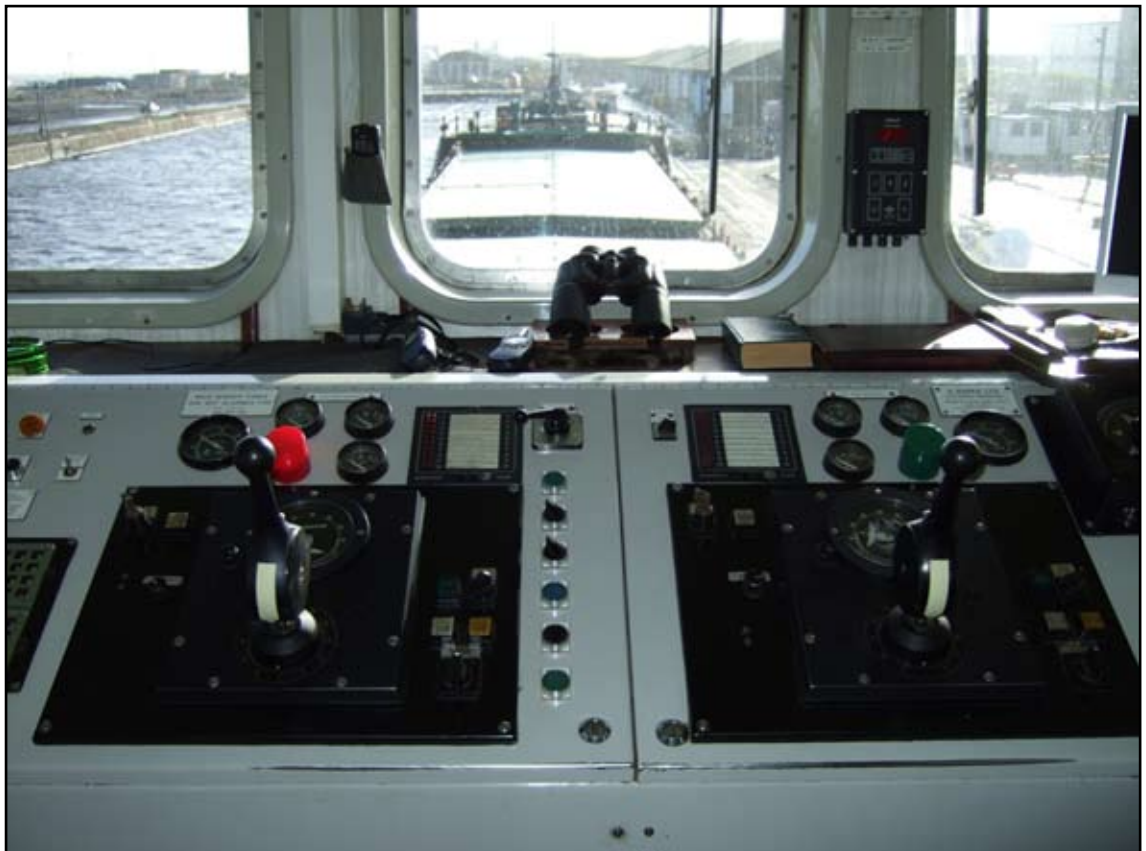
Figure 12

Sea Mithril's wheelhouse azimuth pod controls

However, the master of *Sea Mithril* considered that the control of the azimuths during critical periods of navigation was solely his responsibility, and he always steered the vessel when the autopilot was not selected. None of the remaining crew, including the chief officer, were trained or had experience in steering the vessel by hand.
