Report on the investigation of the
grounding of the cargo vessel

Sea Mithril

on the River Trent

Report No 16/2008
September 2008

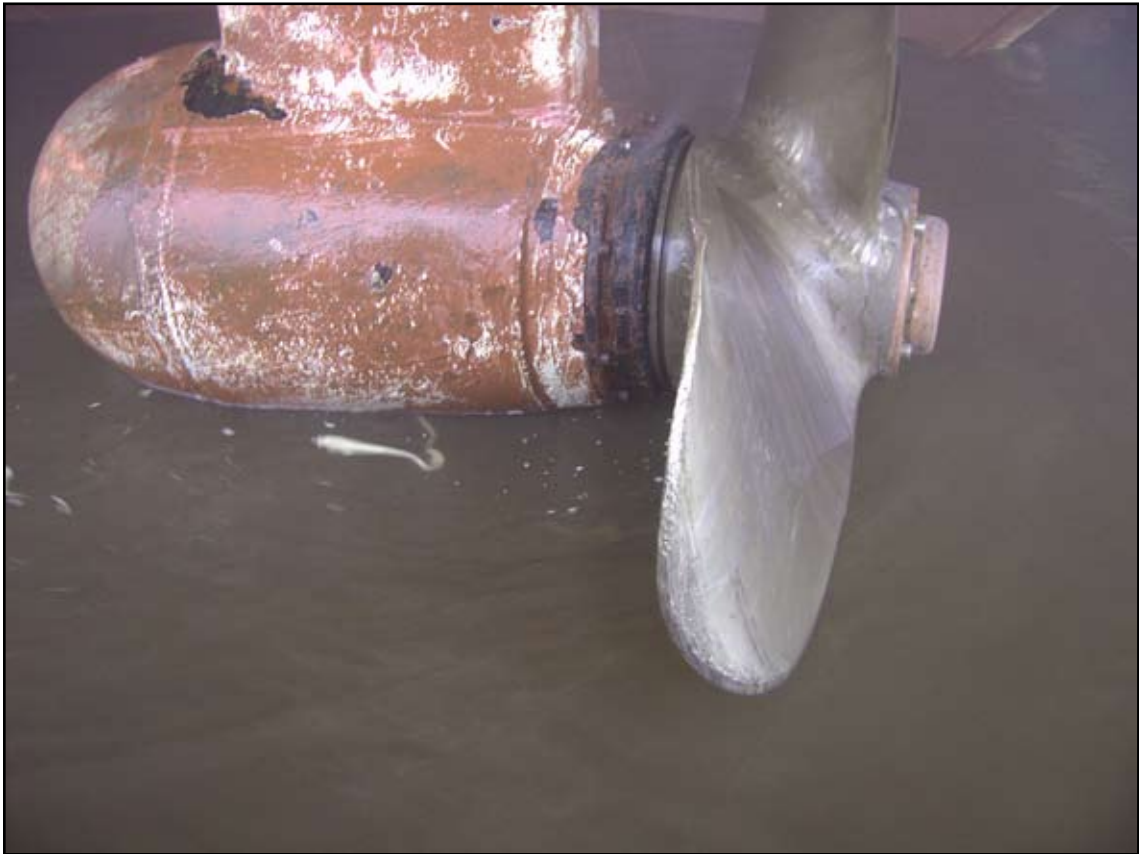
Figure 9

During an inspection at Grove Wharf on 19 February 2008, the vessel's port azimuth pod casing was found to be fractured and its propeller blades badly damaged (**Figure 9**). The vessel was given dispensation to sail to Leith, Scotland, for repairs. ABP Humber was informed of the vessel's condition but was not made aware that the damage had been caused during the groundings the previous day. *Sea Mithril* sailed from Grove Wharf on 19 February with a pilot embarked. She was escorted by a tug during her passage down the Trent and Humber and, at the request of the ship's manager she was closely monitored by the Coastguard during her passage to Leith, where she arrived the following day. When the vessel was later dry-docked it was established that, in addition to the damage already identified, the port azimuth drive shaft had to be replaced. There was also evidence of recent coating damage under the vessel's port quarter (**Figure 10**).

Port azimuth pod and damaged propeller

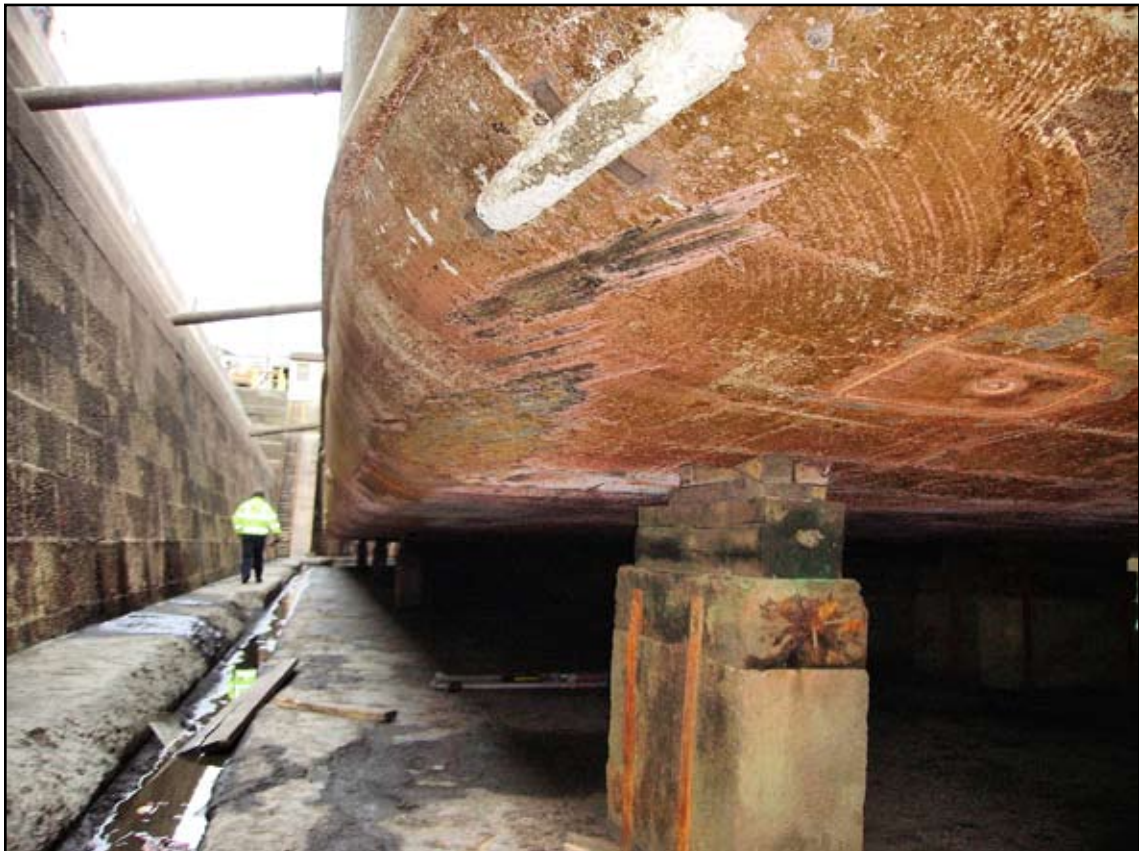
Figure 10

Paint damage to the underside of the hull on the vessel's port side

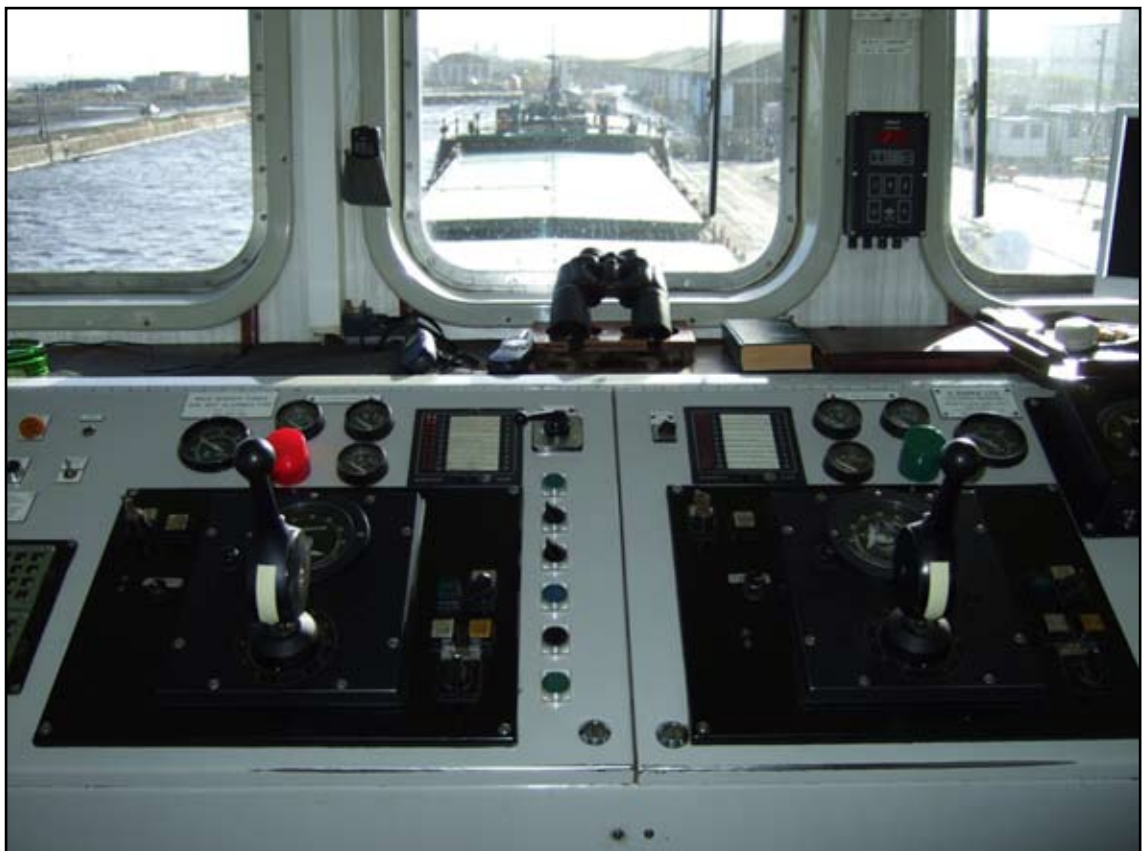
Figure 12

Sea Mithril's wheelhouse azimuth pod controls

However, the master of *Sea Mithril* considered that the control of the azimuths during critical periods of navigation was solely his responsibility, and he always steered the vessel when the autopilot was not selected. None of the remaining crew, including the chief officer, were trained or had experience in steering the vessel by hand.
