Report on the investigation of the  
grounding of the cargo vessel

***Sea Mithril***

on the River Trent

**Report No 16/2008**  
**September 2008**

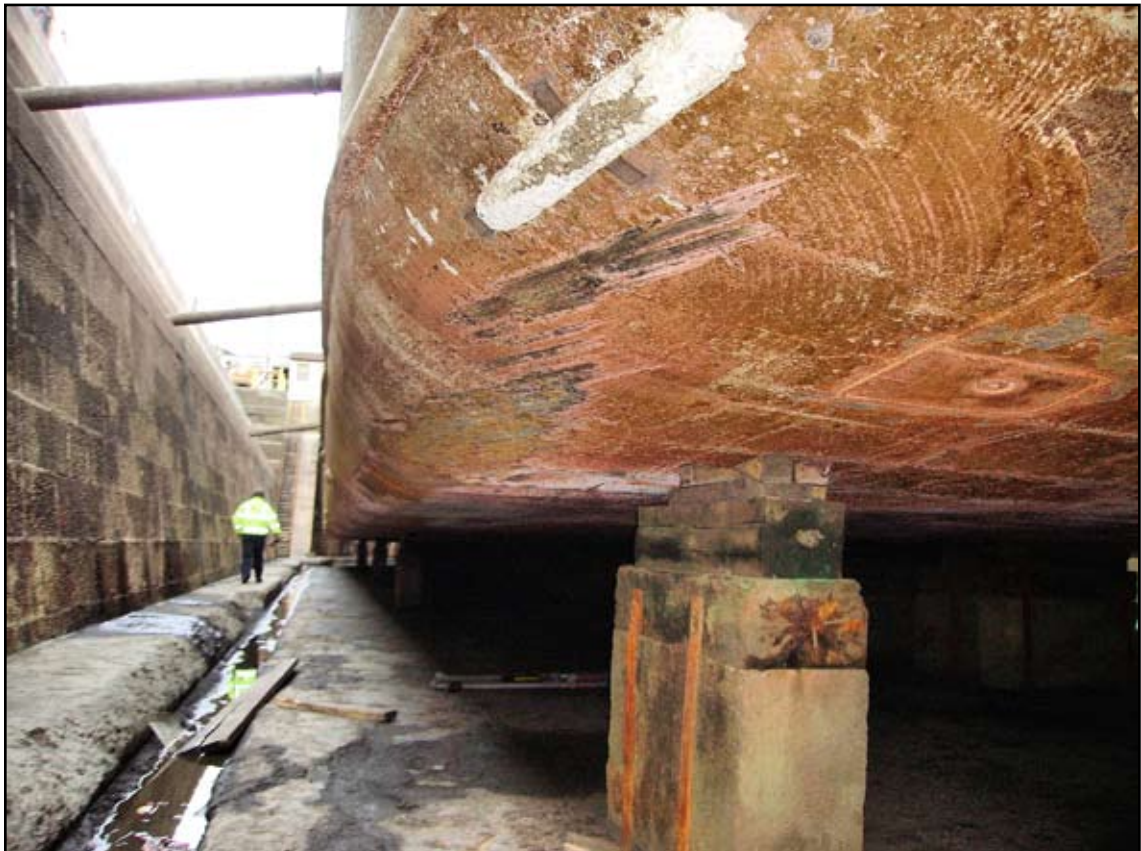
Figure 10

During an inspection at Grove Wharf on 19 February 2008, the vessel's port azimuth pod casing was found to be fractured and its propeller blades badly damaged (**Figure 9**). The vessel was given dispensation to sail to Leith, Scotland, for repairs. ABP Humber was informed of the vessel's condition but was not made aware that the damage had been caused during the groundings the previous day. *Sea Mithril* sailed from Grove Wharf on 19 February with a pilot embarked. She was escorted by a tug during her passage down the Trent and Humber and, at the request of the ship's manager she was closely monitored by the Coastguard during her passage to Leith, where she arrived the following day. When the vessel was later dry-docked it was established that, in addition to the damage already identified, the port azimuth drive shaft had to be replaced. There was also evidence of recent coating damage under the vessel's port quarter (**Figure 10**).

Paint damage to the underside of the hull on the vessel's port side
