Report on the investigation of the  
grounding of the cargo vessel

***Sea Mithril***

on the River Trent

**Report No 16/2008**  
**September 2008**

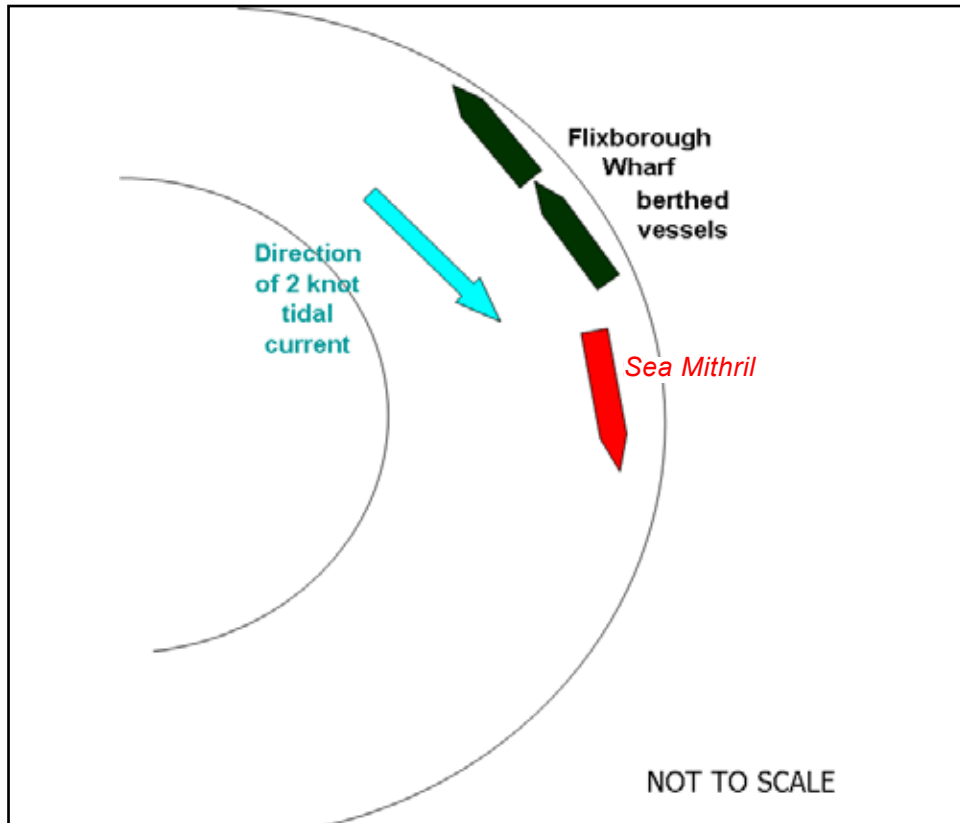
By the time *Sea Mithril* had cleared Flixborough Wharf, her speed had reduced to about 2.5 knots over the ground and she was being swept bodily towards the left-hand bank by the flood tide (**Figure 5**). The pilot advised the master to steer to starboard. When he noticed the vessel's speed from the radar display he immediately advised the master to "speed up" and "come more to starboard." Reed beds were then seen to port, and a few moments later the vessel momentarily touched the river bottom at her stern near the left-hand riverbank.

Diagram showing the position of *Sea Mithril* after passing Flixborough just prior to her touching bottom for the first time

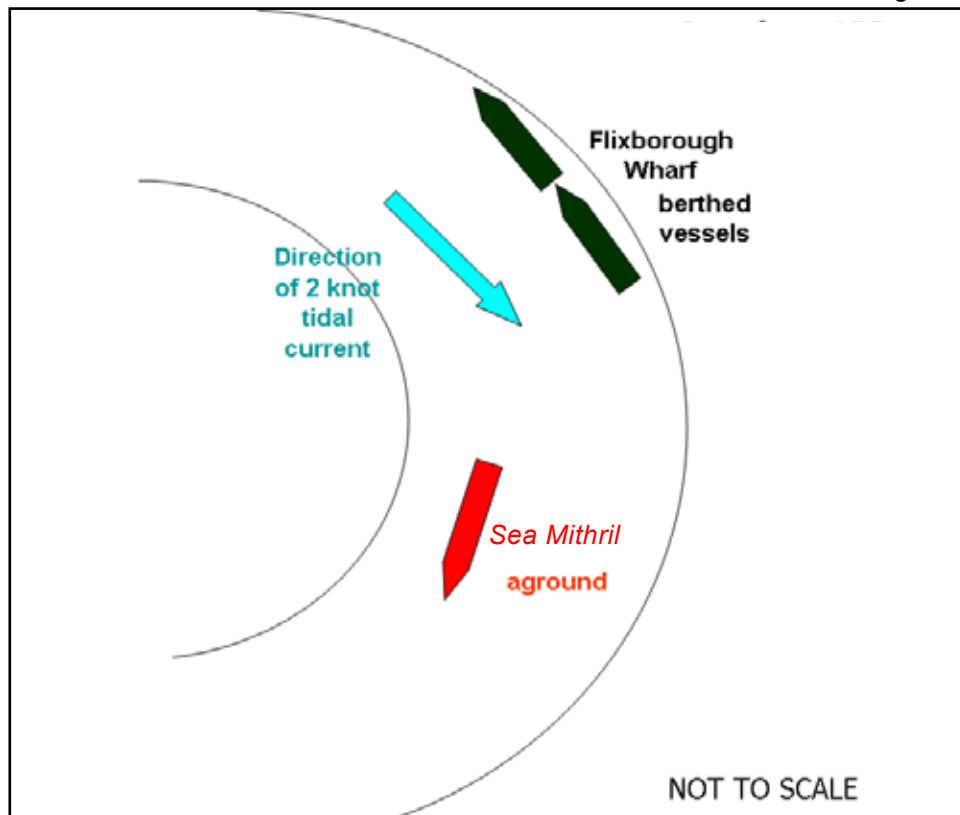
The master quickly put the azimuth controls to full ahead and to starboard. The vessel turned sharply and began to head across the river. The pilot realised *Sea Mithril* was now in danger of grounding in the shallows near the opposite bank and advised the master to turn back to port. Although the master put the engine controls to port, the vessel ran gently aground at 0425 (**Figure 6**).

Diagram showing the position of *Sea Mithril* when aground for the second time

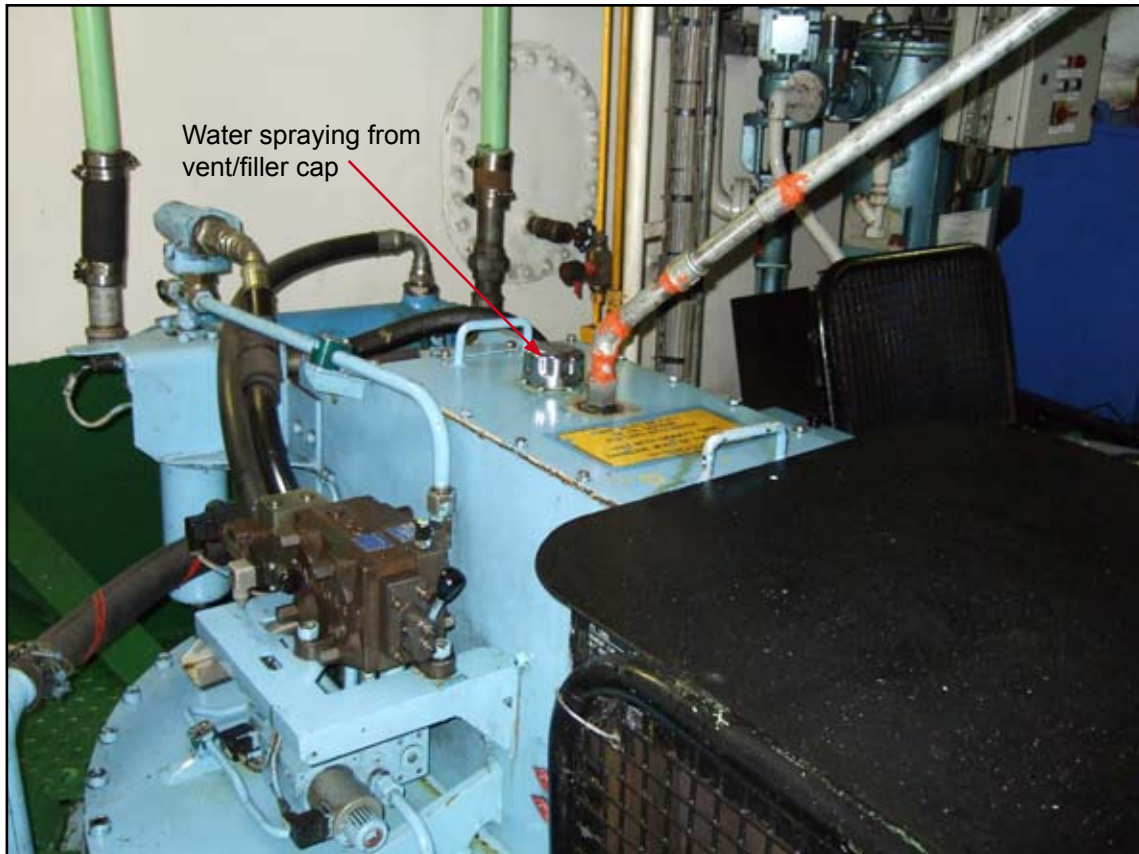
Figure 7

After several minutes, the engineer arrived on the bridge and told the master that water was spraying from the port azimuth oil vent in the engine room (**Figure 7**). The master replied that he wanted to continue running both engines until the vessel had re-floated and was safely alongside. This exchange was in Russian and the pilot was not made aware of the problem that had been reported. All empty spaces and the cargo holds were sounded, but no other water ingress was found.

Photograph showing position of water ingress

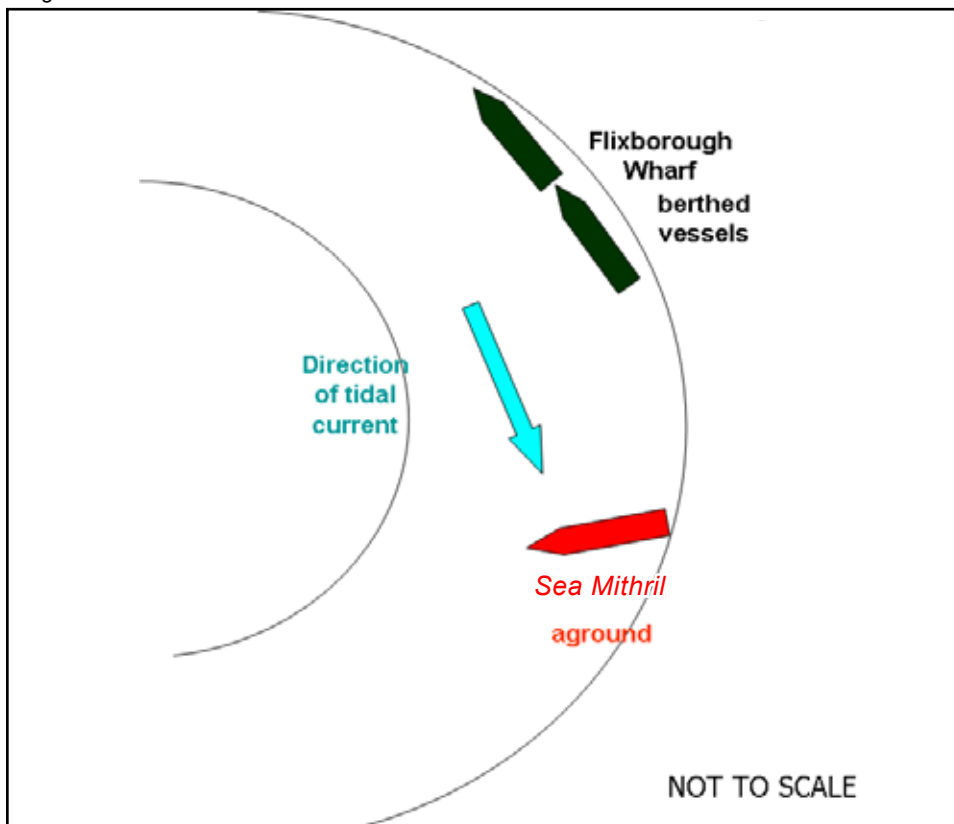
Figure 8

The vessel re-floated at 0447 and, with her engines operating at full astern, she moved rapidly towards the other side of the river, stern-first. The master put the engine controls to full ahead, but this did not prevent the vessel grounding for a third time (**Figure 8**), albeit momentarily.

Diagram showing the position of *Sea Mithril* when touching the river bottom for the third time

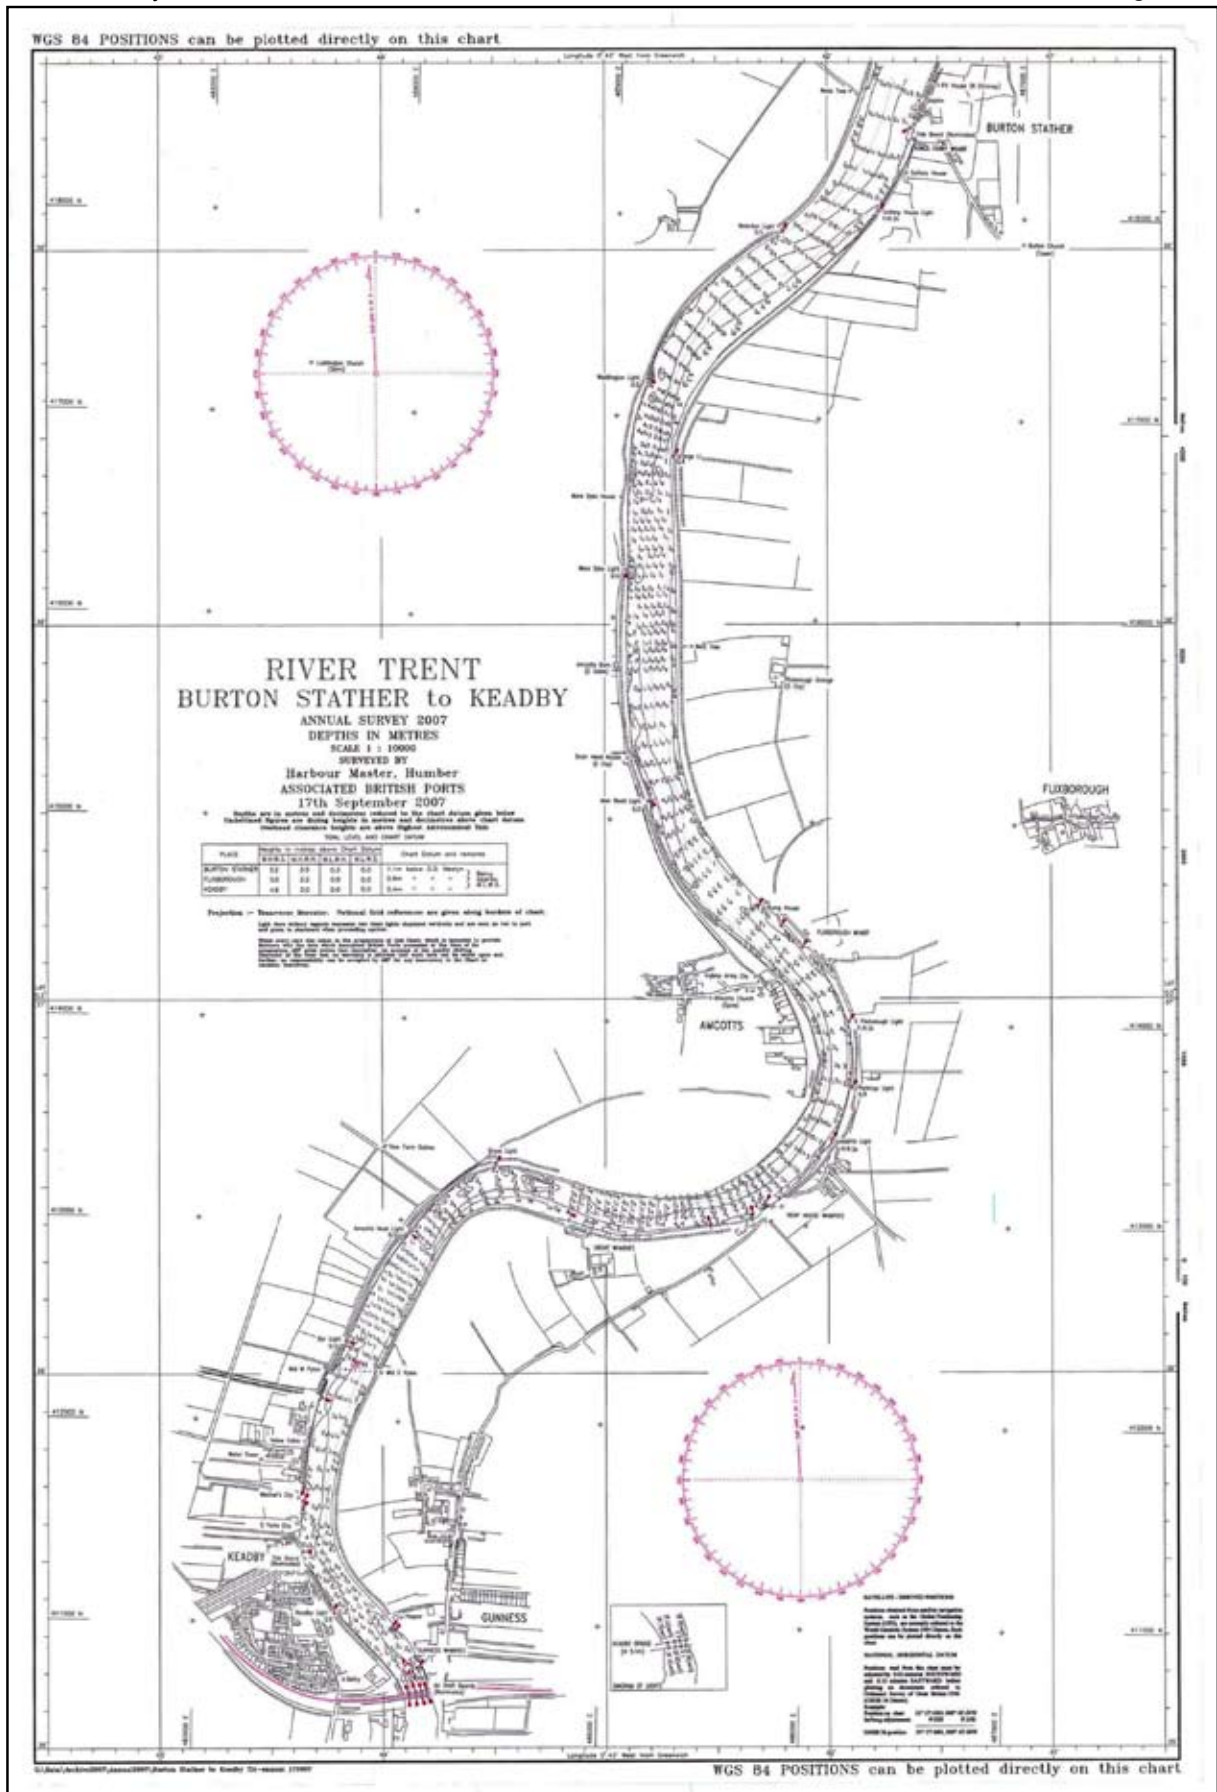
ABP Humber also produces charts of the Humber, Trent and Ouse. Their chart of the section of the Trent in which *Sea Mithril* grounded is of scale 1:10,000 (**Figure 13**). The chart of the upper reaches of the Humber and the approaches to the Trent has a scale of 1:25,000. These charts are regularly updated to incorporate periodic surveys completed by the port authority's hydrographic department and are primarily intended for use by its pilots, who are required to carry copies of the charts when conducting

ABP Humber produced chart of the section of the River Trent (scale 1:10,000)

pilotage acts. Although the charts can be purchased by other river users on request, their availability is not widely advertised. Consequently they are not frequently held on board visiting ships. However, a local notice to mariners strongly advises mariners to ensure they possess up to date navigational information before entering the Humber.
