Report on the investigation into
the grounding of

Pride of Canterbury

“The Downs” – off Deal, Kent

**Report No 2/2009
January 2009**

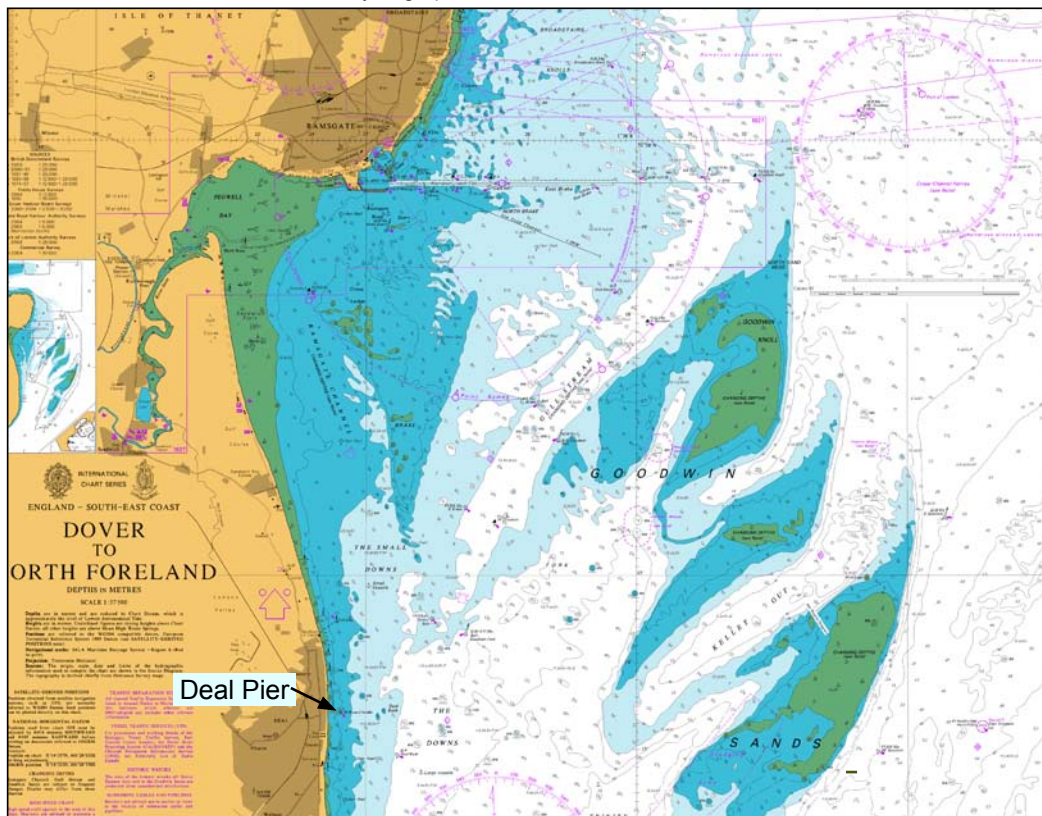
Figure 2

At 0815 *Pride of Canterbury* left the south west lane of the Dover Straits Traffic Separation Scheme and headed towards The Downs, an area off Deal in Kent, which P&O and other ferries use as a holding station when Dover Harbour is closed, due to the shelter provided there from the heavy seas experienced during storm force south-westerly winds. **(Figure 2)**

Chart showing general detail of The Downs area off Deal

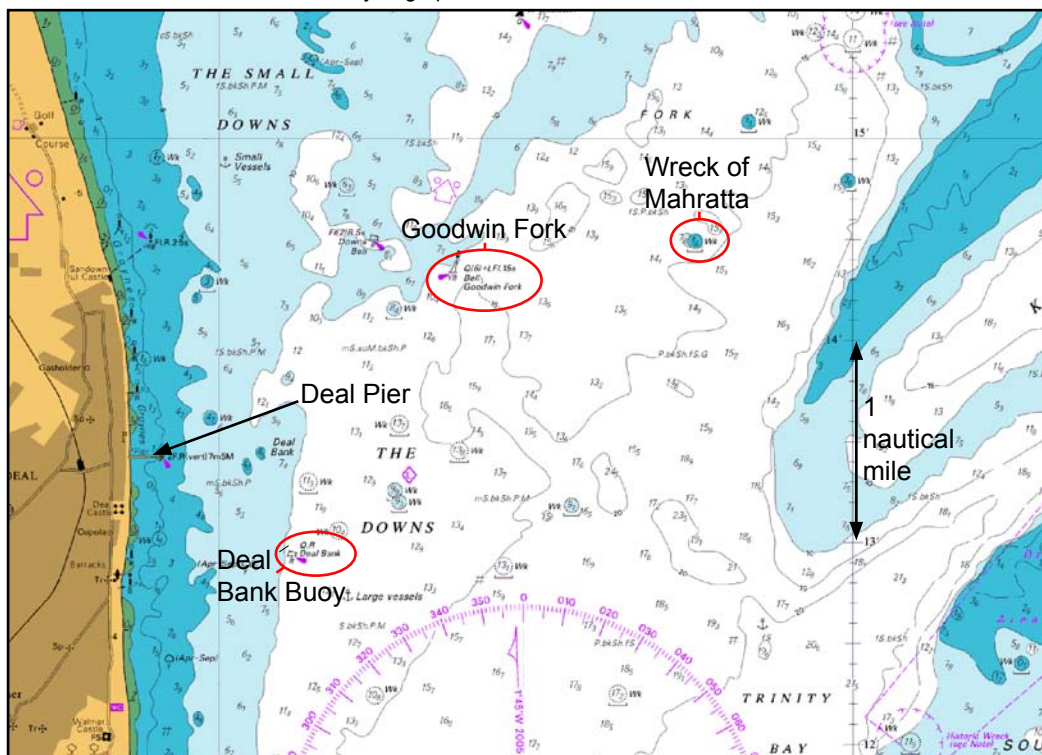
Figure 3

Detail of figure 2

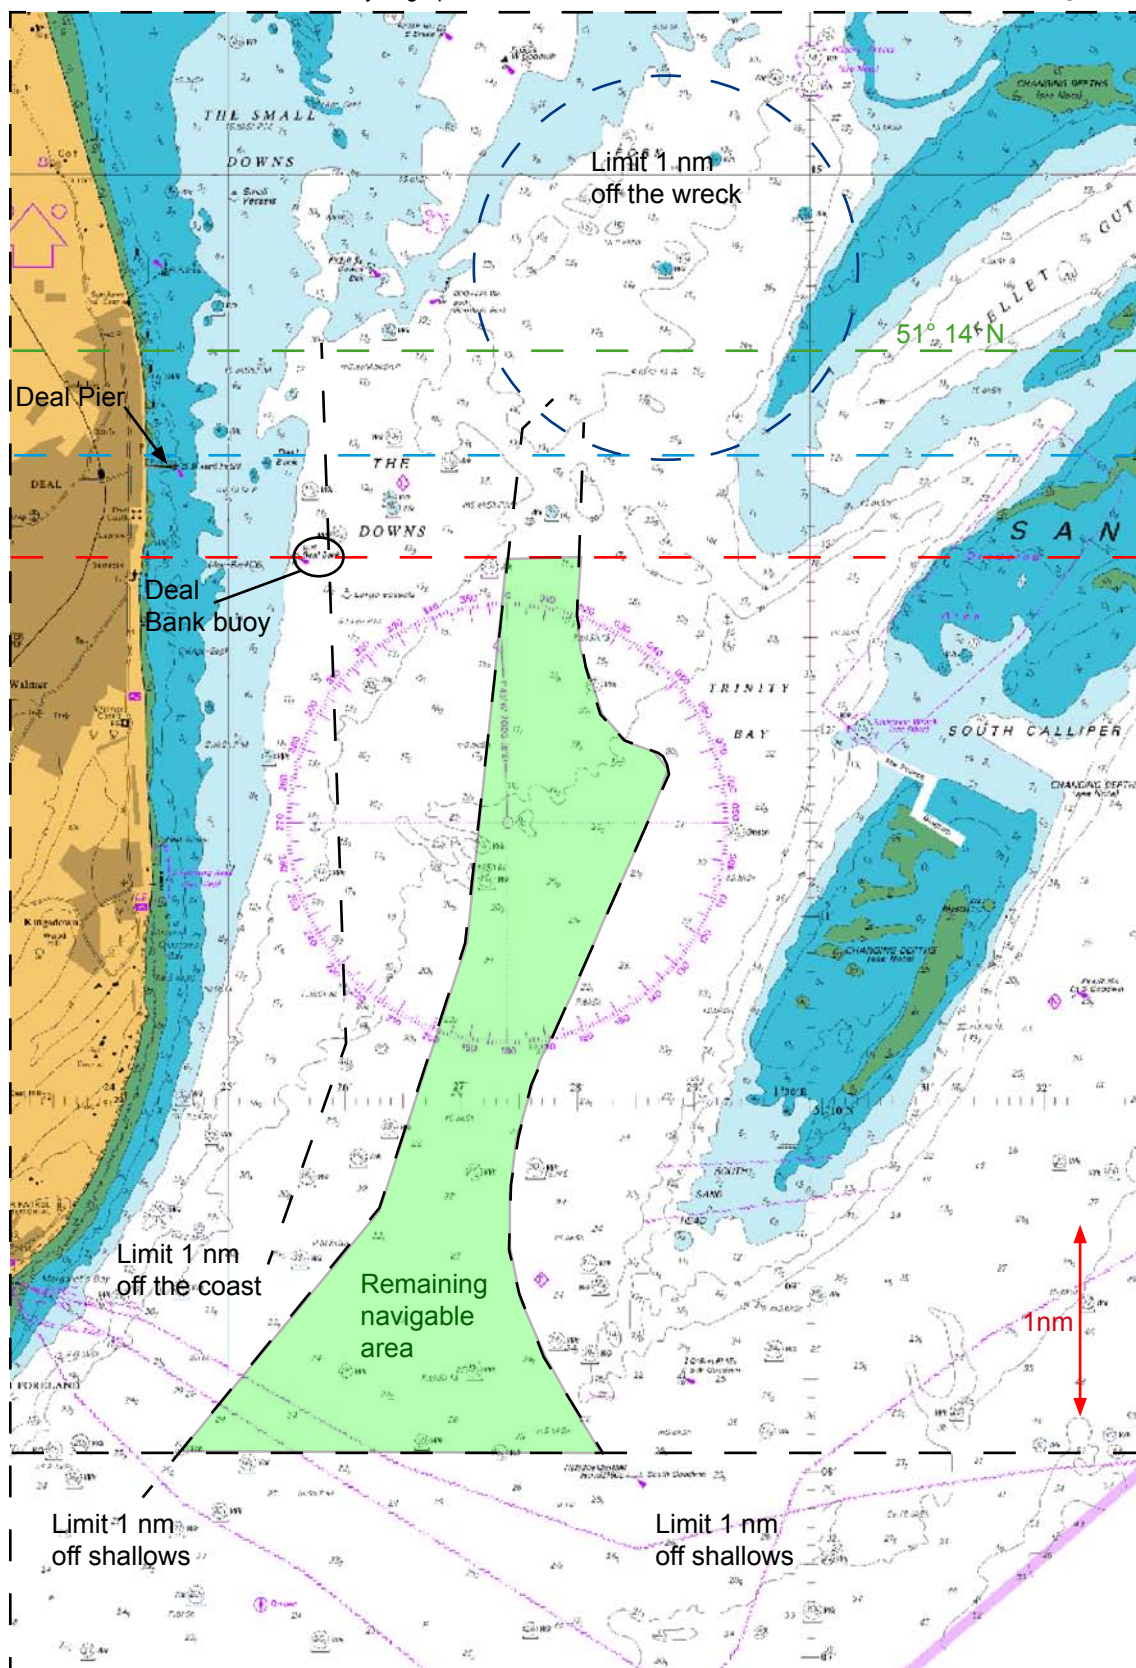
Figure 4

As the vessel approached The Downs, the master explained to the OOW that he wished for the vessel to steam slowly in the area, keeping 1 mile from the coast and clear of the other ferries that were already there. He did not specify any other limits, but it was the normal custom for ferries to avoid passing to the north of a line extending eastwards from Deal Pier and to avoid getting closer than 9 cables¹ to Goodwin Fork buoy. A little later, the master had clarified that he wished the turn on the northern leg to occur when off Deal Bank buoy **(Figure 3)**, and for the vessel to stay at least 1 mile clear of any shallows **(Figure 4)**.

- Navigable area taking account of master's restrictions
- Northern limit on the final run
- Northern limit on the 2nd run
- Northern limit on the 1st run

Because it had been necessary to adjust *Pride of Canterbury's* course and speed several times to avoid other vessels, the watchkeeper suggested to the master that the track of the vessel be extended slightly further north on the next leg into clearer water (**Figure 4**). The master agreed.

Without specific instructions, especially clearly defined no-go areas and a northern limit, being available and marked on the chart, it was not easy for the OOW to ensure that the master's wishes were complied with. Had the paper chart been marked with all limitations required by the master, including subsequent modifications, it would have been clear that the plan could not have been easily complied with (**Figure 4**).

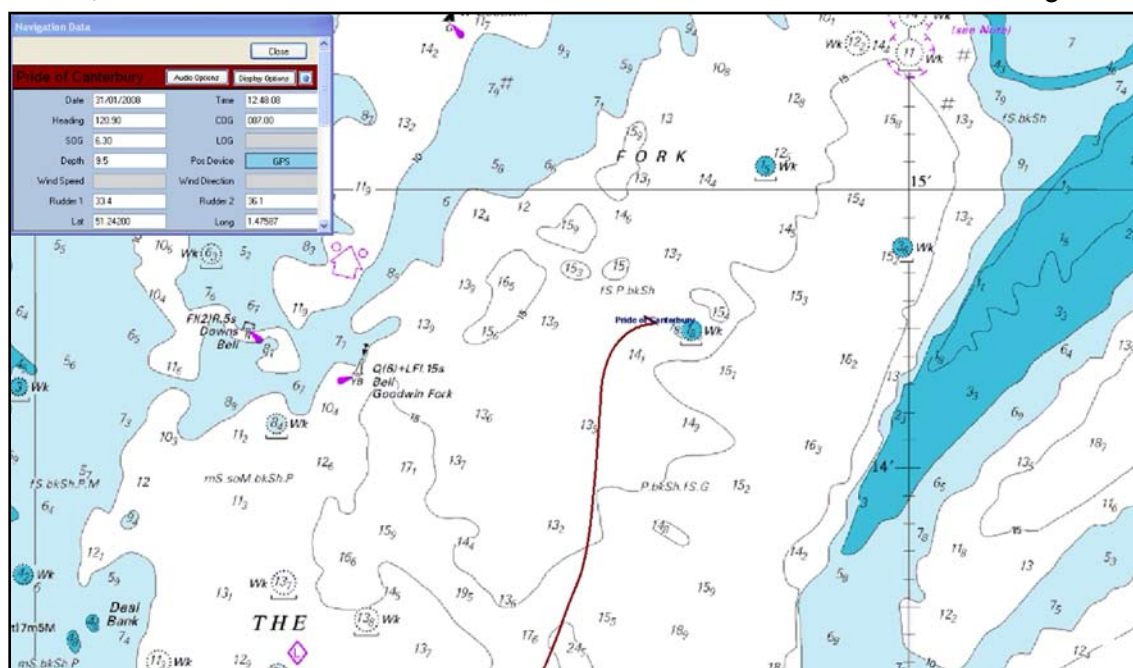
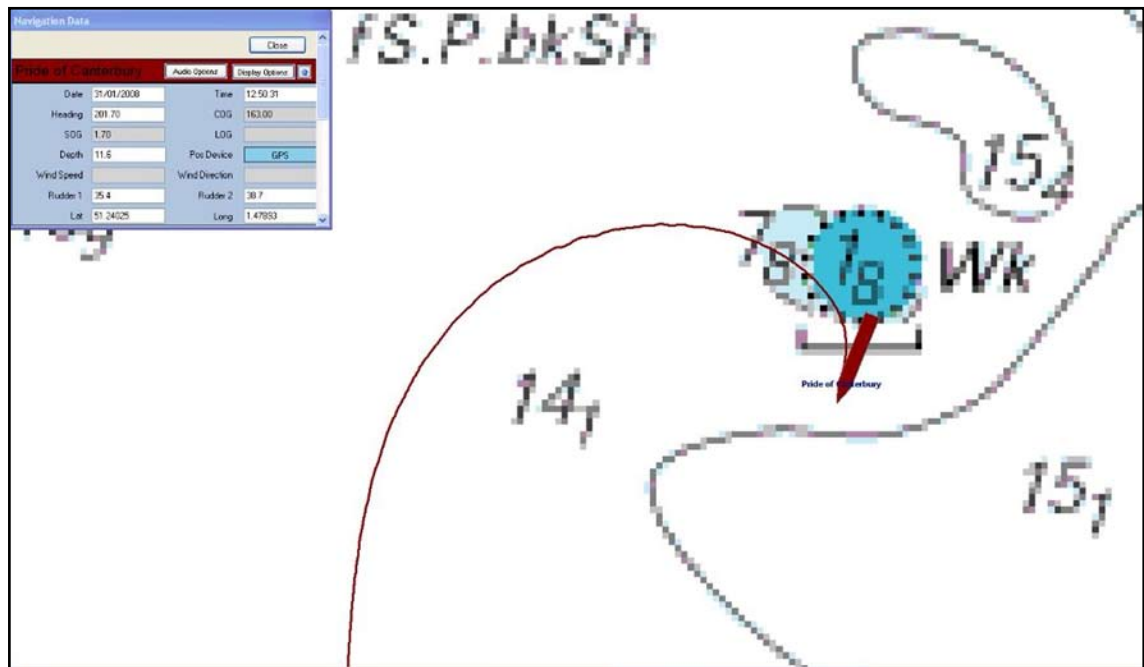
Figure 5a

As the turn continued, the VMS display indicated that *Pride of Canterbury's* bow had swung clear of the shallow patch. Full starboard helm was maintained, and it appeared to the bridge team that the shallows had been cleared. However, at 12:50:40, a loud noise was heard and vibrations were felt as she struck, what was later identified as, a submerged wreck (**Figure 5a & b**). Alarms were received on the bridge indicating that there was a problem with the port controllable pitch propeller (CPP).

Detail of track record of *Pride of Canterbury* approaching the wreck of *Mahratta*

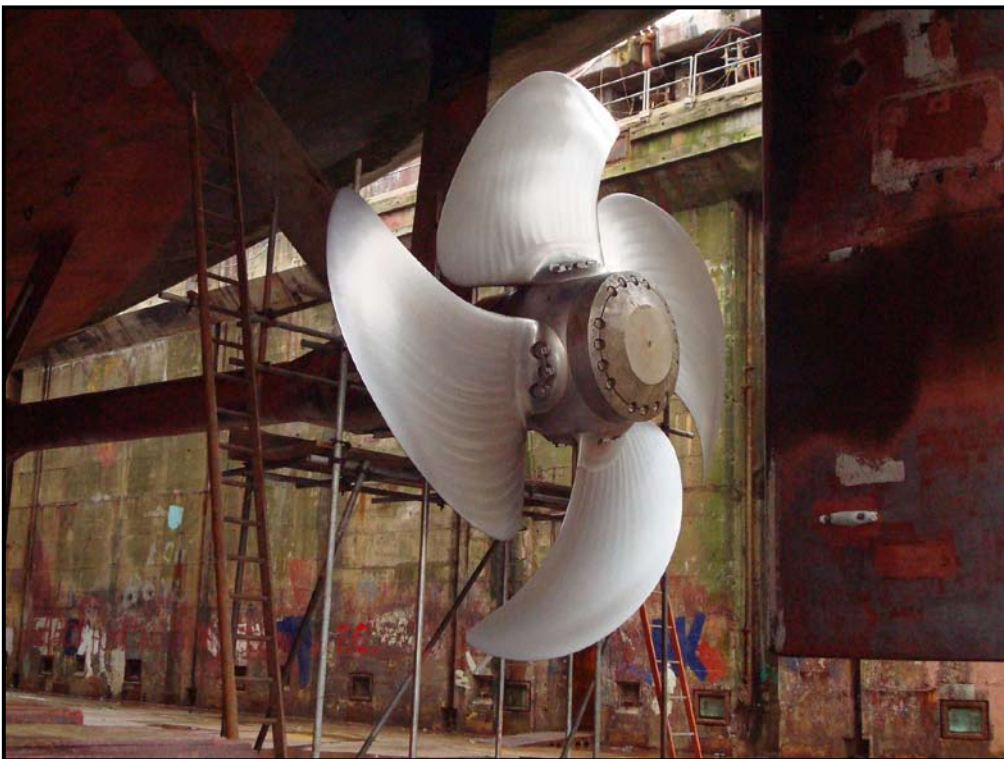
Figure 7

Starboard CP propeller and hub

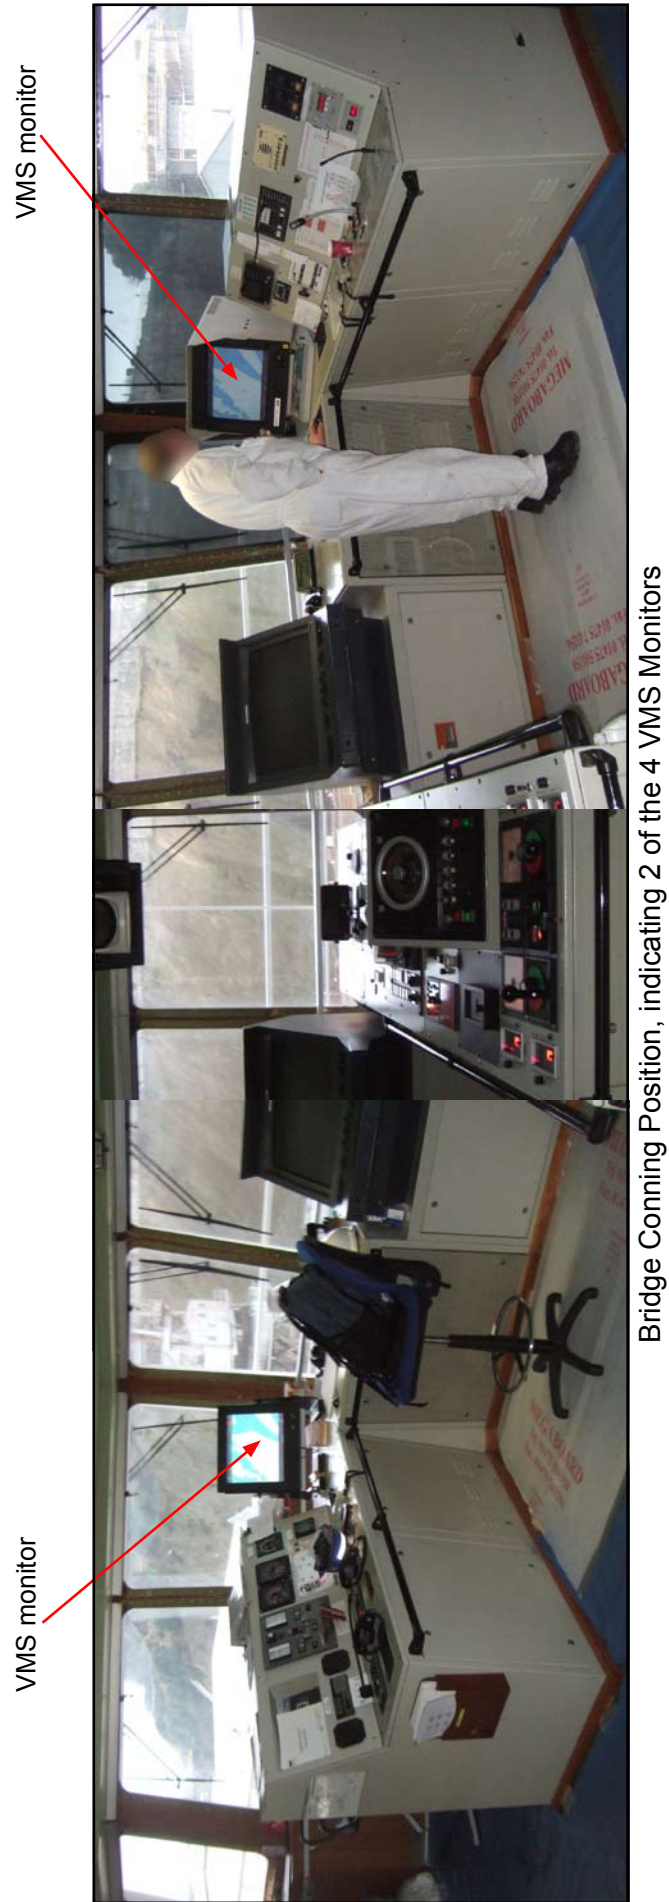
Figure 10

Bridge Conning Position, indicating 2 of the 4 VMS Monitors

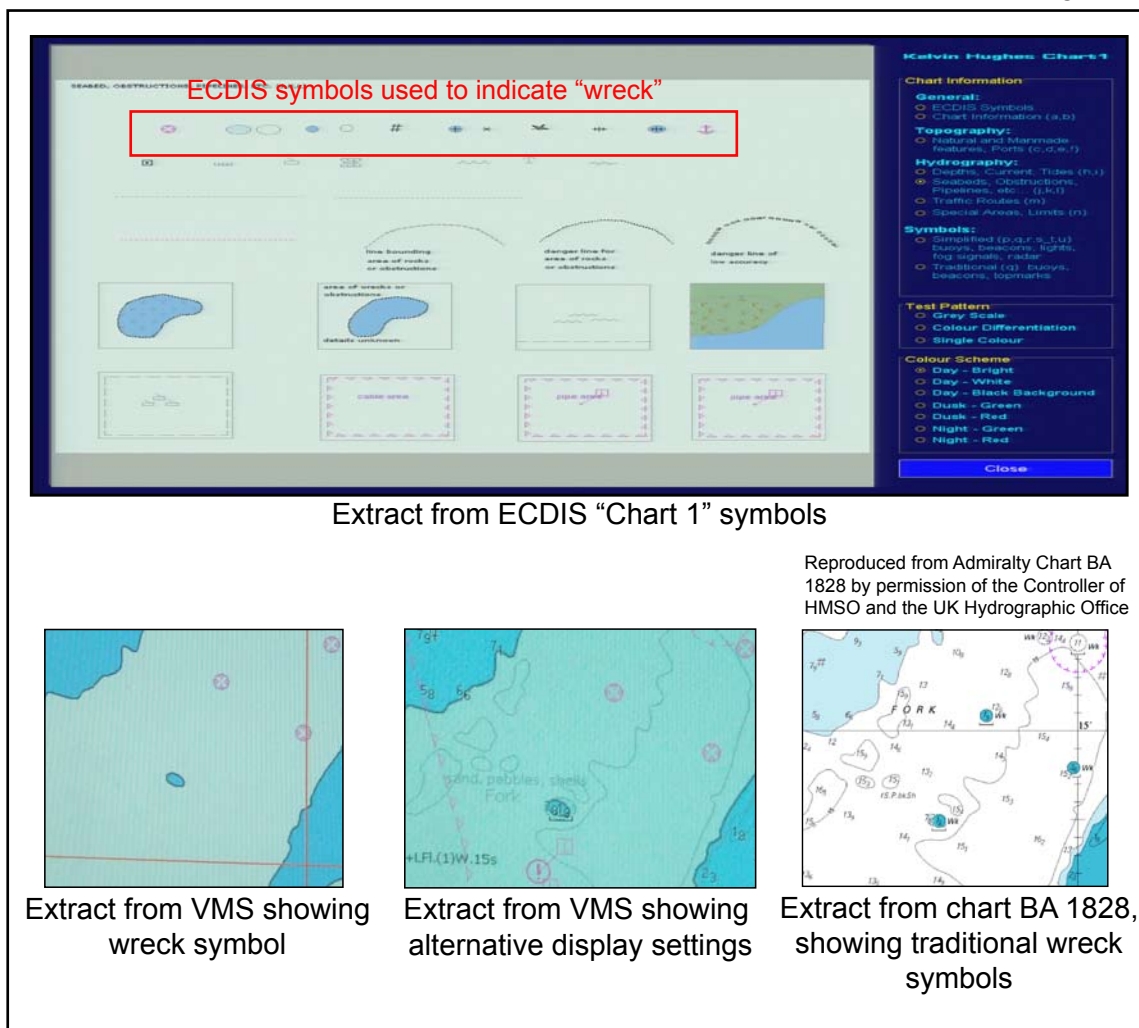
The lack of proper training in the use of ECDIS possibly led to the wreck being undetected. It is possible that the wreck on the shallow patch was displayed, but that the ECDIS symbol was misunderstood. Display options permit differences between the symbols displayed on paper charts and on ENCs (**Figure 11**). Another explanation, which is also linked to a lack of proper training, is that the “misapplication” of certain user settings may result in a dangerous underwater obstruction not being displayed on the screen. If the initial value for the safety contour is selected without understanding the constraints, and the option for display of obstructions is set inappropriately, an ECDIS may not display the underwater hazards with sufficient clarity to alert the navigator. If a passage plan had been drawn using the VMS, and the VMS safety check function had been used, the presence of dangers on the route would have been automatically highlighted. However, no passage plan for the area of The Downs was formulated.

The wreck was clearly displayed on chart BA 1828, but because the bridge team were not systematically fixing the vessel's position on the chart, it did not assist them in detecting the obstruction.
