Report on the investigation of
the collision between
Lady Hamilton of Helford
and
Blithe Spirit

Falmouth Bay, Cornwall, England

3 October 2007

Report No 8/2008
April 2008

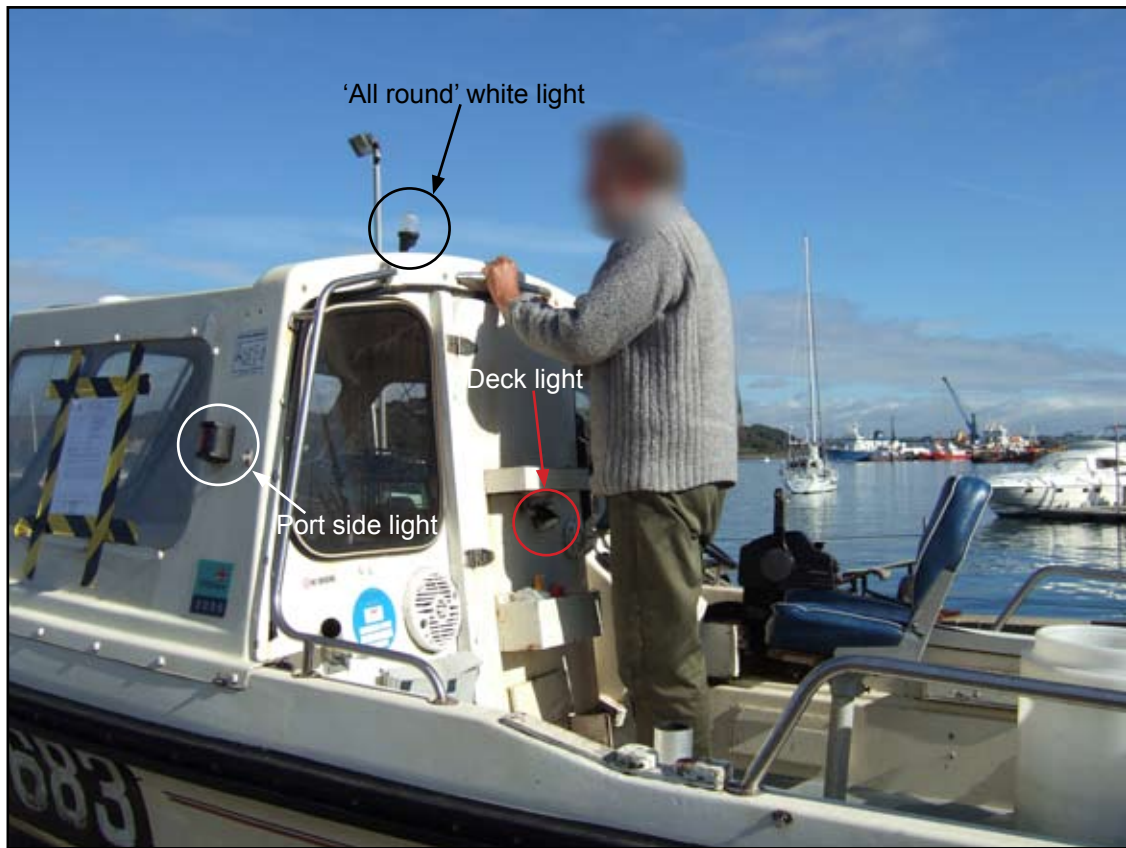
Figure 3

Blithe Spirit navigation and deck lights

The day after the accident, the white navigation light switch was found to be in the off position, and its bulb had failed. The starboard sidelight also failed to illuminate when the power was switched on. Both sidelights were dismantled and inspected (**Figure 10**). The port sidelight bulb was in very poor condition, but was the appropriate type for the fitting and functioned correctly. The starboard sidelight bulb was canted over to one side, which caused its end caps to short out the electric circuit. When the bulb was squared up in its housing it illuminated correctly. The bulb was not designed for the housing, it was too long and it did not have conical end caps with locating nipples to hold it in place. The flares and smoke floats carried on board were out of date and in very poor condition.

As the bulb of *Blithe Spirit's* all round white light was subsequently found to have failed, and the bulb in the starboard sidelight, which was an auto bulb and not the correct type for its housing, had been dislodged, it is also possible that one or both of these lights were not illuminated. However, it is equally possible that the sidelight bulb was dislodged and the all round light bulb failed when the vessels collided.

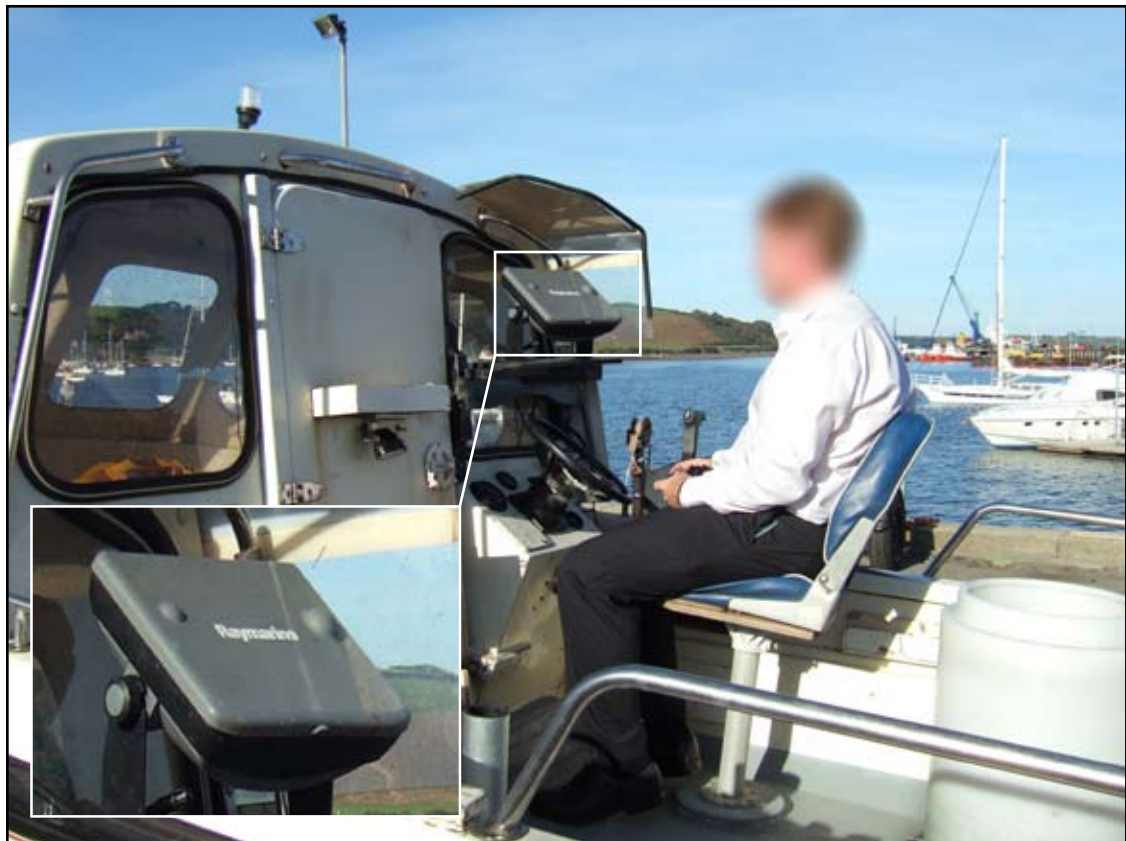
Figure 4

View from the seated position on board *Blithe Spirit*

The actions of *Blithe Spirit's* skipper also indicate a complacent approach to the operation of his craft. He habitually transited the bay at speed during darkness and was fully aware that he was unable to see ahead when seated. However, he made no attempt to monitor the effectiveness of his alteration to port. The skipper's lack of action in this respect not only indicates an acceptance or disregard of the risks involved, but it also demonstrates a lack of awareness of the pace at which situations change when travelling at speed. The poor condition of the pyrotechnics on board *Blithe Spirit*, and her skipper's decision not to wear a lifejacket or kill-cord are further examples of the skipper's casual attitude to safety. On this occasion, he was extremely fortunate. Had he been thrown into the water rather than into the boat on impact, it is almost certain that, unconscious and without a lifejacket, he would have drowned.

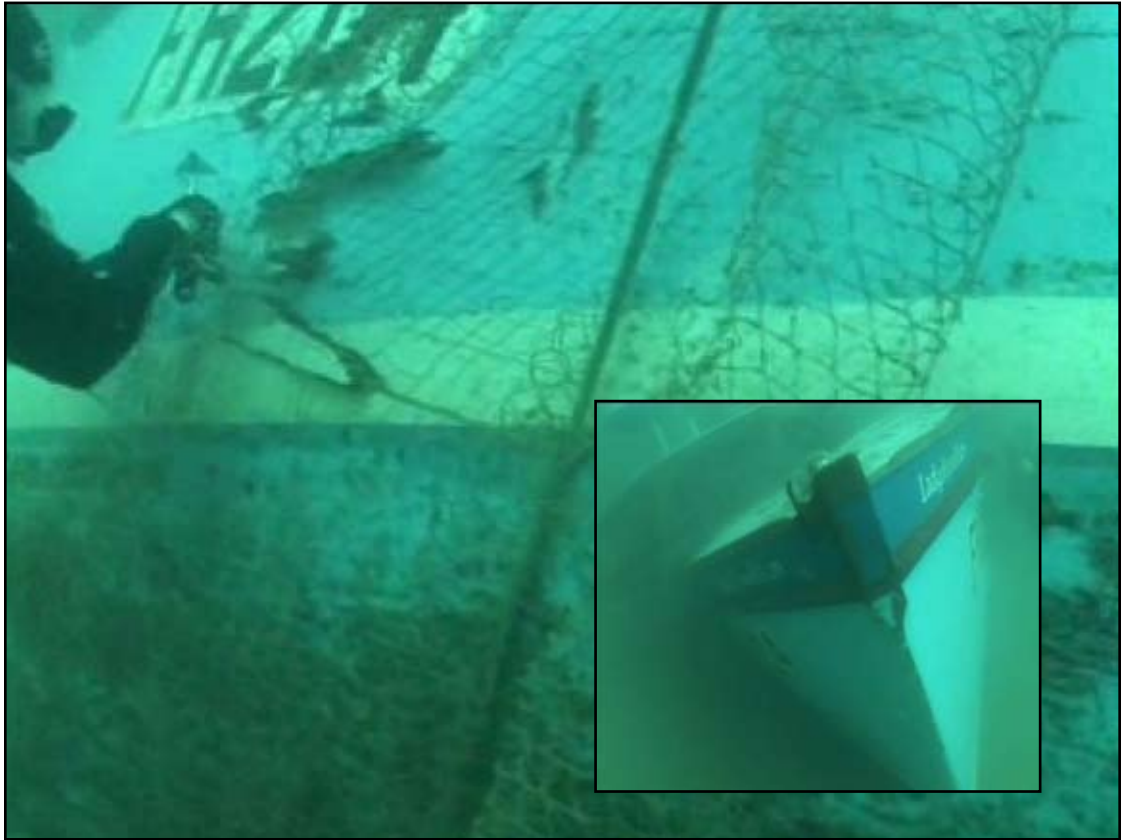
Figure 5

Following the foundering of *Lady Hamilton of Helford*, several dive surveys were conducted to assess her suitability for recovery. During a dive survey conducted on 5 October 2007, video footage indicated that the vessel had been struck above the waterline on her port side, adjacent to the wheelhouse (**Figure 5**). This damage was confirmed when the vessel was later recovered (**Figure 6**). The impact had caused a number of wooden planks on and above the waterline to split. A number of additional planks below the waterline had also cracked and sprung. The extent to which the wheelhouse structure had been dislodged to starboard is shown at **Figure 7**.

Damage observed by diving team

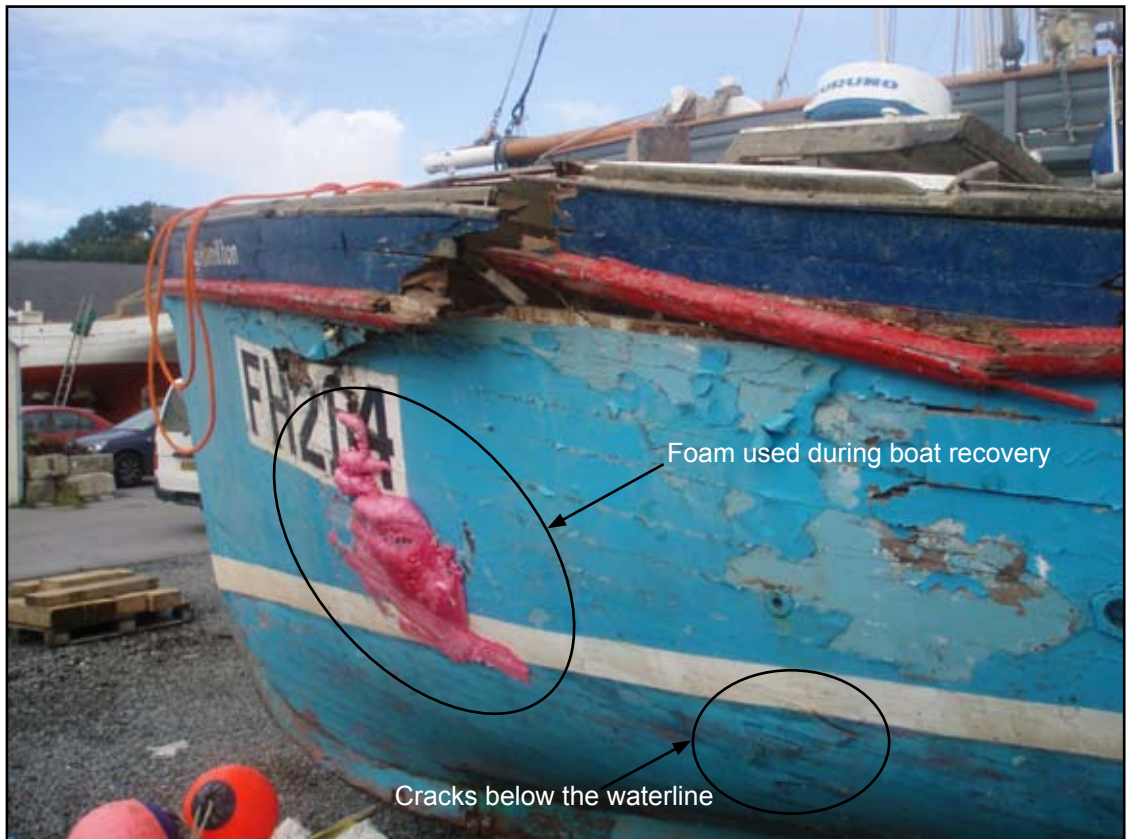
Figure 6

Damage to the hull of *Lady Hamilton of Helford*

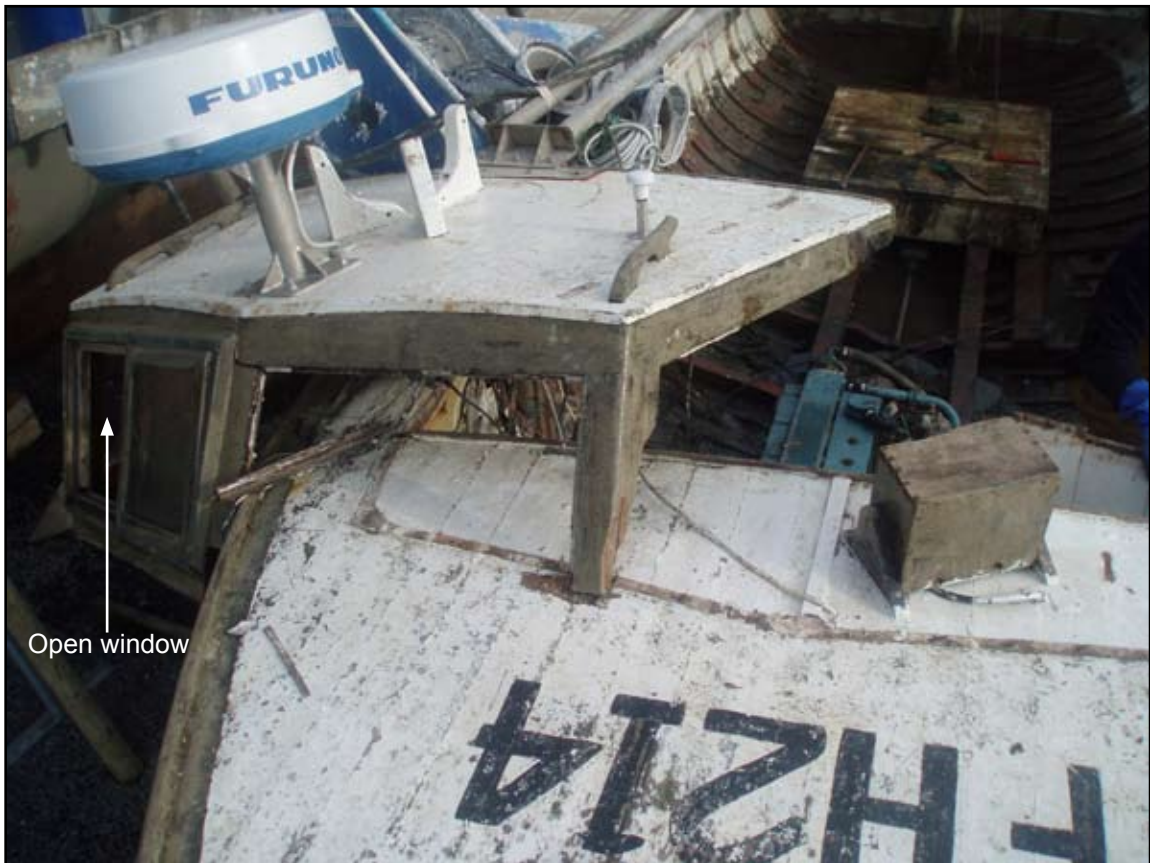
Figure 7

Damage to the wheelhouse of *Lady Hamilton of Helford*

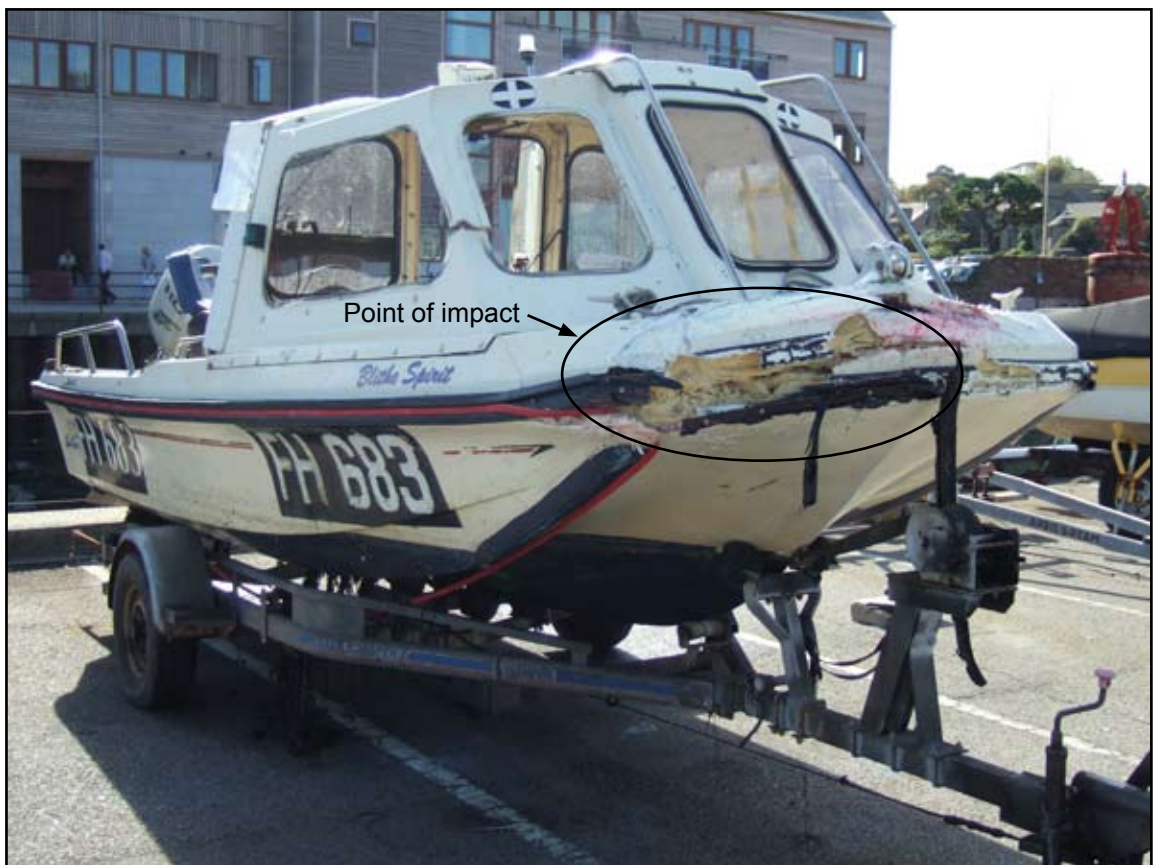
Figure 8

Damage to the bow of *Blithe Spirit*

The glass-reinforced plastic (GRP) of the starboard side of *Blithe Spirit's* blunt nosed bow was compressed and split across a length of approximately 1m (**Figure 8**). Traces of paint matching the paint used on the hull of *Lady Hamilton of Helford* were found on the damaged bow area and chines (**Figure 9**). The starboard side and starboard forward facing cabin windows had been knocked out and the stanchion between them was torn. Two Perspex windows of identical dimensions to the windows missing from *Blithe Spirit* were later found on the deck of *Lady Hamilton of Helford* after she was recovered.

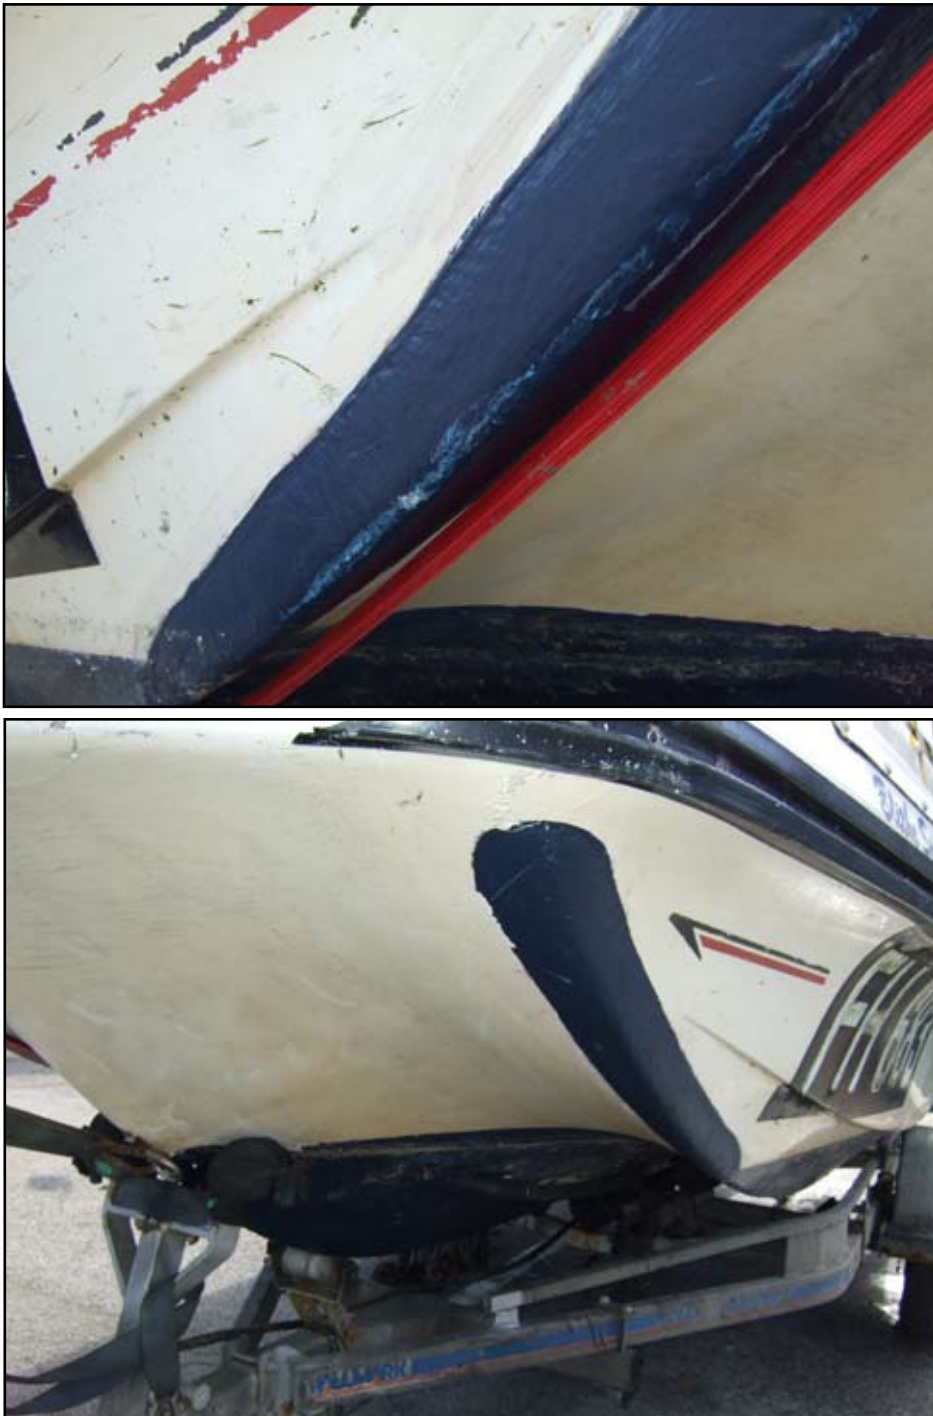
Figure 9

Paint marks on chines of *Blithe Spirit's* hull

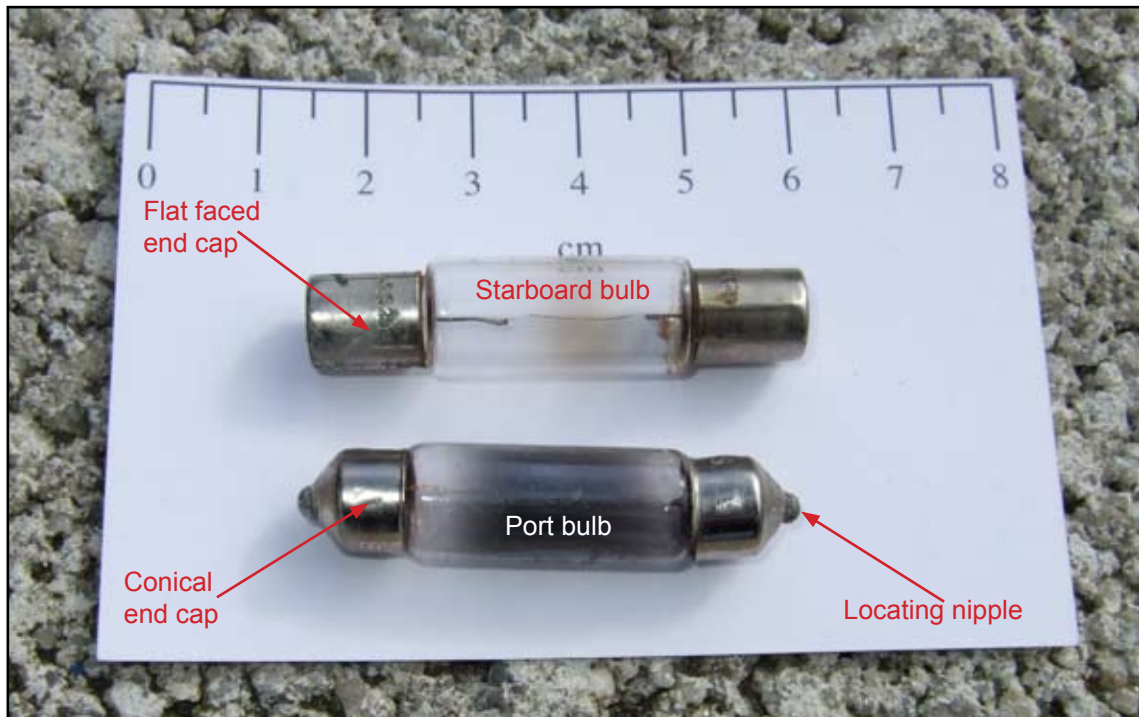
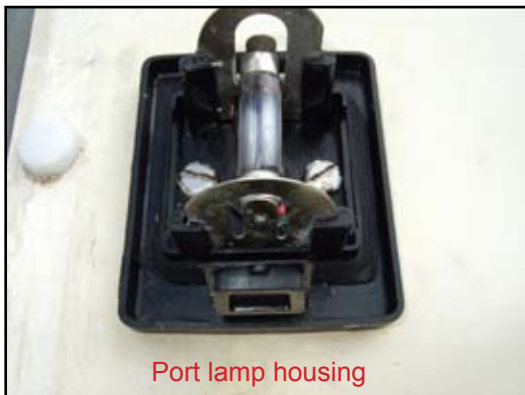
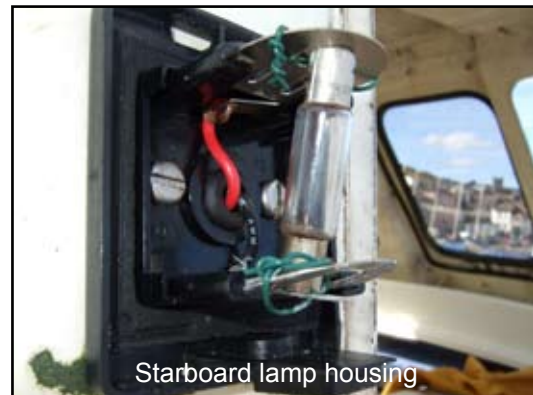
Figure 10

Blithe Spirit's sidelight lamps

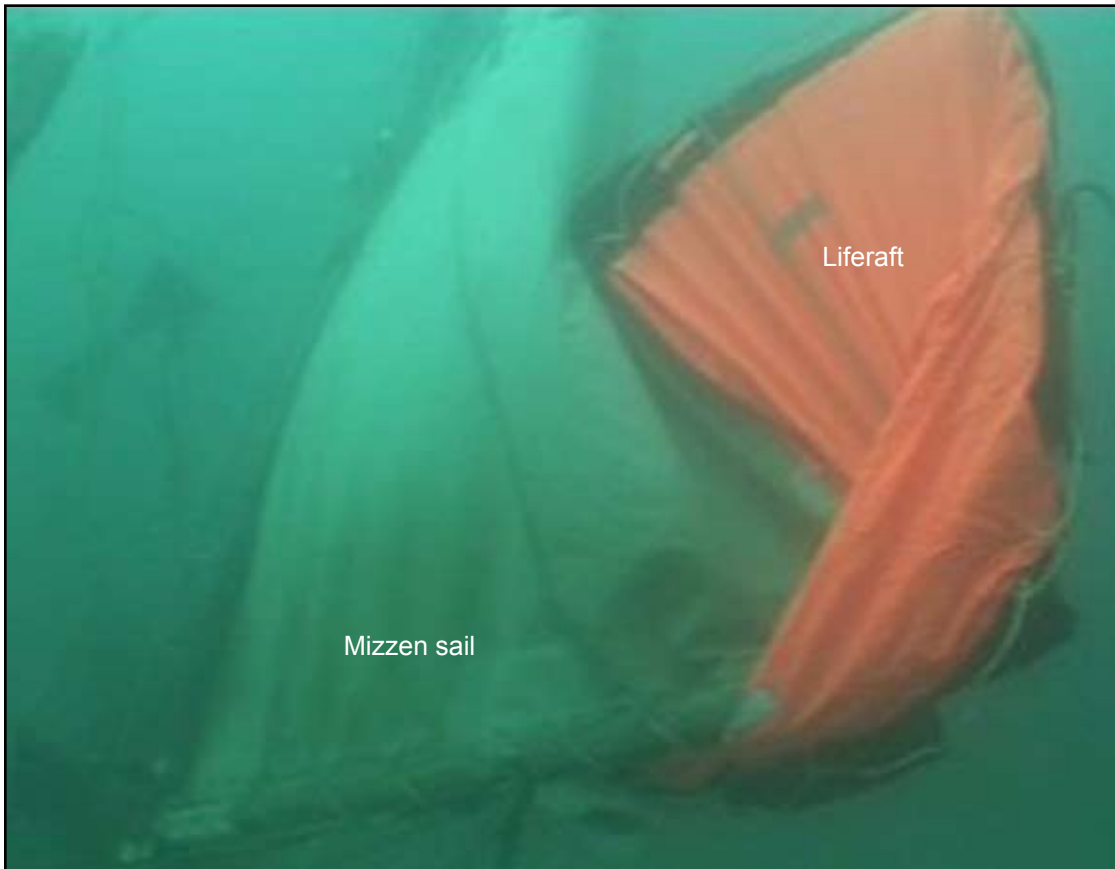
Figure 11

Lady Hamilton of Helford's liferaft (photograph taken during diver's survey)

The liferaft on board *Lady Hamilton of Helford* failed to fully inflate and was therefore unusable. It was fortunate that the pilot boat was sufficiently close to quickly assist her crew; otherwise the failure of her liferaft would potentially have led to more serious consequences.

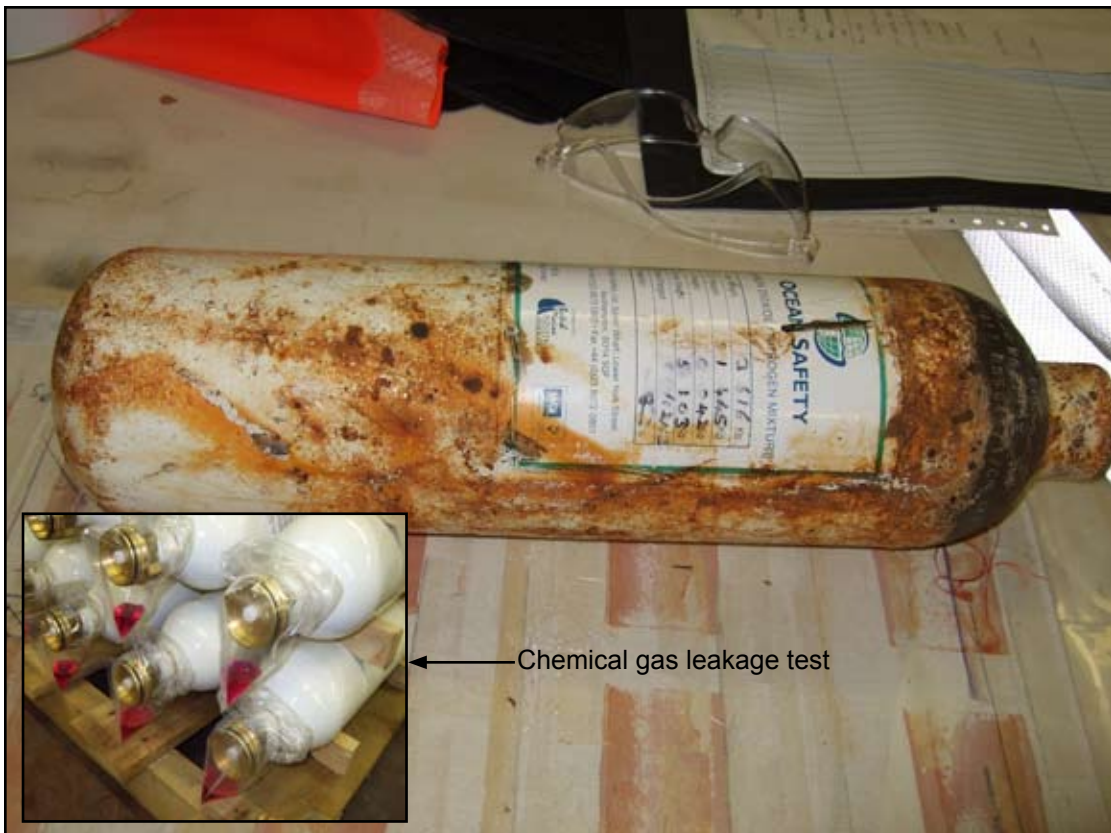
Figure 12

The carbon dioxide (CO₂) gas cylinder and its operating head were also examined. The operating head appeared to function correctly but the steel cylinder had a significant amount of corrosion (**Figure 12**). The cylinder was charged with CO₂ and subjected to a chemical leakage test. The test indicated that at least 0.0022g of CO₂ had escaped over a 1-hour period. Attempts to locate the exact leakage point, by immersing the pressurised cylinder in water, failed. This indicated that the leak was extremely small. The manufacturer concluded that the gas leakage path was most probably through the threaded connection between the cylinder neck and its operating head. The test report is at **Annex A**.

Liferaft CO₂ gas cylinder

Tests on the liferaft (**Annex A**) indicate it did not fully inflate because there was insufficient CO₂ in its cylinder and gas had leaked from the cylinder via an extremely small leak in the screw connection to its operating head. However, it has not been possible to determine how long the leak had been present. The weight of the cylinder was not recorded on the liferaft's maintenance record sheet during its annual services (**Annex B**), and the cylinder had not been pressure tested in 2004, as required by the manufacturer. Although records indicate that the cylinder was re-filled in 2002, the reasons for this are not known.

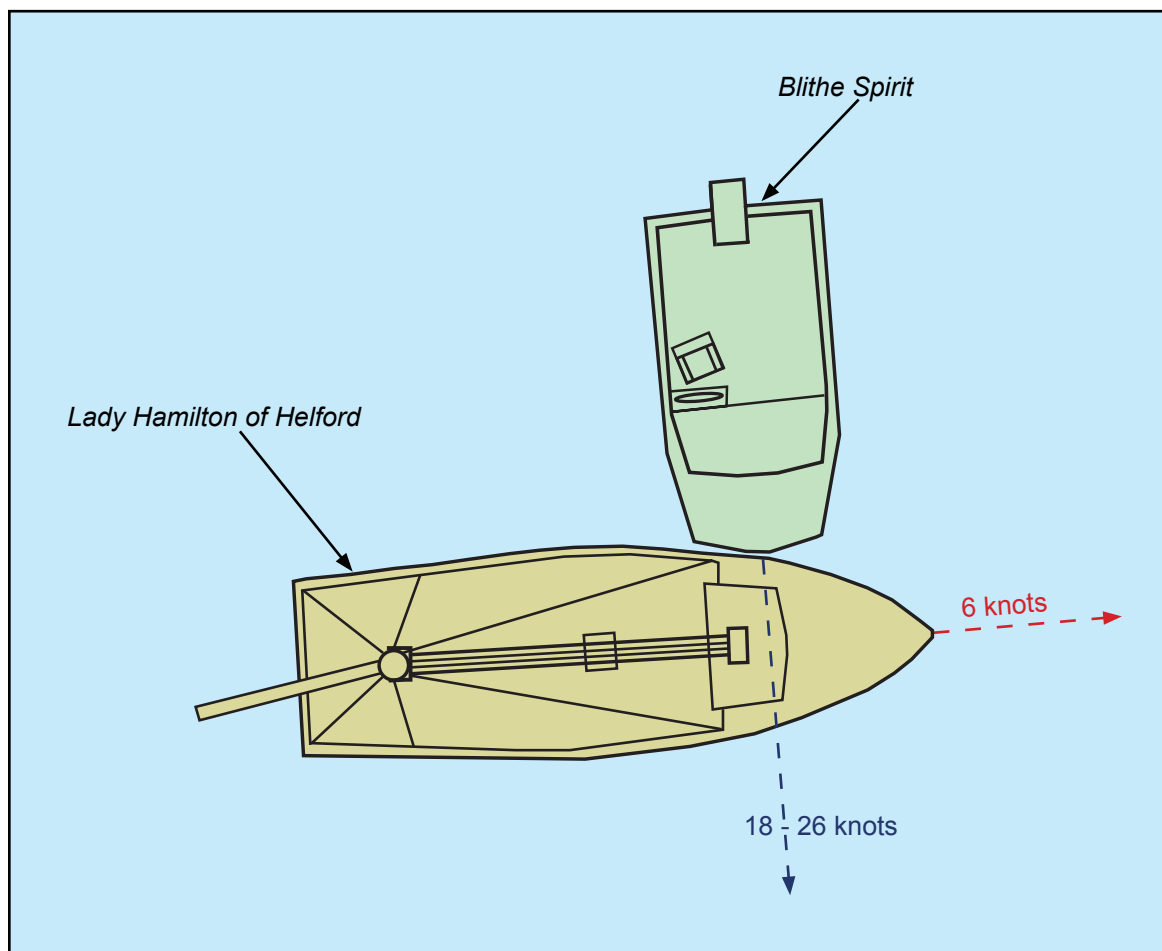
Figure 13

Lady Hamilton of Helford was struck on her port side forward and the damage to *Blithe Spirit* indicates she impacted with her starboard bow. The relative positions of the damage and the force of impact is consistent with the directions and the speeds of the vessels at the time (**Figure 13**). The geographical location of the collision is also consistent with intersection of the vessels' intended passages. The paint marks on the starboard and centre chines of *Blithe Spirit* (**Figure 9**) indicate that the dory rode up the side of *Lady Hamilton of Helford* before deflecting to port.

Estimated relative position of vessels on impact
