Report on the investigation of
work undertaken in a dangerous enclosed/confined space
and the consequent attempted rescue on board

ERRV Viking Islay

resulting in the loss of three lives
at the Amethyst gas field, 25 miles off the East Yorkshire coast, UK
23 September 2007

Report No 12/2008
July 2008

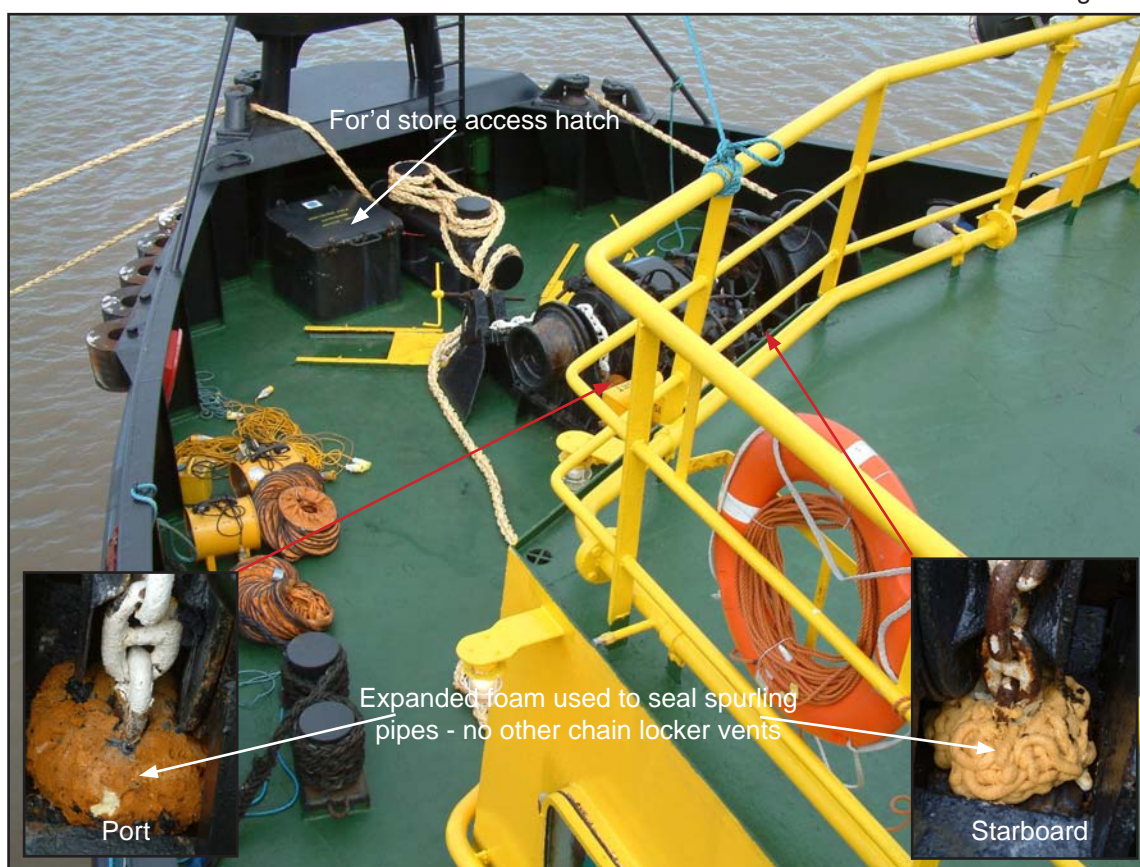
Figure 1

As was normal in preparation for arrival, *Viking Islay*'s starboard anchor had been walked out a short distance; it was not dropped clear of the hawse pipe, but just moved enough to confirm that it was free and clear to be run out in case of any emergency. Possible impediments to the anchor chain running free included the expanded foam, that was routinely used to seal the top of the spurling pipe¹ on the foredeck, and light rope lashings used to secure the anchor chain within the chain locker (**Figure 1**).

The foam was used to prevent water entering the chain locker via the spurling pipe. Light lashings were sometimes applied inside the chain locker by the crew, in order to prevent the hanging part of the anchor chain from moving in rough weather (**Figure 2**). Such movement could cause the chain to bang noisily against the spurling pipe, or other steelwork.

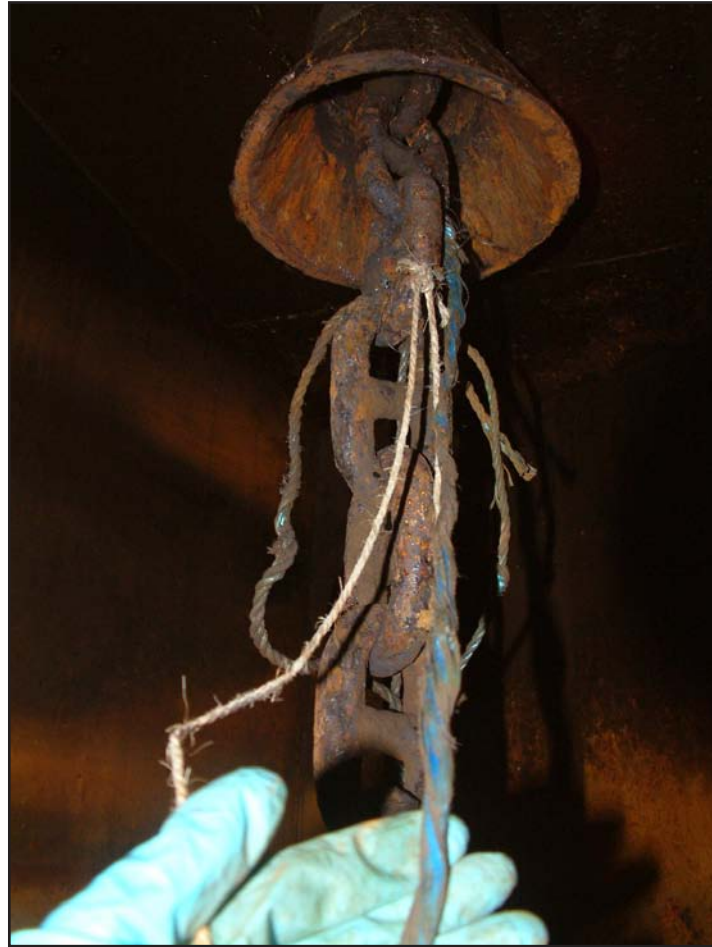
Figure 2

Chain locker - showing rope lashings used to stop anchor chain rattling

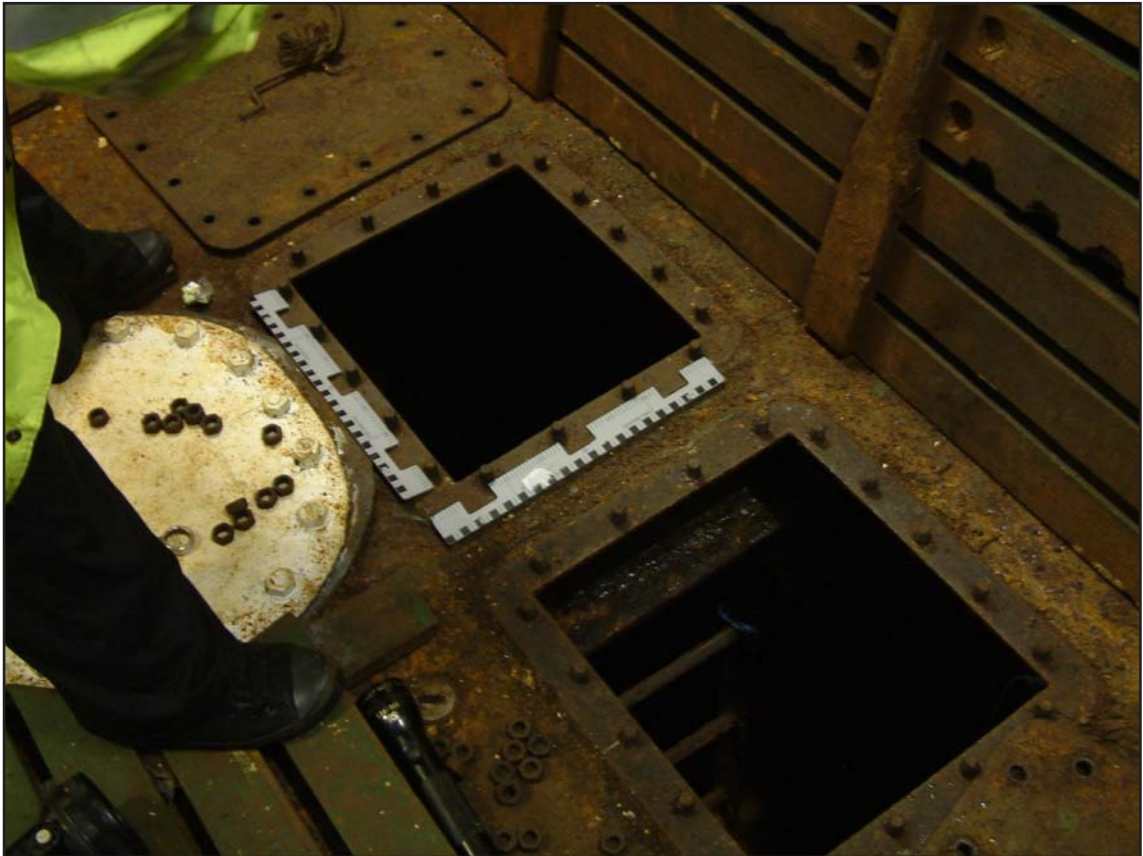
The two day workers went to the aft part of the foc'sle store and lifted the loose duckboards, beneath which were three access manholes. The forward hatch served the fore peak water ballast tank, and the after two gave access to the port and starboard sides of the anchor chain locker. Although there were two manholes, the internal dividing bulkhead which separated the two anchor chains only extended to about half the height of the chain locker, and the upper parts of the spaces were common. The manholes serving the chain locker were smaller than that serving the ballast tank, and were square in shape rather than the more conventional oval found at the ballast tank access. The heavy steel manhole covers were secured with eighteen 24mm nuts and bolted down onto a rubber gasket, so forming a watertight seal (**Figure 5**).

Foc'sle store - showing access hatches to chainlocker

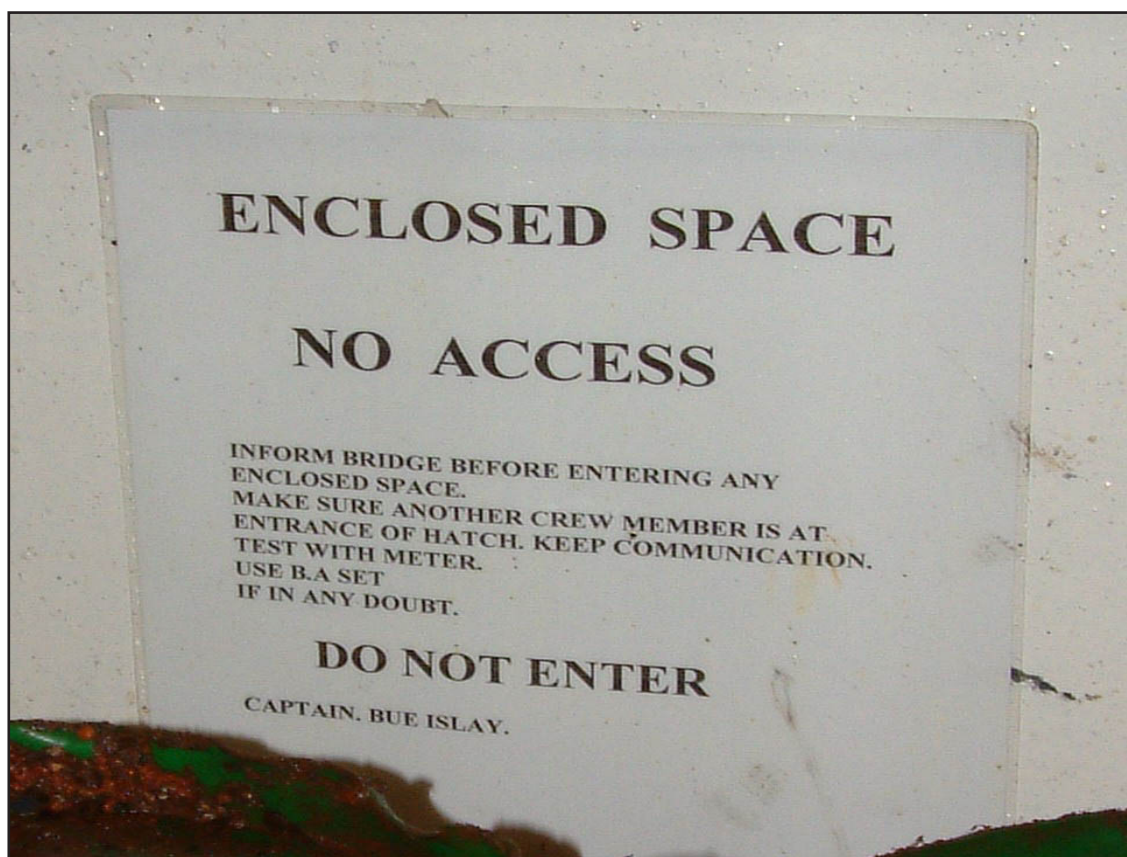
Figure 6

On entering the foc'sle store an empty EEBD was found, and a notice was seen posted up on the after bulkhead of the compartment, near to the manholes (**Figure 6**). The notice appeared to have been made onboard during the period 2002 – 2005. The ship's crew did not know when the notice had been posted.

Sign attached to aft bulkhead of foc'sle store

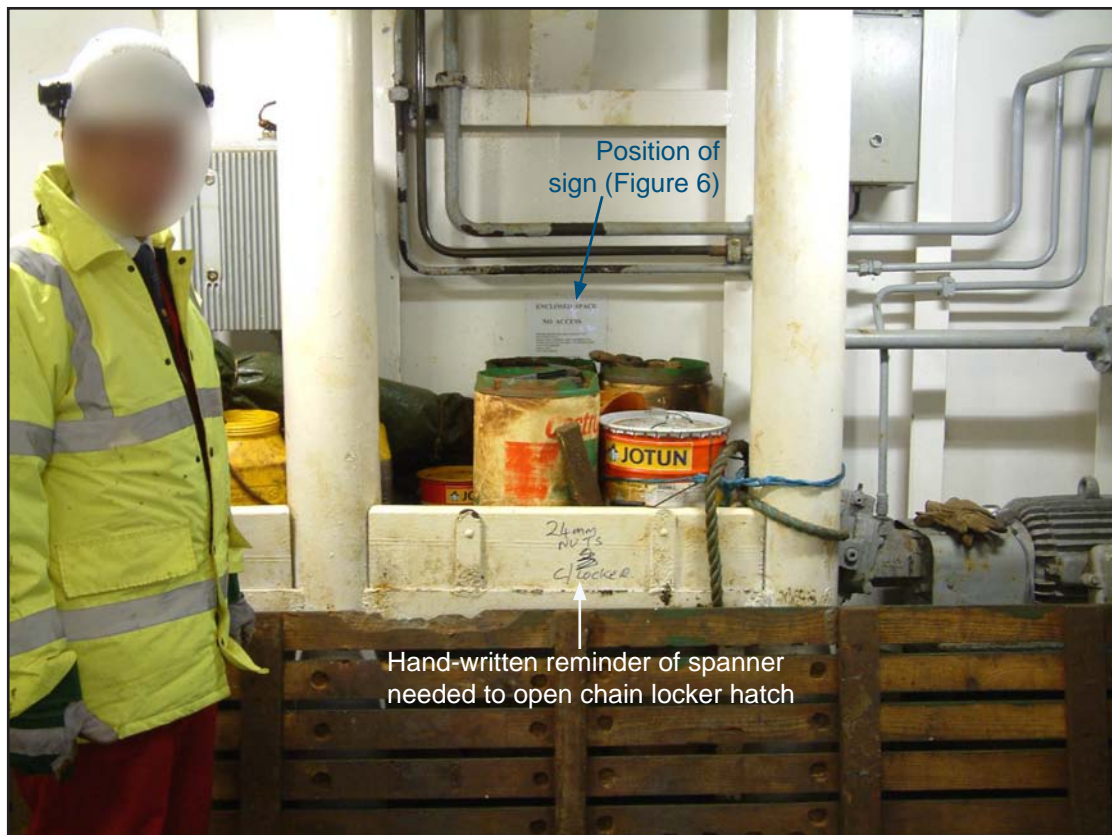
Figure 7

A reminder of the correct size of spanner needed to open the manhole covers was seen, handwritten in marker pen, near the openings (**Figure 7**).

Foc'sle store looking aft

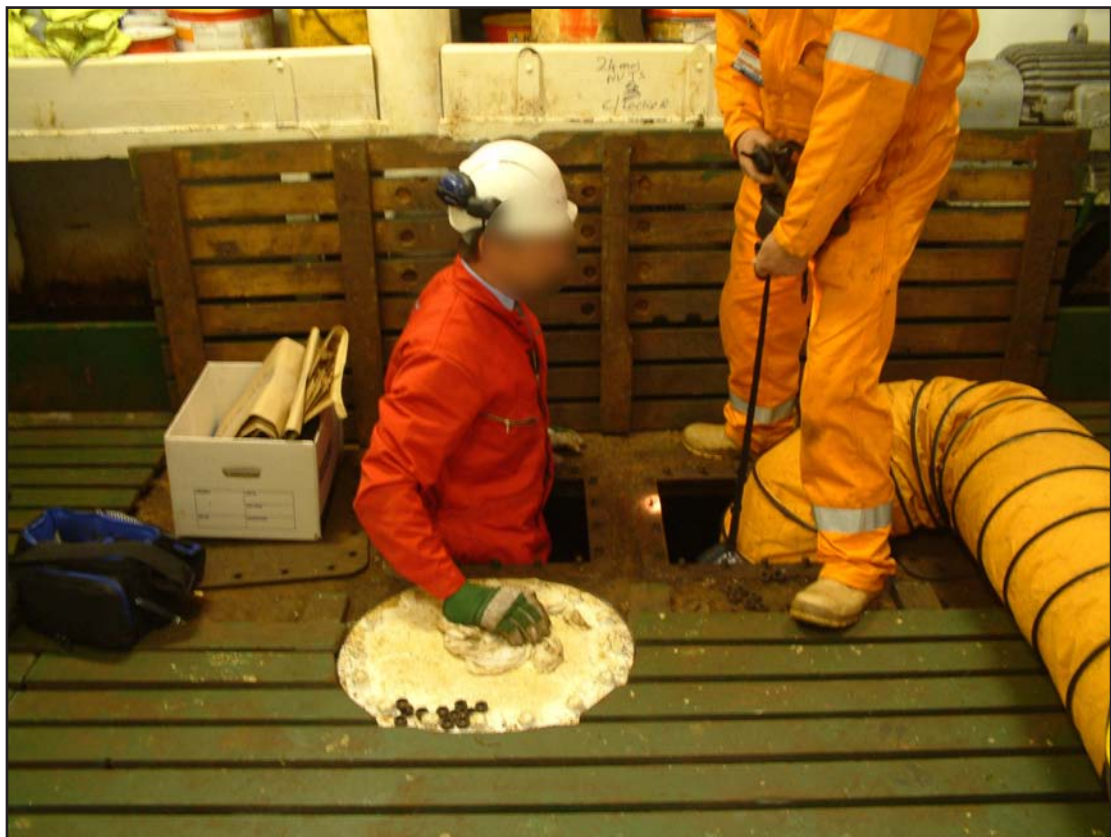
Figure 8

Being aware of the most probable cause of the accident, both chain locker manhole covers were removed, the foam broken out of both spurling pipes and the space was force ventilated. The analyst re-tested the space and certified it safe to enter; the manhole openings were noted to be particularly small (**Figure 8**).

Foc'sle store - showing cramped access to chain locker

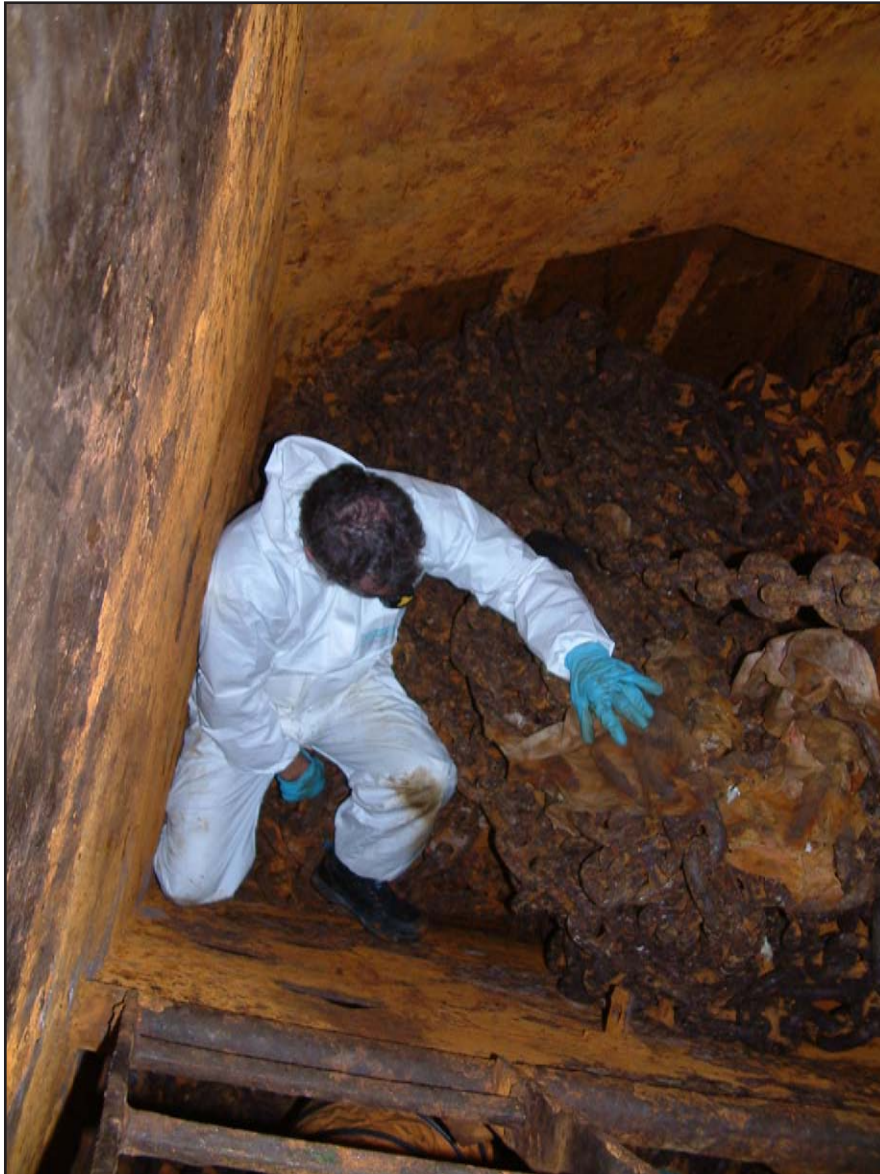
Figure 9

The inside of the chain locker was inspected, measured and photographed. The main part of the chain was found piled in the middle of the space in a fairly solid lump, probably indicating that it had not moved for an extended period of time. No significant foreign objects were found, other than small amounts of textile material, probably rags used to plug the spurling pipes prior to applying expanded foam. Some salt water was present in the bilges at the bottom of the chain locker, below the false floor (**Figure 9**).

Chain locker - showing anchor chain
