Report on the investigation of the
parting of a mooring line on board

Dublin Viking

alongside at Berth 52 in the Port of Dublin, Ireland

**Report No 7/2008
March 2008**

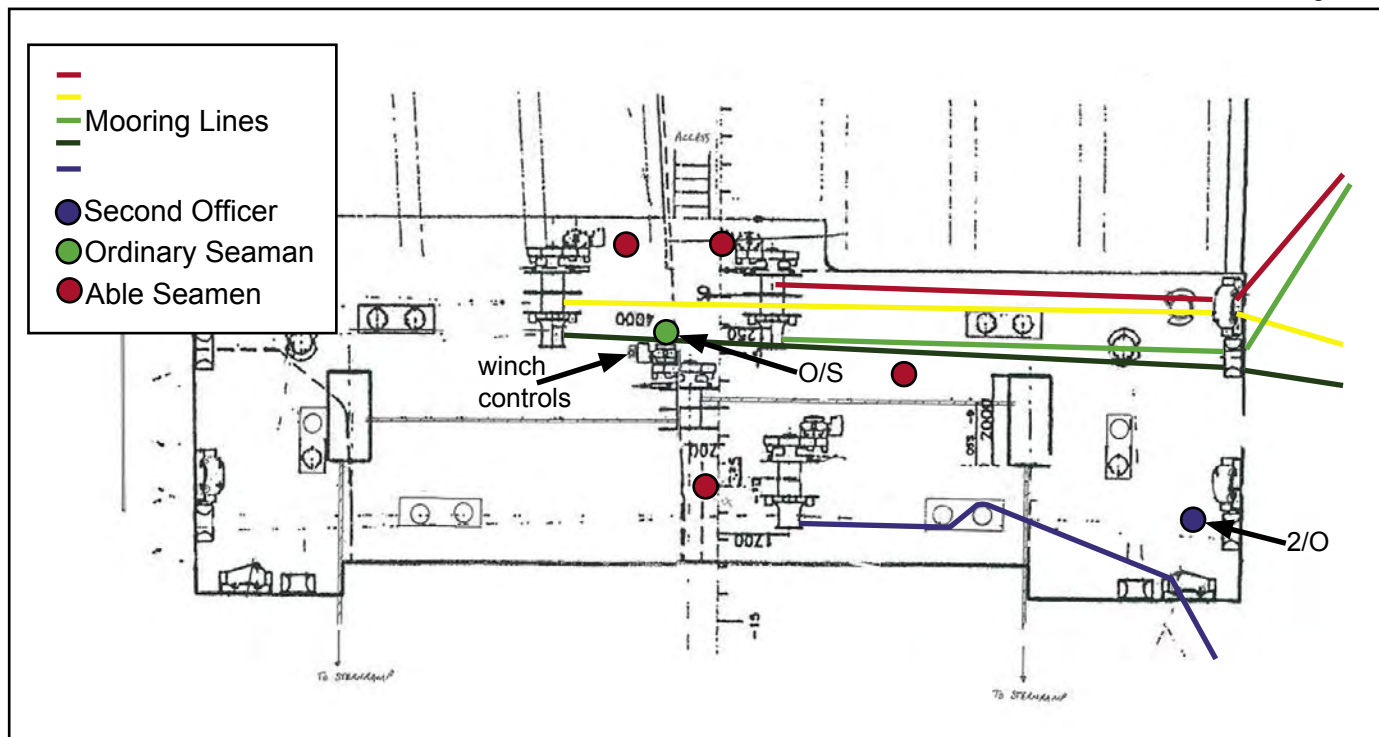
Figure 3

Position of crew on the after mooring deck

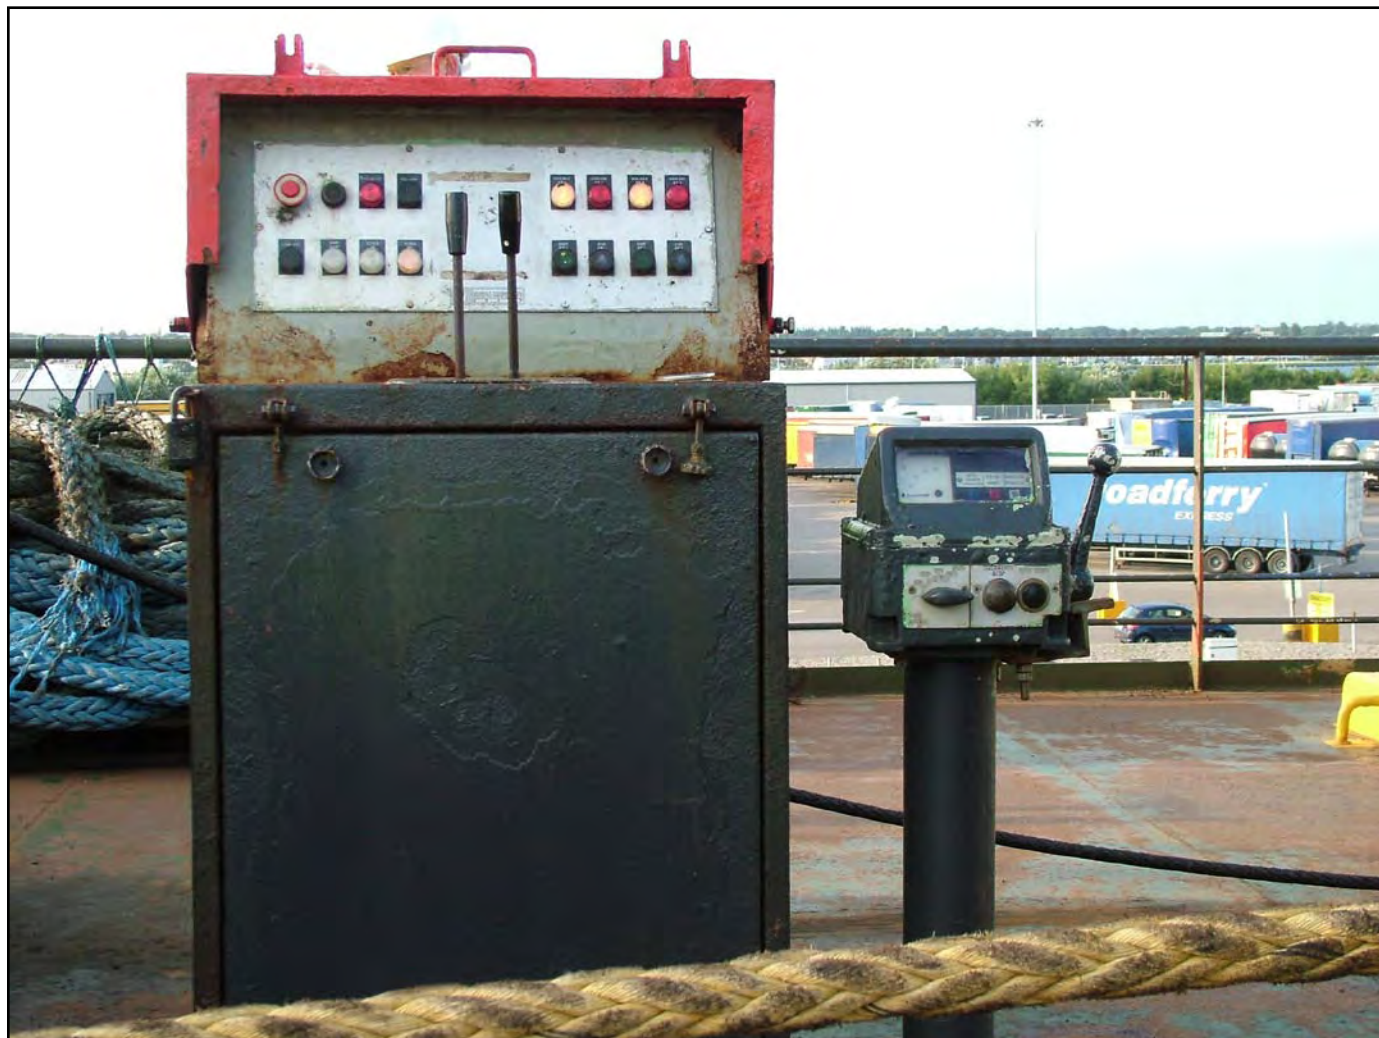
Figure 4

Stern line and stern ramp winch controls

The winch was inspected by a manufacturer's service technician and found to be generally in working order, with two exceptions: the wiring connection to the strain gauge in the auto tensioning system was reversed, and the springs to automatically return the control lever to the neutral position had corroded and failed.

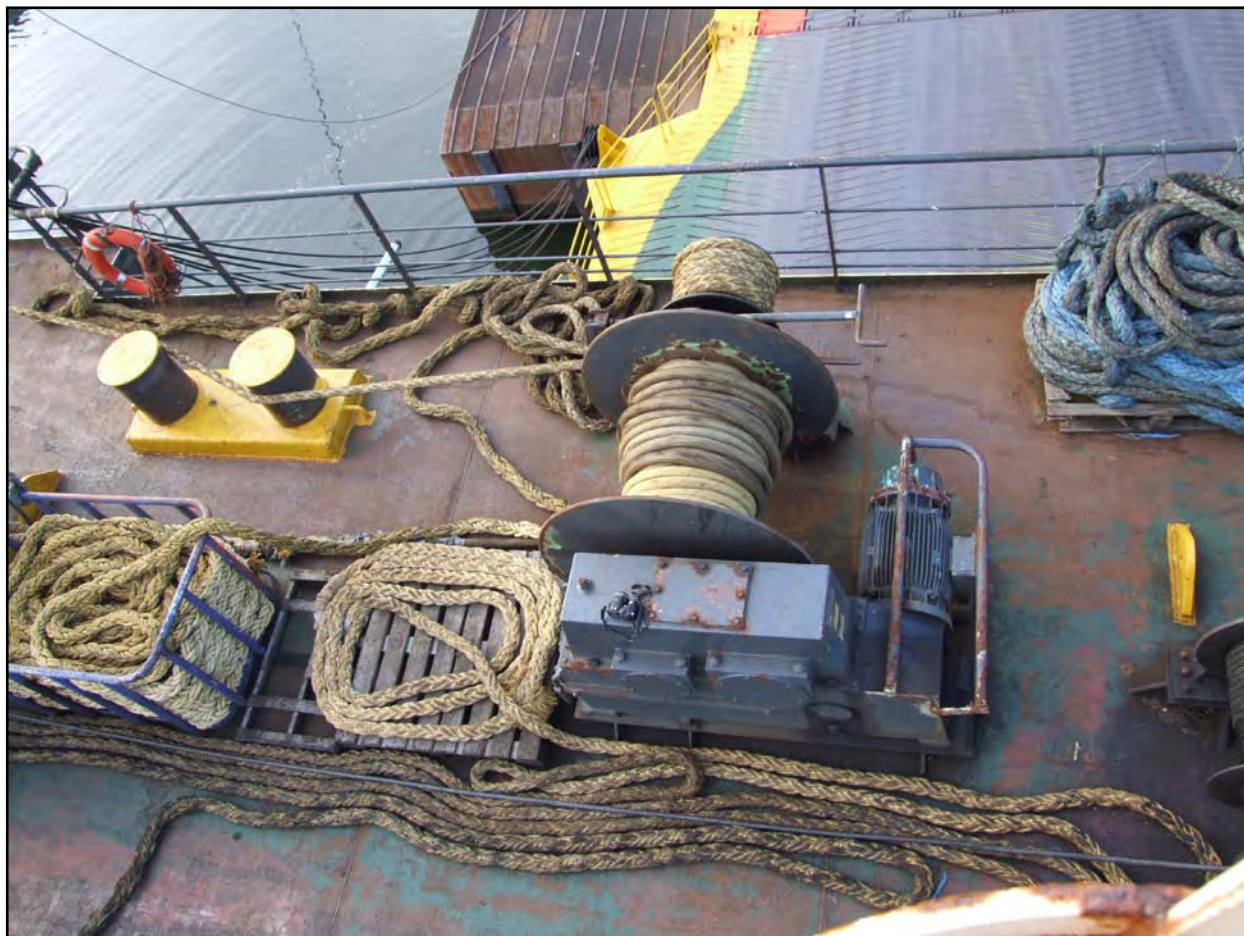
Stern line electric mooring winch

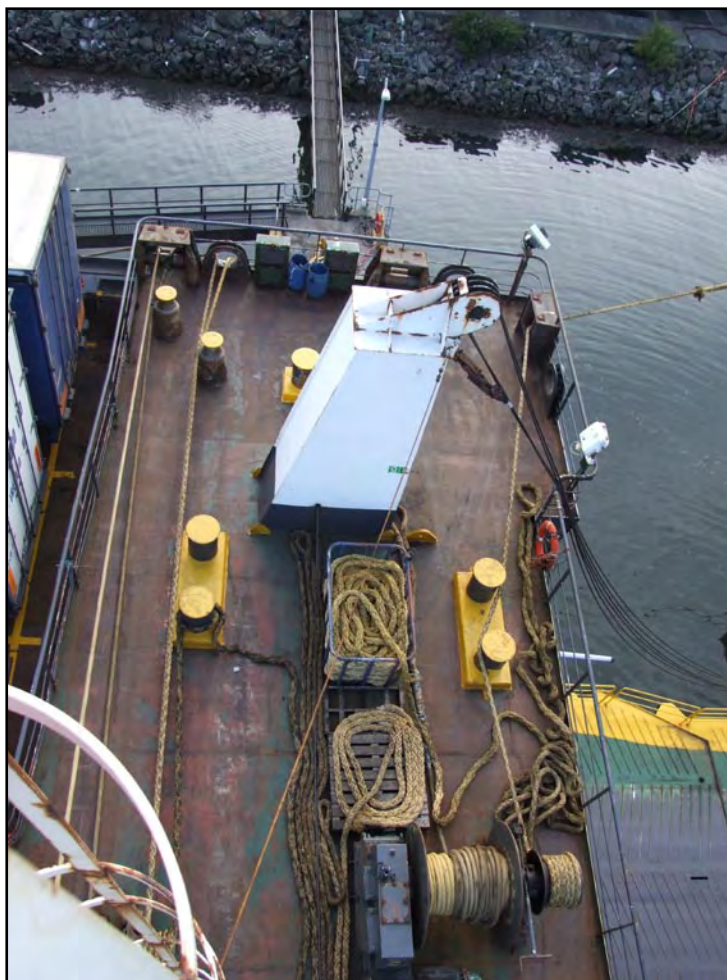
Starboard side of aft mooring deck

The paint coating on the aft mooring deck had deteriorated and been worn away in several places, exposing the deck material. Corrosion products and other debris had accumulated on the deck. This was in contrast to the forward mooring deck, which was

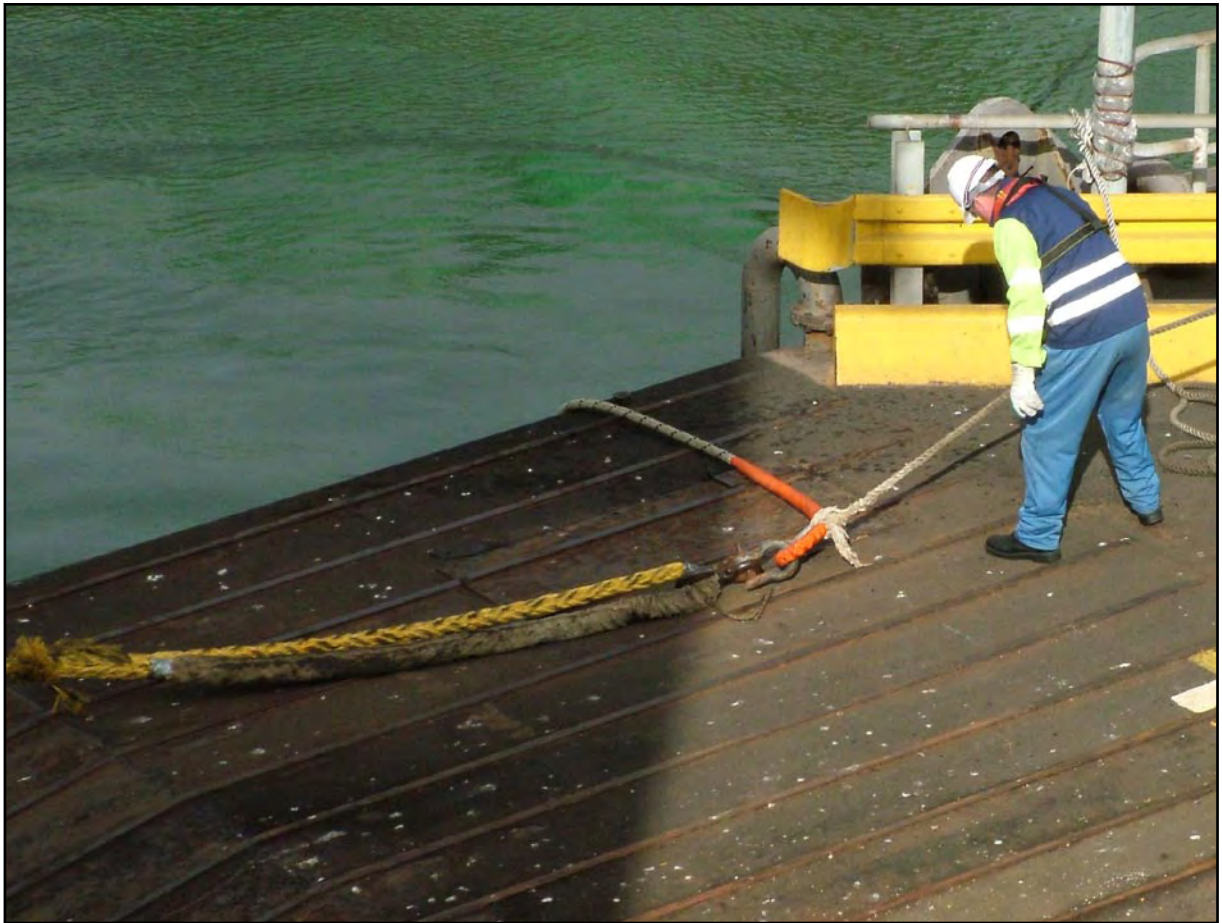
Connection between ship and shore supplied stern lines

The stern line was a composite of steel chain, HMPE and polypropylene lines, and no consideration had been given to how the individual elements contributed to the system as a whole. Of all the components, the polypropylene line, provided by the vessel, was by far the most elastic. The relatively inelastic chain and HMPE line resulted in the majority of the elasticity being provided by a relatively short length of polypropylene line. This meant that any load on the stern line would cause the short length of polypropylene line to stretch the most and place that element under the greatest strain. The stretching cycle would have been repeated many times in service, contributing to increasing fatigue effects.

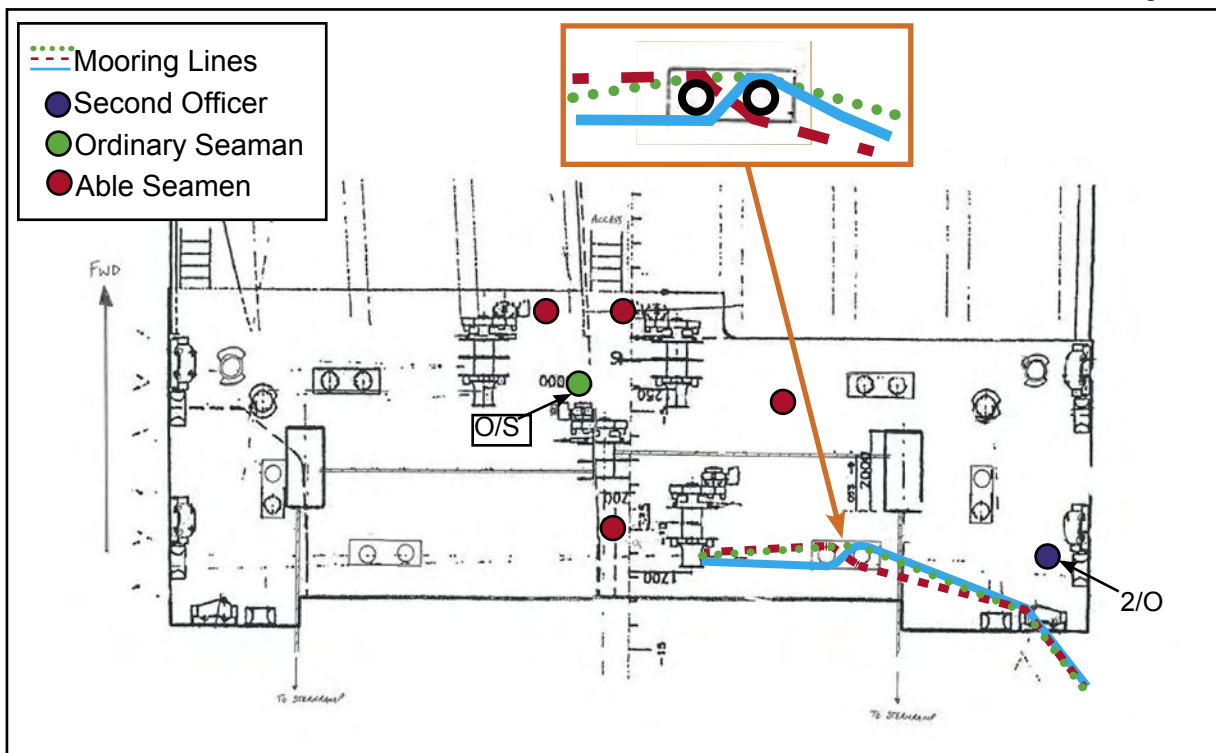
Figure 9

Possible line configurations around bitts (light blue is the most likely)

The lead chosen for the polypropylene stern line involved two changes of direction through a universal roller fairlead, then around or through a set of bitts before being turned up on the winch drum end. The mooring line changed direction either three or four times, each of which caused additional localised wear and loading. This also increased the number and size of potential snap-back zones if the rope parted. Examination of the parted line showed some areas where yarns had been fused together by heat generated in localised overloading, probably at the points where the line passed round bitts or fairleads. Although working areas of bitts and fairleads were worn smooth, scaling and corrosion were evident close by and a yarn from the parted line was found snagged in rust scaling on one of the bitts. All these factors contributed to the deterioration of the mooring lines.

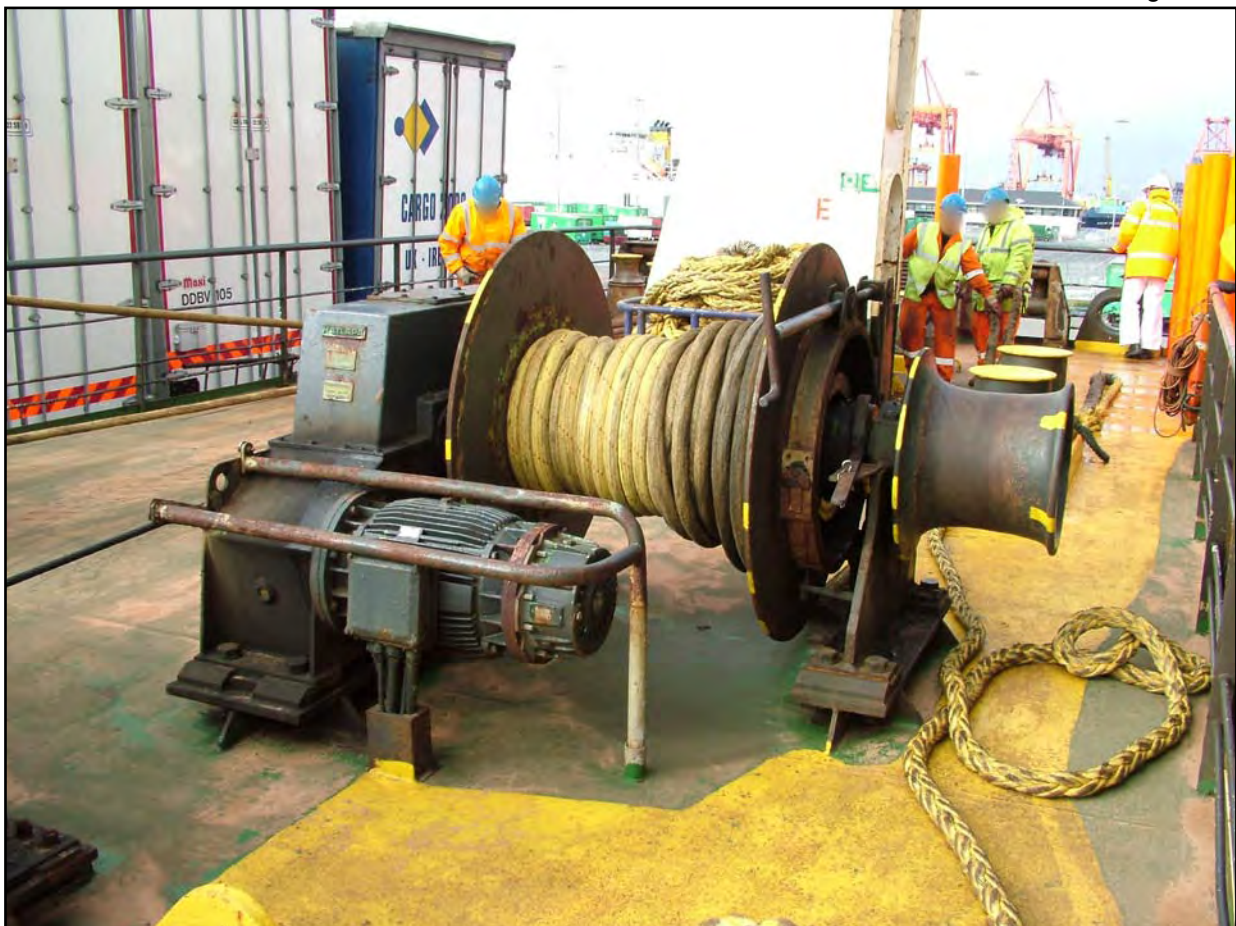
Figure 10

Orientation of band brake on mooring winch

The method used to secure the stern line prevented the opportunity for the winch to surge or render under excessive load. The band brake should have rendered at about 310kN and the motor surged under normal running conditions at 189kN. However, the rope storage barrel had been left in gear, with the band brake on, effectively combining the effects of the band brake (310kN) with the effect of the automatic motor disc brake (220kN) to generate a braking force approaching the rope's normal breaking load when new. While this holding load was not substantially different from the effect of securing

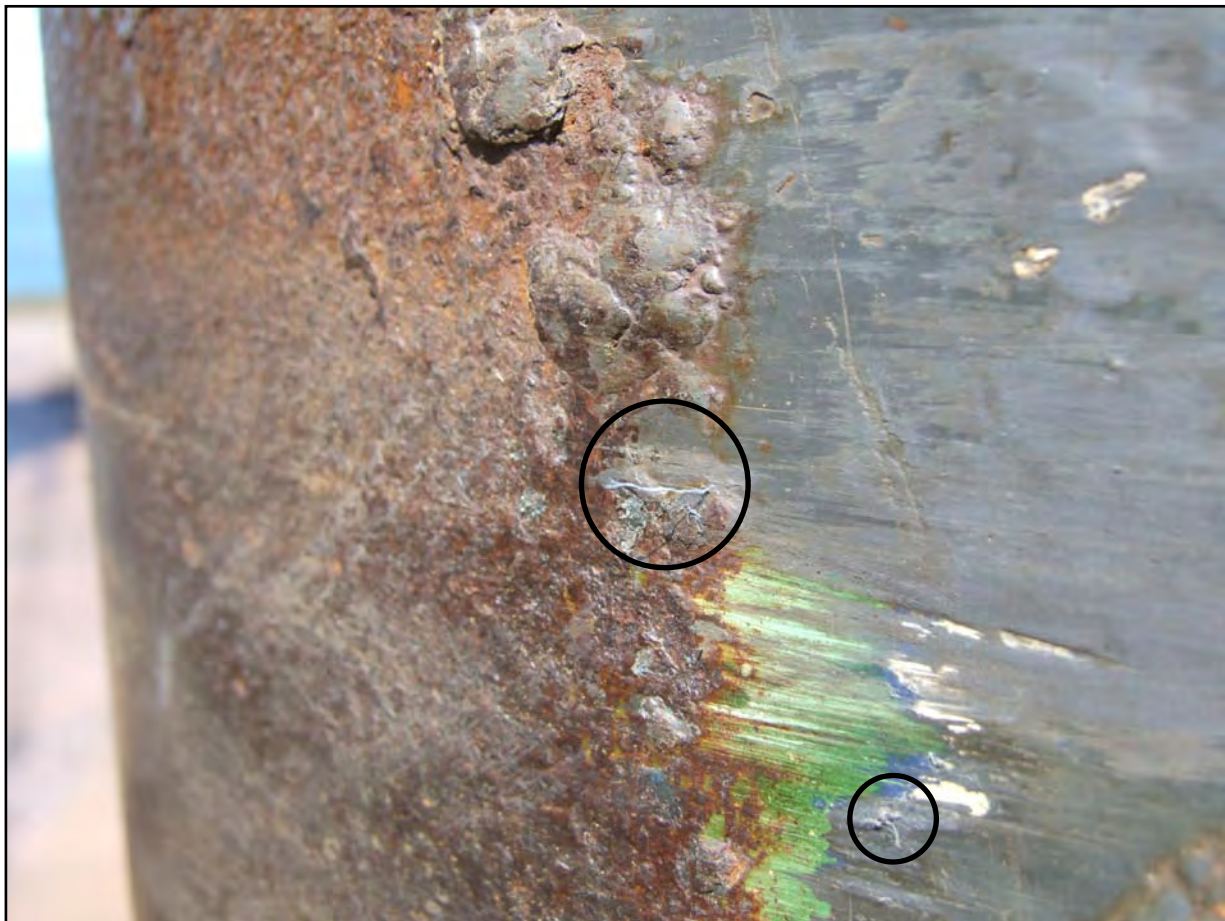
Snagged yarn from parted rope on mooring bitts

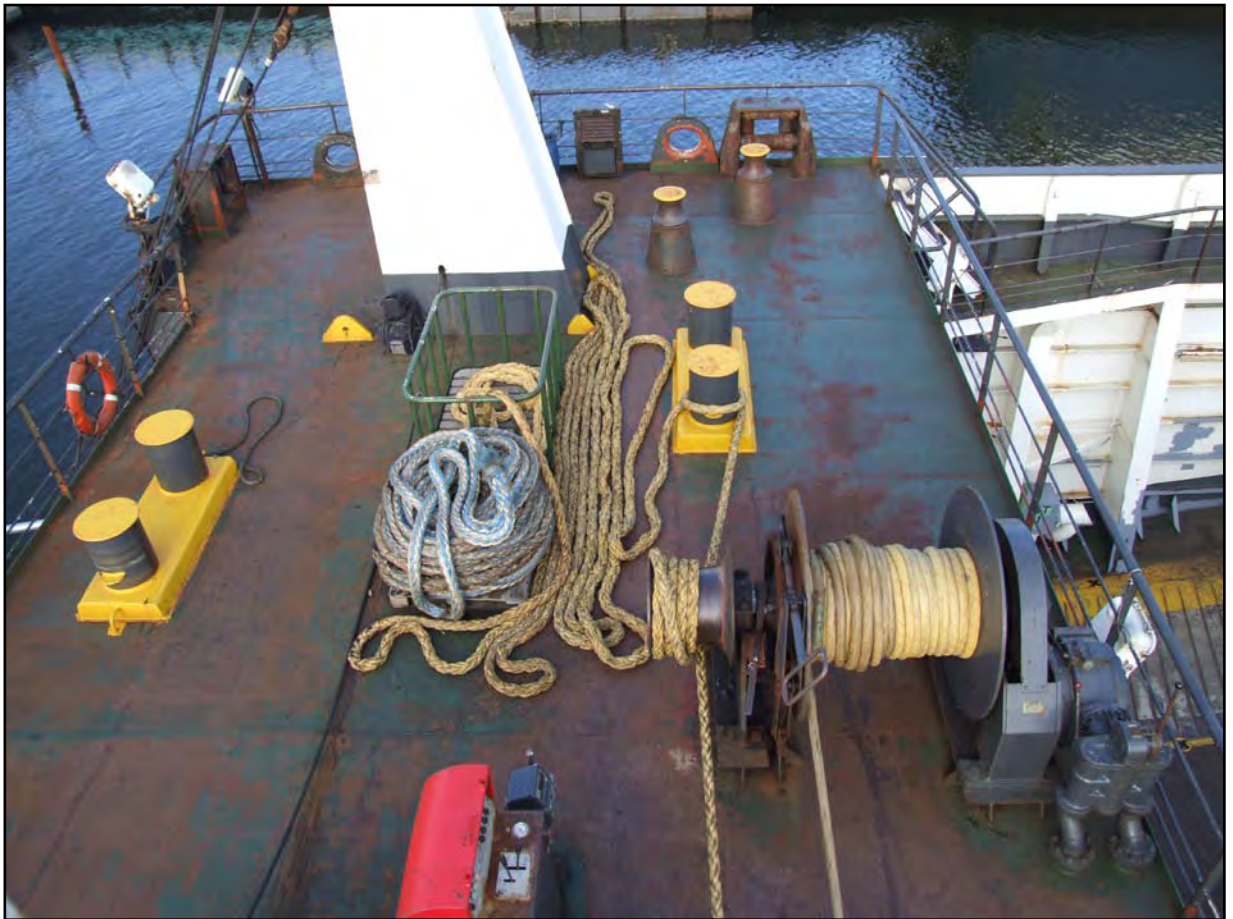
Over subsequent months it became common practice for winch barrels to be left in gear, with their band brakes on and with lines turned up on drum ends, either loosely backed up or not backed up at all (**Figure 12**). The band brake was applied to the rope storage barrel, and the barrel was left clutched into the main shaft, transferring the braking effect to the warping drum end.

Example of methods used to secure mooring lines

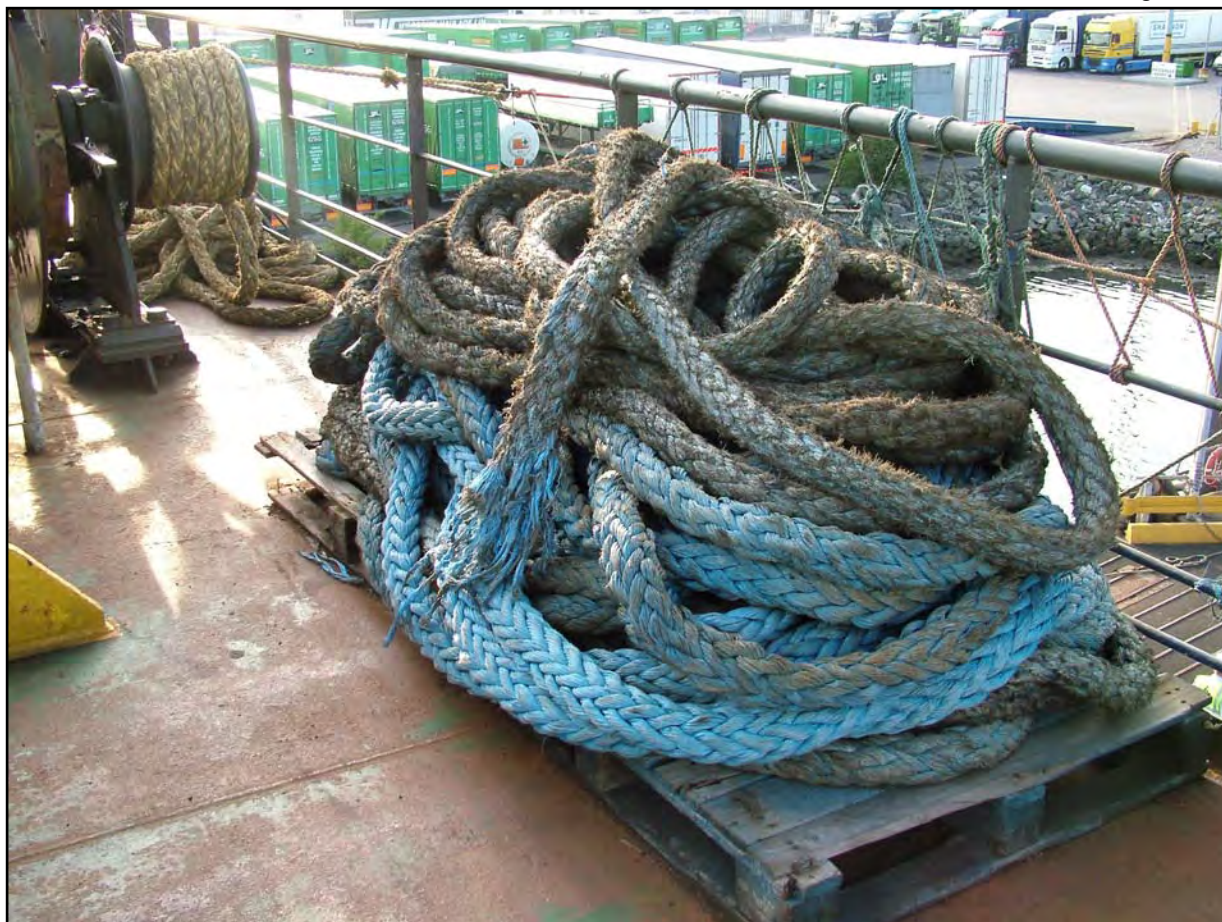
Figure 13

Parted stern line in normal storage position
