Report on the investigation of
the capsizing of

Army Cadet Force
Rigid Raiding Craft

In Loch Carnan, South Uist,
Western Isles of Scotland

Report No 6/2008
March 2008

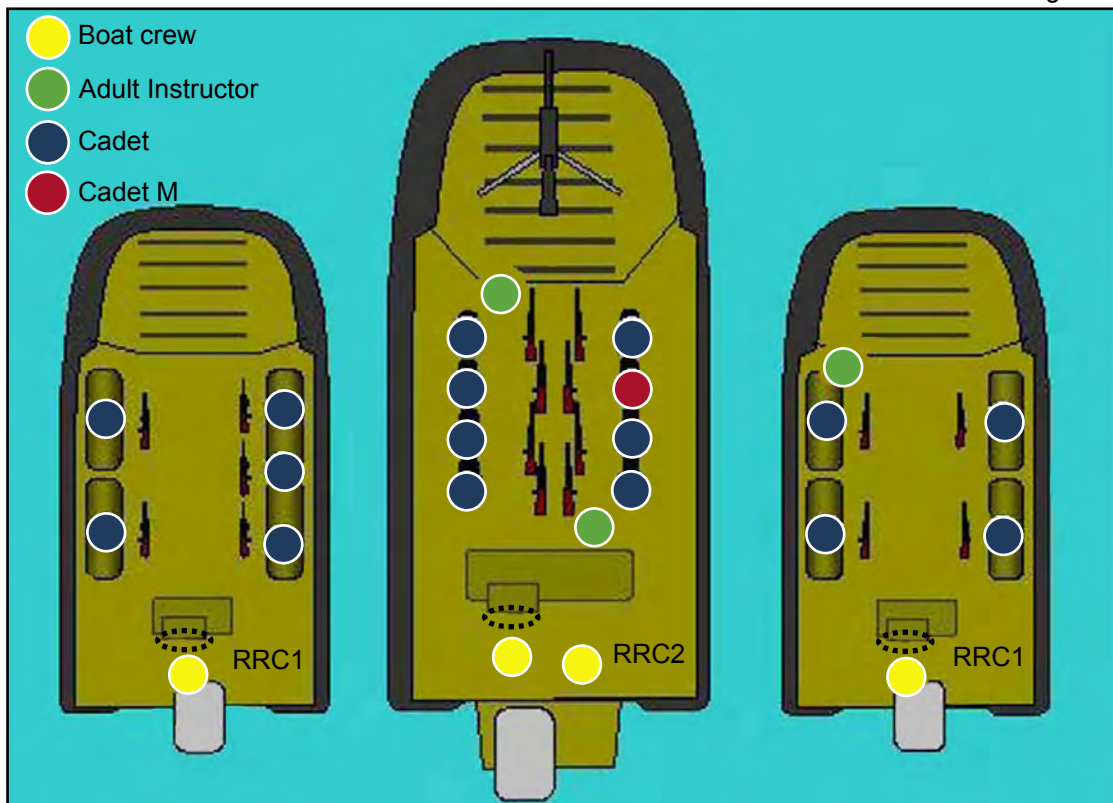
Figure 2

Boat loading at the time of capsizing

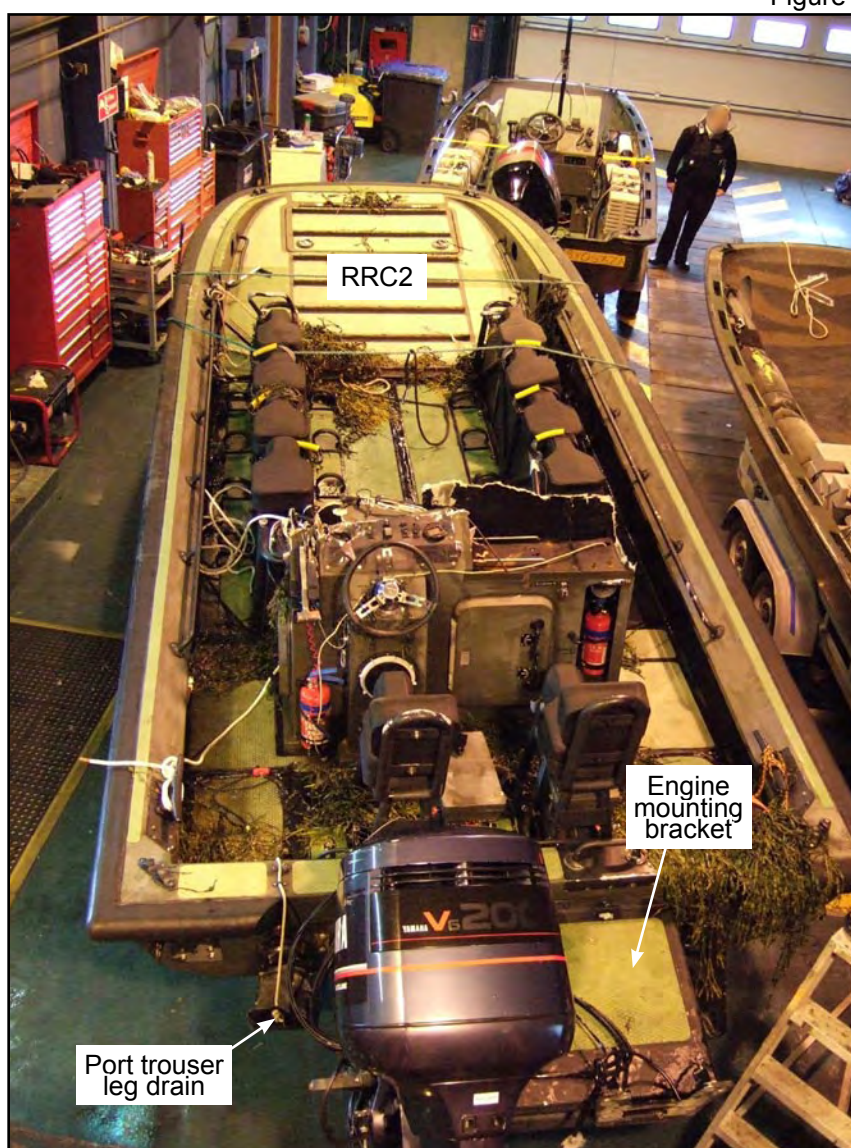
Figure 4

With the exception of the damage caused to the boat's steering console and seats when it landed onshore (**Figure 4**), the interior of the recovered hull showed no significant signs of damage. Evidence of minor damage and earlier repairs was found on the external hull. The hull buoyancy material in an area of damage approximately 12cm long and 2cm wide (**Figure 5**) contained water.

Rigid raiding craft after capsizing

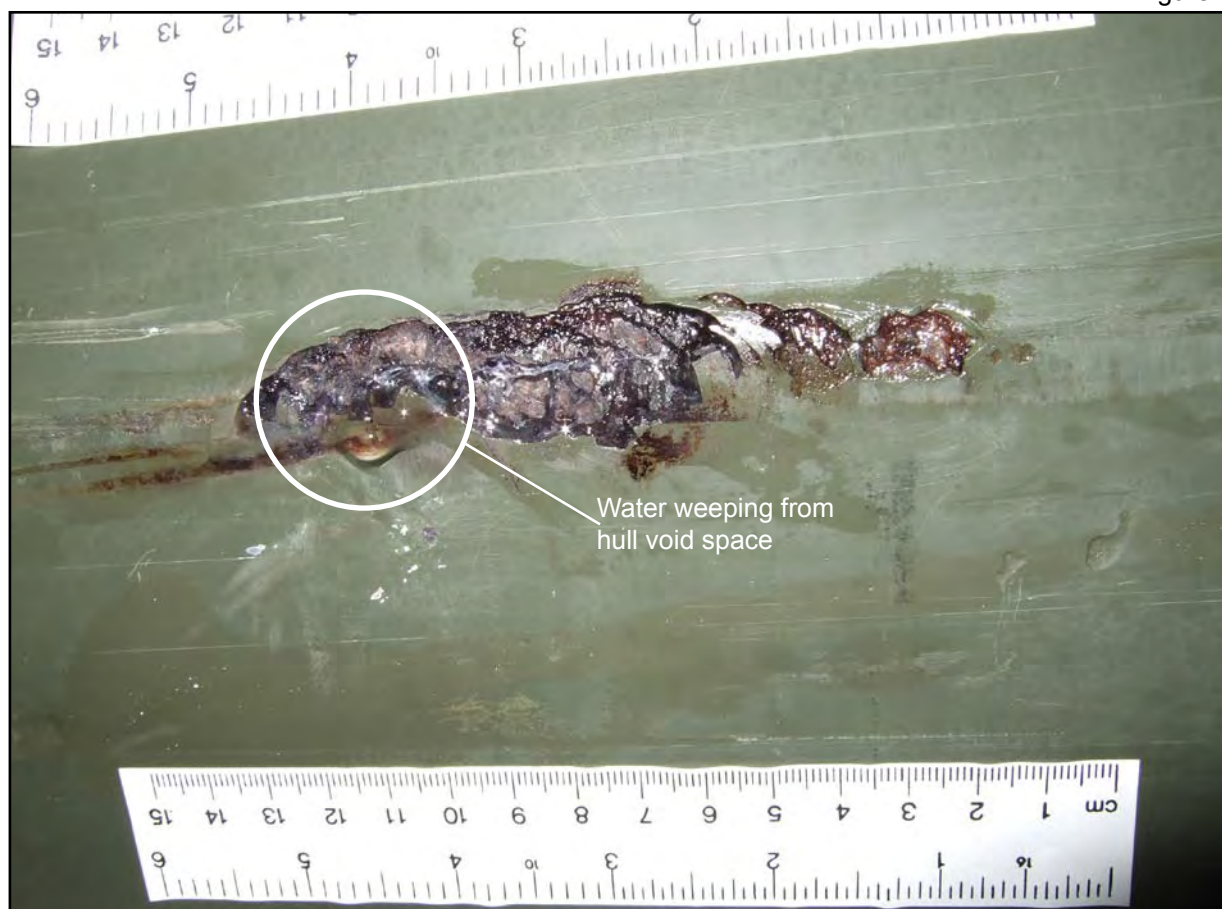
Figure 5

Hull damage

The minor damage to the hull of the RRC2 observed following the accident could have adversely affected the buoyancy of the craft to some degree. However, it is not known whether the damage occurred before or after the capsize and, in view of the results of the trials conducted, it is not considered to have been a contributory factor.

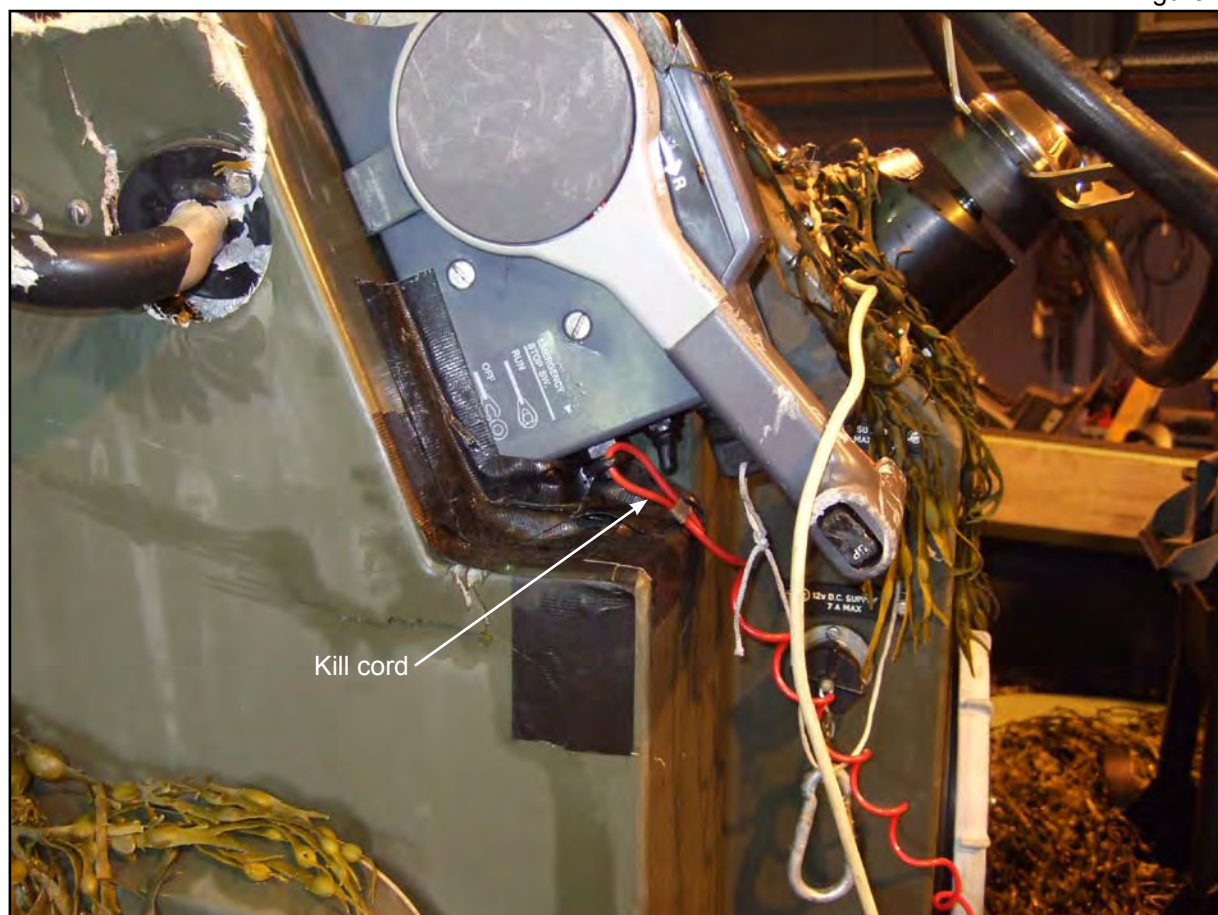
Figure 6

The Yamaha 200BETO, 2 cycle, 6 cylinder outboard motor fitted to the RRC2 was manufactured in 1991. The engine was positioned on the port side of the mounting bracket (**Figure 4**). Although there was evidence of minor water ingress on the spark plugs, the engine was in a sound condition. As the engine was not connected to any electronic control or monitoring device, it was not possible to determine the engine performance immediately prior to the accident. The kill cord¹⁸ was found attached to the engine cut out switch (**Figure 6**).

Kill cord

re-secure the boat's kill cord, which was found attached to the engine cut off switch after the RRC2 had been recovered. In view of the CEO's rest pattern during the week before the accident, it is unlikely that his performance or decision-making was adversely affected by fatigue.

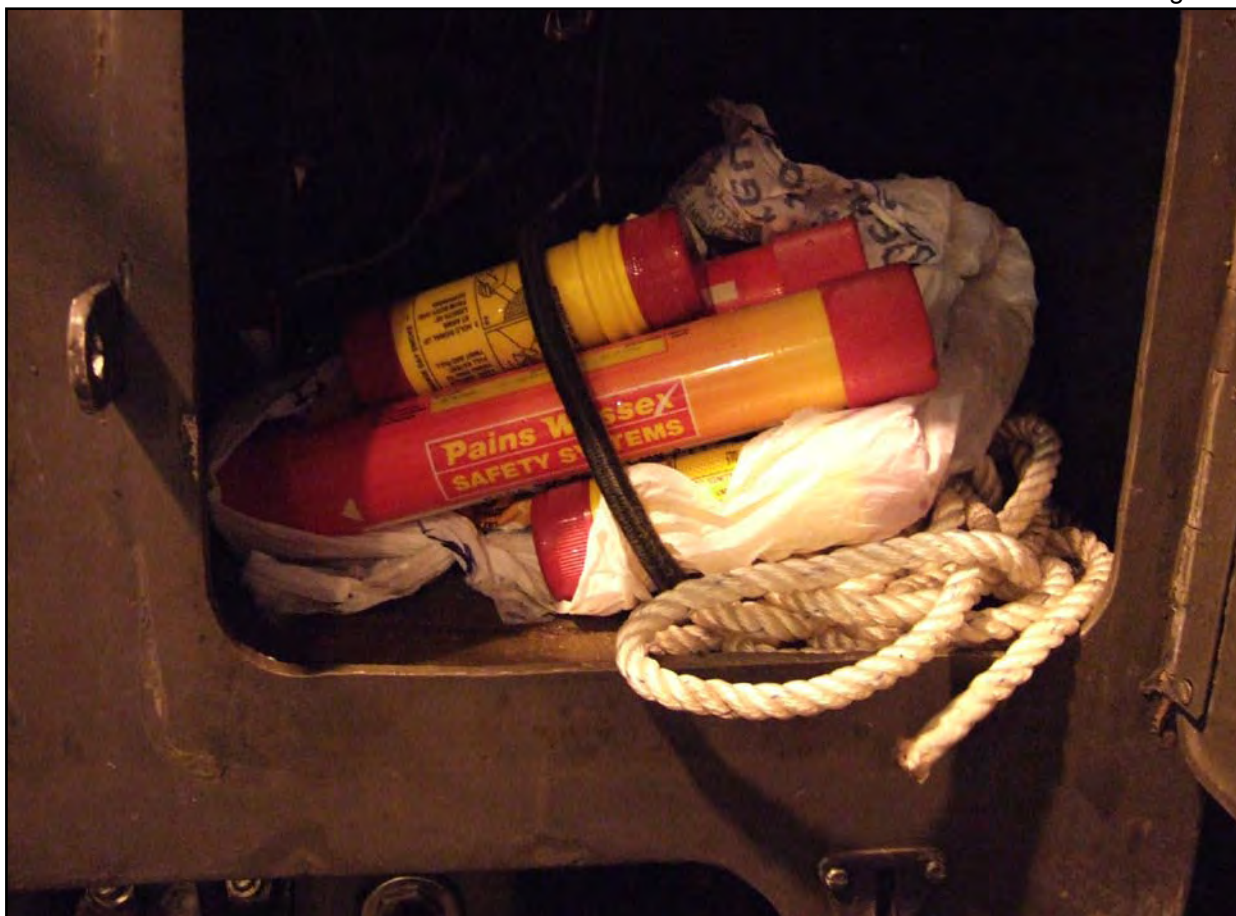
Figure 7

The pyrotechnics found on board the RRC1s after the accident were out of date. The pyrotechnics recovered from the lead RRC expired in June 2006. They were stored in the boat's console cabinet in a carrier bag and were found to be wet and lying in a pool of water (**Figure 7**). The pyrotechnics in the rear RRC expired in August 2005.

Boat one pyrotechnics

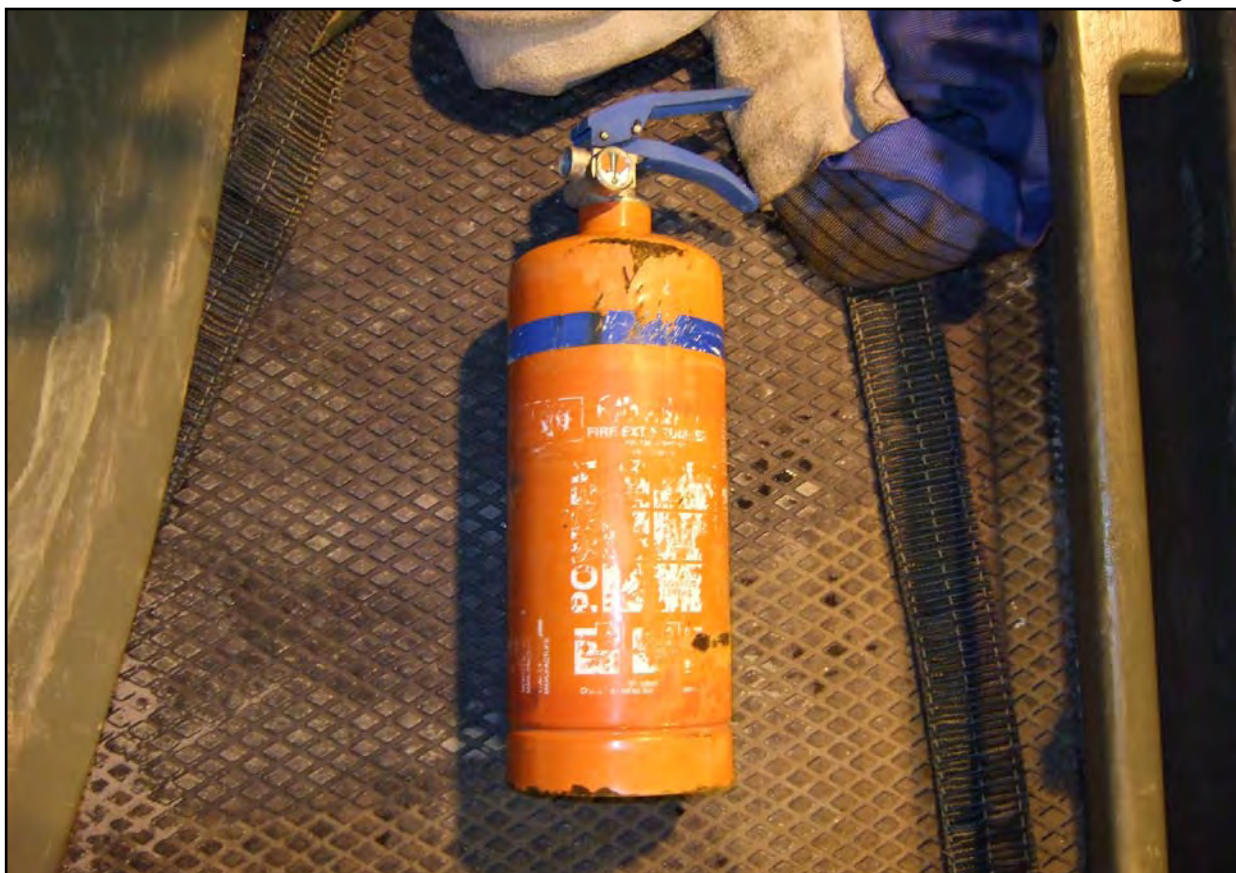
Figure 8

Each boat was equipped with dry powder fire extinguishers. Some of the fire extinguishers were found to be in a poor condition (**Figure 8**). There were no procedures in place to inspect the extinguishers, and their maintenance history was unknown.

Dry powder fire extinguisher from vessel

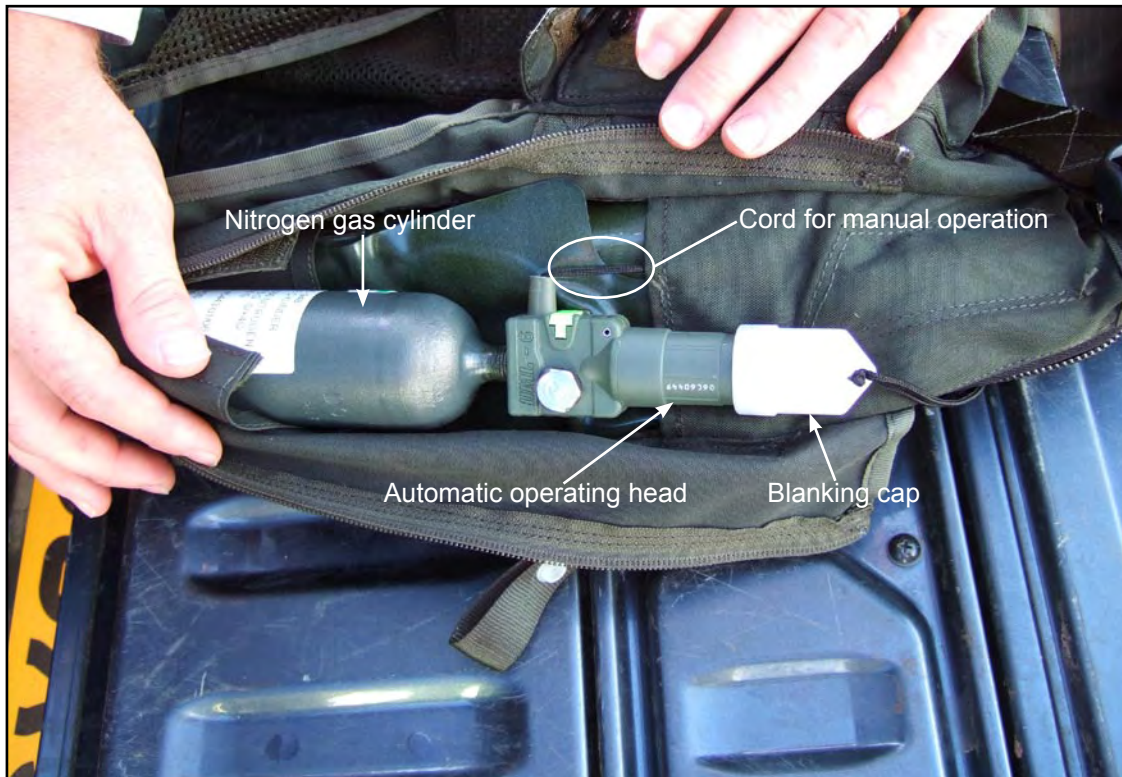
Figure 9

The lifejackets used by the adults and cadets recovered from the water were inspected after the accident, and a number of observations were noted. In particular, the lifejacket worn by the female instructor was found to have a blanking cap fitted over its activation head (**Figure 9**). One of the ATLJs was found to have partially deflated and its gas cylinder was found to be loose. The spray hoods had not been deployed and a number of the high visibility patches had been concealed by the green flaps (**Figure 10**).

Manually operated Landing Craft lifejacket used by the female instructor

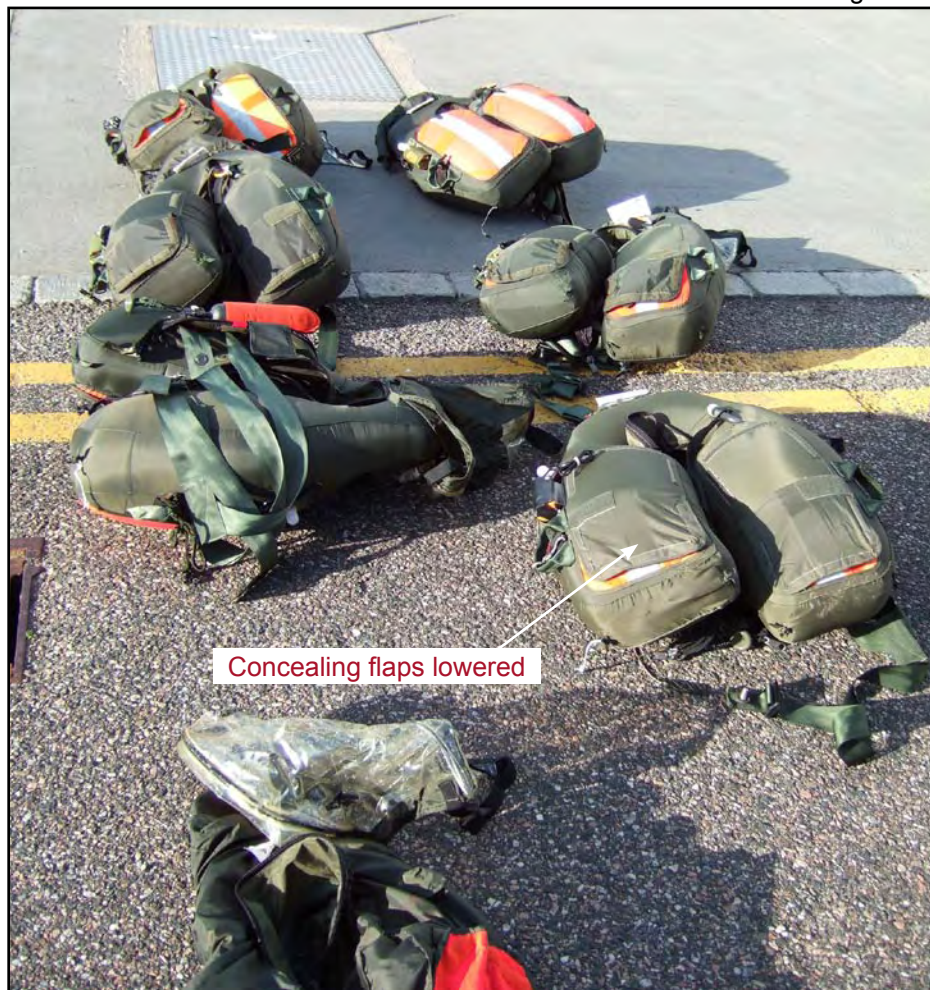
Figure 10

Lifejackets recovered from cadet survivors

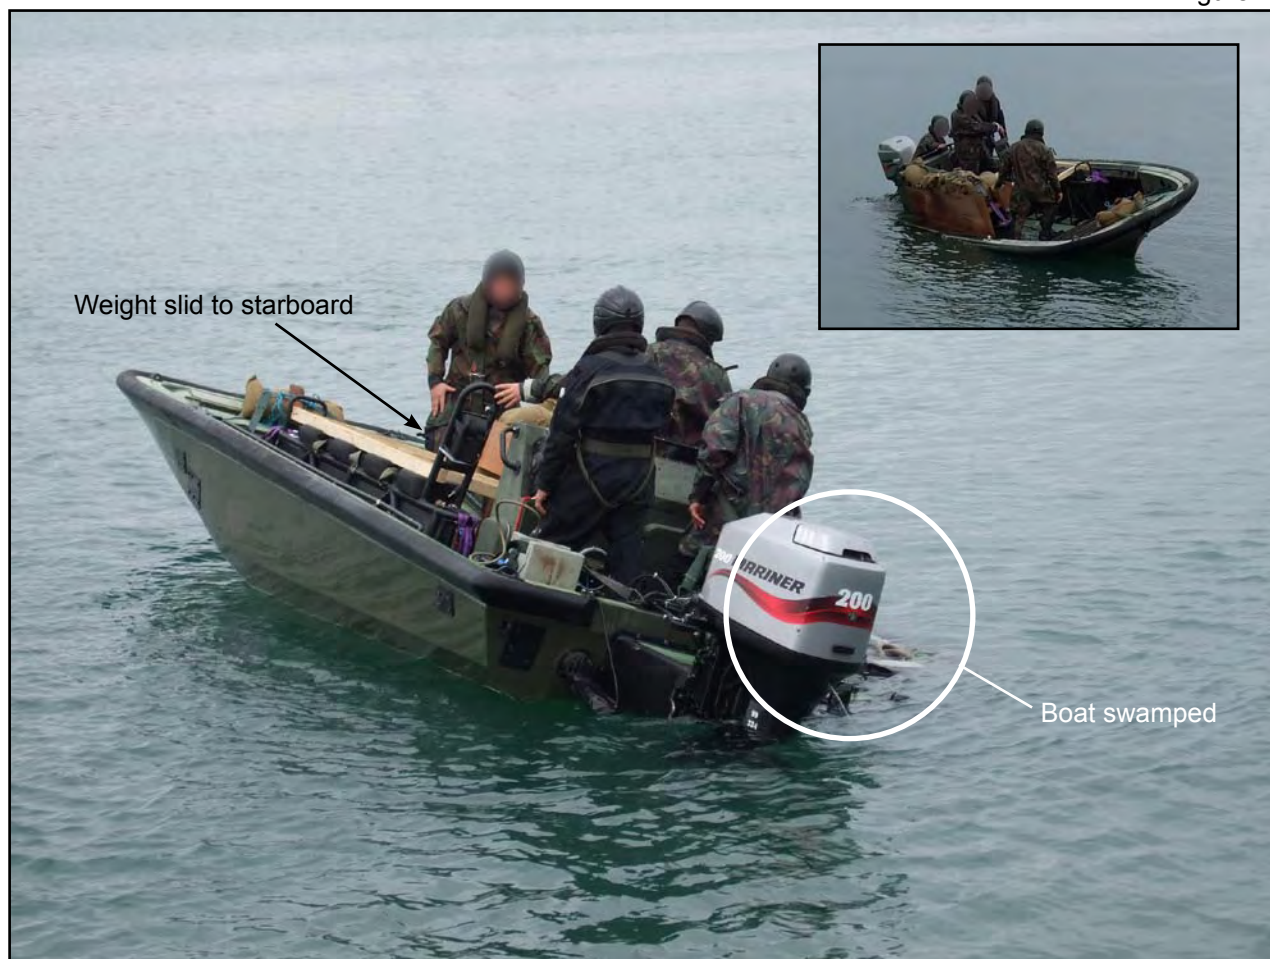
On 3 October 2007 the Fleet Landing Craft and Raiding Craft Trials Authority, at the request of the Army's Land Accident Prevention and Investigation Team (LAIT), carried out a series of static and dynamic stability trials using an in service RRC2 configured similarly to the craft operated by the ACF (**Figure 11**). The observed results supported the findings of the MCA tests. During the trials, it was noted by the experienced trials coxswains that the positioning of the outboard motor on the port side of the engine mounting bracket had a detrimental effect on the handling characteristics of the craft. It was also noted that when accelerating from a standing start in a straight line, with a similar amount of water in the boat to that present prior to the capsizes, the water was removed in 38 seconds with the trouser leg drains deployed.

Rigid raiding craft (Mk 2) capsizing trial conducted for the Army

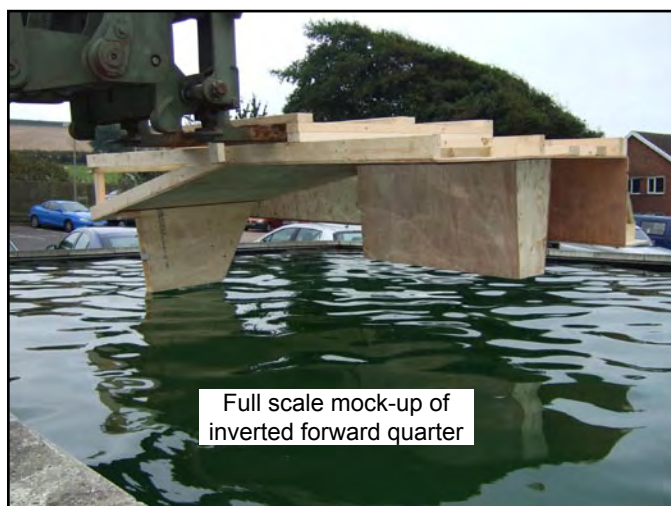
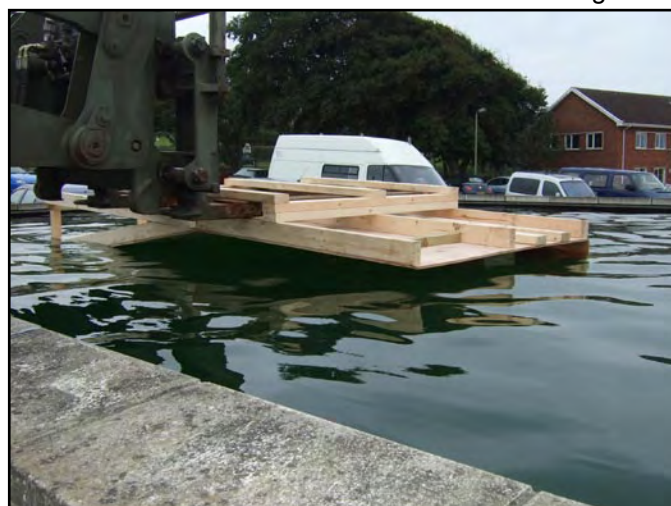
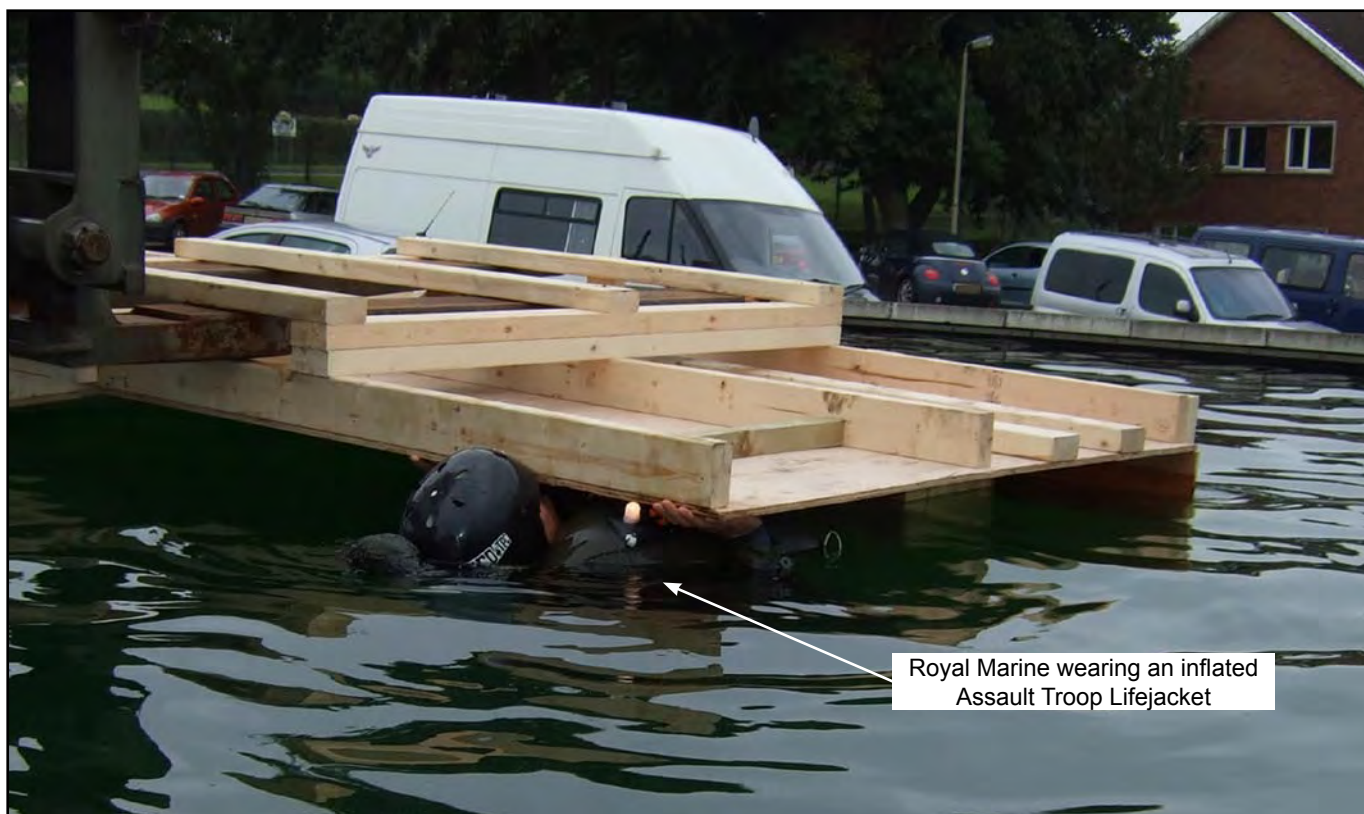
Figure 12

The Fleet Landing Craft and Raiding Craft Trials Authority also conducted a demonstration of the effect of the buoyancy of the ATLJ. For the demonstration, a wooden mock up of the port forward quarter of a capsized RRC2 was constructed and lowered into a pool to leave an air gap similar to the one generated by the upturned craft. A Royal Marine Commando, wearing an inflated ATLJ, was then positioned under the rig and instructed to force his way under the upturned seats. However, the inflated lifejacket pinned him to the deck of the rig and he was unable to make an escape (**Figure 12**). The trial was repeated using an approved 150N buoyancy lifejacket during which the marine found it relatively easy to escape from beneath the rig.

Assault Troop lifejacket escape trial

1. The lifejacket worn by Cadet M was not approved for use by children, and its buoyancy was over three times that of the SOLAS approved lifejackets supplied by the MoD for cadet force adventurous training activities. Consequently, once inflated, it would have pinned Cadet M under the craft and prevented her escape. [2.4]

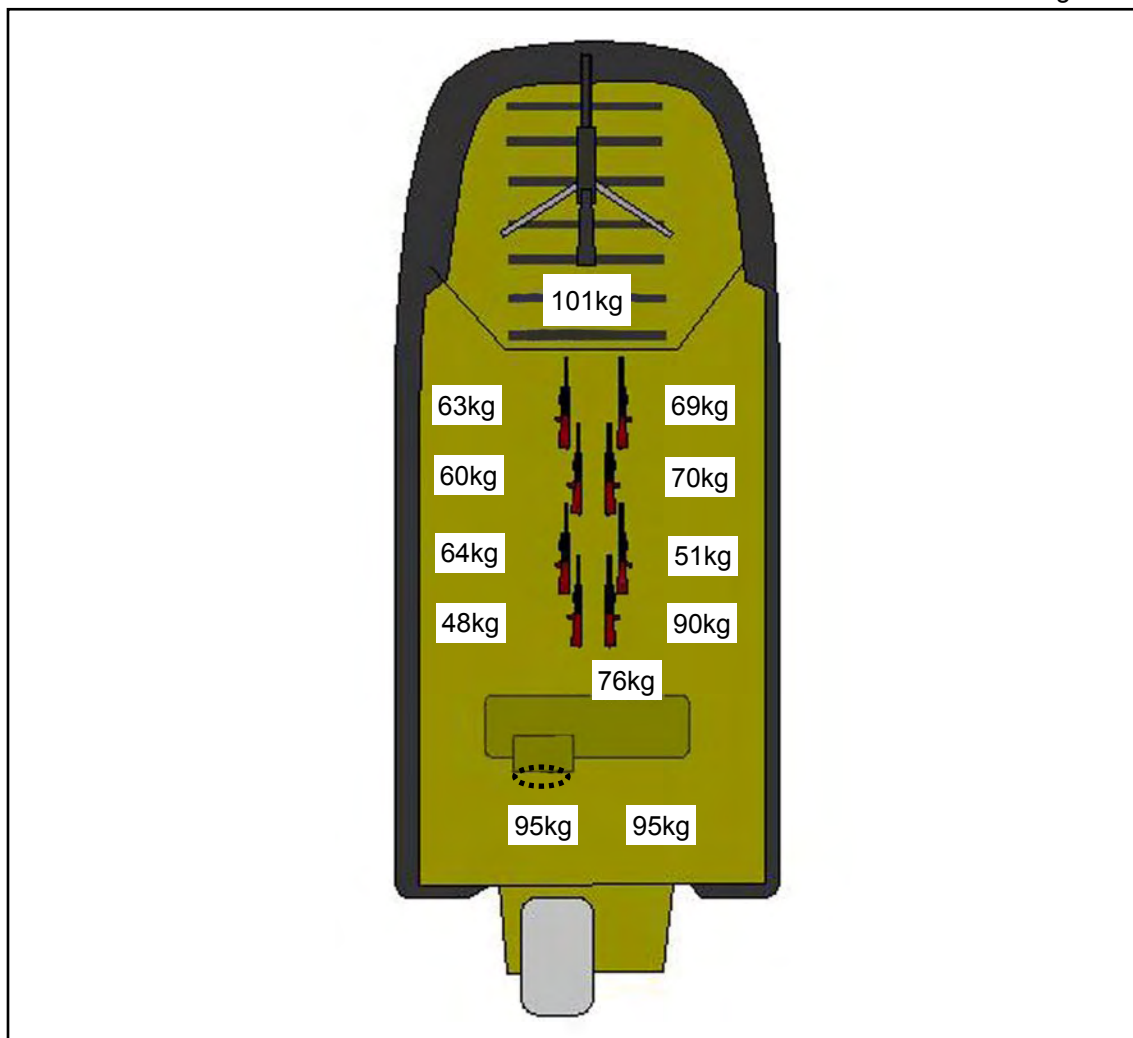
Figure 13

After the water entered the RRC2, it became trapped on the deck because the trouser leg drains had not been lowered and there was no alternative means of escape. In view of the offset position of the single outboard engine (**Figure 4**), it is likely that the vessel was listing to port to some degree. The list increased as the water naturally flowed to, and collected, on the lower side.

Boat weight distribution

The trigger for capsize was the movement of the cadets seated on the port side towards the starboard side. This transfer of weight induced a heeling moment to starboard, which resulted in the accumulated water flowing across the deck. It is evident that the combined weights of the cadets and water were then sufficient to cause the craft to capsize. This is supported by trials conducted following the accident (**Figure 11**). However, unlike the trials, it is probable that capsize could not be prevented by the cadet's return to the centre of the craft as the rate of capsize is likely to have been greater due to the vessel's turn to starboard and the environmental conditions.
