Report on the investigation of
the fire and subsequent sinking of

Lady Candida

off Corsica

Report No 4/2008
February 2008

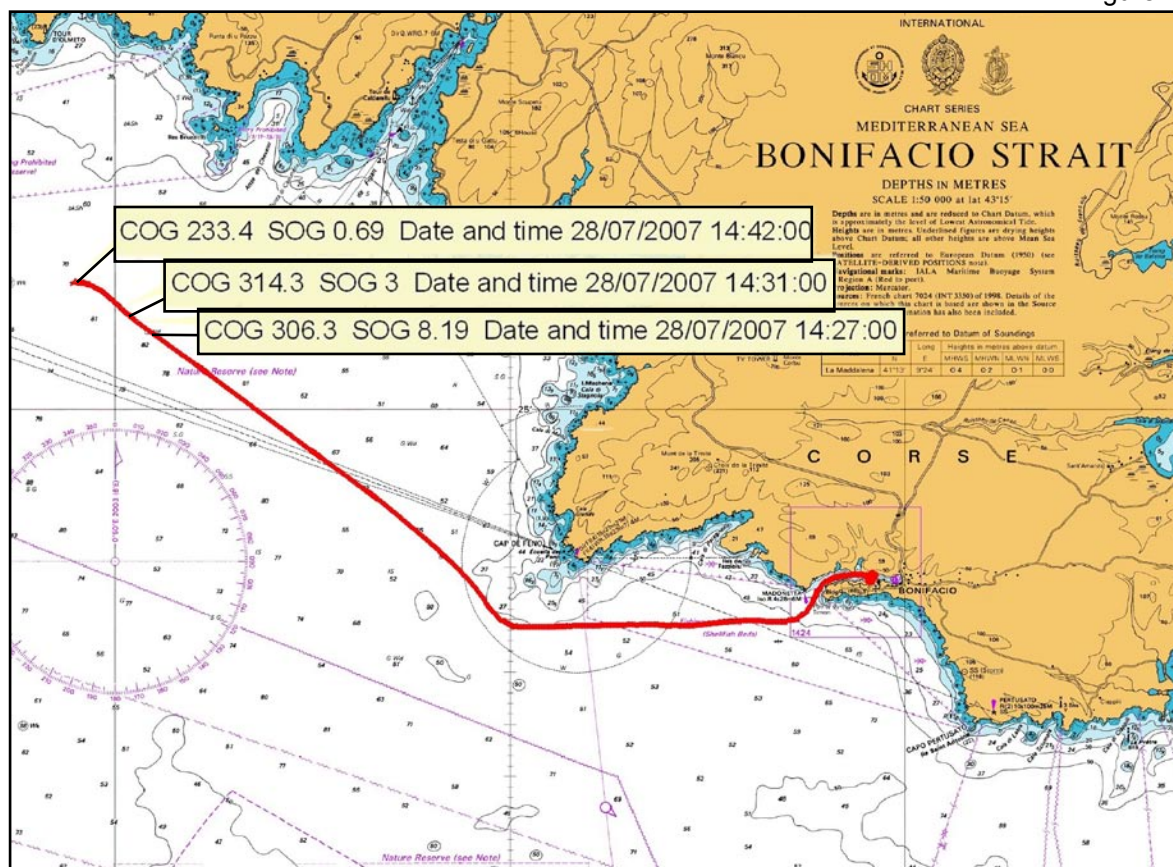
Figure 1

During the afternoon of 28 July 2007, *Lady Candida* was on passage from Bonifacio to Campomoro, Corsica on a north westerly heading at a speed of 8 knots (**Figure 1**). The wind was westerly at 23 knots and the sea was calm. On board were six crew, comprising the captain, a senior deckhand, a junior deckhand, a chef, and two stewardesses. Also on board were 11 passengers from the same family, comprising 7 adults and 4 children between the ages of 6 and 8 years. The adult guests were on the vessel's aft deck and the children were inside the accommodation. The captain and senior deckhand were on the bridge deck.

ECDIS extract taken from the captain's laptop computer

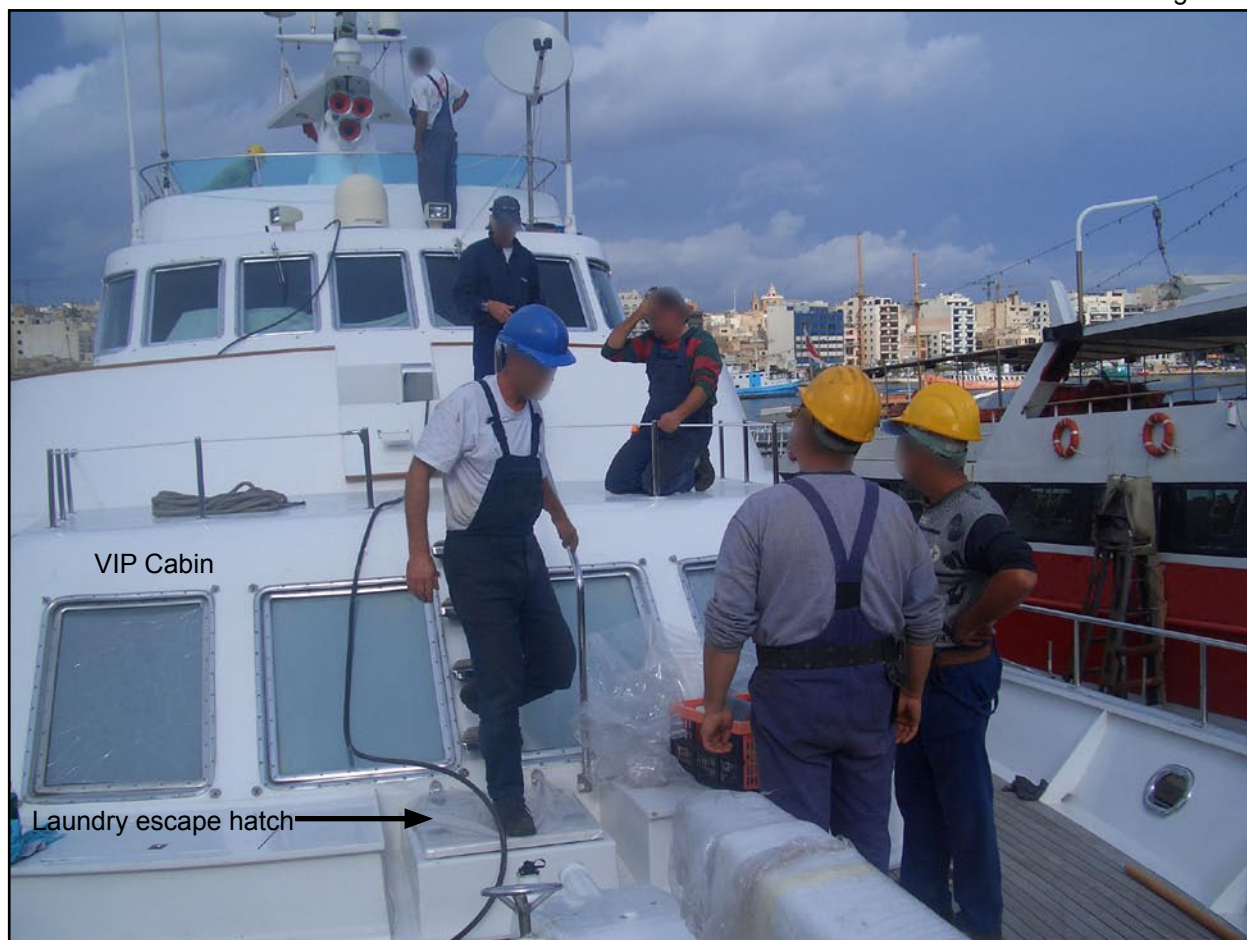
Figure 2

Foredeck, escape hatch and VIP cabin

On his return from the engine room, the captain reduced speed to about 3 knots (**Figure 1**) and was informed by the senior deckhand that there was a fire in the laundry and that the junior deckhand was inside. The captain ran forward via the internal alleyway (**Figure 3**), but when he opened the door between the guest and crew accommodation, he saw the alleyway in the crew accommodation was filled with thick black smoke. After shouting to the junior deckhand and establishing that he was alright, the captain closed the door and went up to the top deck and ordered the rest of the crew to prepare a fire hose. He then went to the foredeck and instructed the junior deckhand to get out of the laundry because he was not wearing breathing apparatus.

Once the junior deckhand was clear, the captain looked through the escape hatch and saw flames at the compartment's deck-head. Flames were also seen coming out of the laundry vent, and the VIP cabin (**Figures 2 and 8**) was beginning to fill with smoke. The captain instructed the senior deckhand to go to the engine room and start the fire pump while he attempted to fight the fire through the open hatch using a portable extinguisher.

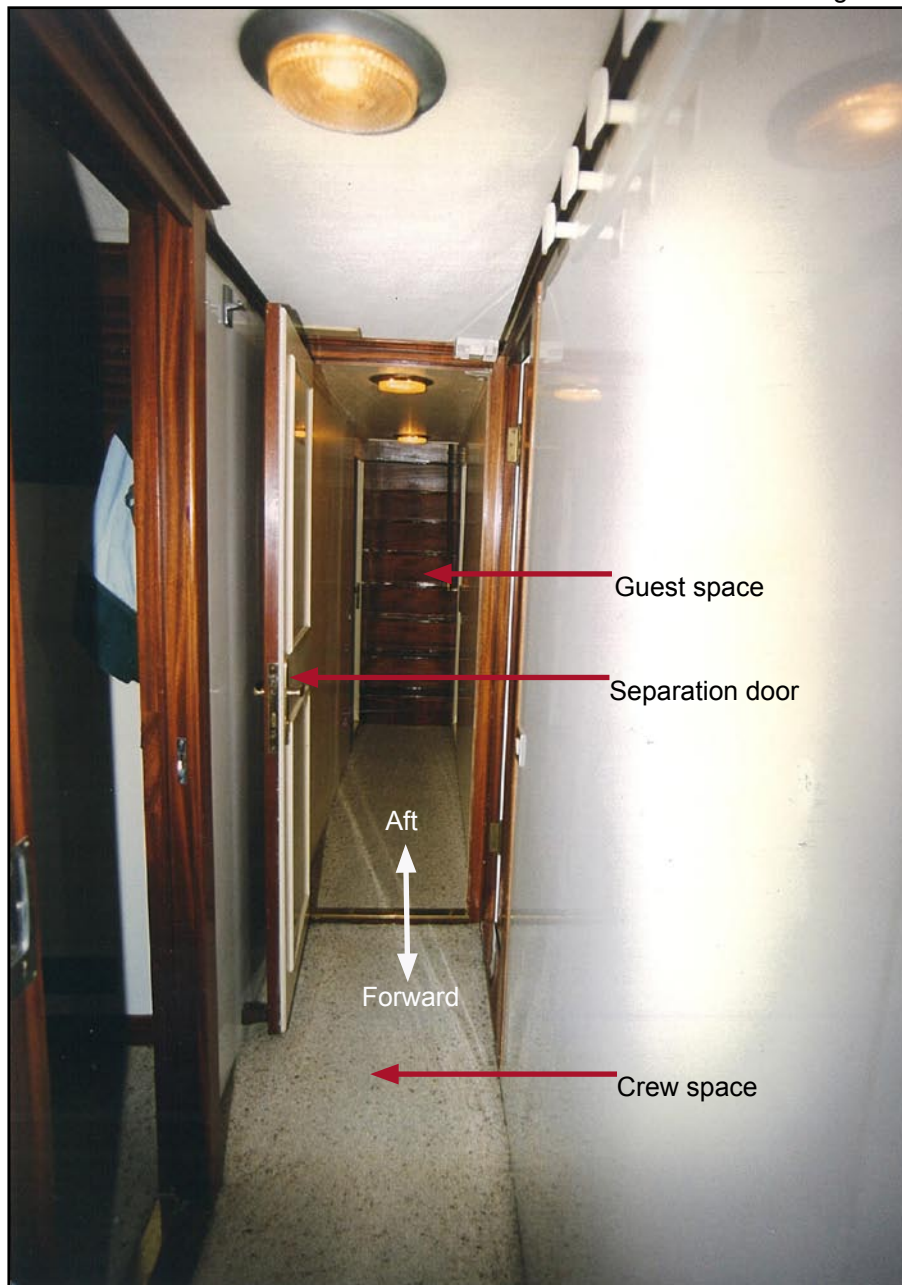
Figure 3

Internal alleyway

Internal access to the laundry was by an alleyway (**Figure 3**). At the forward end of the alleyway, a flight of three steps led to the laundry room and a crew cabin, which shared a common two-way door (**Figure 6**). The main control panels for the 110V DC windlass (**Figure 7**), which had a history of overheating, were sited behind the stairs.

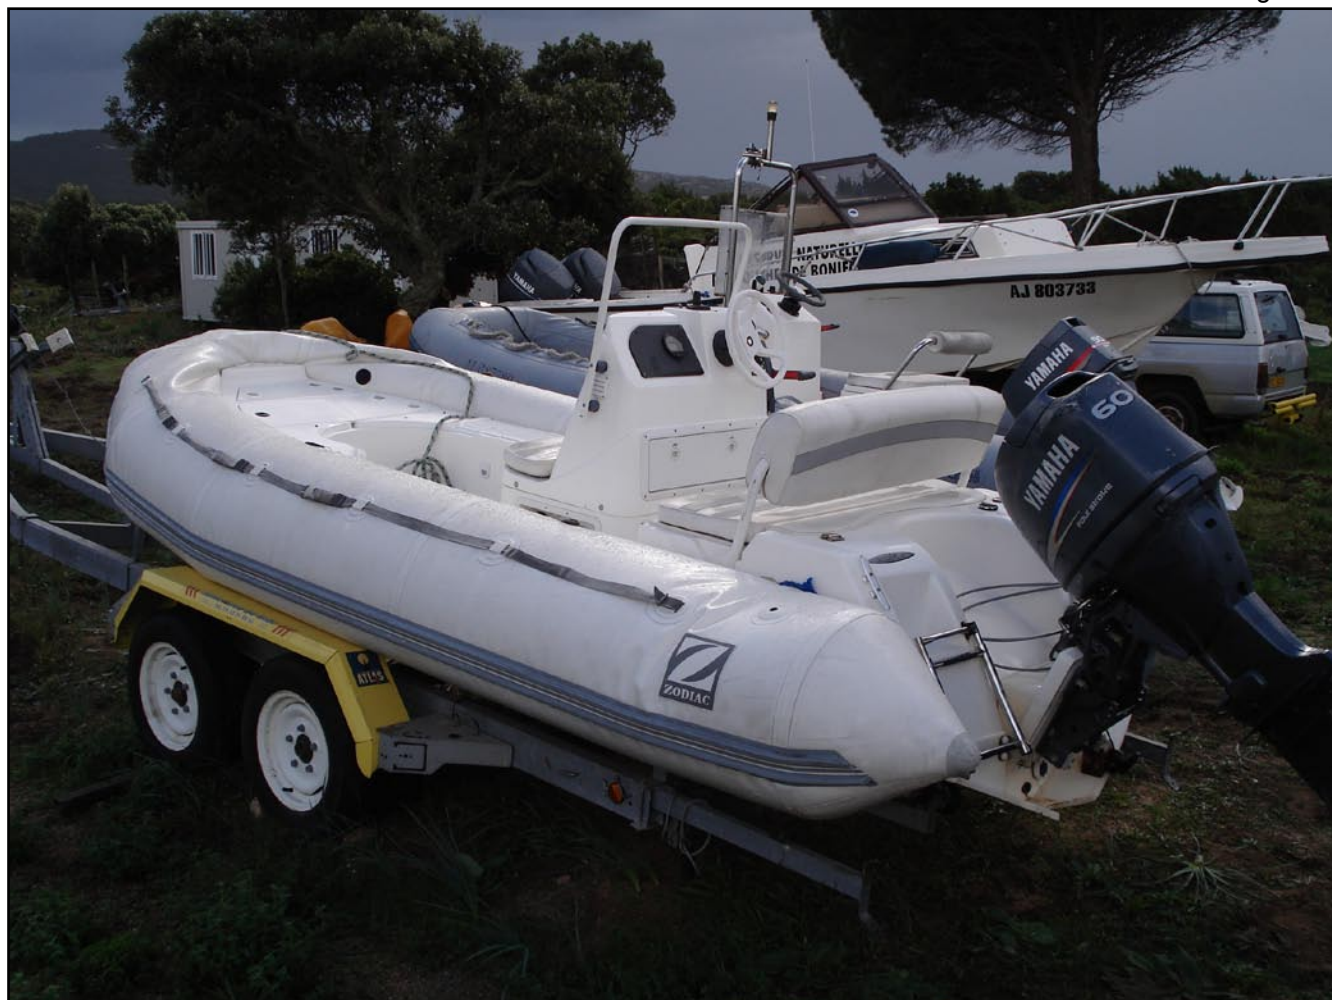
Figure 4

The captain decided to evacuate the guests using the vessel's tender (**Figure 4**), which was being towed. The guests were assembled on the aft deck, where the adults donned lifejackets and the children donned buoyancy aids; no children's lifejackets were carried. Driven by the junior deckhand assisted by one of the stewardesses, the tender transported the guests about 3nm to Chevaneau, Corsica.

Zodiac tender model YL 480 DL

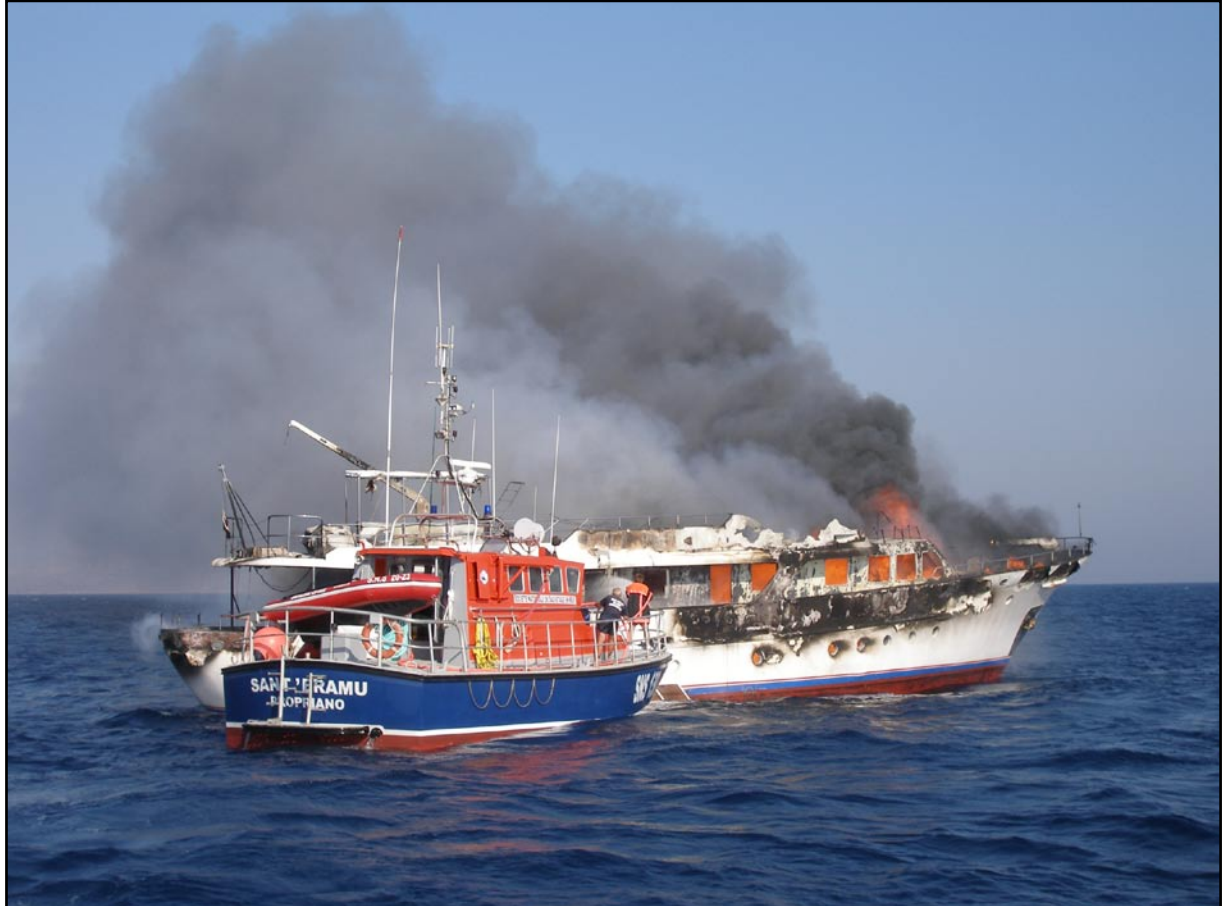
Figure 5

The rescue boat *Sant Eramu* arrived at the scene at 1732 and started to extinguish the fire. She was joined by a second rescue boat an hour later. By this time, much of the superstructure had disappeared, the engine room was in flames and the port holes of the cabins were missing (**Figure 5**).

Lady Candida on fire

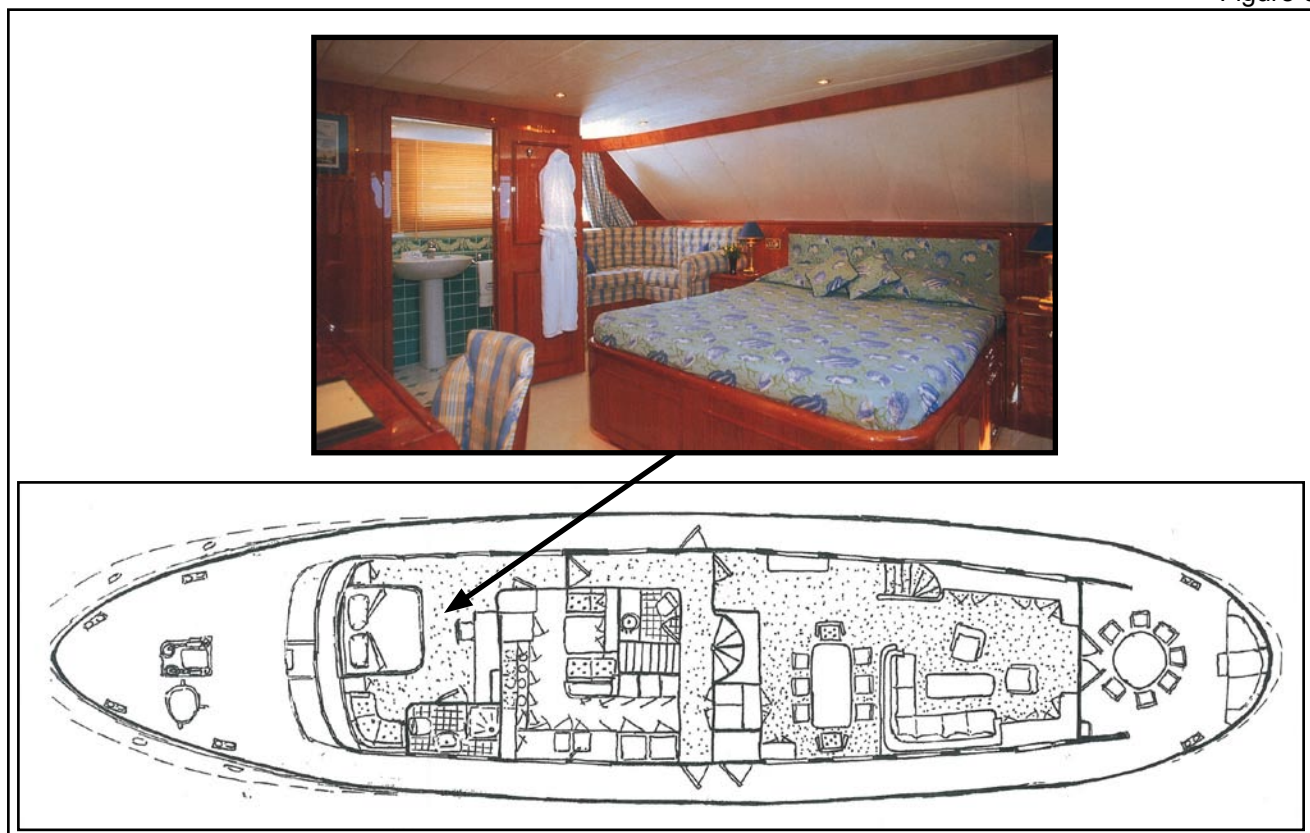
Figure 8

Above and aft of the laundry was the VIP cabin (**Figure 8**), which had been converted from a study. During the conversion, the stepped bulkhead below the cabin's front windows was cut away and a new sloping section, probably made from marine plywood, was inserted (**Figure 9**) to allow a bunk to be fitted as far forward as possible.

Position of VIP cabin

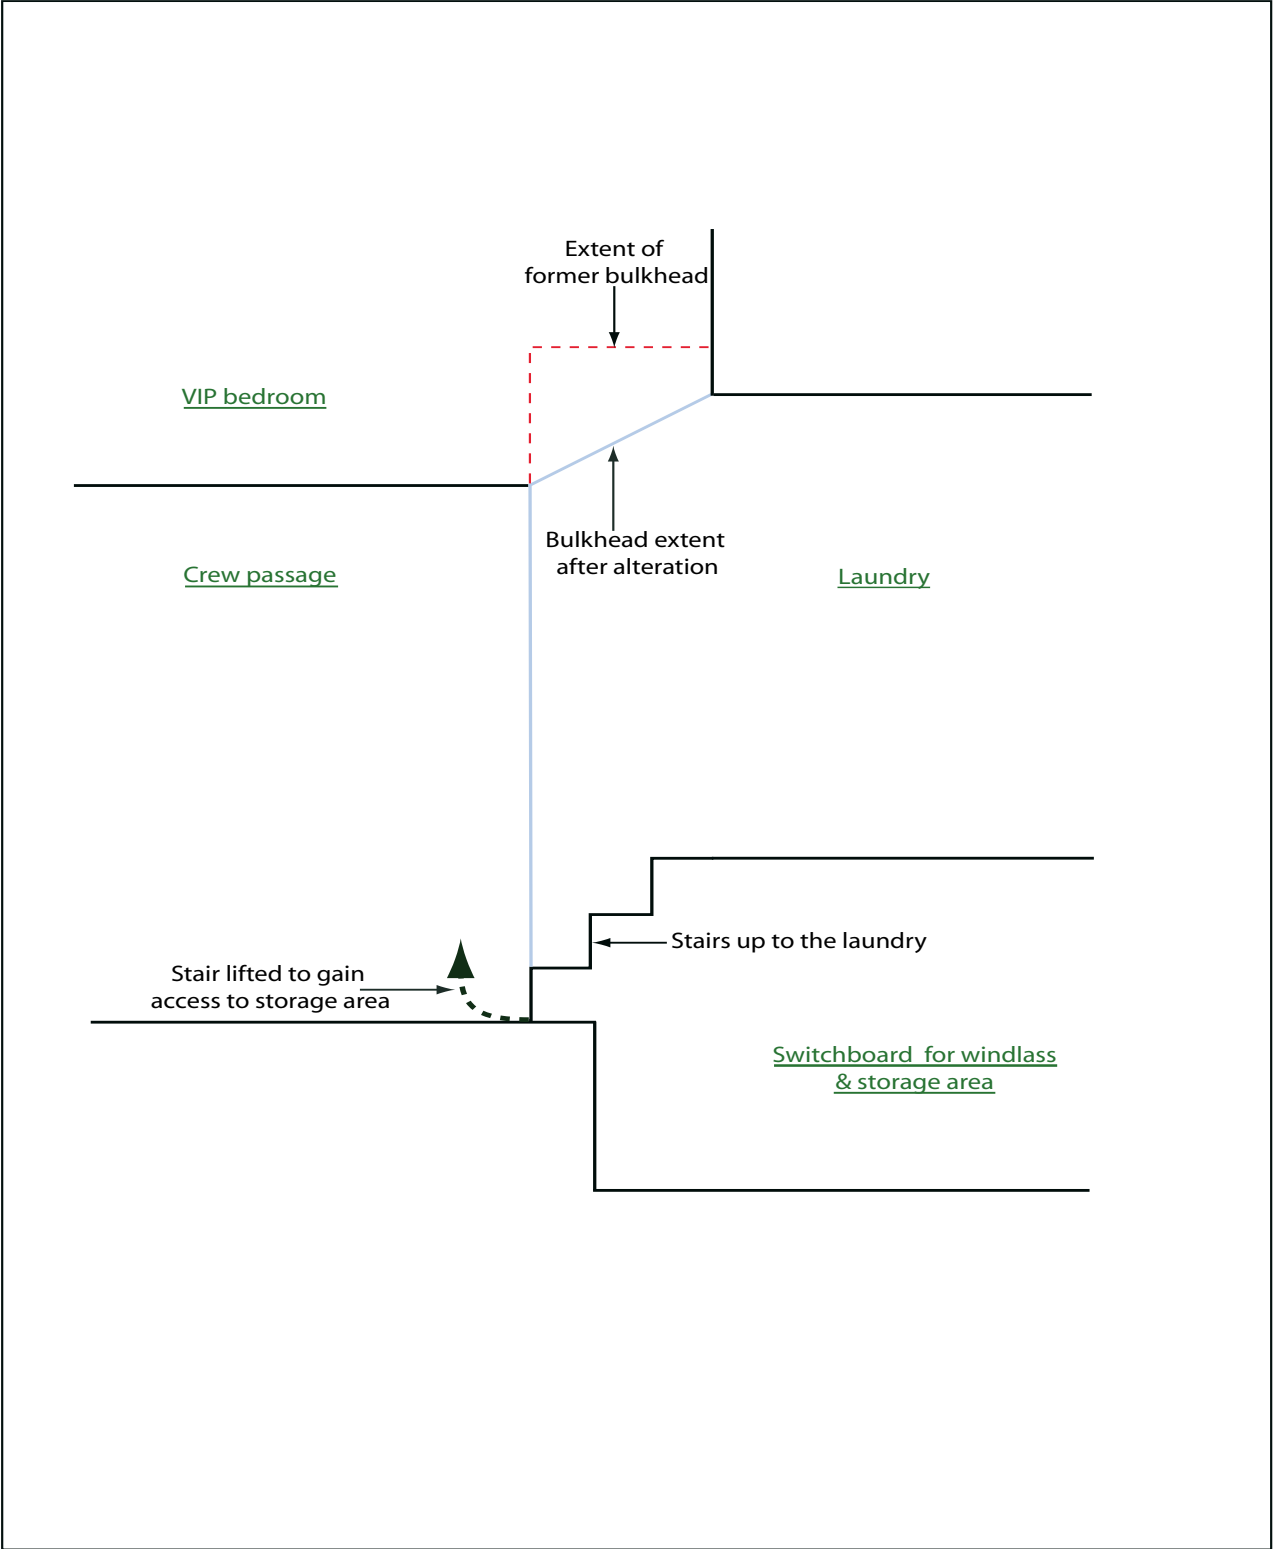
Figure 9

Internal bulkhead

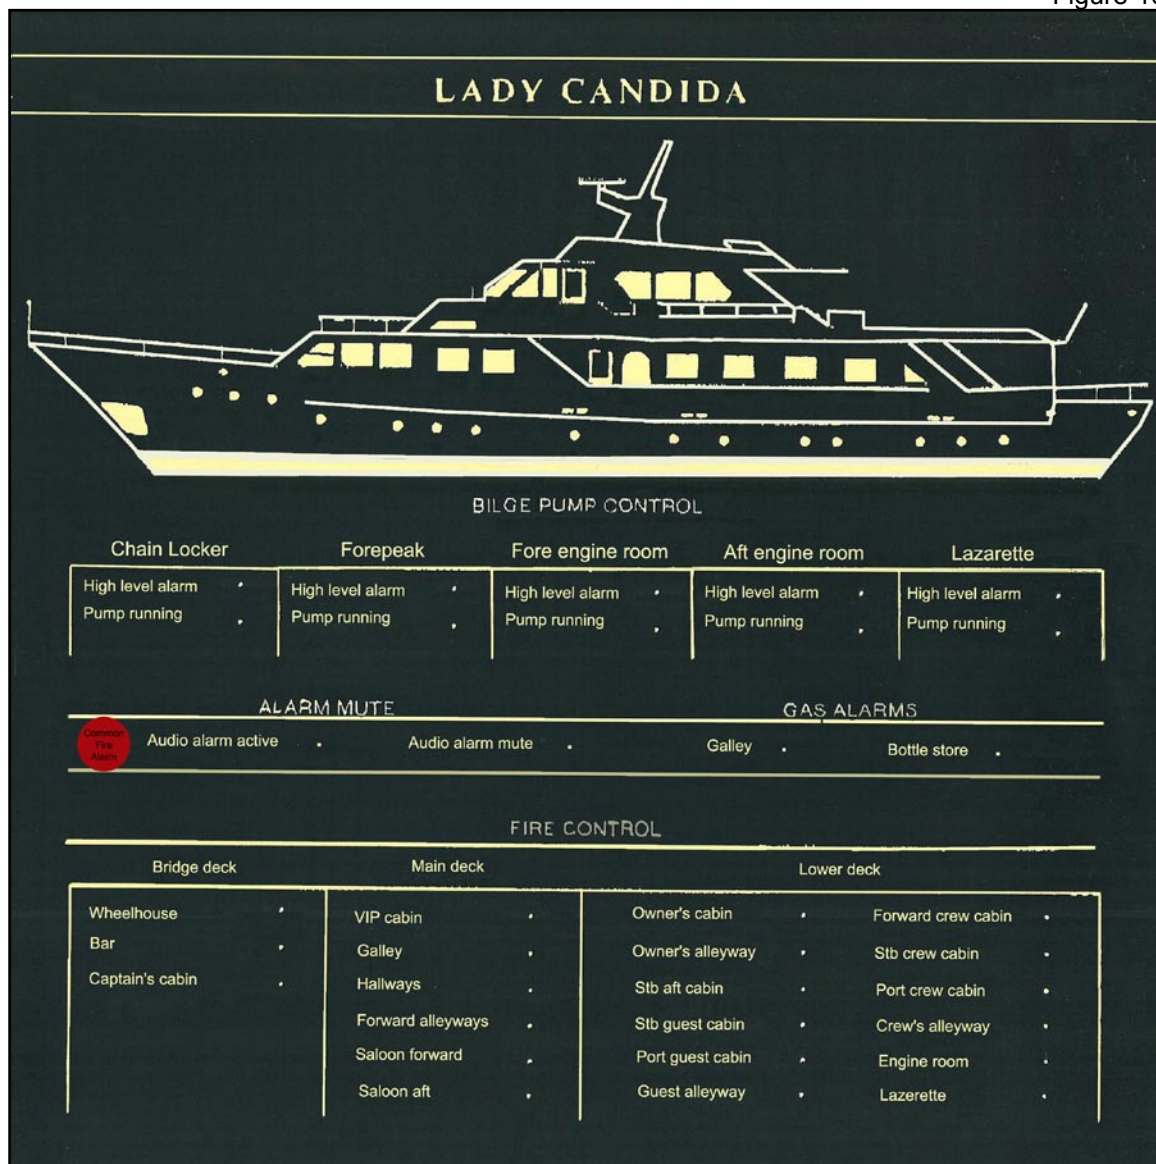
Figure 10

Alarm control panel

The control panel LEDs, which also provided indication for bilge levels, bilge pump operation and gas leaks, were arranged schematically for ease of identification. Switches on the control panel enabled the LEDs to be tested and for audible alarms to be muted. The status of the mute switch on the main alarm panel at the time of the fire is not known. The yacht did not have a dedicated general alarm, but the smoke sensors could be activated simultaneously by a push button on the control panel, which sent an independent 9V supply to each sensor. A high level alarm system for the vessel's black and grey water tanks was also sited on the bridge, the audible alarms of which were muted.
