Report on the investigation of
two accidents during berthing and unberthing
of

Logos II

St Helier, Jersey

Report No 1/2008
January 2008

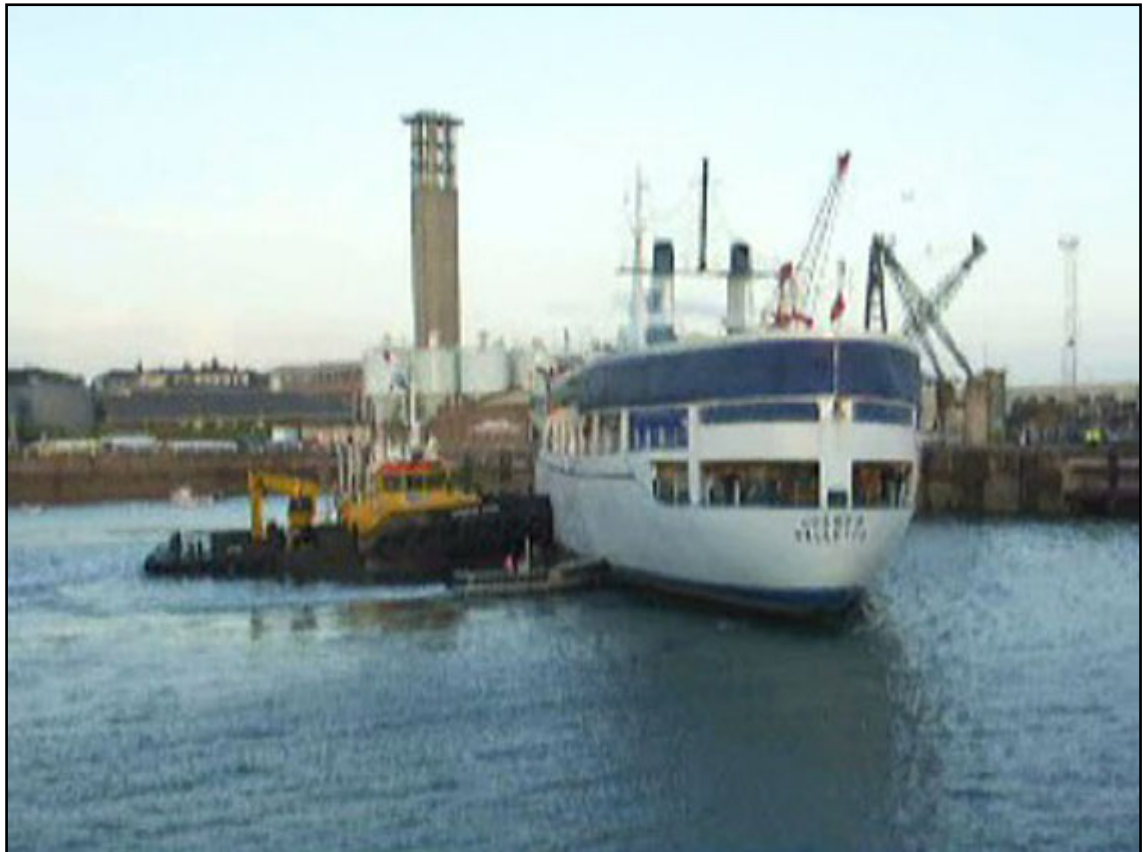
Figure 6

On clearing the pier heads, *Marineco Toomai* took up a position just aft of amidships (**Figure 5**) on the port side of *Logos II*. At 2043, the DHM instructed both tugs to push the vessel towards Victoria Pier. His instruction to *Marineco Toomai* was: 'can you push easy on the stern, we will to push her bodily down' [sic]. The DHM looked over the port side on several occasions as *Logos II* closed Victoria Pier, but was unable to accurately determine the position of *Marineco Toomai* due to obstructions in his line of site. He assumed she was in her assigned station; he did not check directly with the tug and was not informed otherwise. Soon after, *Halcyon*, a harbour work boat which had been requested by the DHM to standby to assist, positioned herself on the port quarter of *Logos II* and also started to push (**Figure 6**). This action was not requested or seen by the DHM.

Marineco Toomai & Halcyon pushing on port quarter (image captured from video)

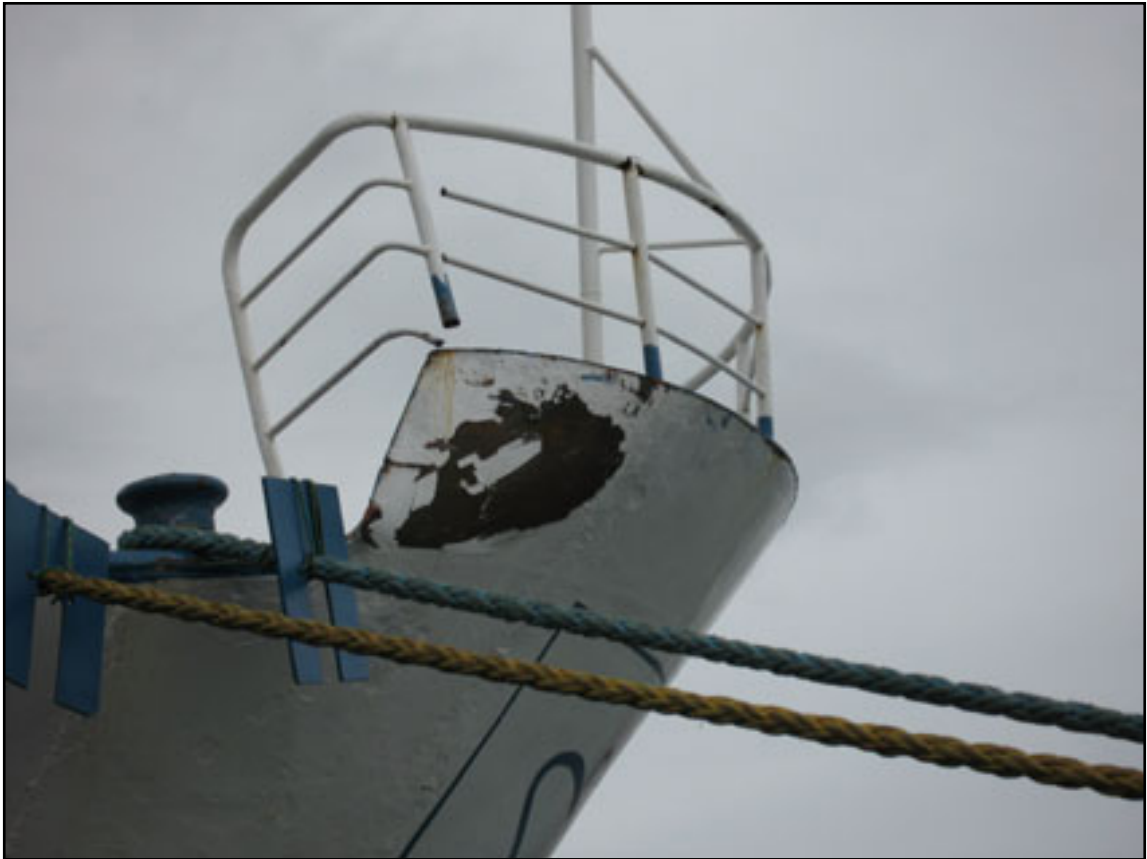
Figure 7

Time and date	:	2047 (UTC+1) on 20 June 2007
Location of incident	:	St Helier, Jersey
Persons on board	:	197
Injuries/fatalities	:	None
Damage	:	Vessel sustained indent on her starboard bow, bent pulpit railings and superficial damage to paintwork. Structural damage was caused to two small craft and minor damage to a shore crane.

As *Logos II* neared the berth, the vessel's bow started to close the pier much quicker than intended. This was commented upon by the master, and the DHM attempted to check this movement by ordering *Titan* to stop pushing and *Marineco Toomai* to push with full power. He also ordered the engines to full astern. These actions failed to check the vessel's movement, and at 2047 her bow made contact with the quay and a shore crane (**Figures 7 & 8**).

Damage to starboard bow of *Logos II*

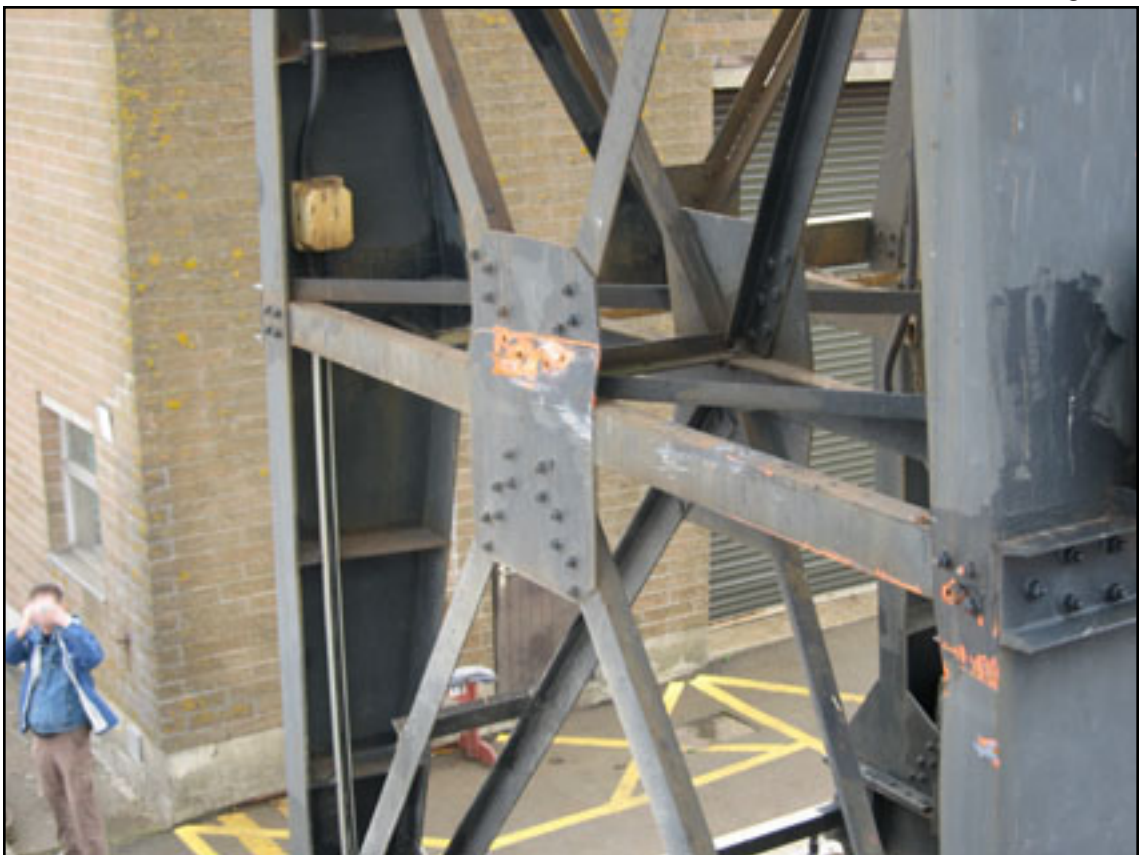
Figure 8

Damage to shore crane

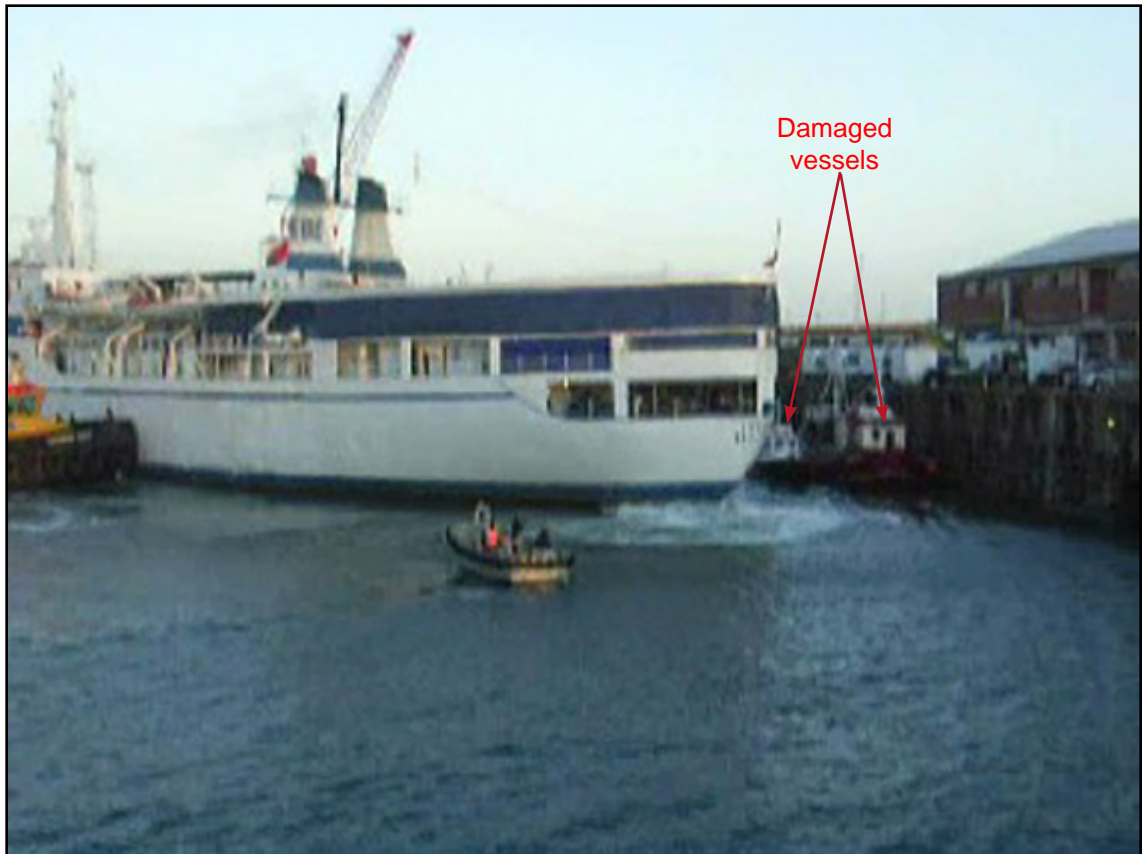
Figure 9

The DHM immediately ordered the engines to be stopped and then set to half ahead, and for the helm to be put to hard to starboard. The aft tug was also ordered to stop pushing, but the stern of *Logos II* made contact with two of the small boats (**Figure 9**).

Stern of *Logos II* prior to contact with boats moored at London Berth
(image captured from video)

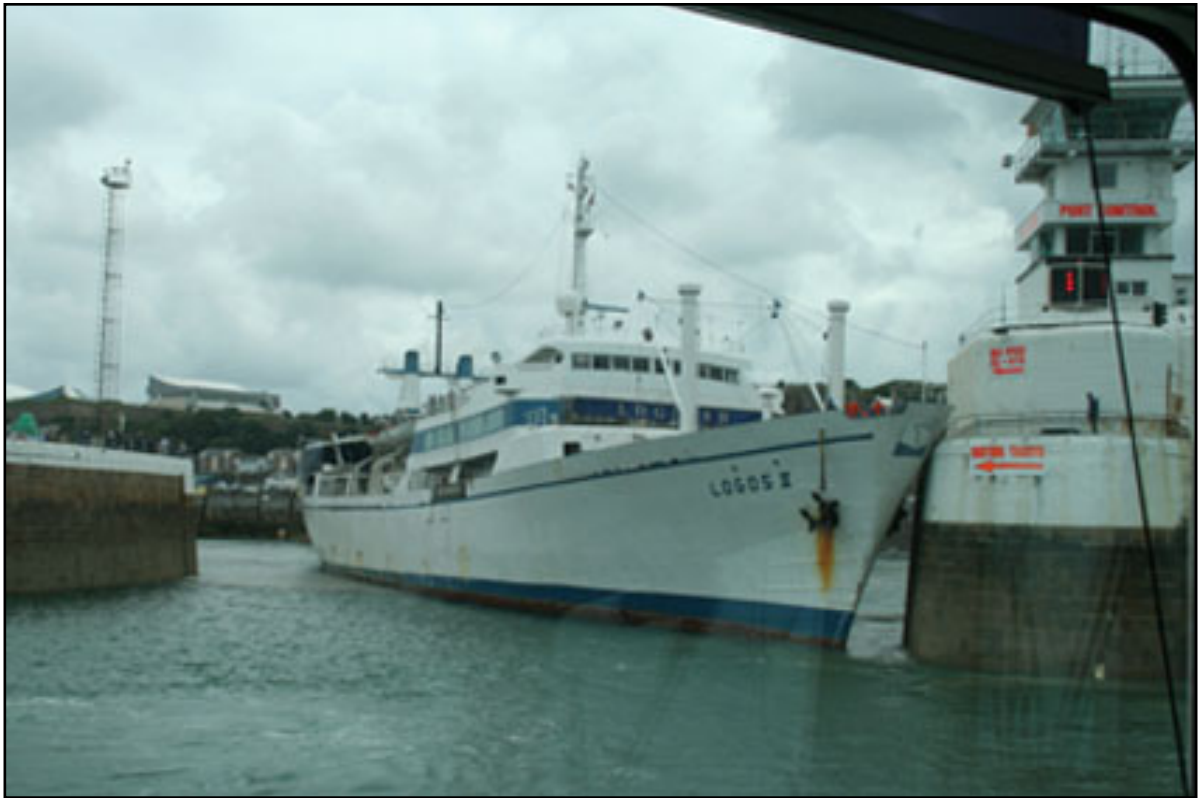
Figure 11

Without the assistance of the forward tug, *Logos II* came to rest with her port bow on the Victoria Pier head (**Figure 11**) at 1200. Damage to the vessel was superficial, but damage to the concrete and railings on the pier head was more extensive (**Figure 12**). A tow line was quickly re-secured to *Duke of Normandy*, and *Logos II* was pulled clear of the pier head. The tow was then released to allow the ship to increase speed, but when the AHM attempted to alter course to the south, *Logos II* again failed to respond to the helm, and the assistance of *Duke of Normandy* was required to push her bow towards her intended heading. The vessel then completed her departure from St Helier without further incident.

Logos II in contact with Victoria Pier head

As soon as the tow line parted, there was little action the pilot could take to avoid the ship's bow coming to rest on Victoria Pier head. In view of the influence of the north west wind, along with the poor handling characteristics of the vessel and the close proximity of the pier heads, attempts to manoeuvre *Logos II* clear might have resulted in more serious damage.

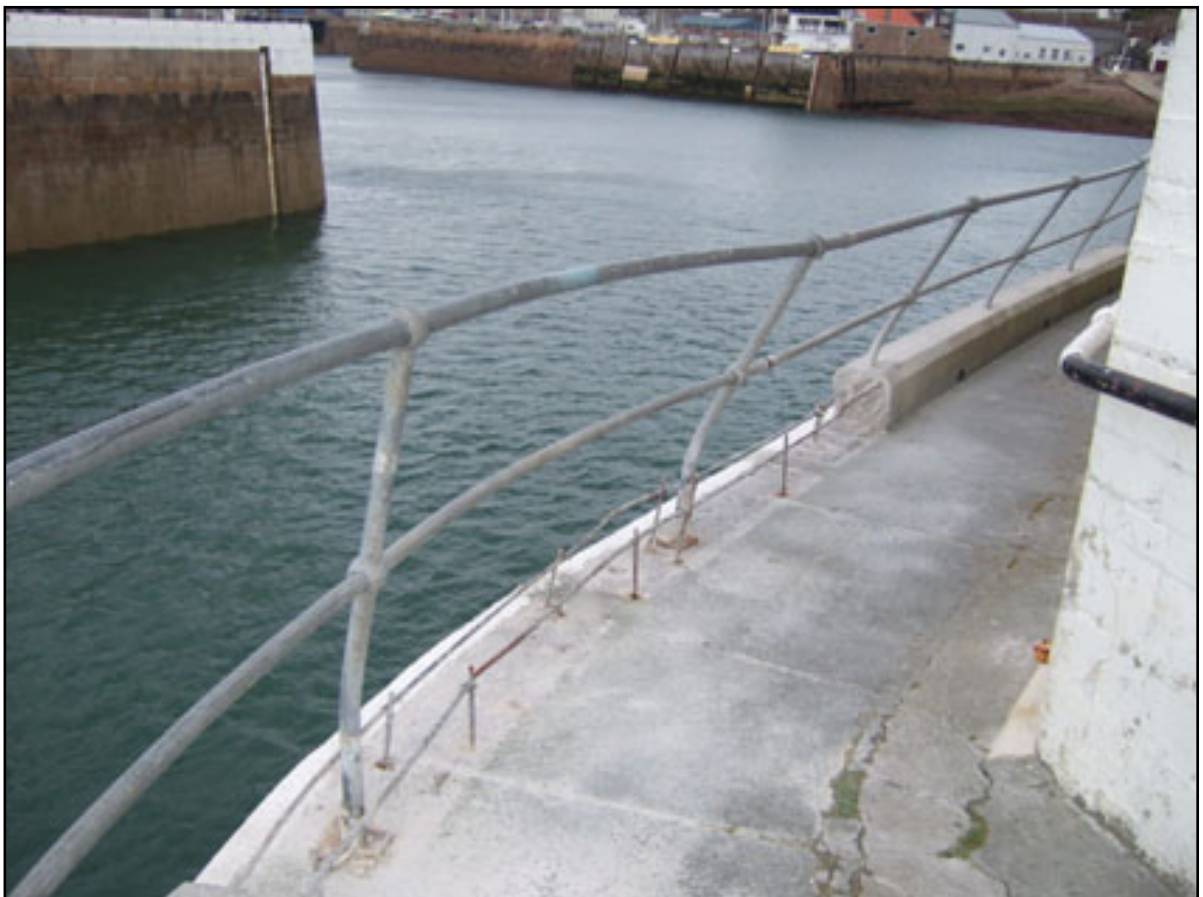
Figure 12

Time and date	:	1200 (UTC+1) on 26 June 2007
Location of incident	:	St Helier, Jersey
Persons on board	:	189
Injuries/fatalities	:	None
Damage	:	Structural damage was caused to concrete land ties and safety railings on Victoria Pier head.

Damage to Victoria Pier head
