The Liquefied Petroleum Gas (LPG) carrier, *Gas Monarch*, collided with the sailing yacht, *Whispa*, in dense fog 6 miles ESE of Lowestoft on the evening of 16 April 2007. There were no physical injuries on either vessel. There was no damage to *Gas Monarch* and initial structural damage to *Whispa* was relatively minor. However, the damage to the yacht worsened due to progressive flooding as she was towed to Lowestoft by a lifeboat.

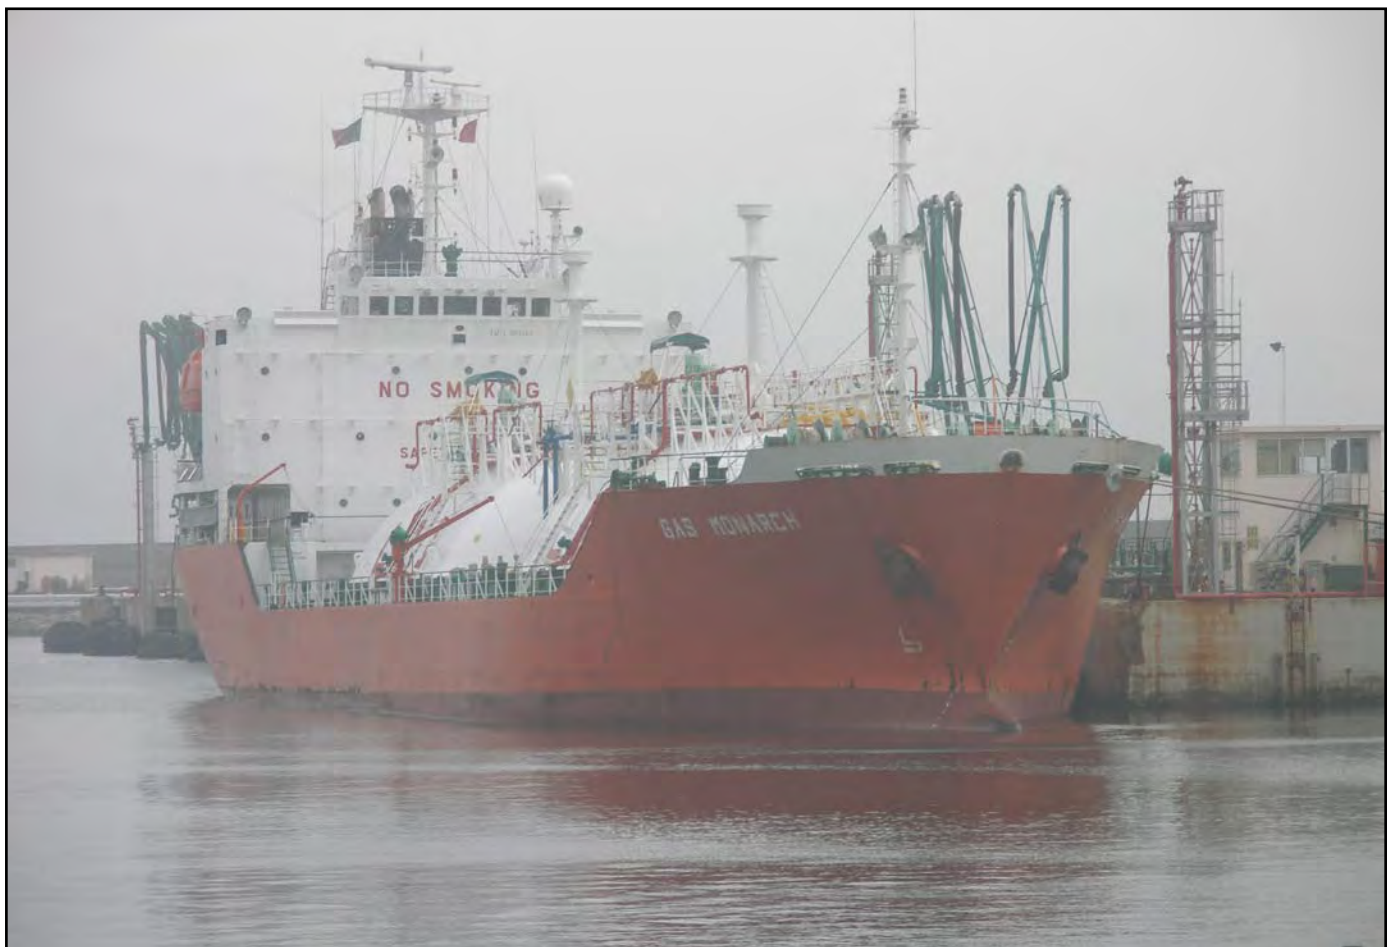
Figure 1

*Gas Monarch*
