Report on the investigation of the collision between

***Gas Monarch and Whispa***

6 miles ESE of Lowestoft

**Report No 25/2007  
December 2007**

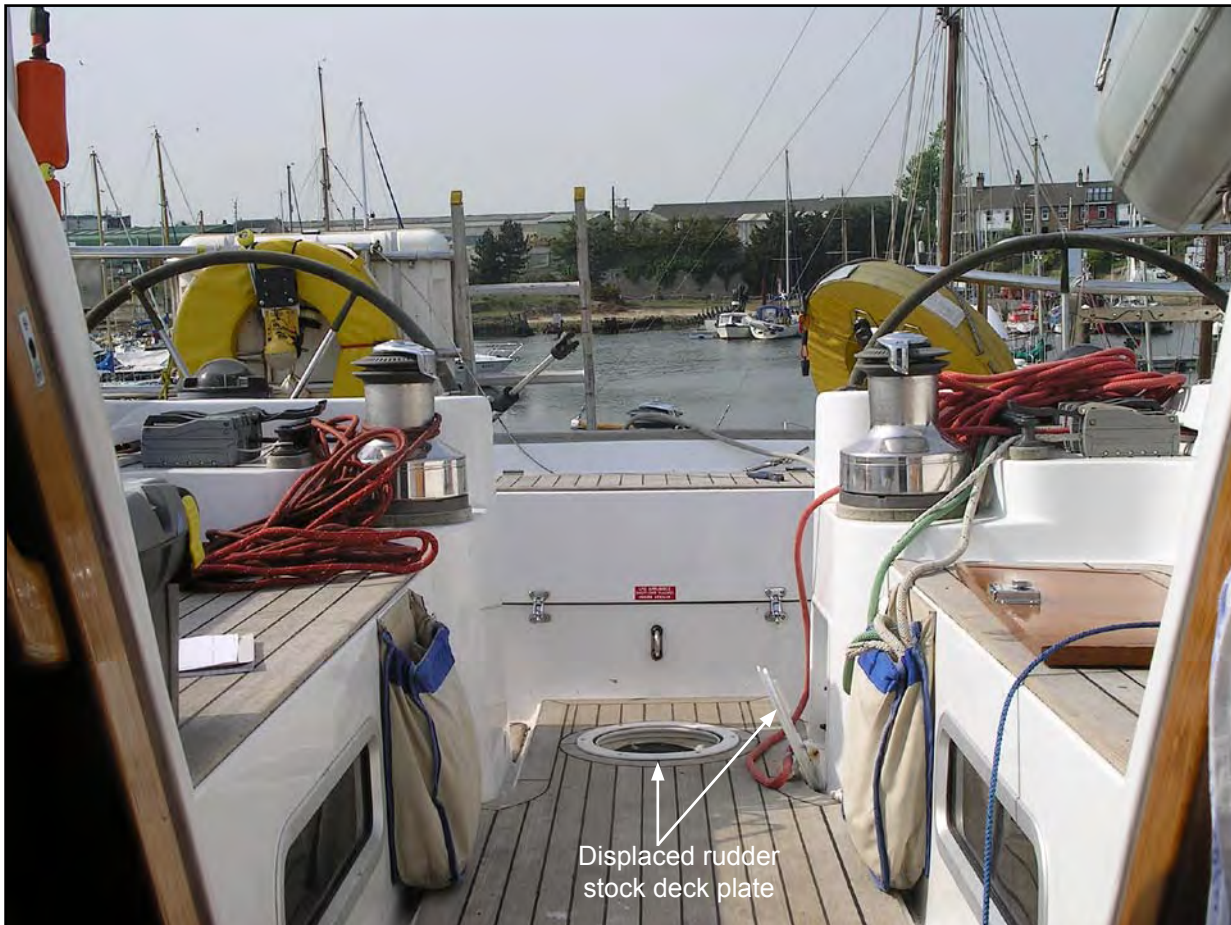
It took several minutes for the skipper of *Whispa* to compose himself but, once calm, he and his crew member carried out a check for damage. It was apparent that the rudder stock deck plate (**Figure 6**) was displaced, and on inspecting below deck they discovered that the vessel's lazarette had some 18 inches depth of the water in the space. On putting the vessel's engine into forward gear (the skipper had put the engine in neutral immediately after the collision), it was found that the steering was severely damaged. No other damage was evident below decks, and they were not unduly worried about the yacht sinking because she had a transverse watertight bulkhead forward of the lazarette, thus containing water ingress to that compartment.

Whispa's deck, showing the displaced rudder stock deck plate

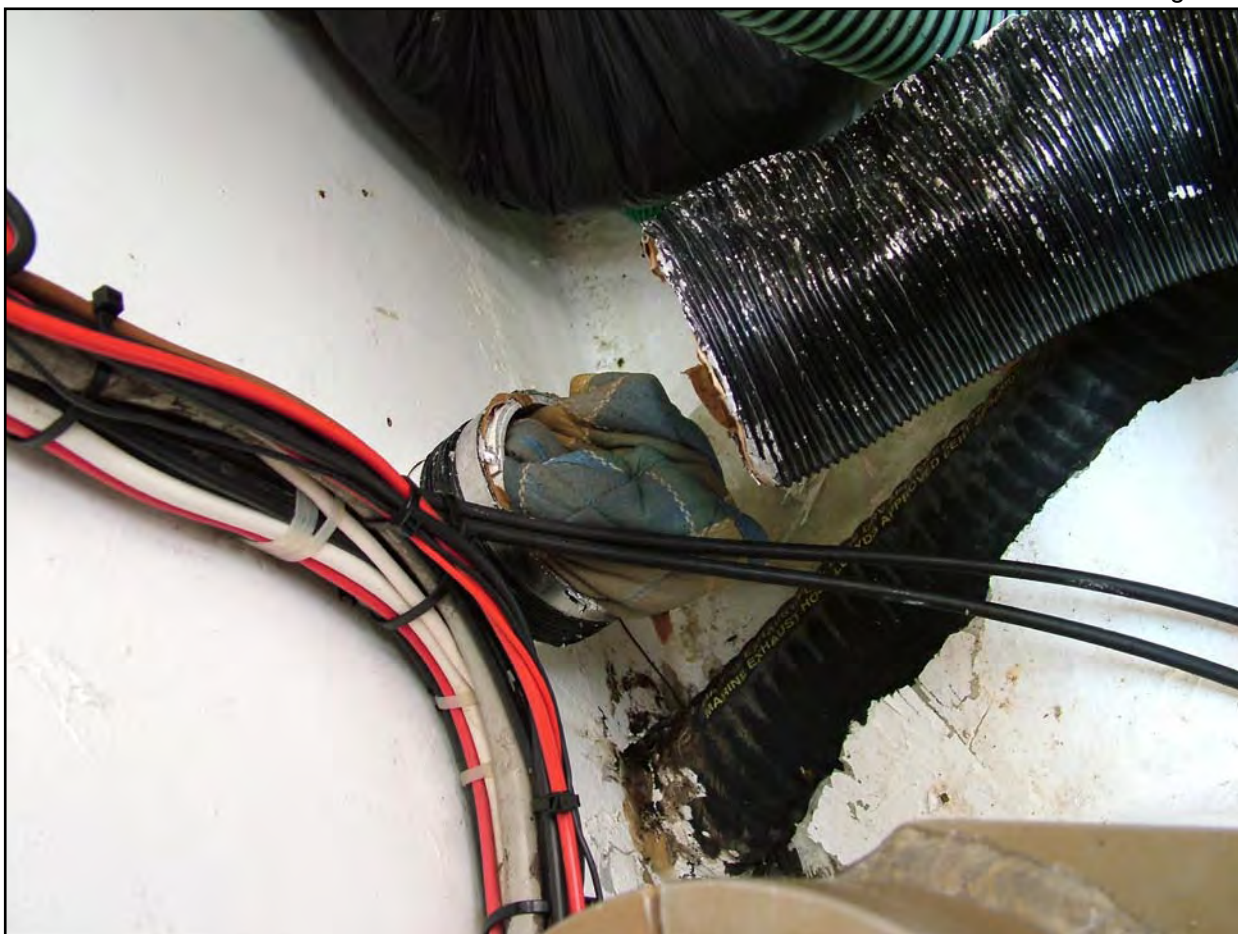
alongside *Whispa* to assist. Two crewmen from the lifeboat boarded *Whispa* with a portable salvage pump, and after several minutes succeeded in starting and priming the pump. Thereafter it took over an hour to contain the flooding to a level where the tow could be resumed. The flooding had been caused as a result of hot air conduit pipes passing through the watertight lazarette bulkhead becoming sheared by the damaged steering gear during the tow. Once the route of the flooding had been established, *Whispa's* skipper was able to stuff rags into the sheared 4 inch bore pipes (**Figure 7**). This reduced the flooding significantly.

Sheared air conduit

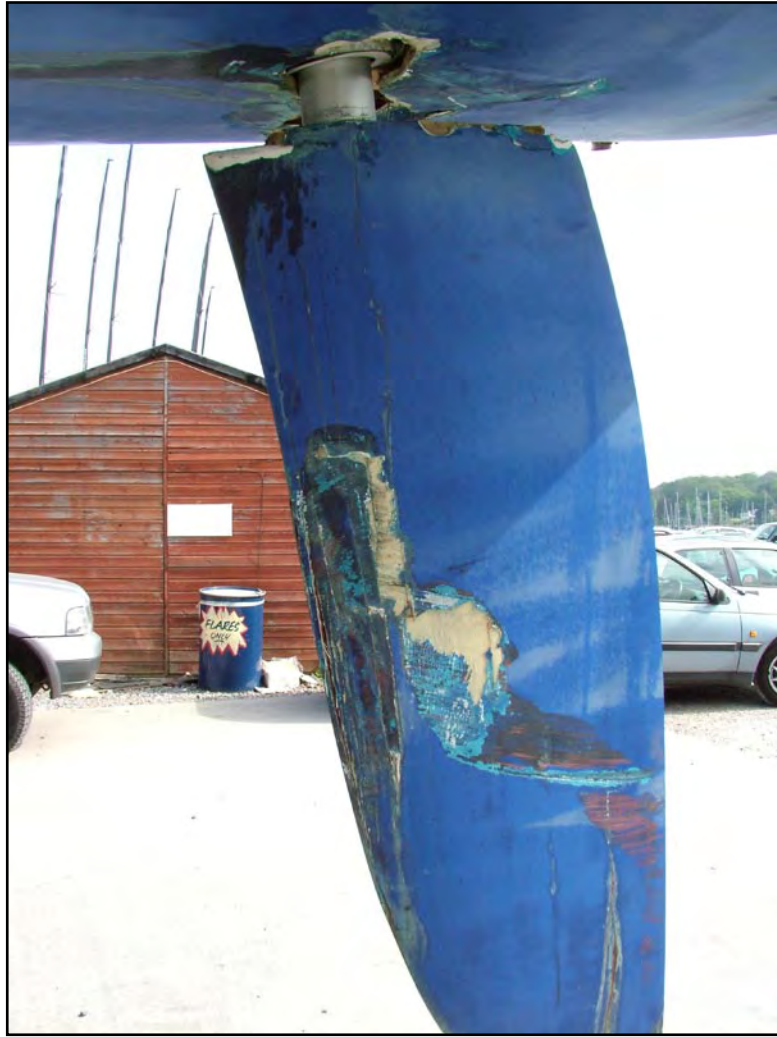
Figure 8

Once under tow, grinding noises were heard coming from *Whispa*'s stern, indicating damage to her rudder, and *Whispa* sheered dramatically to port. This made the tow very difficult. Drogues were then streamed from *Whispa*'s quarter, which helped improve the tow slightly.

Damage to rudder by *Gas Monarch's* bulbous bow

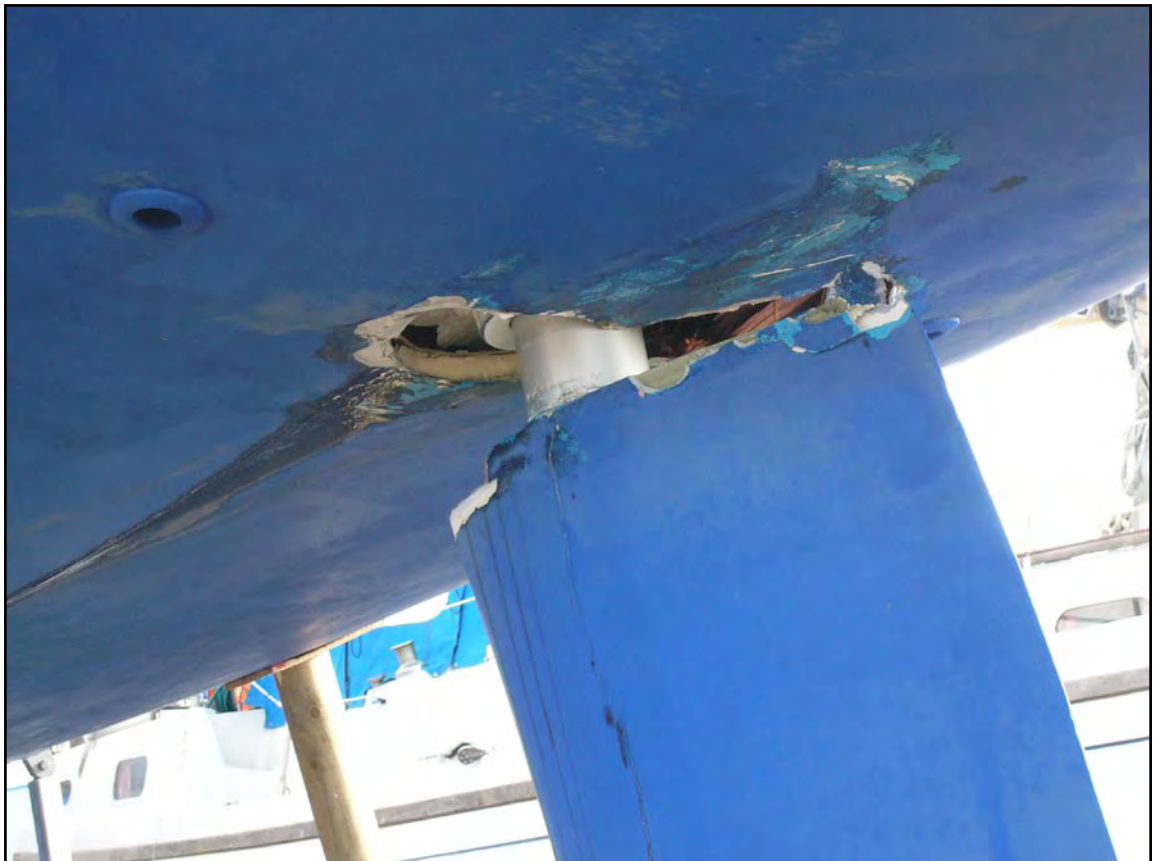
Figure 9

Damage to hull above rudder

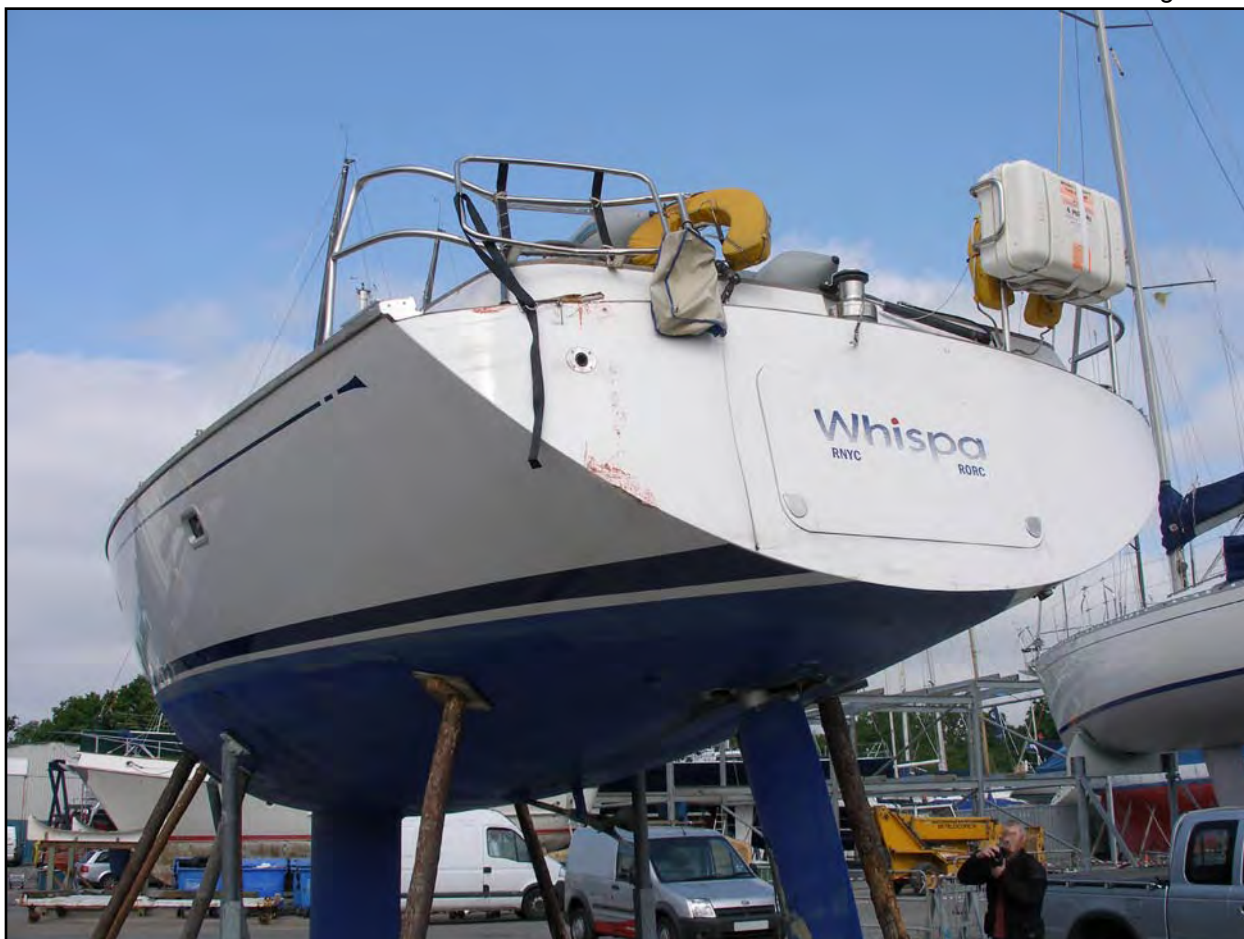
At 0044 on 17 April, Lowestoft lifeboat resumed the tow, and by 0400 *Whispa* was safely alongside Lowestoft Haven Marina where staff were waiting to lift her from the water. Once clear of the water, the full extent of the collision damage was revealed (**Figures 8, 9 and 10**).

Damage to *Whispa's* transom and pushpit

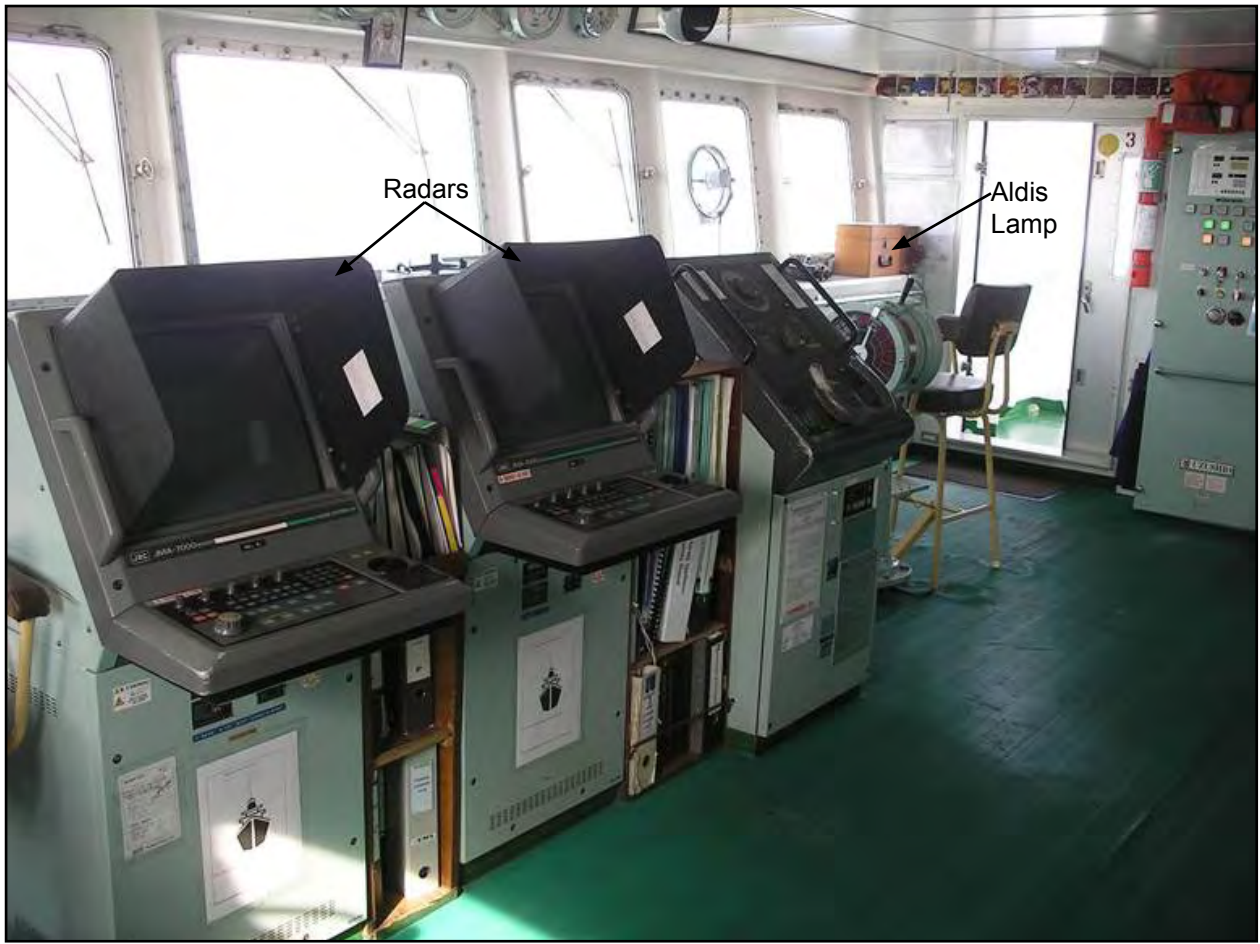
Gas Monarch's radars

Resulting from its own investigation, EMS requested ship's staff to conduct radar performance tests. These were carried out using the method advised in the radar operations manual (**Annex 2**). These tests revealed that neither radar was achieving 50% of optimum attenuation. On 10 May 2007, the vessel was attended by service technicians in the port of Antwerp, where it was established the magnetron on each radar had deteriorated to well below optimum capability. It was also found that the radar scanner bearings on the X band radar were worn to the extent that they were allowing vertical play of 2cm in the antenna.

Soon after the accident, the vessel's radars were inspected by service technicians in the port of Antwerp, where it was confirmed that the magnetron on each radar had deteriorated to well below optimum capability, and they were duly replaced. It was also found that the radar scanner bearings on the X band radar were worn to the extent that they allowed vertical play of 2cm in the antenna. A recommendation was made by the technicians to have this attended to as a matter of urgency.

Less than a year previously, the X band radar's magnetron had been replaced in Amsterdam. It is possible that the play in the radar scanner was contributory to the deterioration of the magnetron in such a short time span. The play in the scanner could also be responsible for deflecting some of the radar's energy from the wave guide and, thus, also contribute to poor performance.

- Following an appropriate performance check of the vessel's radars, the equipment was serviced and magnetrons replaced.
- Accelerated its programme to fit S-VDR across the fleet and implemented a regime whereby VDR data is used to assist masters and auditors when reviewing operational practices on board the vessels.

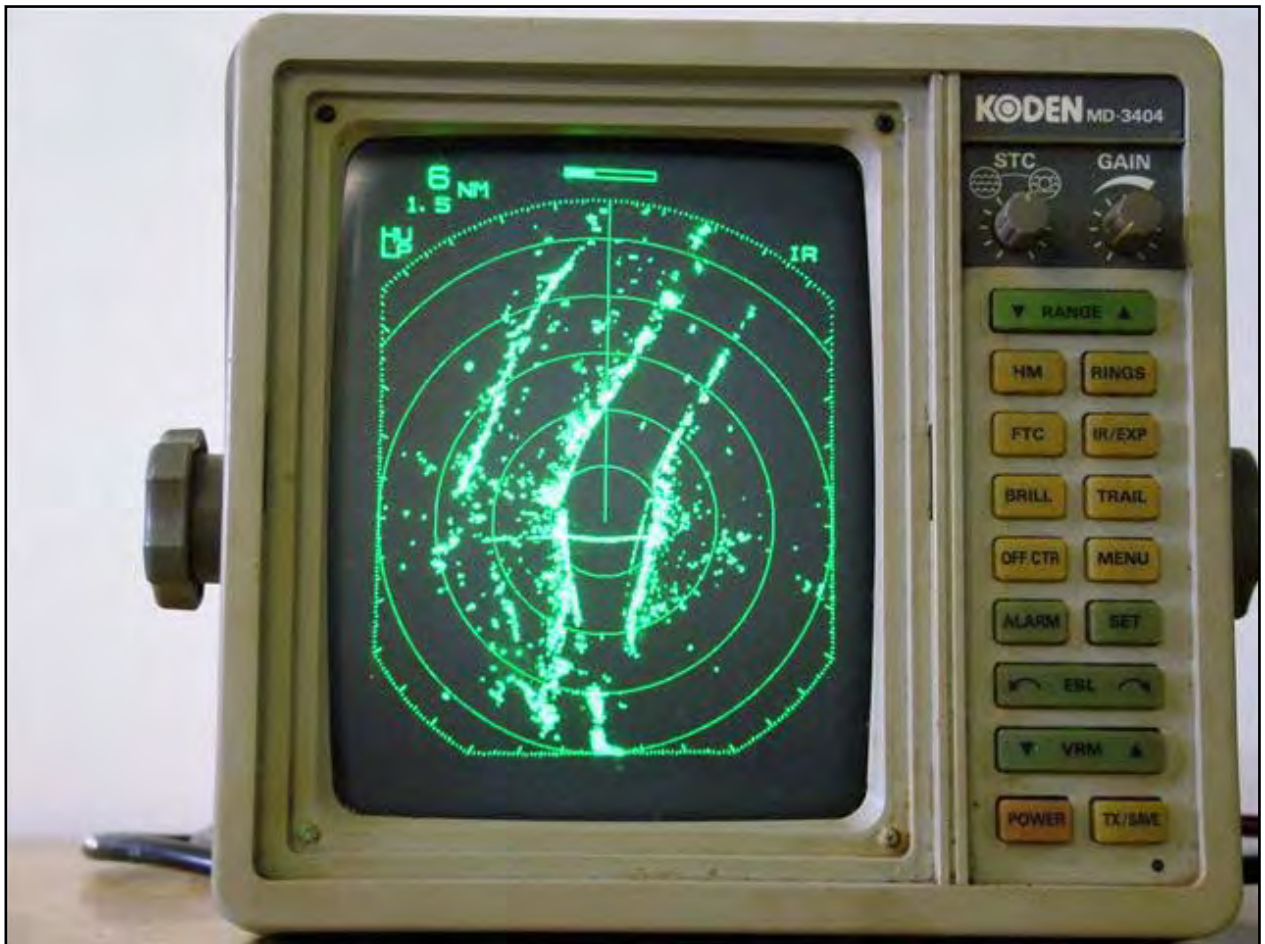
Whispa's radar screen, showing 1.5 mile range rings and oblong screen

*Whispa's* skipper was unsure about the configuration of his radar's range rings and the total distance he was observing ahead of his vessel created by the radar screen's oblong configuration (**Figures 14 and 15**). He was not aware that when on a 6-mile range scale the range rings were 1.5 miles apart, and when on 3-mile range the rings were 1 mile apart. Instead he believed them to be 1 mile and 0.5 mile apart respectively, as is more commonly found. However, regardless of the range scale in use, the skipper was confident that the helm alteration was demanded of the autopilot when the approaching vessel was close to the radar's 2.5 mile guard zone. Analysis of data stored by *Whispa's* GPS showed that the alteration took effect when the vessels were 1.3 miles apart.

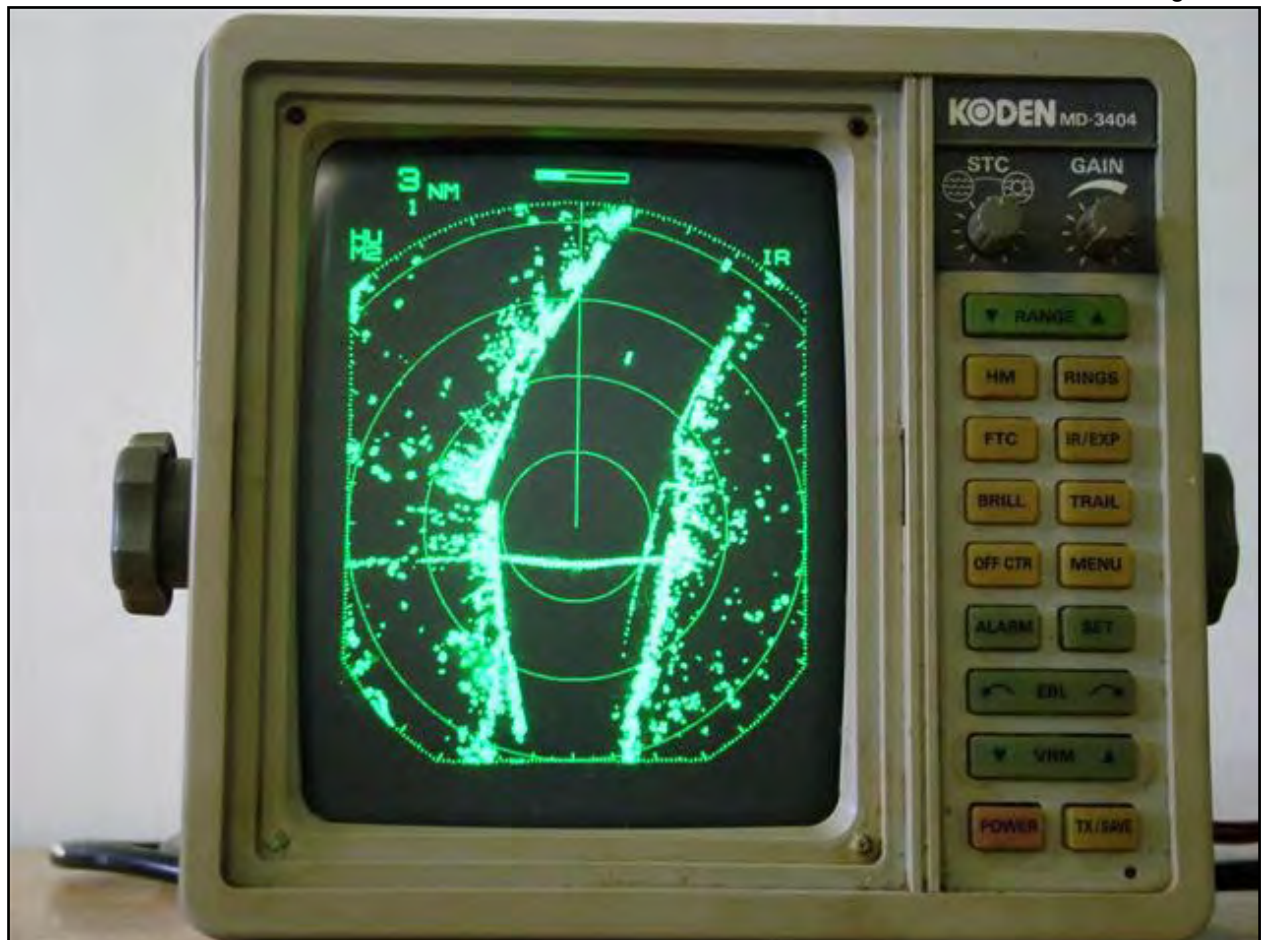
The skipper was unaware that his radar had a 24-mile range capability, and believed that the 6 and 3 mile scales had range ring spacing of 1 and 0.5 mile respectively (**Figures 14 and 15**). It was the skipper's perception that, when the radar was set on the 6-miles range, contacts coming onto the extremity of the screen directly in front of the yacht were 6 miles distant, when in fact they were actually about 8 miles away due to the oblong shape of the screen (**Figure 14**). On the 6-mile range, the radar screen was configured so that the last complete range ring was displayed at 6 miles; this screen configuration gave the effect of being continually off-centre, with additional off-centre options if required.

Whispa's radar screen showing 1 mile range rings on a 3 mile scale

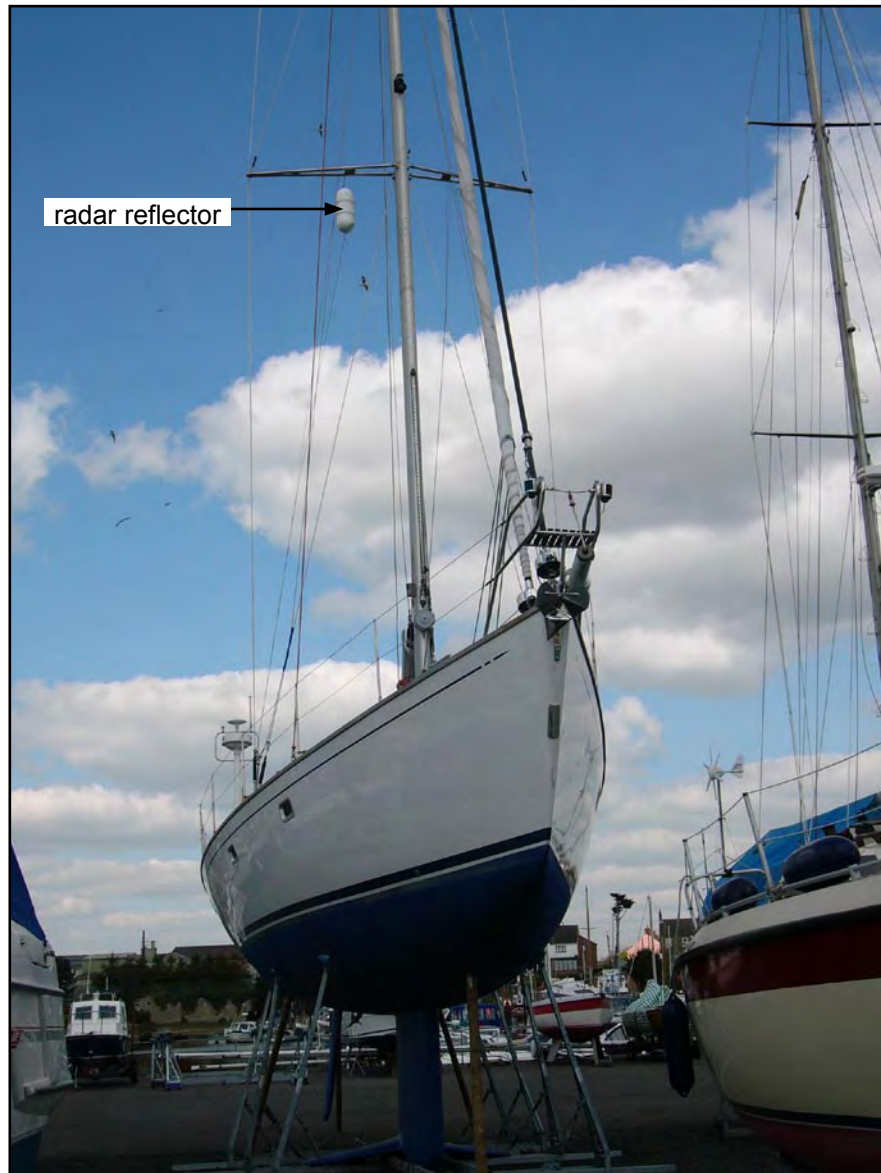
*Whispa*'s hull form was extremely smooth and streamlined, with an aluminium mast extending almost 20m above sea level. A radar reflector was suspended from the mast cross tree at about 6m above sea level (**Figure 19**). At no time previous to the accident had other skippers expressed concern to *Whispa*'s skipper about the vessel's radar image.

*Whispa's* radar reflector and mast
