Report on the investigation of the  
keel failure, capsize, and loss of one crew member from  
the Max Fun 35 yacht

***Hooligan V***

10 miles south of Prawle Point

**Report No 19/2007**  
**August 2007**

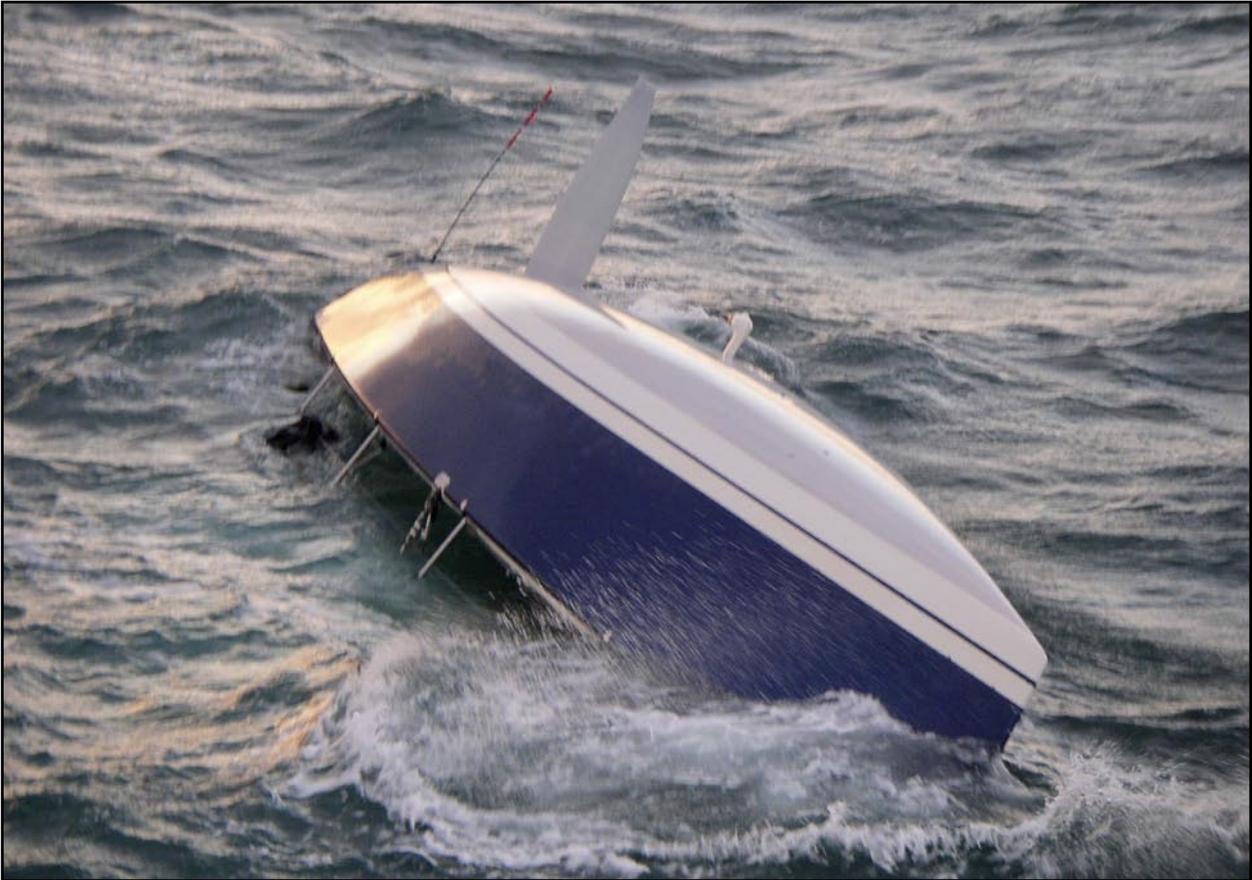
Figure 2

As *RFA Wave Knight* proceeded towards Plymouth, the upturned hull of *Hooligan V* was spotted by the bridge lookout. At 0745 the sighting was reported to Brixham Coastguard who requested Torbay lifeboat to proceed to the scene to assess the feasibility of towing the boat into port and so remove the risk of any future collision. The lifeboat arrived on scene at 0815. The coxswain of the lifeboat was able to confirm that the keel had sheared off but that there were no signs of any hull damage or other signs of contact with an underwater object (**Figures 2 and 3**).

Hull condition on arrival of Torbay lifeboat - port side

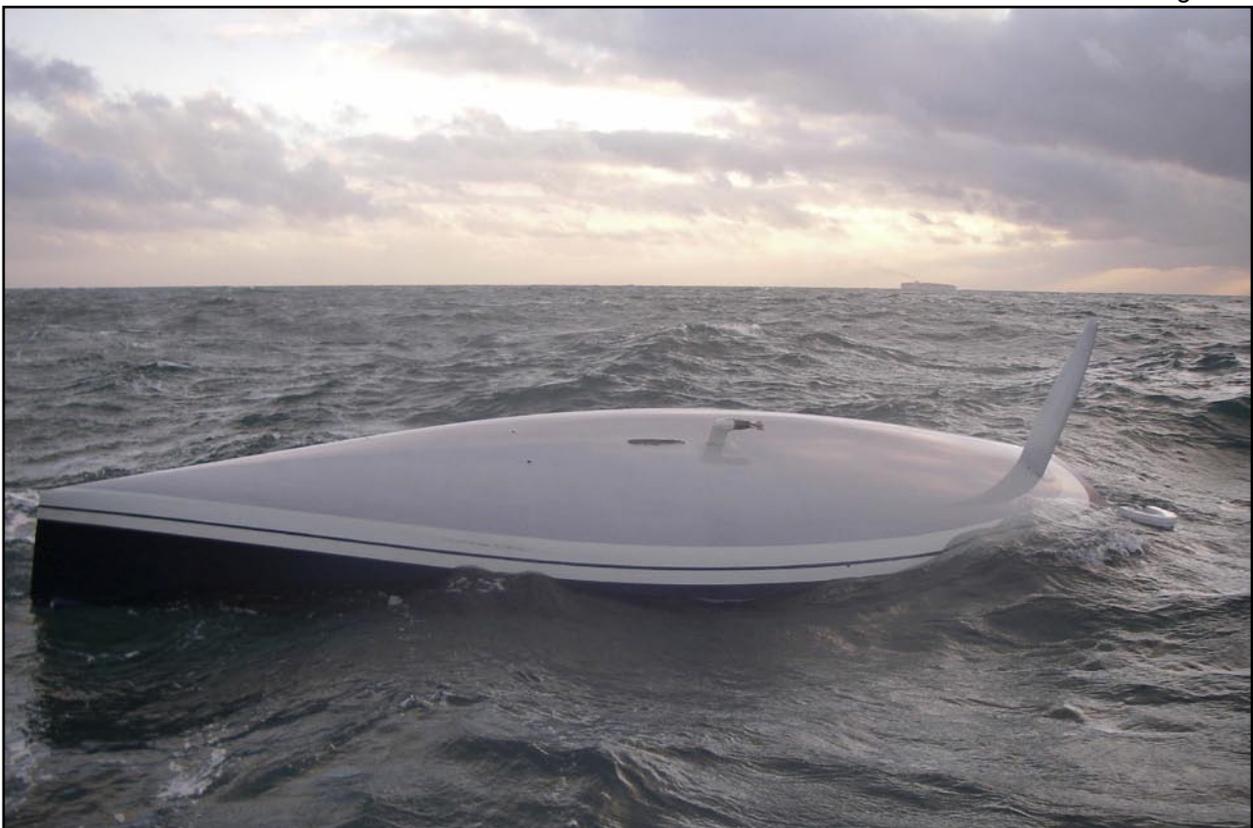
Figure 3

Hull condition on arrival of Torbay lifeboat - starboard side

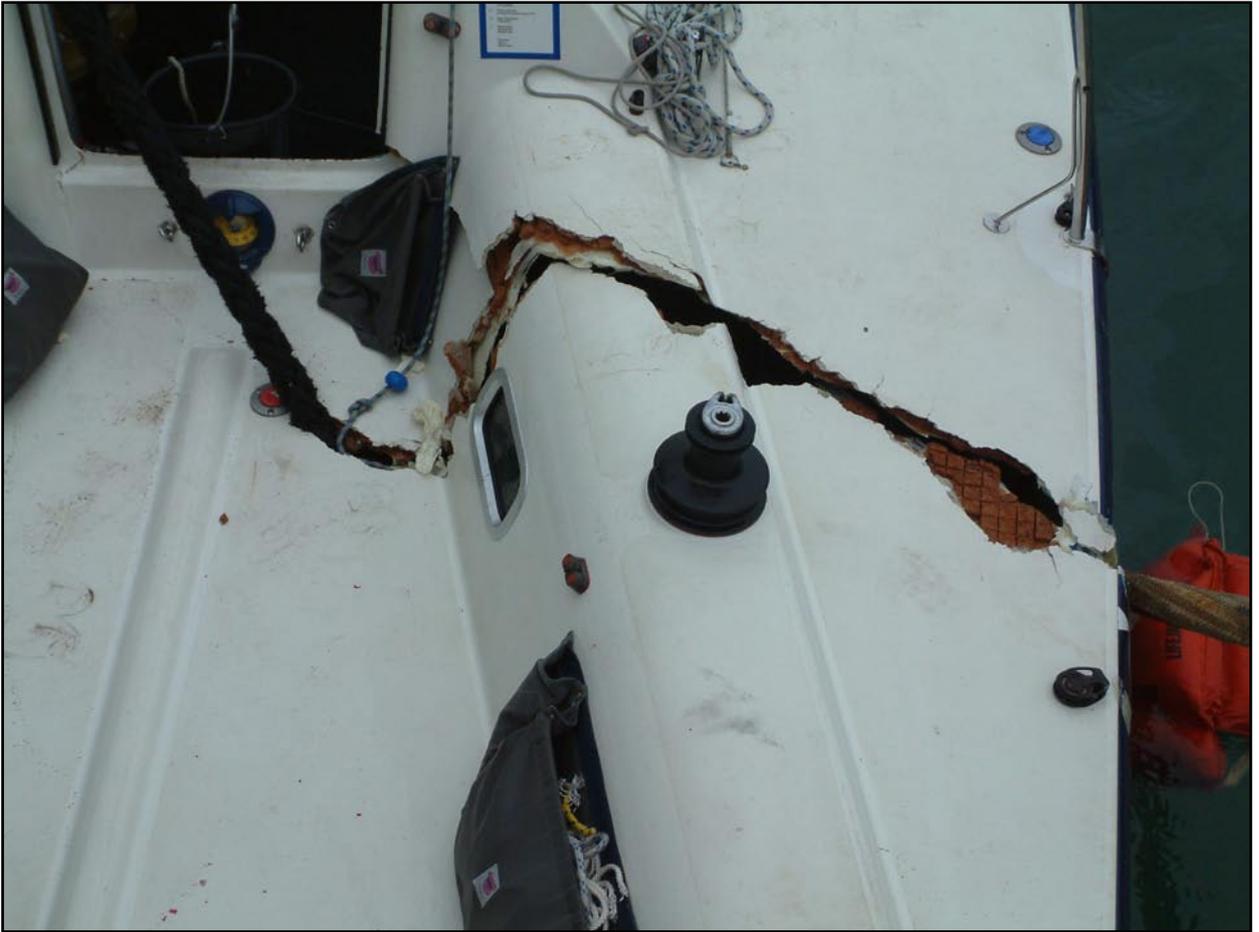
Figure 5

Initial investigations identified that the hull had been severely damaged by the salvor's ropes and those secured by *RFA Wave Knight*. These had cut through the GRP foam sandwich layers as *Hooligan V* was being towed by the Torbay lifeboat, and later by the salvor (**Figures 5 and 6**).

Rope damage - starboard side of cockpit

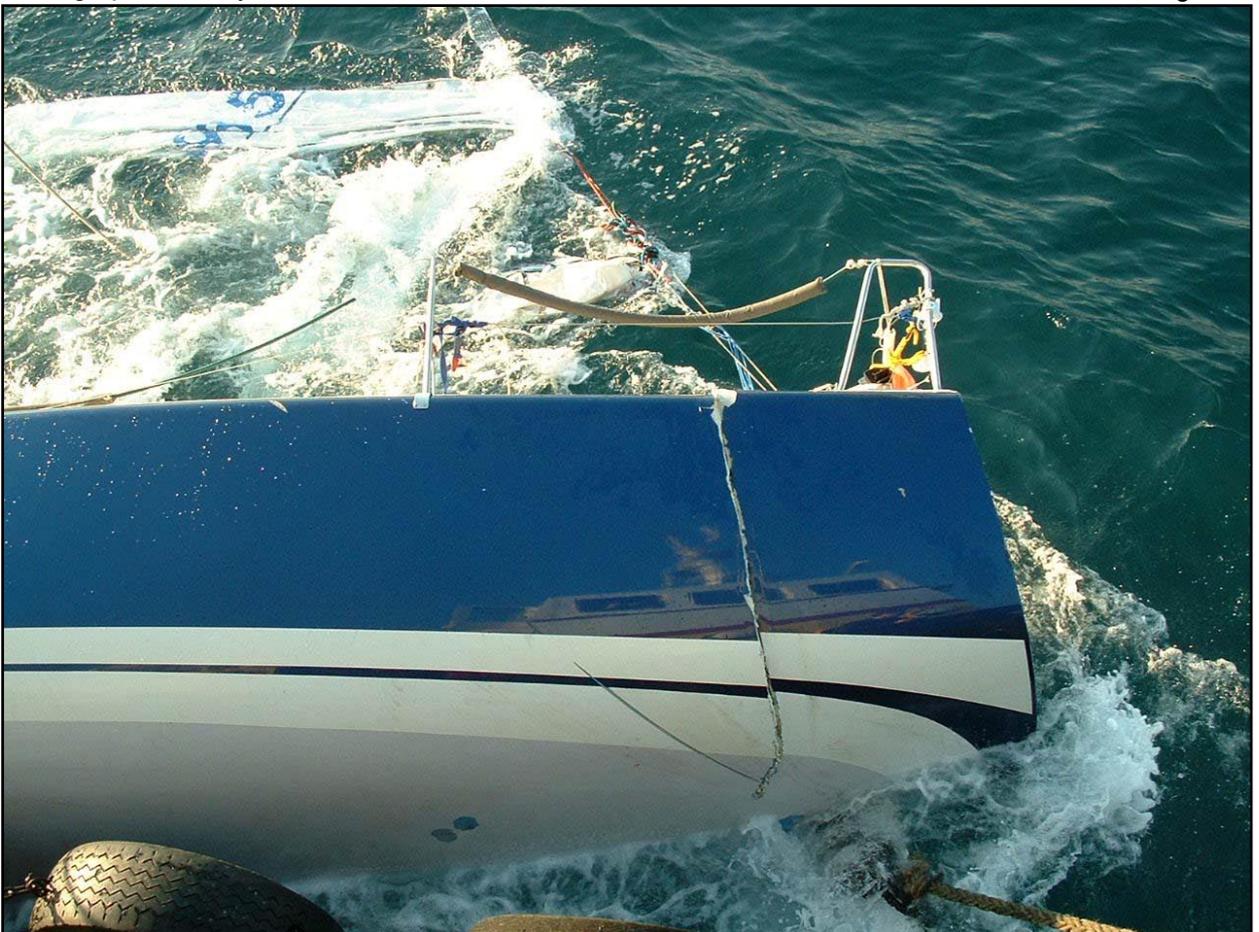
Figure 6

Rope damage to hull under port side of cockpit

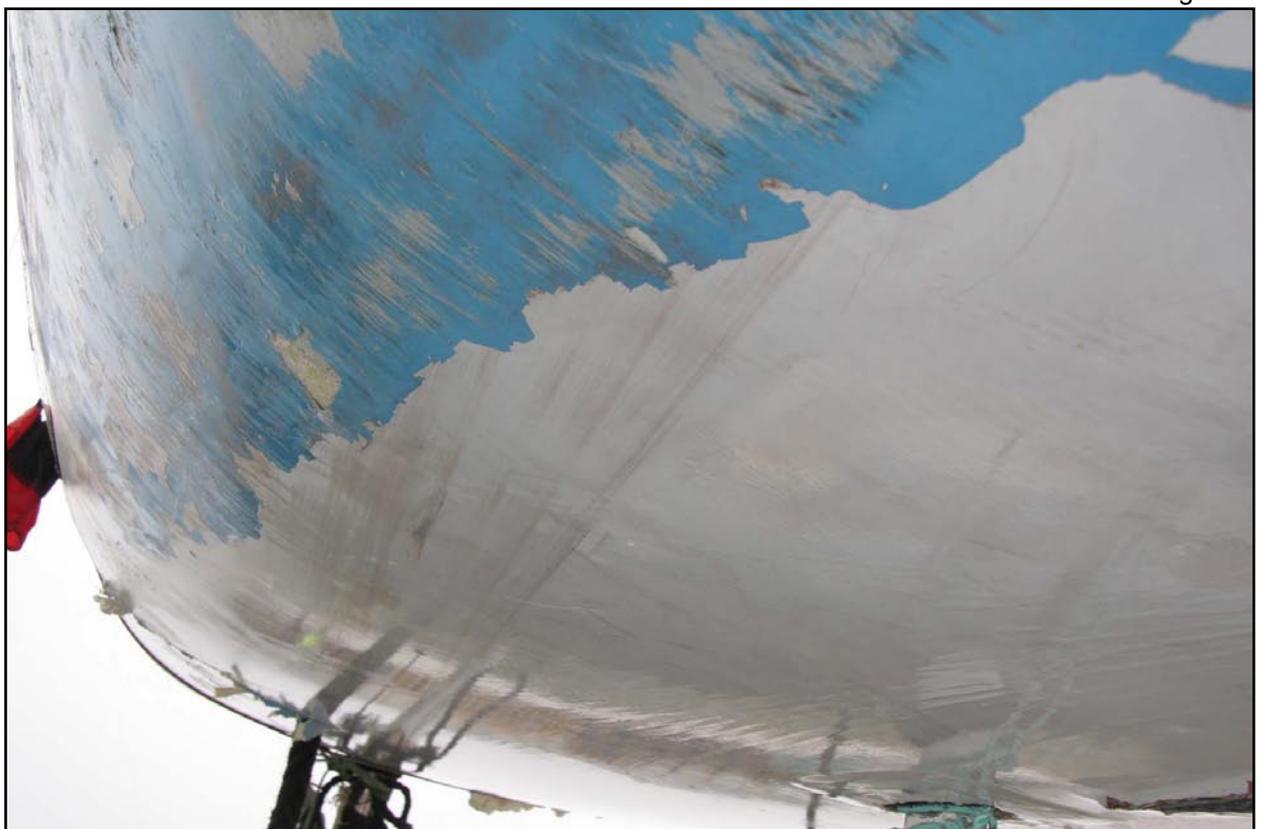
Figure 7

There was also evidence of paint markings, some minor impact damage and circumferential and longitudinal scratch marks down the port and starboard sides caused during connection of the towing ropes by *RFA Wave Knight's* RIB, Torbay lifeboat and the salvor. These were predominantly on the antifouling surfaces (**Figures 7 and 8**). The stem was badly damaged below the waterline, resulting in full penetration through the hull (**Figure 9**). The rudder was also bent, but the engine sail drive unit was intact.

Paint and scratch marks on starboard side

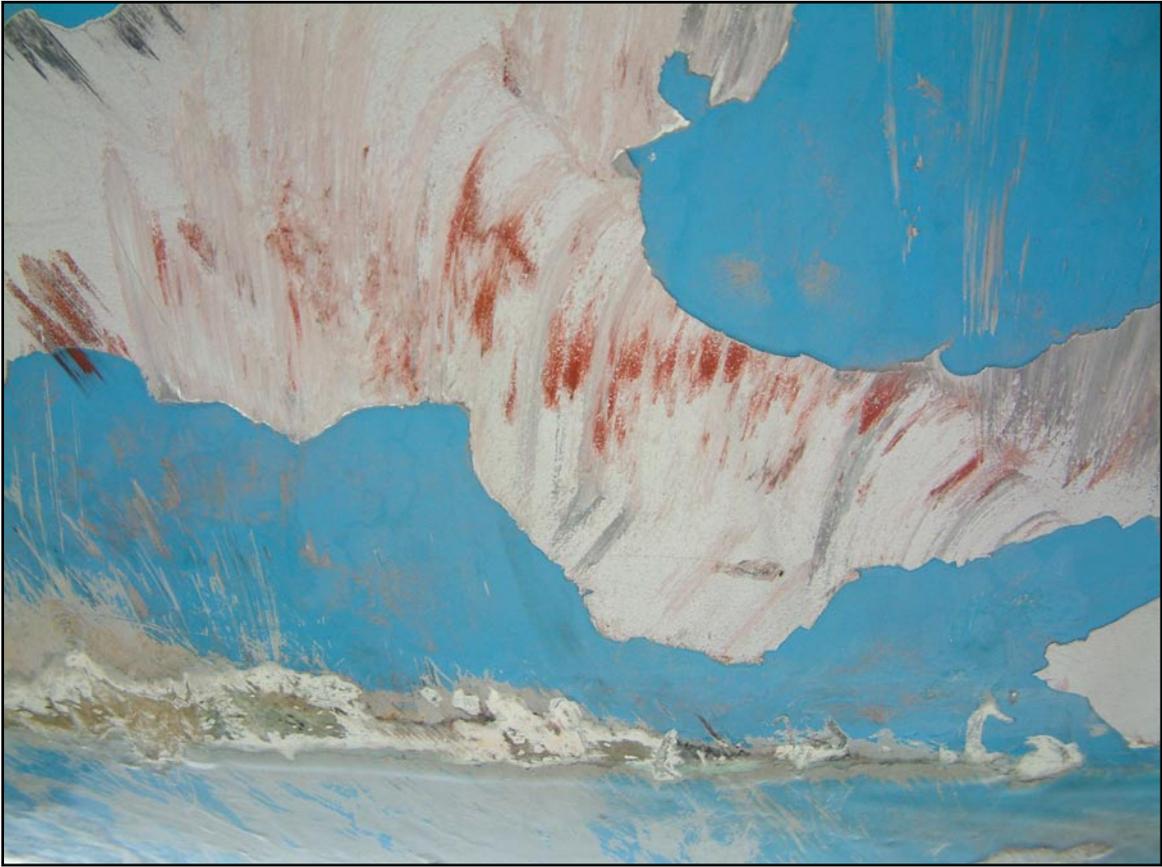
Paint and scratch marks on port side

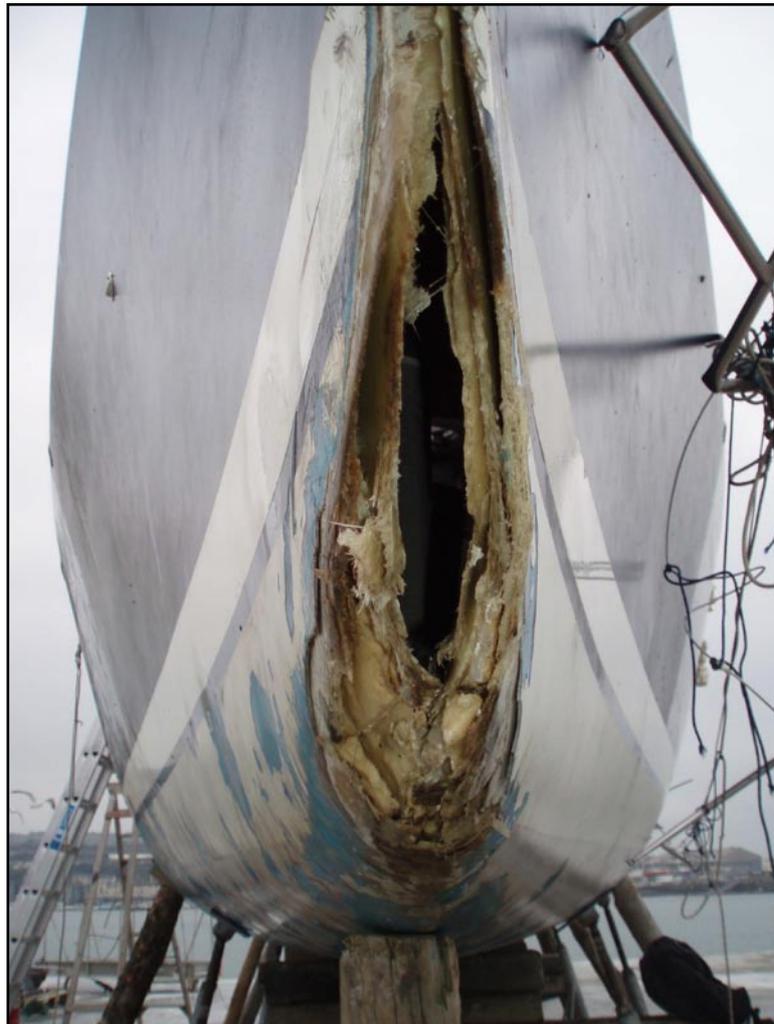
Figure 9

Stem damage showing full penetration of the hull

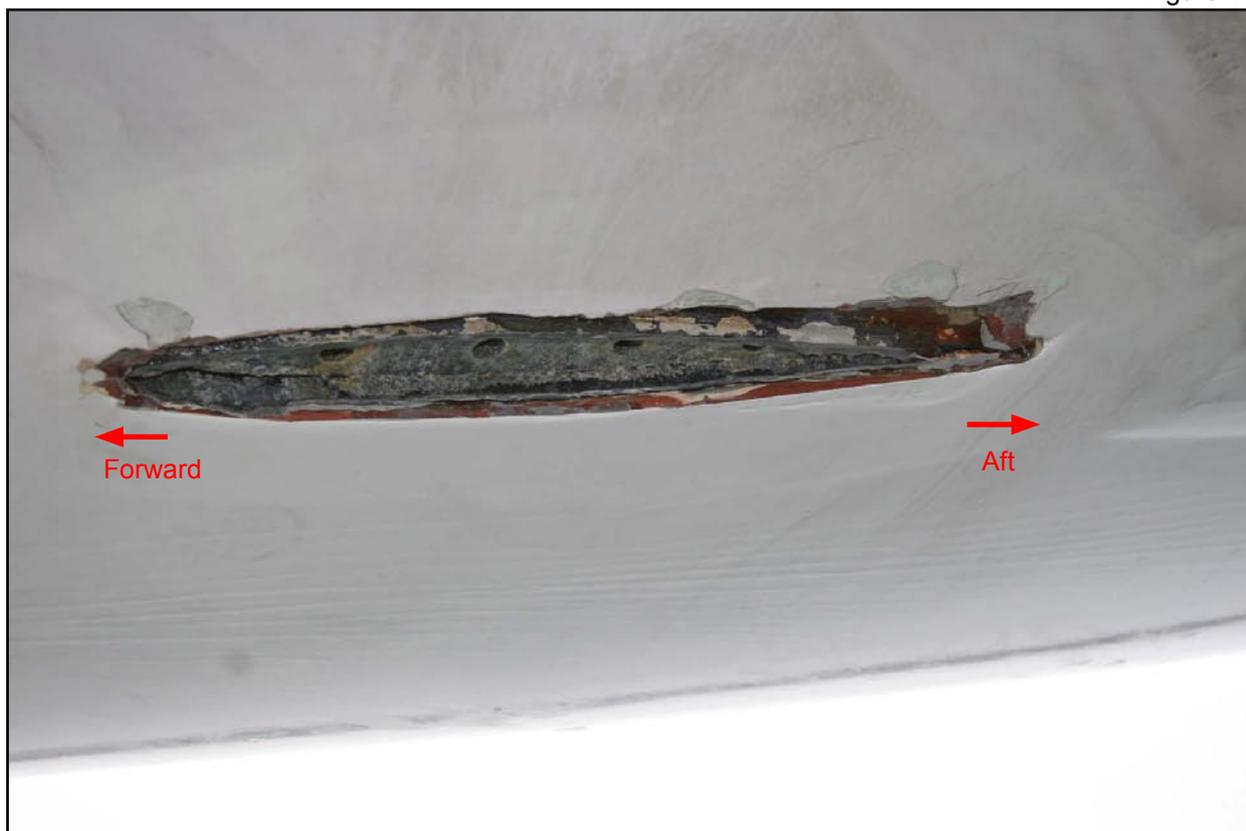
Figure 10

The keel was found to have been detached just below the fillet weld which had secured the fin to the taper box (**Figure 10**). The presence of “beach marks” (**Figure 11**) on the fracture surface suggested that the fin had become detached through a mechanism of fatigue failure. There was also evidence of corrosion around the area of the weld.

Remains of fin, showing point of detachment

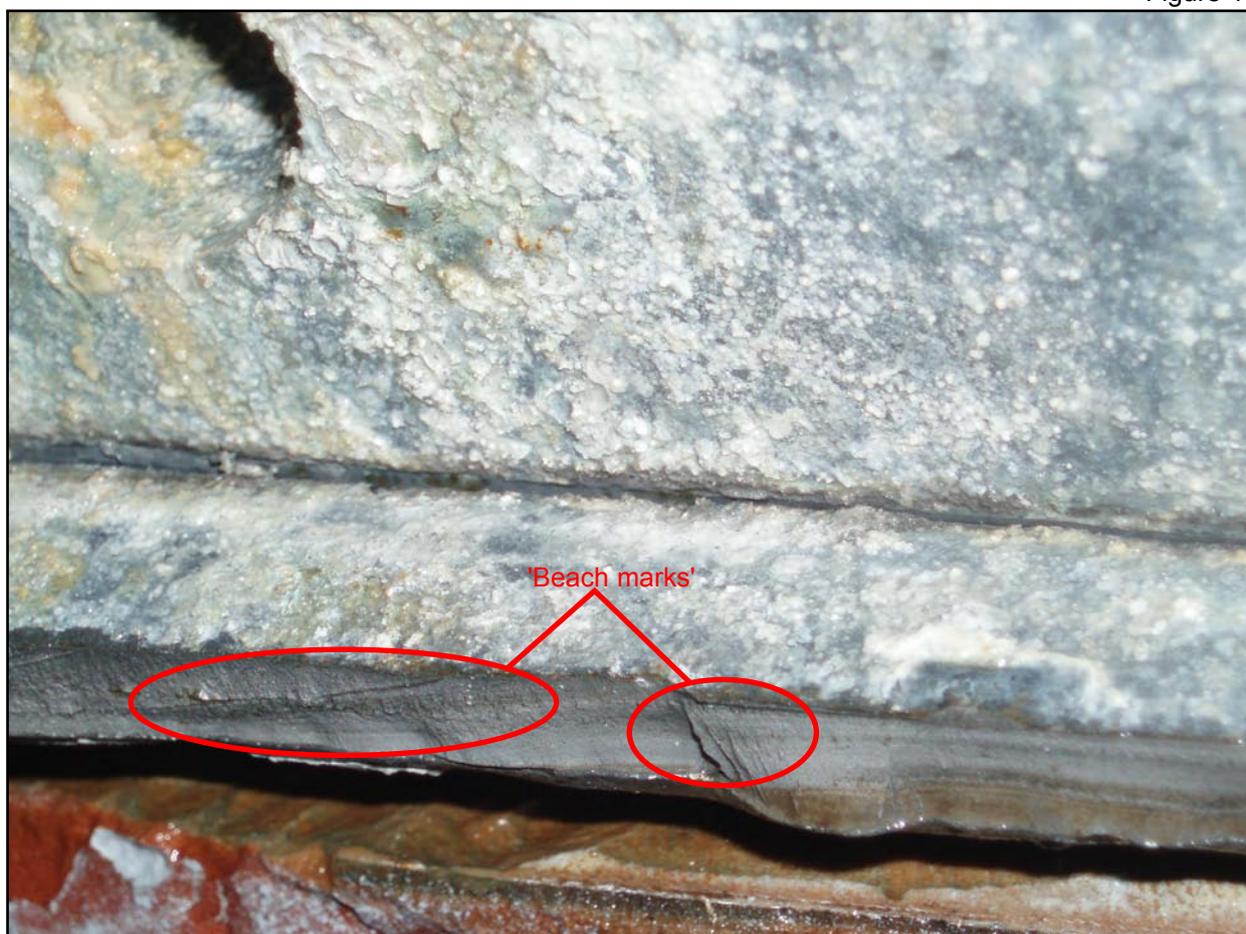
Figure 11

Remains of fin, showing 'beach marks'

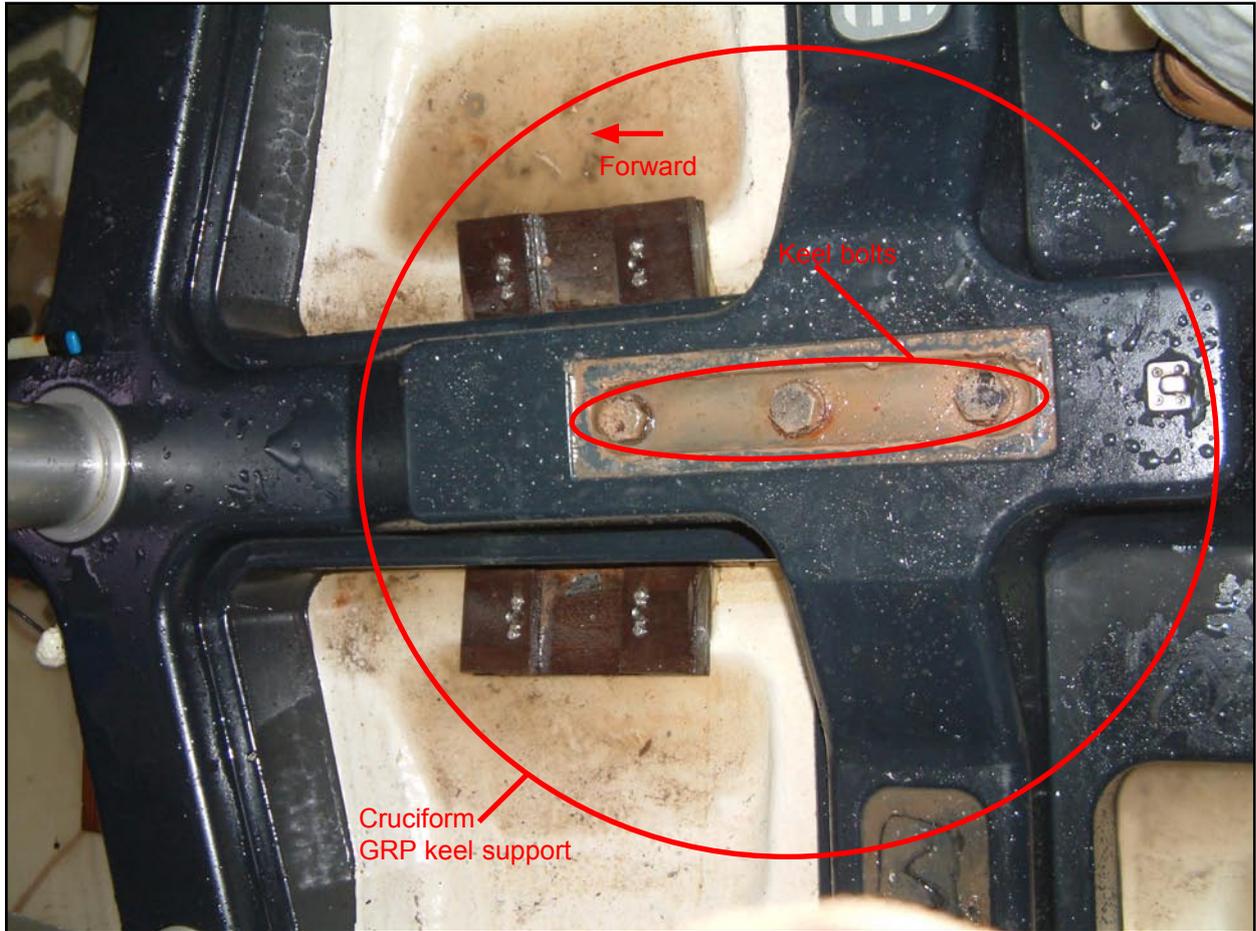
Figure 12

With the exception of the rope induced hull splits, the internal structure was sound. The substantial GRP, cruciform structure supporting the keel was visually examined. There was no evidence of cracking, deformation or de-lamination. The keel bolt cover was removed and, although the three keel bolts showed signs of light corrosion, they were in place (**Figure 12**). No attempt was made to check the tightness of the bolts as this was intended to be done under controlled laboratory conditions.

Keel GRP supporting structure and keel bolts

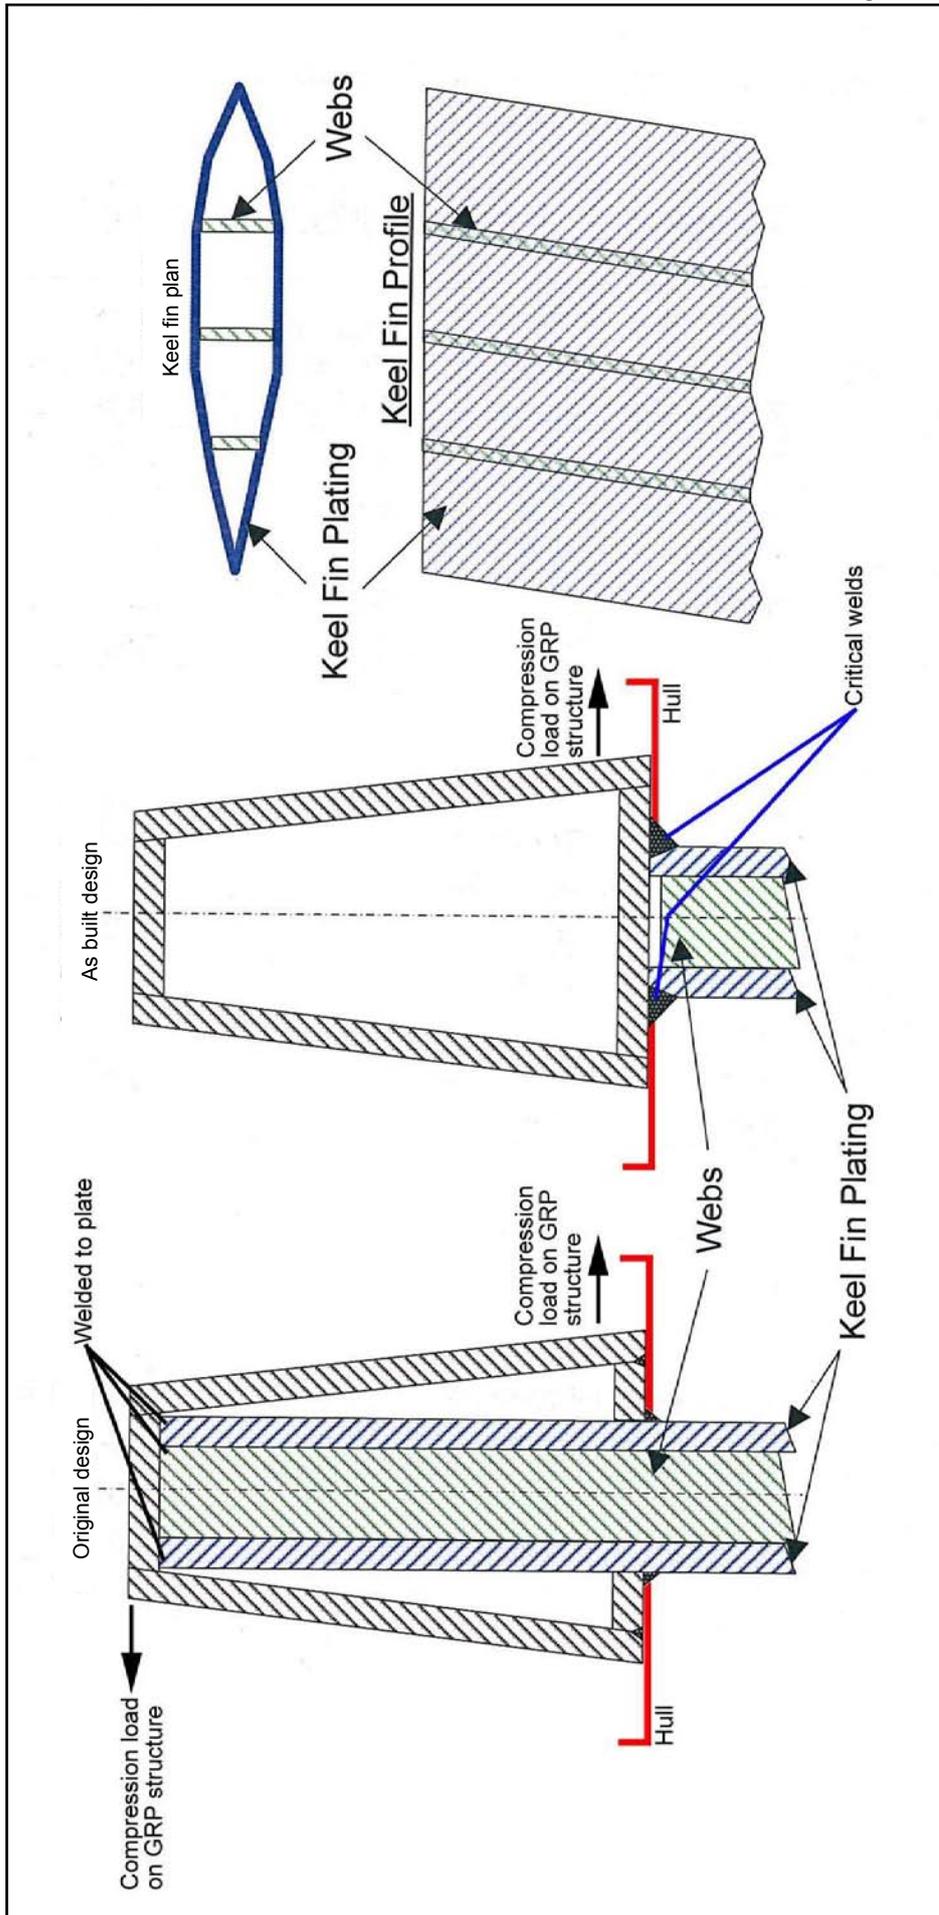
Figure 18

The main changes made by the fabricator were that the keel's internal stiffening webs were terminated short of the underside of the bottom plate of the taper box and also that they were not welded to the plate. Additionally, a critical fillet weld was introduced in the highly stressed area of the fin attachment to the taper box. The fabricator also specified that the fin was to be hot dip galvanised to give a degree of corrosion protection. A technical drawing of the changed, “as built” design is at **Figure 17**. A schematic showing the comparisons of the “original” and the “as built” designs is at **Figure 18**. A schematic of the configuration for the connection of the keel fin taper to the hull is at **Figure 19**.

Schematic comparison of 'original' and 'as built' designs

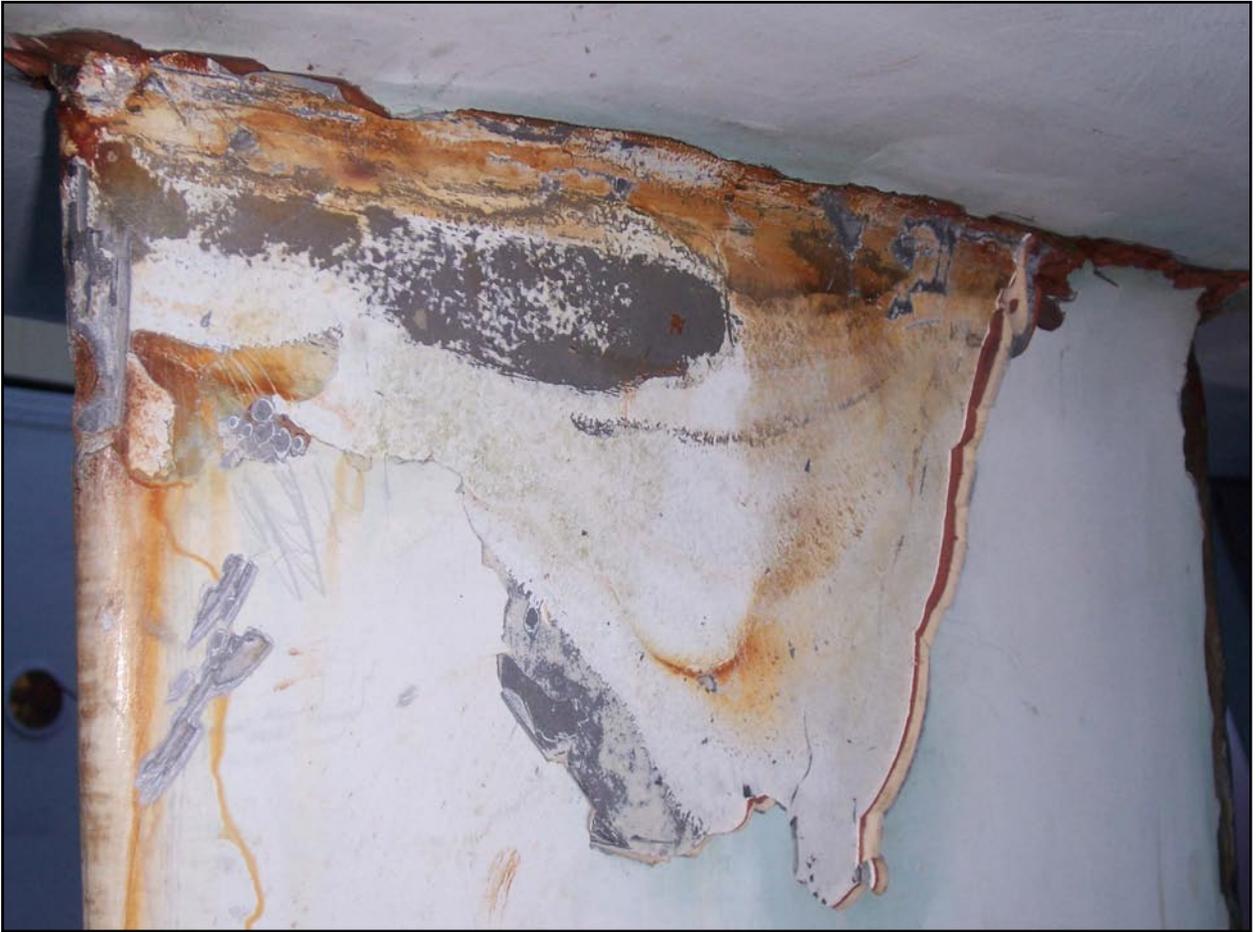
On taking the boat out of the water, significant damage was found to the keel fin's port (**Figure 23**) and starboard side (**Figure 24**) epoxy filler and anti-fouling surfaces near the hull juncture. The amount of detachment was most severe on the port side of the keel fin and, in this case, bare steel and corrosion products were clearly evident. There were also corrosion products and detachment of the epoxy coating and primer on both the leading and trailing edges of the fin.

Condition of port side of the keel - November 2006

Fast Tack Yachts' staff wire brushed the surfaces to remove the corrosion products and immediately primed the surfaces to prevent the onset of corrosion. Unfortunately the staff did not critically examine the reason for the surface and filler detachment. The implications of this oversight are discussed at Section 2.

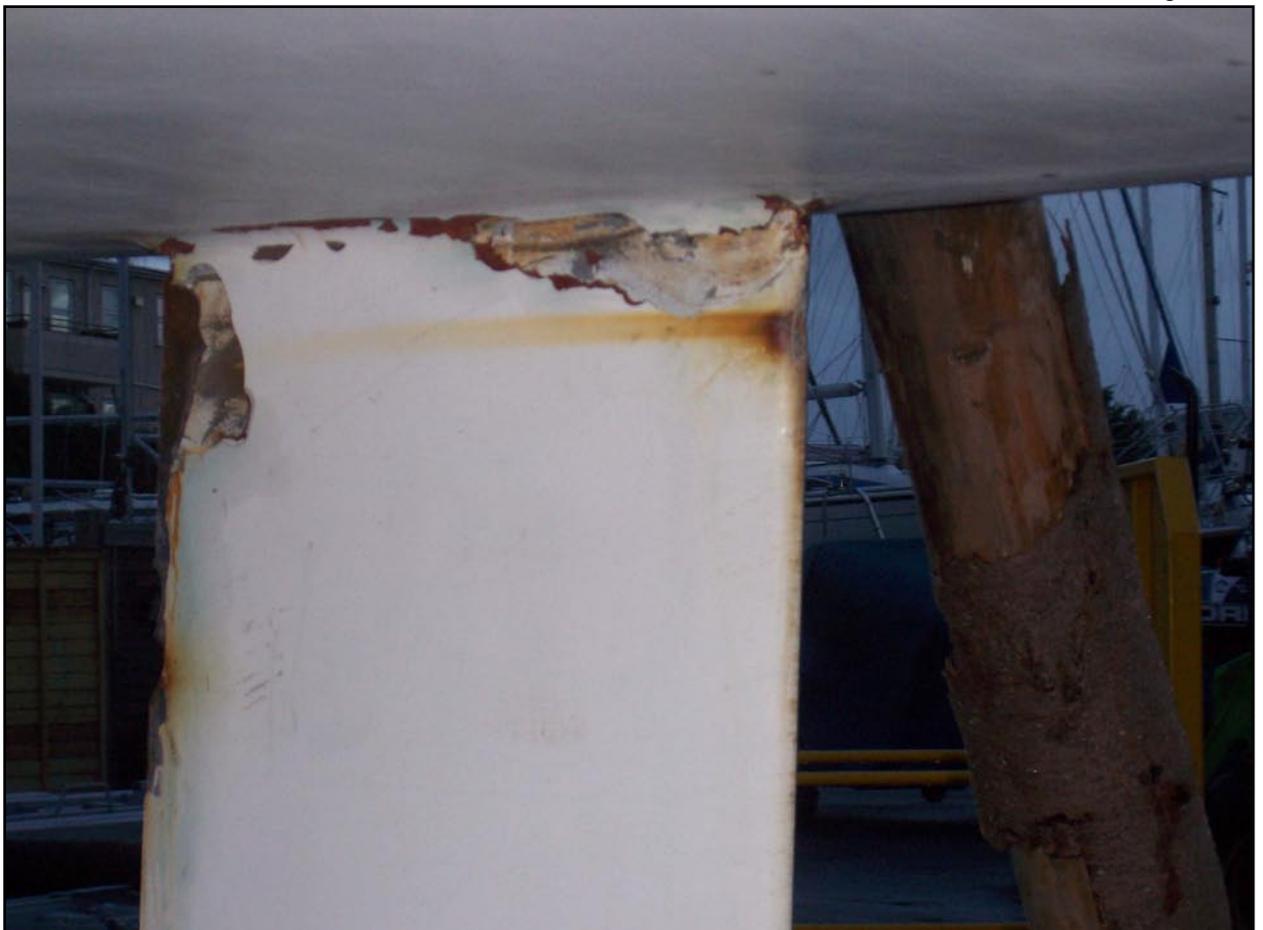
Condition of starboard side of the keel - November 2006

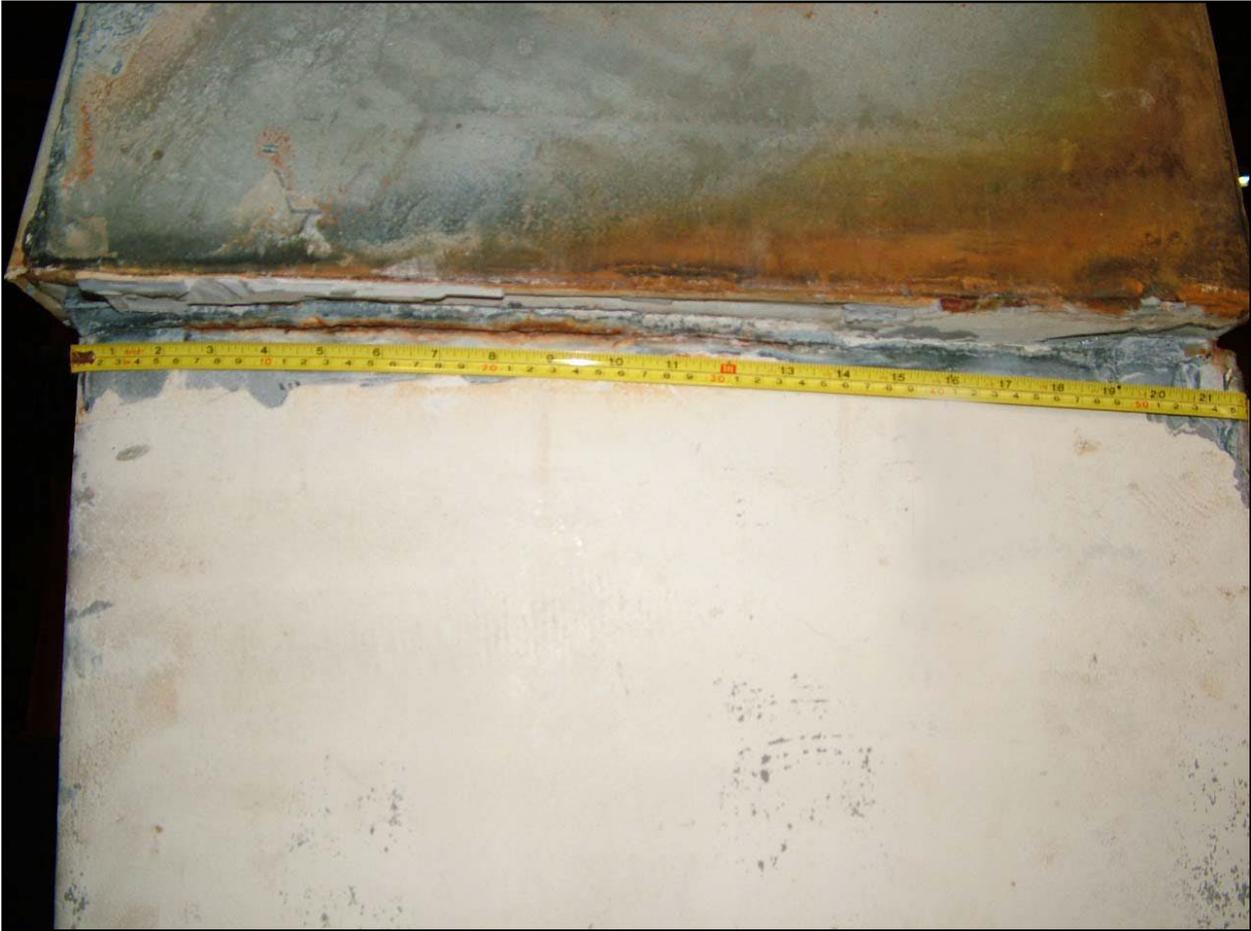
Figure 25

In March 2007 the owner was concerned that one of these boats, *Who Cares*, was not in an upright position when alongside the pontoon. The boat was taken out of the water and it was found that the keel fin had suffered a 370mm fracture along the port side directly under the fillet weld connecting the fin to the taper box (**Figures 25 and 26**).

The failure had occurred in an identical position to that of *Hooligan V*. The fin was removed from *Who Cares* and returned to the fabricator. MAIB inspectors examined the GRP female taper (**Figure 27**) on board *Who Cares* and found it to be defect free. They also examined the failed keel.

Fracture of the port side of the keel fitted to *Who Cares*

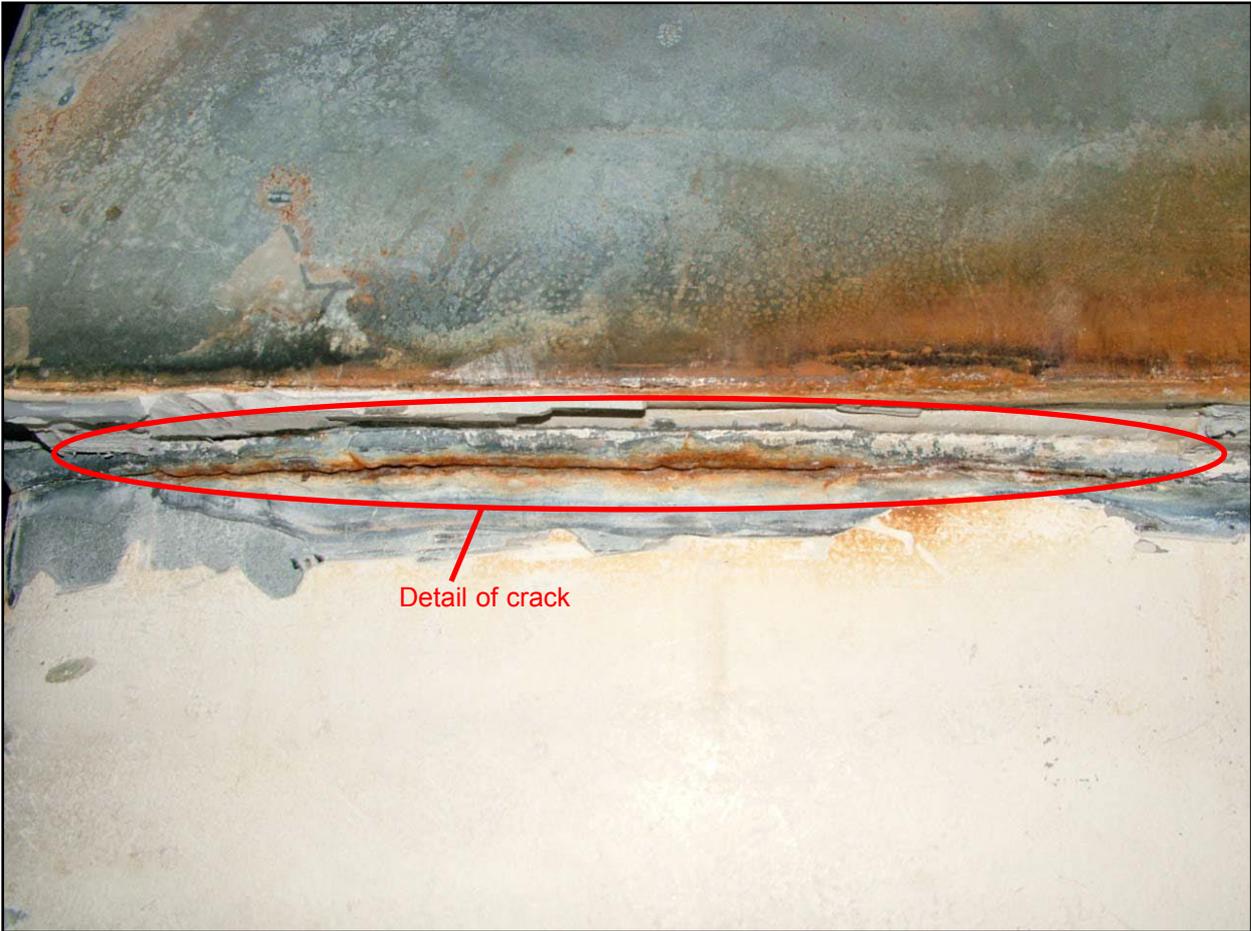
Figure 26

Detail of the fracture to the port side of the keel fitted to *Who Cares*

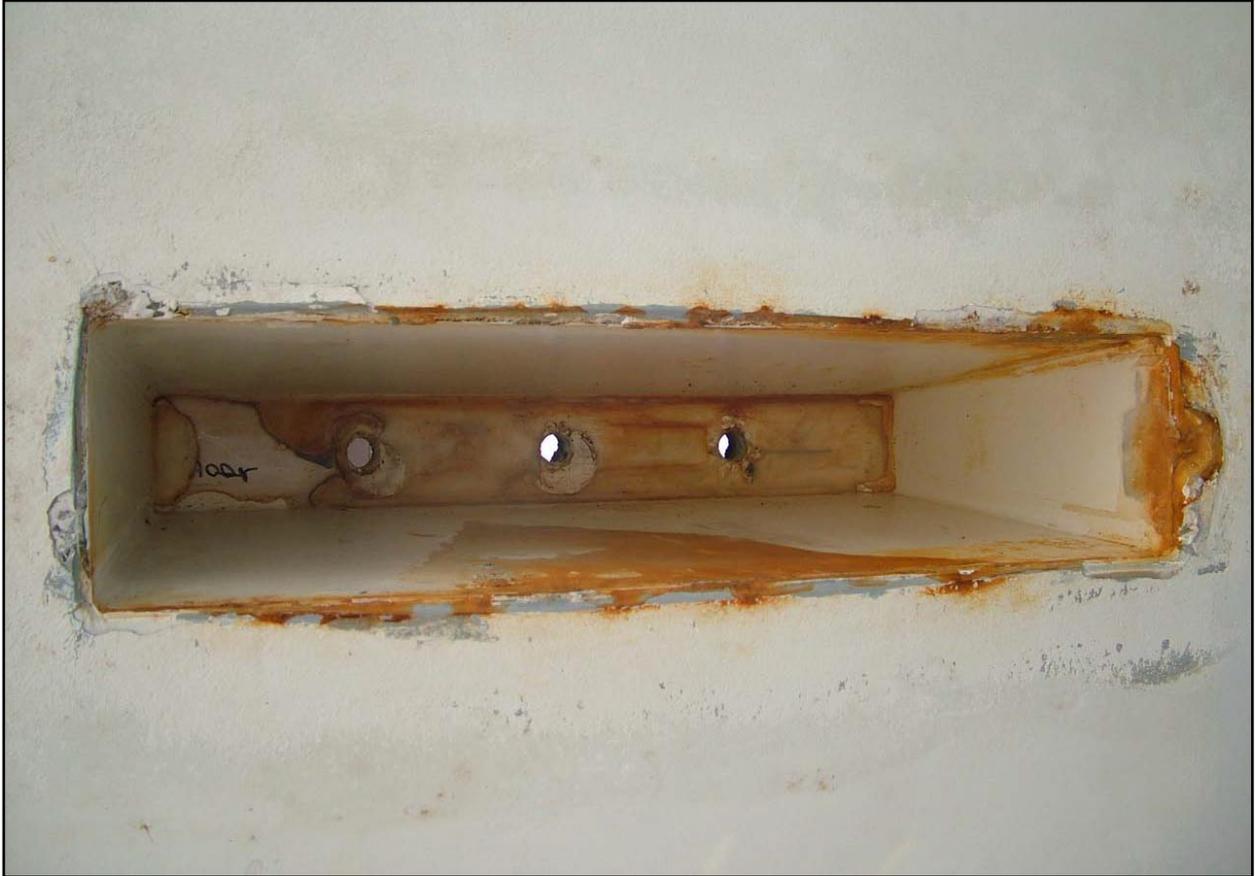
Figure 27

Female GRP fin taper fitted to *Who Cares*

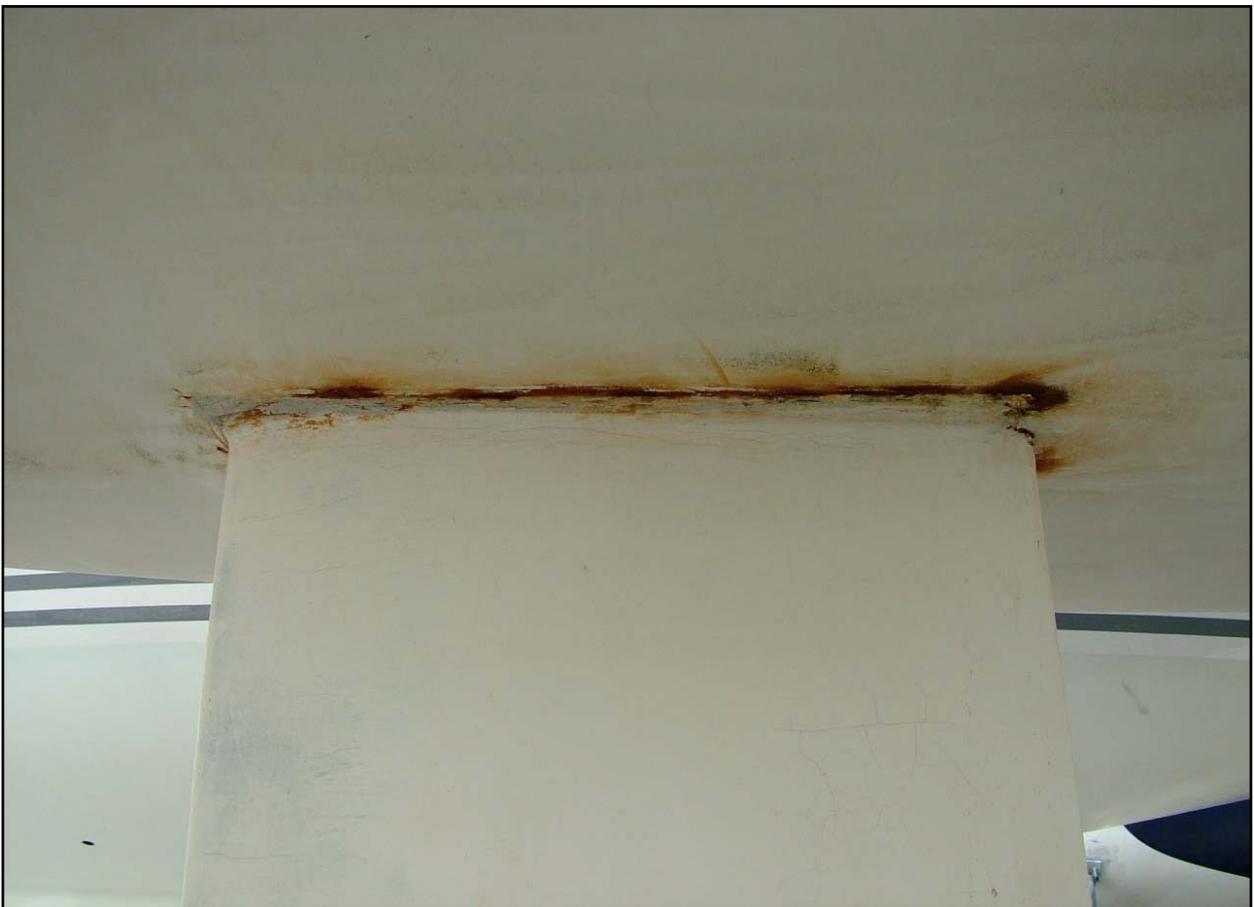
Figure 28

The keels of two other Max Fun 35s, *Mad Max* and *Guts "n" Glory* (**Figures 28 and 29**) were also visually examined. Both exhibited movement of the keel, evidenced by cracking of the epoxy fillers and anti-fouling surfaces. The condition of the steel keel structures has not been determined.

Keel of *Mad Max* showing cracking of the epoxy fillers and anti-fouling

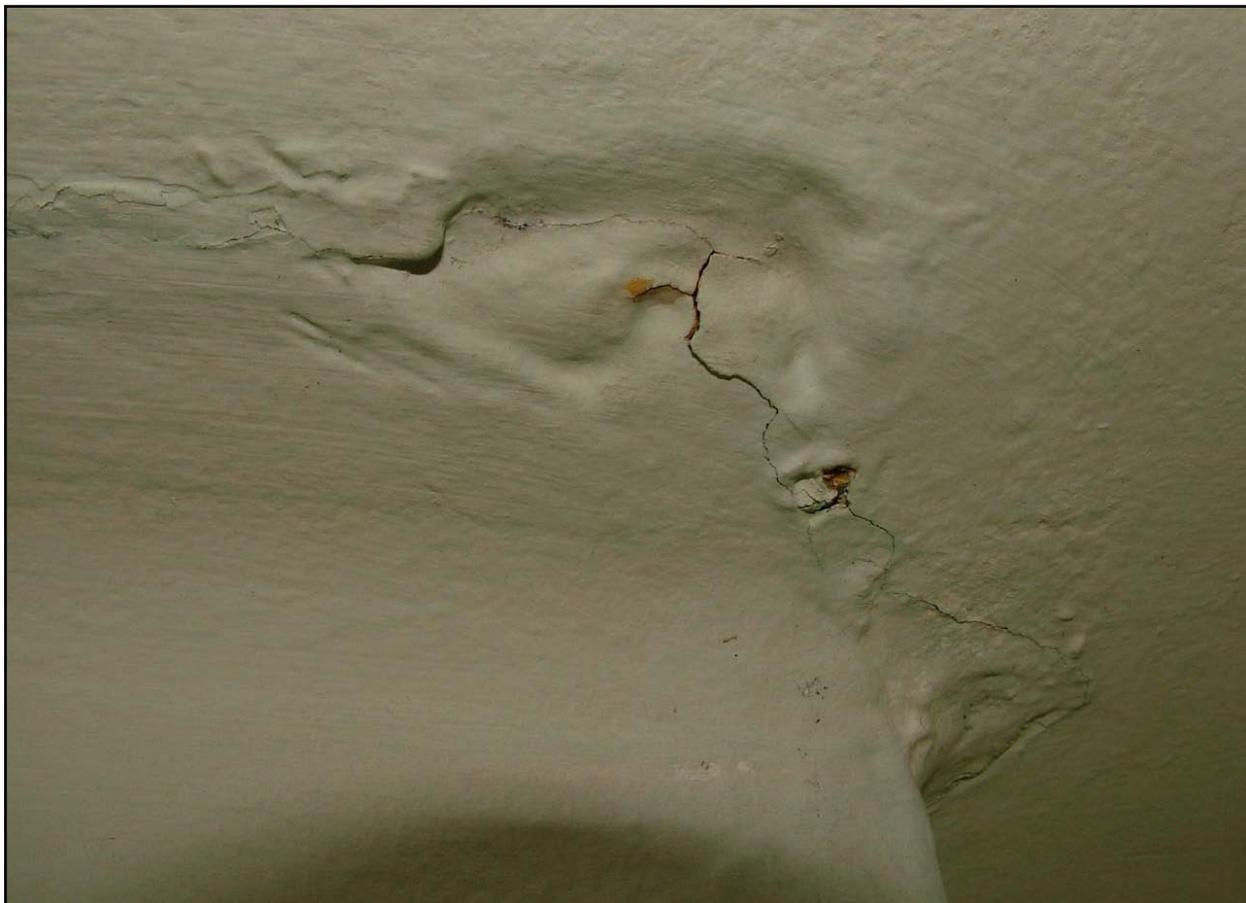
Keel of *Guts "n" Glory* showing cracking of the epoxy filler and anti-fouling
