Report on the investigation of the  
keel failure, capsize, and loss of one crew member from  
the Max Fun 35 yacht

***Hooligan V***

10 miles south of Prawle Point

**Report No 19/2007**  
**August 2007**

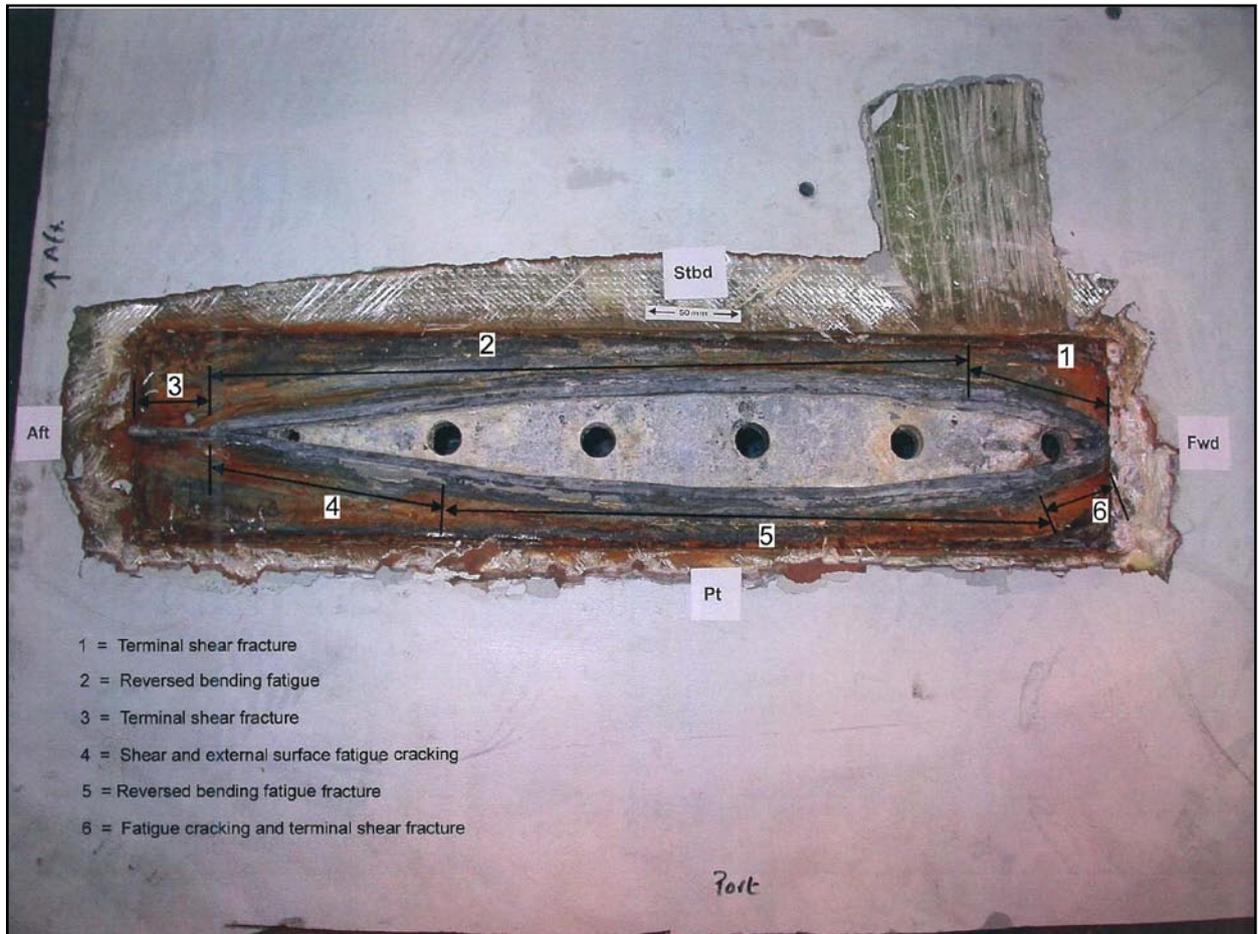
Figure 31

Predominant fracture types

In the case of highly stressed, fabricated keels it is good practice to carry out a detailed periodic visual check of the integrity of the keel. Wherever there is any doubt about the condition of the keel the use of Non-destructive Examination (NDE) techniques will confirm whether cracks are present. There is a wide range of techniques available, from the relatively cheap, dye penetrant and Magnetic Particle Indicator to the more expensive radiography and ultrasonic procedures.

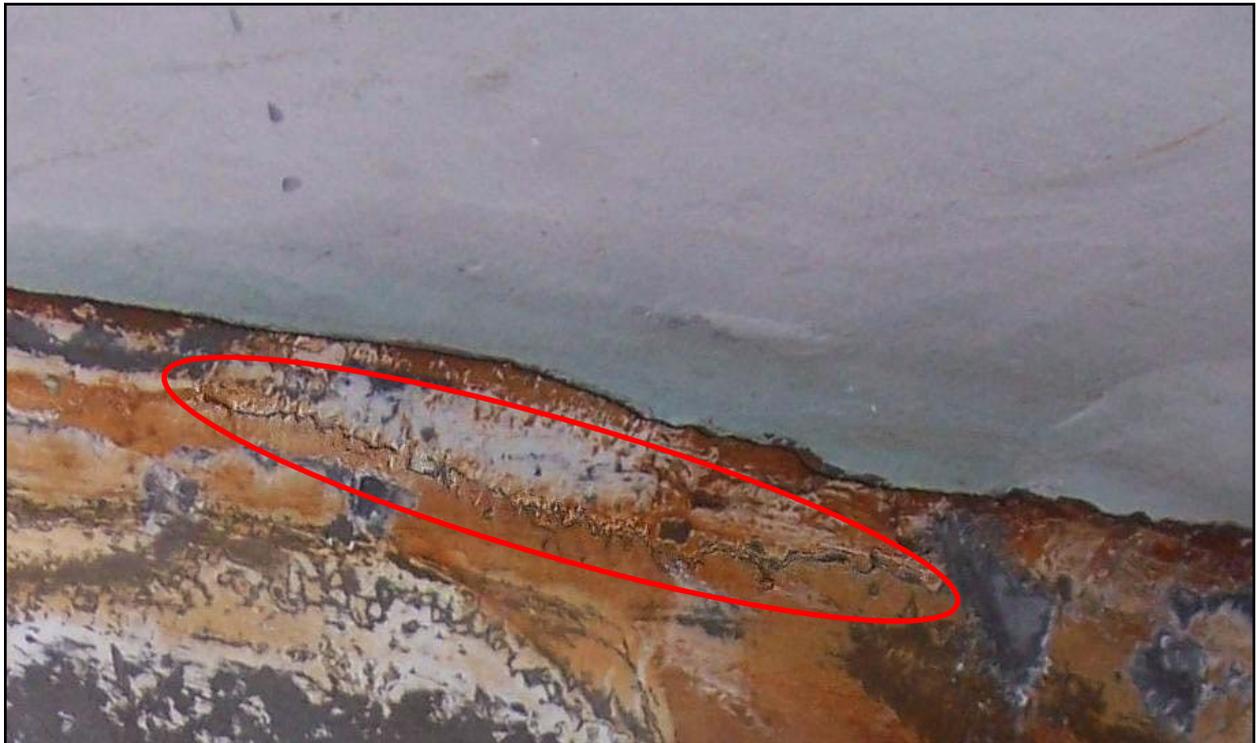
Figure 32

Site of possible crack - port side of keel photographed at Queen Anne's battery, November/December 2006
