Report on the investigation of
the loss of two lives and one seriously injured person
on board the Singaporean registered tanker

FR8 Venture

close to the west pilot station to Scapa Flow in the Orkney Islands
on 11 November 2006

Report No 16/2007
July 2007

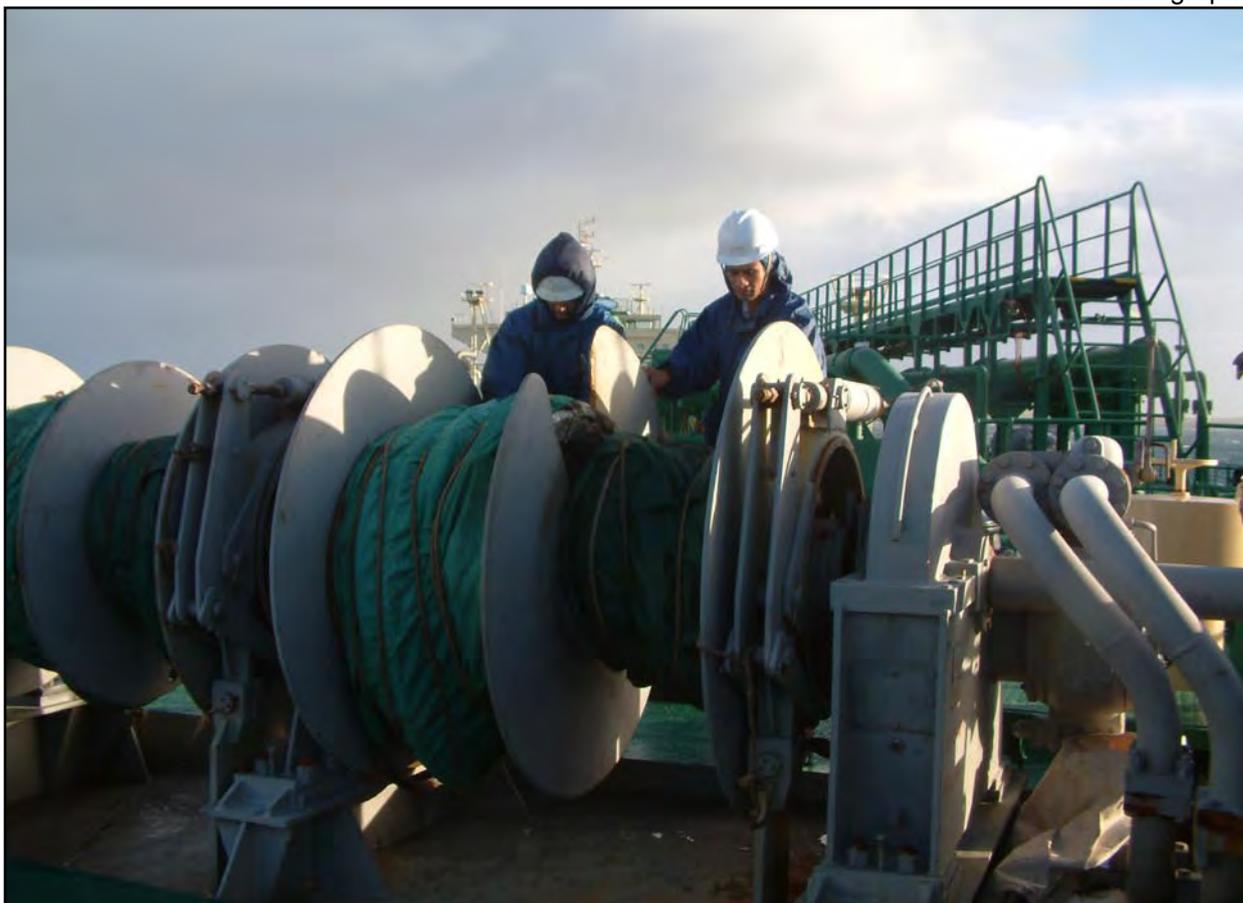
When the OS and AB Ravindra arrived forward, the latter joined AB Kharva on the platform on the aft side of the starboard winch to help him lash the canvas covers around the mooring wires (**Photograph 2**). The OS had joined the bosun who was standing behind the storeroom door. The bosun told the OS to place a wire lashing through the starboard anchor cable. Just as the OS made a move towards the starboard anchor cable, the first of two large waves were shipped over the bow.

A reconstruction of the positions in which AB Ravindra and AB Kharva were standing

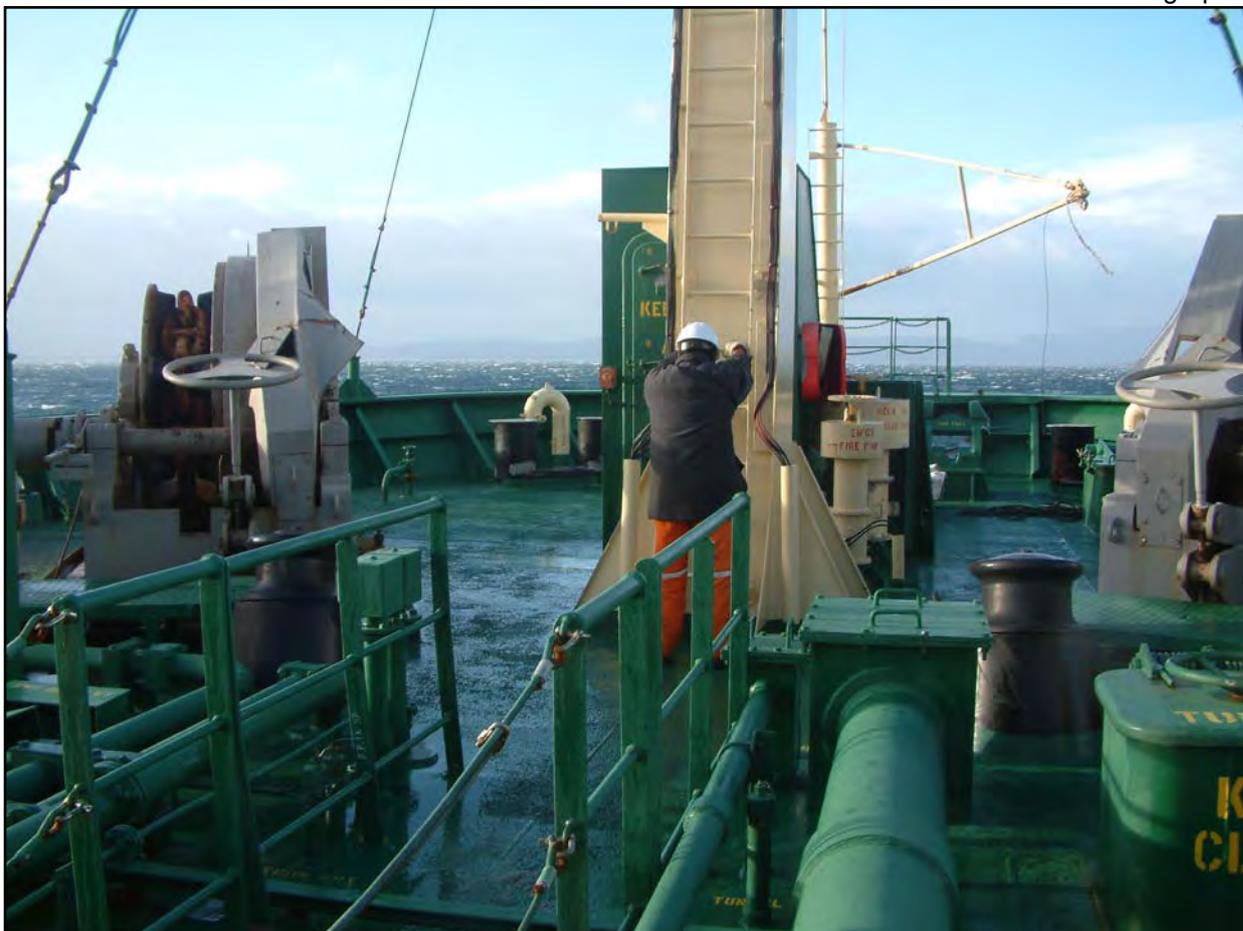
Photograph of the bosun showing how he clung onto the foremast ladder rungs

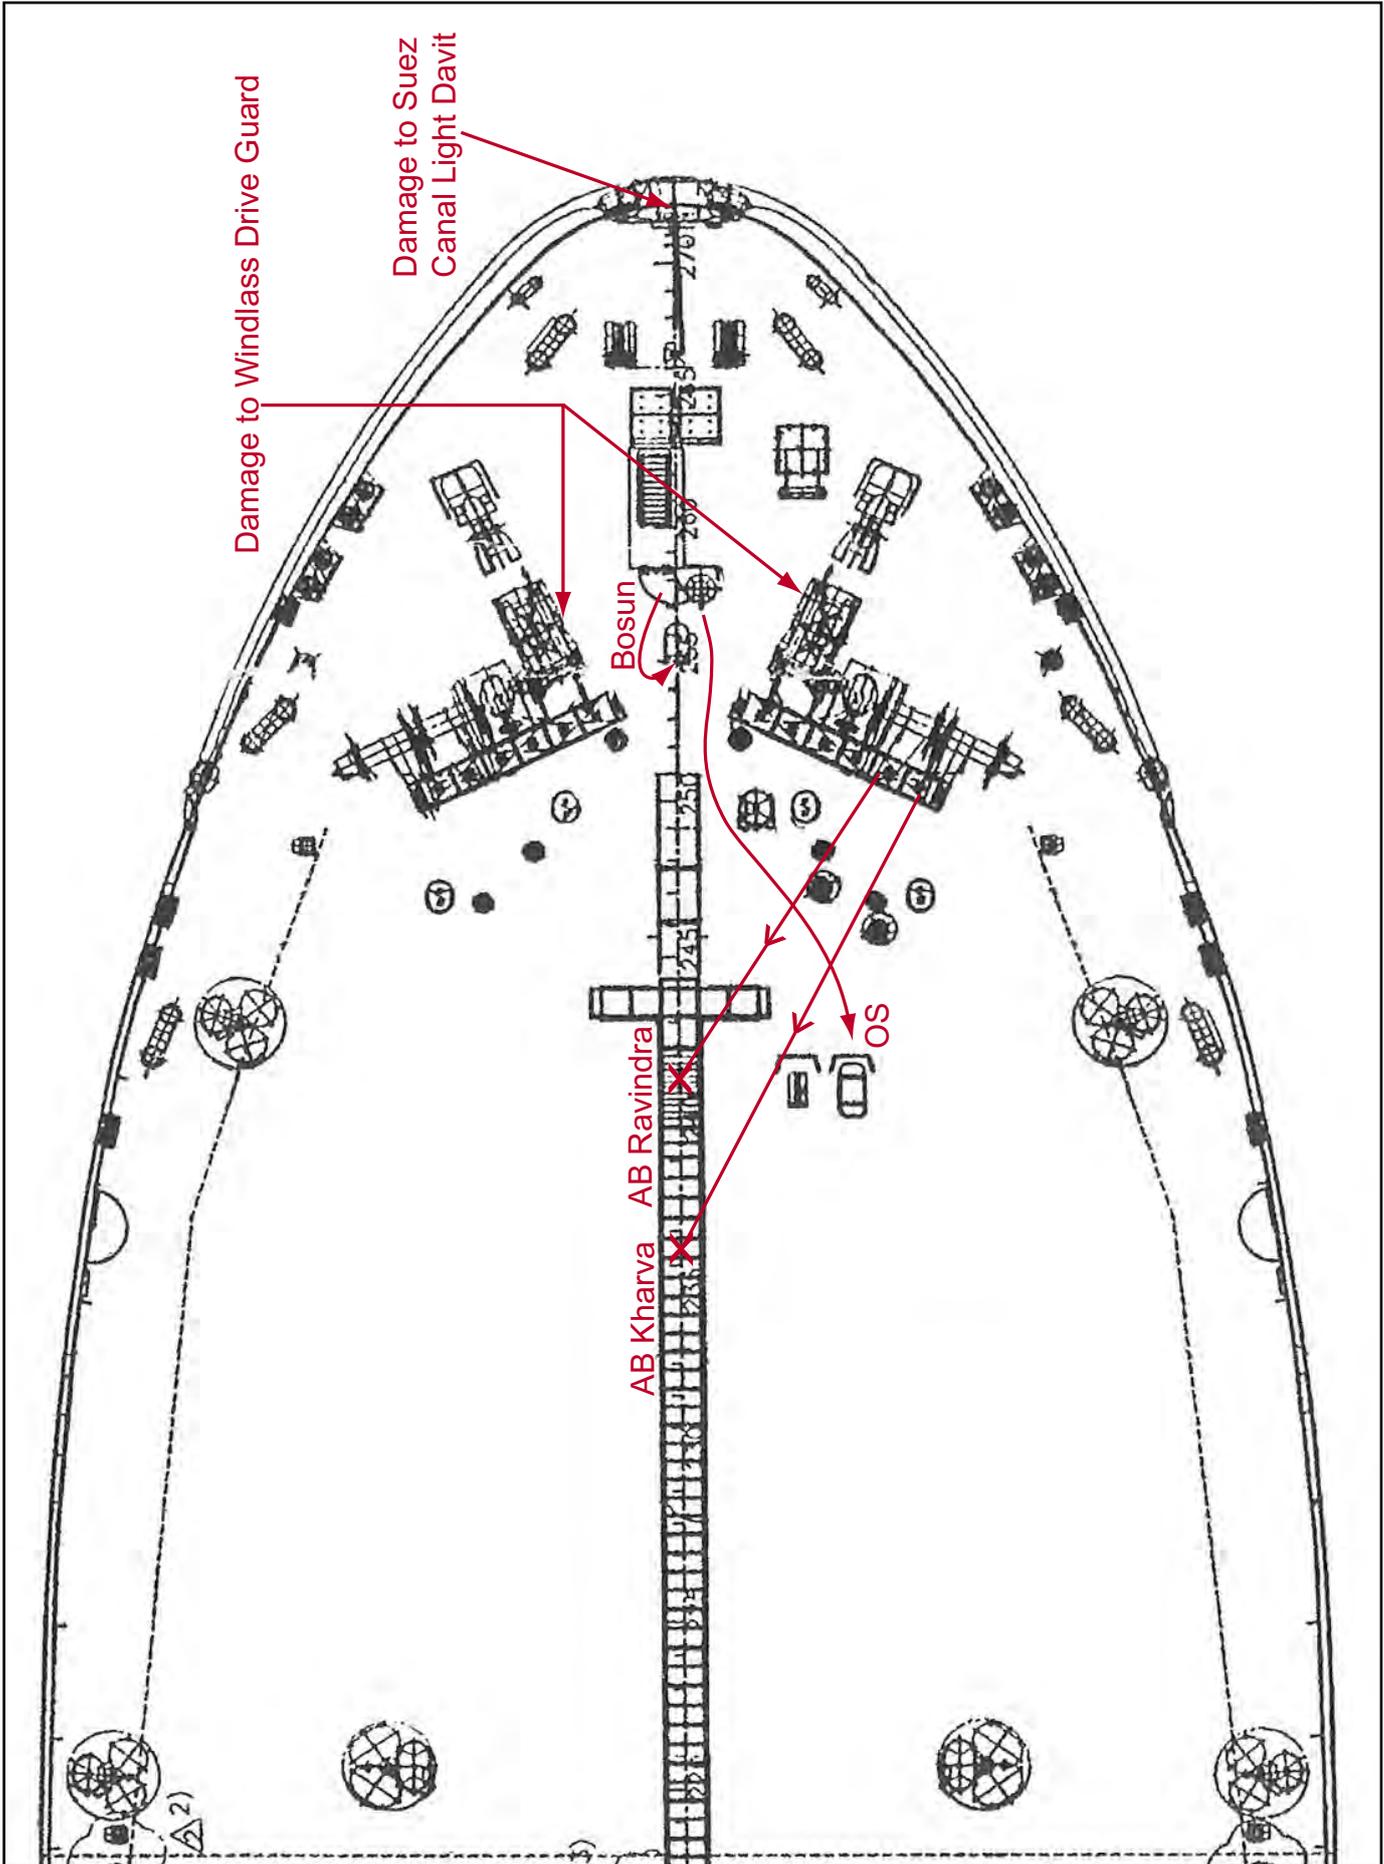
Time and date	:	1220, 11 November 2006
Location of incident	:	Latitude 58° 45.1'N Longitude 003° 11.01'W near the west pilot station for Scapa Flow
Persons on board	:	24
Injuries/fatalities	:	Two fatalities and one serious injury
Damage	:	Minor damage to Suez light davit and to both windlass gear wheel guards

Plan of foredeck showing movement of the four seamen and damage to the ship

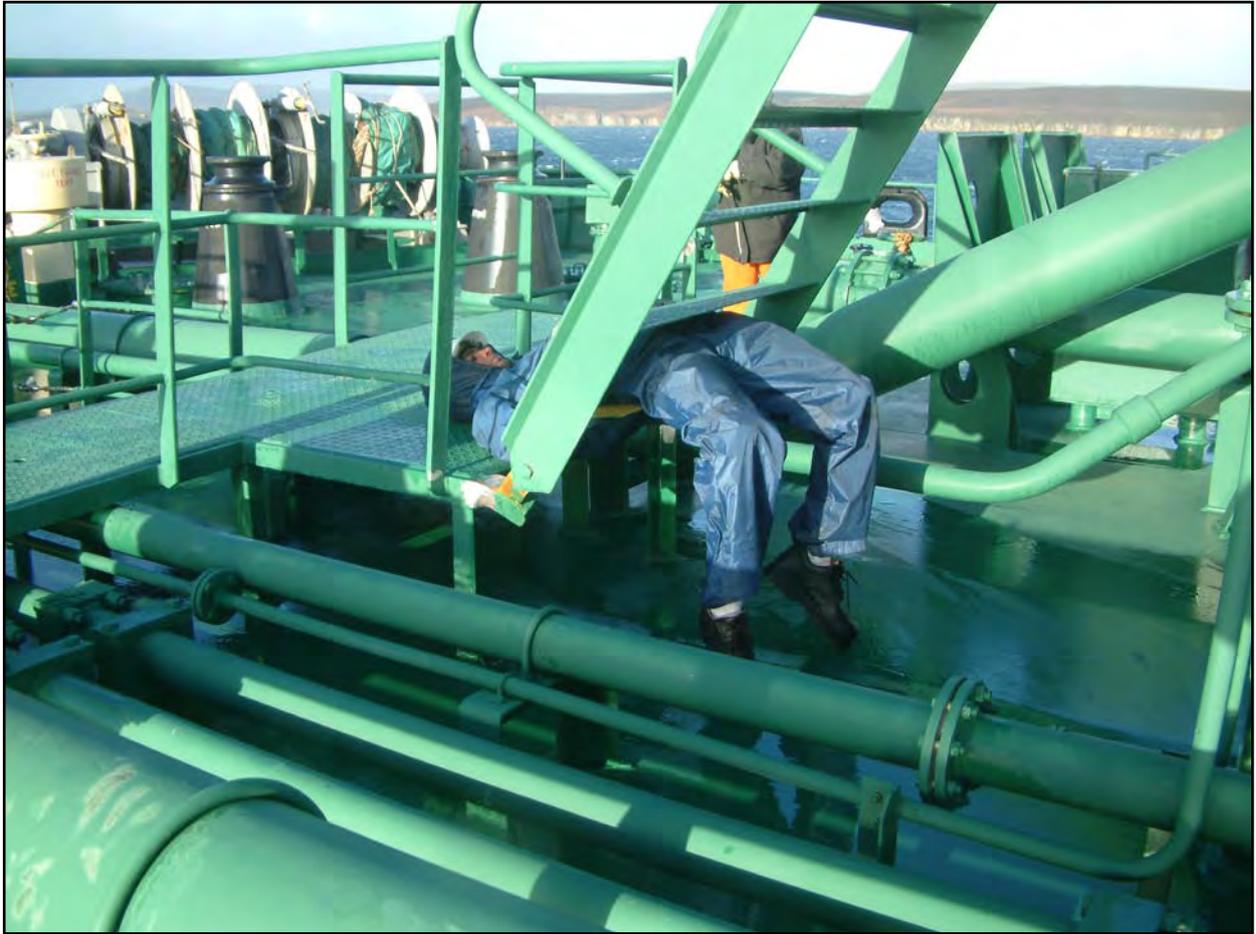
A crew member demonstrates how AB Ravindra was found

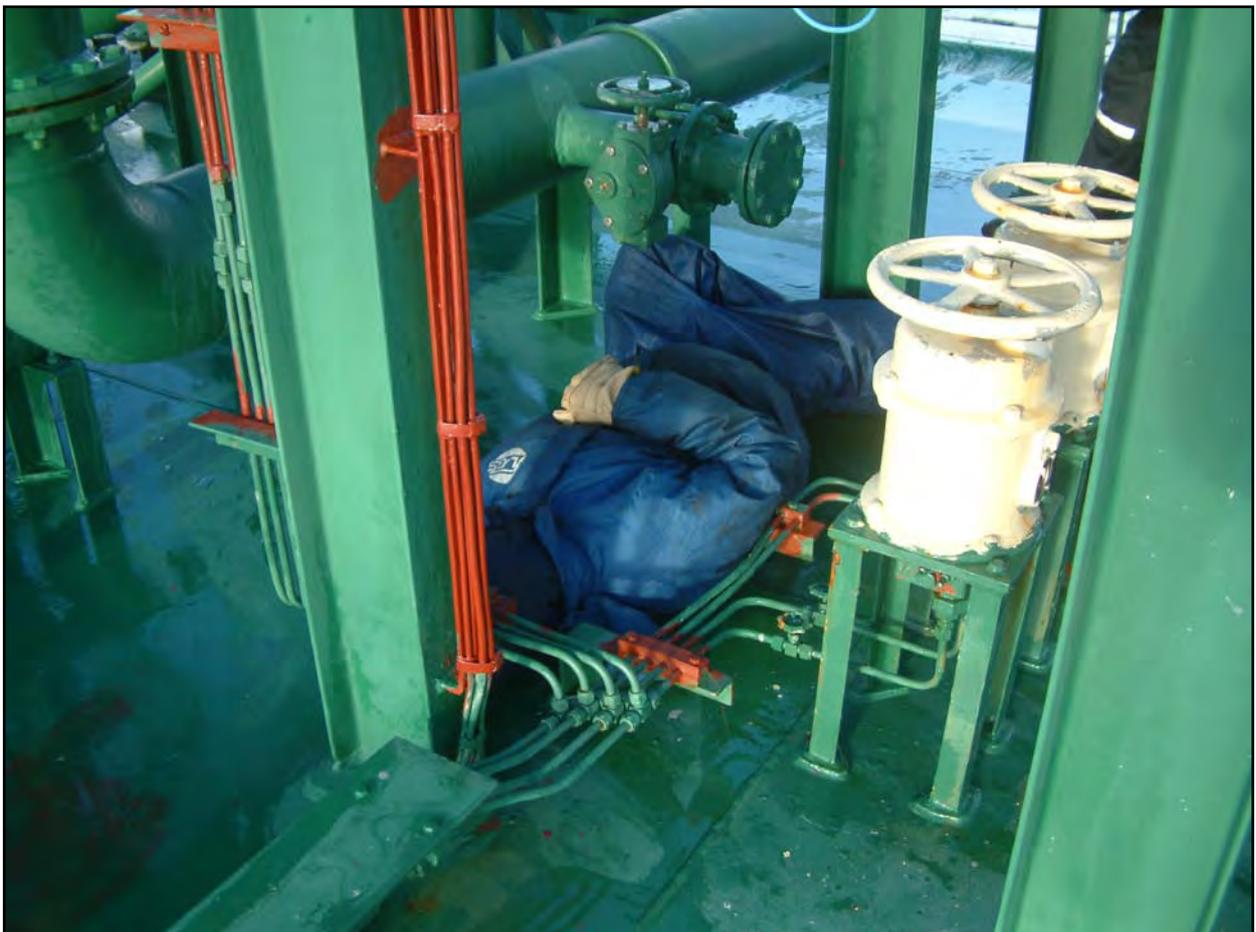
A crew member demonstrates how AB Kharva was found
