Report on the investigation of the machinery breakdown  
and subsequent fire onboard

***Maersk Doha***

2 October 2006

**Report No 15/2007**  
**July 2007**

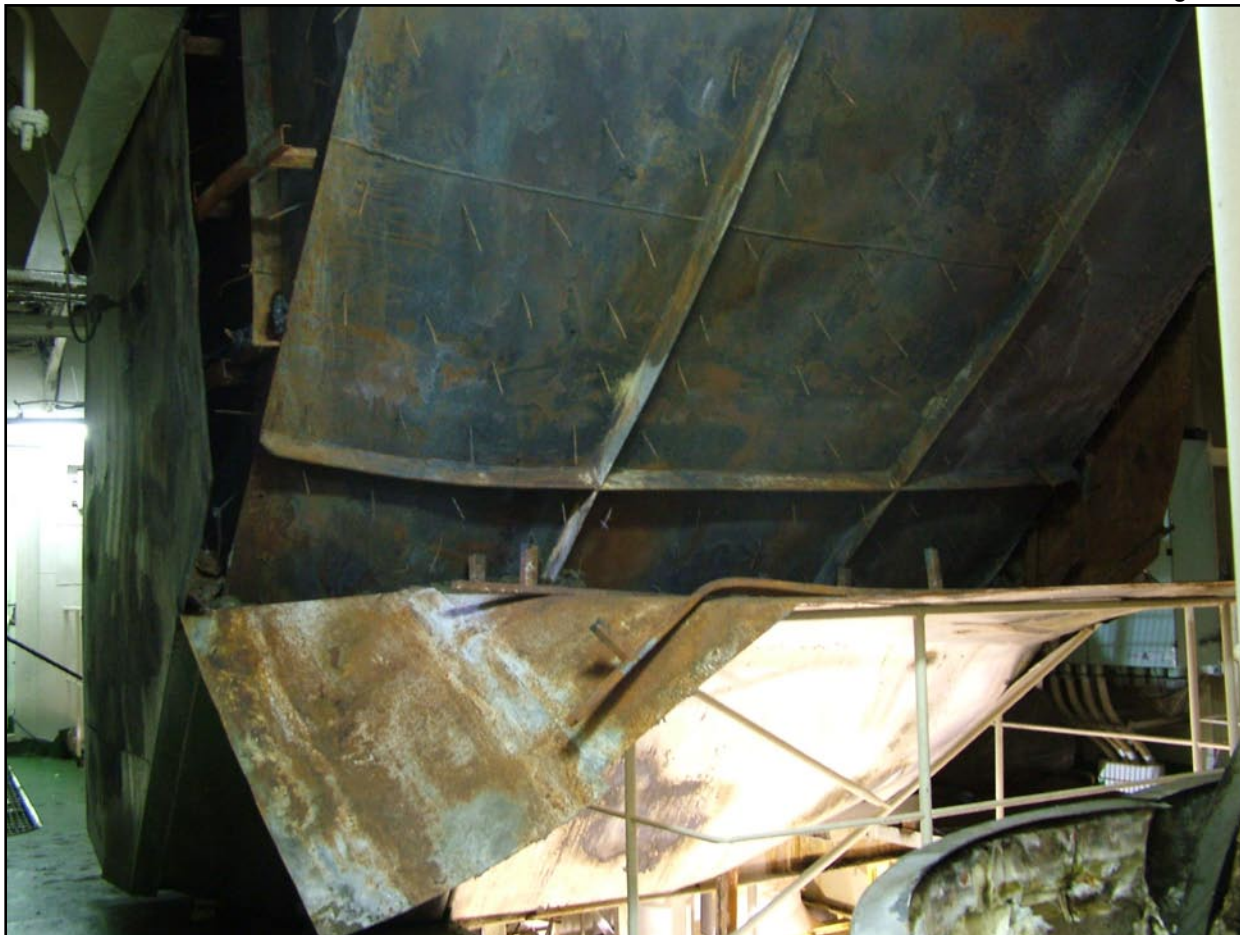
View of EGE and detached insulation

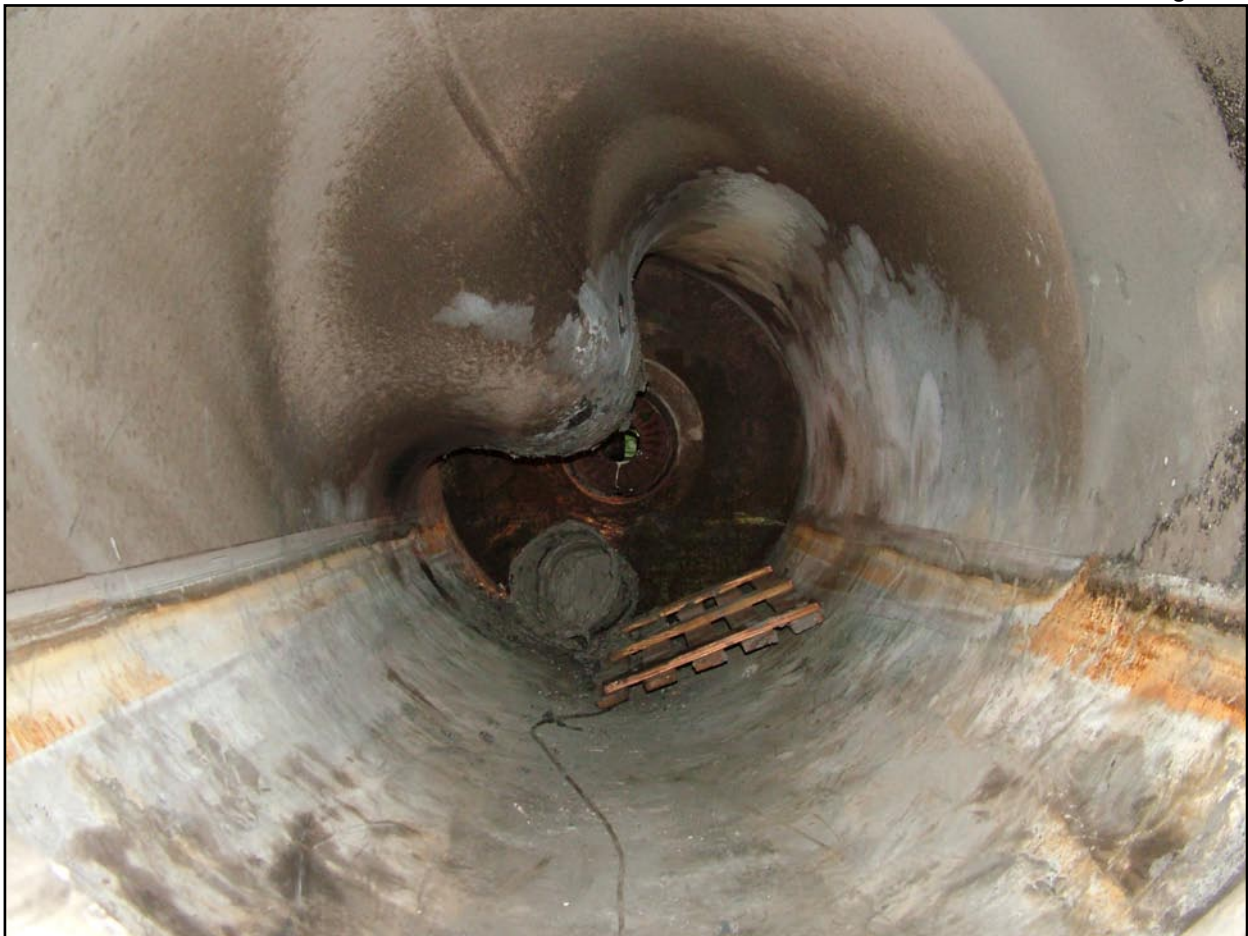
Figure 3

Once the auxiliary boiler was cool enough to inspect, a bulge measuring about 1m long and extending about 0.6m into the furnace tube was discovered **Figure 3**. A circumferential crack, about 0.3m long was also found across the peak of the bulge. No defects were reported with the auxiliary boiler control mechanism or surveillance system.

Auxiliary boiler - distorted furnace tube

Temporary repairs to the cracked furnace tube in the auxiliary boiler were made by a welder from the same company that was fabricating the new fire tube. He cut back the cracked area and welded the gap from both water and furnace sides. There was little that could be done to the distorted bulge in the furnace tube and it remained in the immediate path of the burner flame. It was inevitable that the flame would impinge on the bulge, which was coated with refractory cement to help protect it from overheating. After some difficulty in making the flame burn steadily, pressure in the auxiliary boiler was worked up slowly to between 3.5 and 4 Bar. The safety valves could not be adjusted to this lower working pressure and were reduced to their minimum settings of about 6.5 Bar.

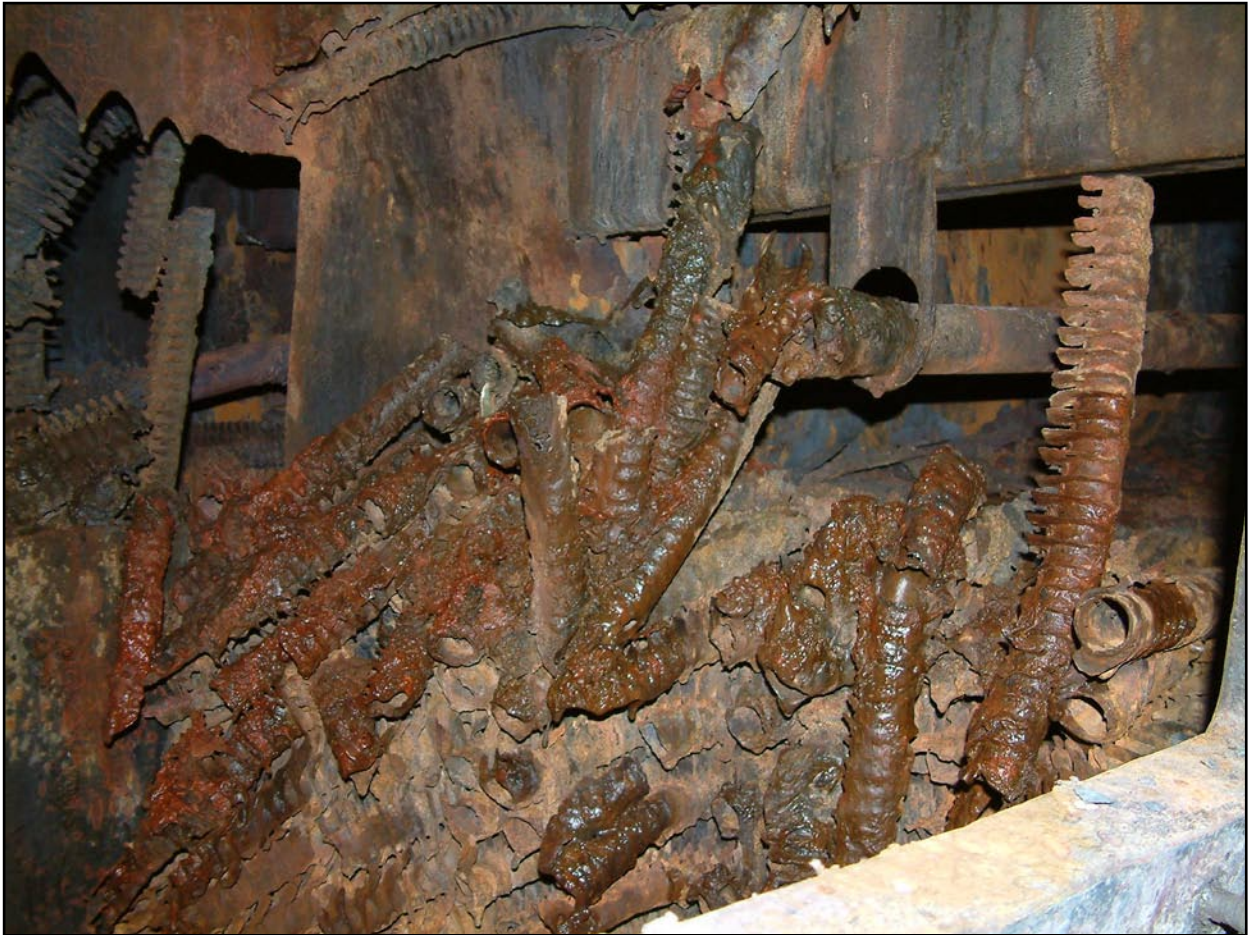
Figure 4

The EGE was severely damaged with over half the tubes having melted **Figure 4**. Molten metal had solidified and gathered with ash and slag at the base of the exhaust trunking **Figure 5**. The EGE structure and casing were buckled by heat, which had also radiated to burn paintwork, cables, light fittings and fire detectors in the surrounding area.

Damaged tubes in EGE

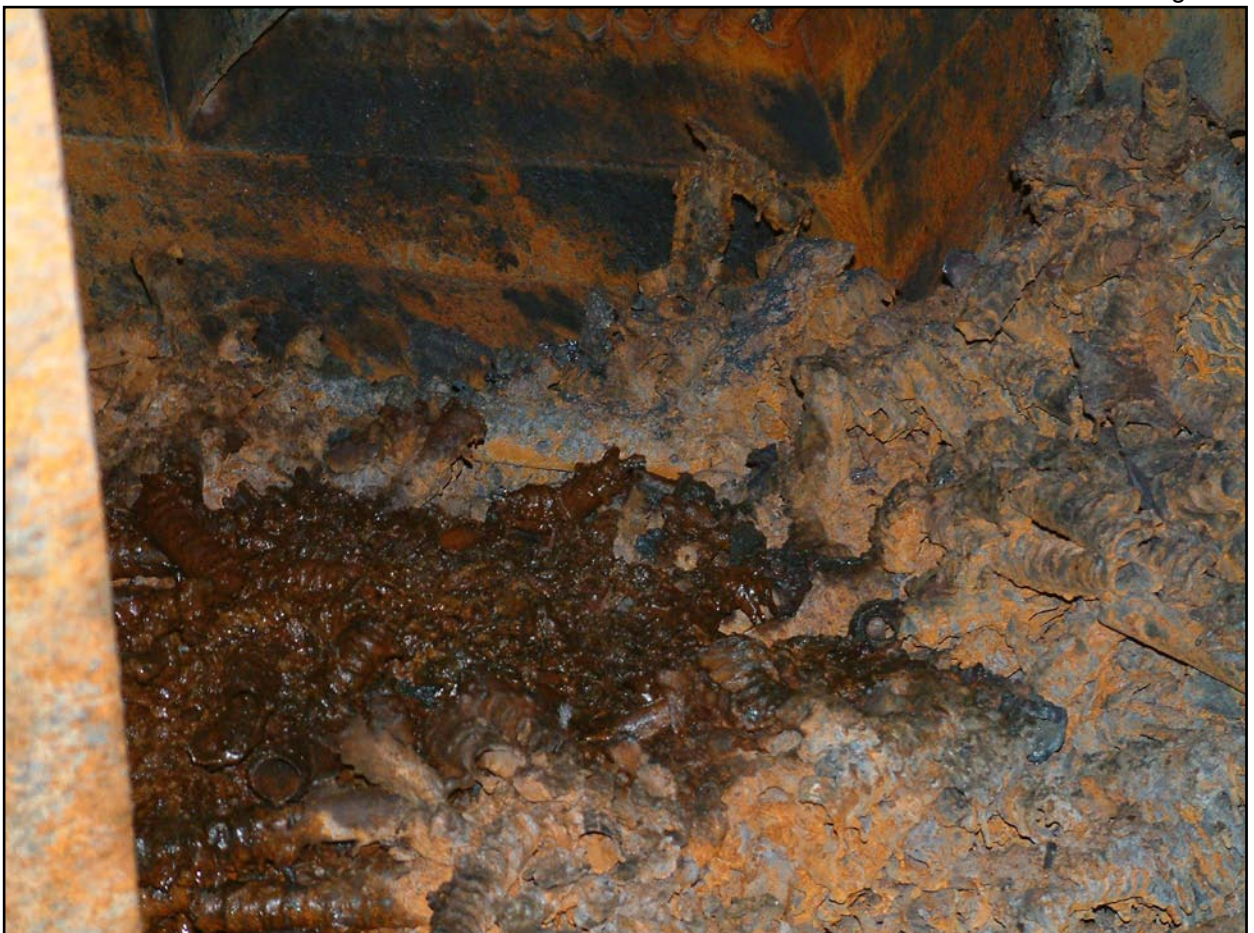
Figure 5

Debris at base of EGE trunking

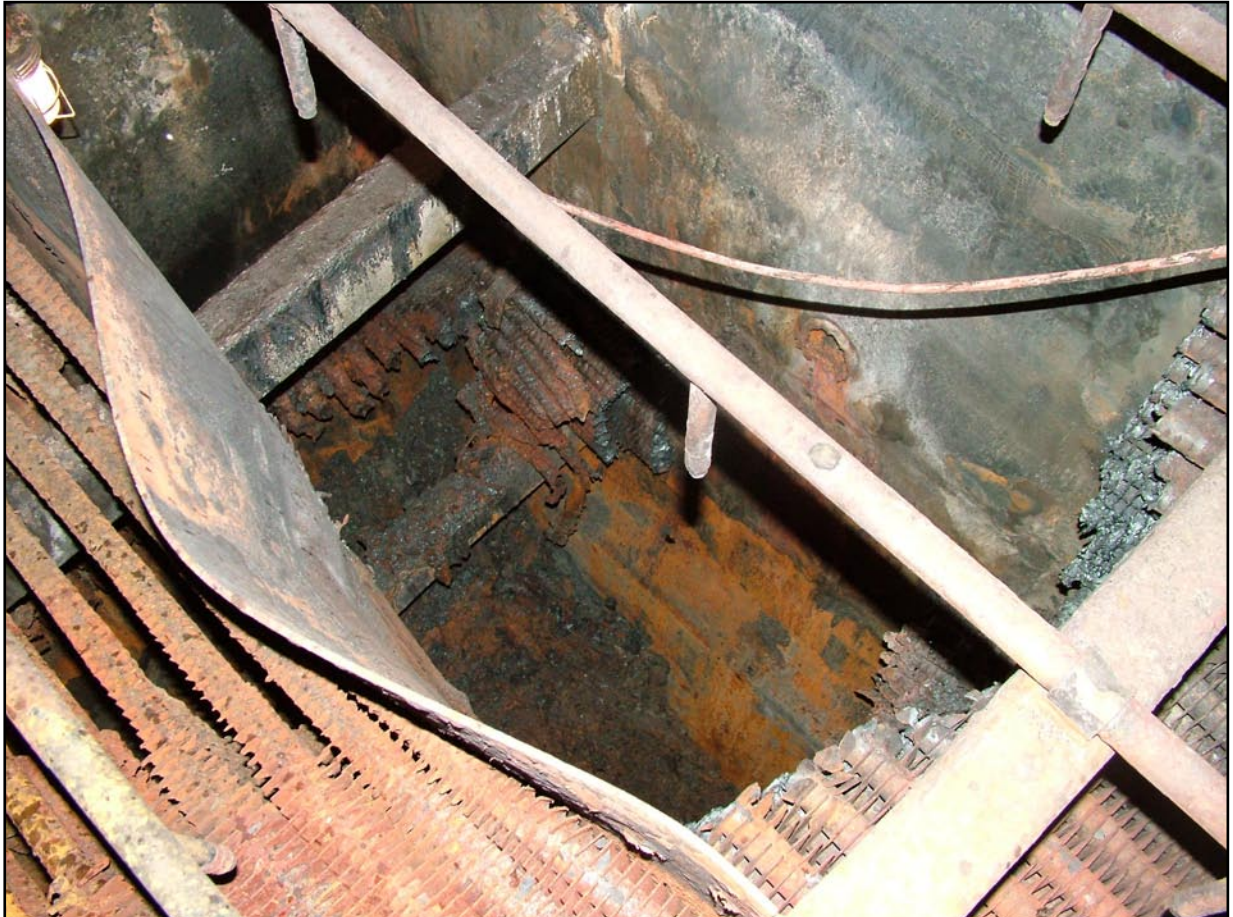
Figure 6

Location of damaged tubes, cut away to create exhaust gas path

Solidified metal was removed from the lower part of the EGE casing, and the damaged tubes cut back to create a path for the main engine exhaust gases **Figure 6**. Replacement parts for the EGE were ordered and repairs planned for a programmed maintenance period in the future.
