Report on the investigation of the injury to
a member of the crew on board the fishing vessel

Sian Elizabeth

14 September 2006

Report No 3/2007
March 2007

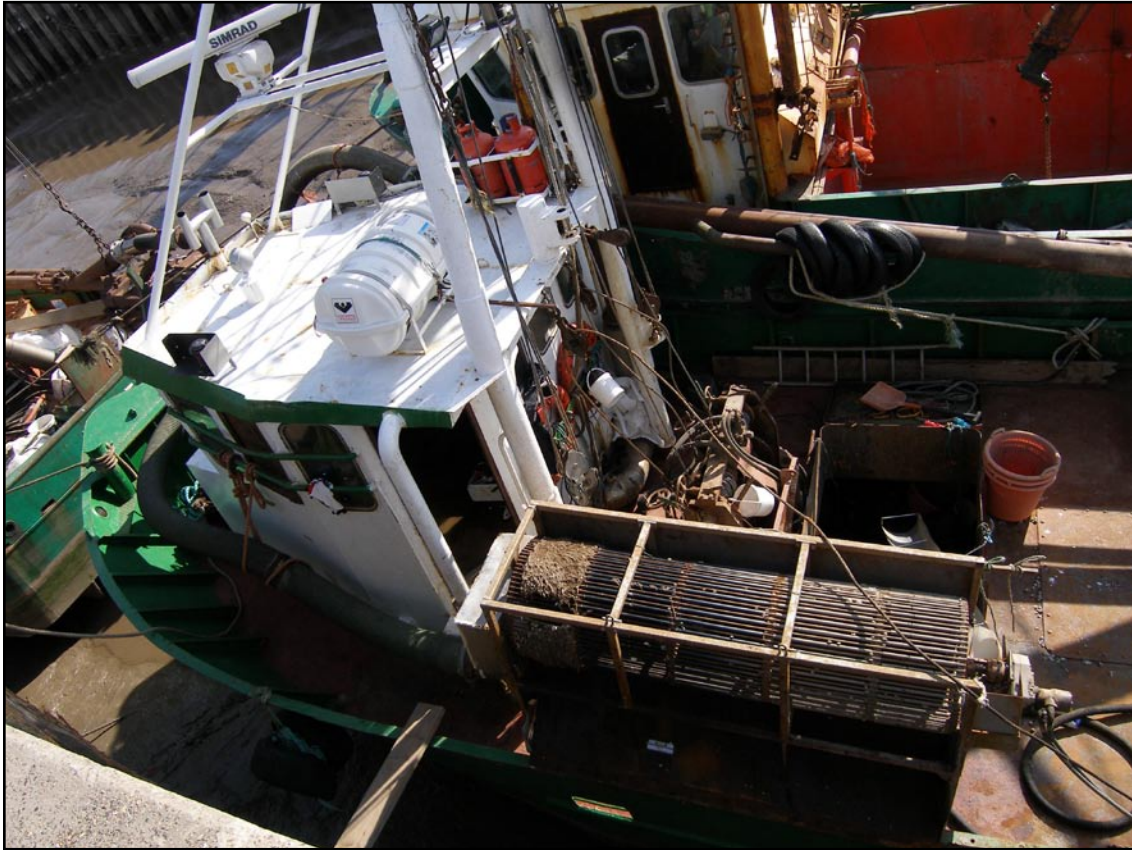
Figure 1

The riddle - plan view

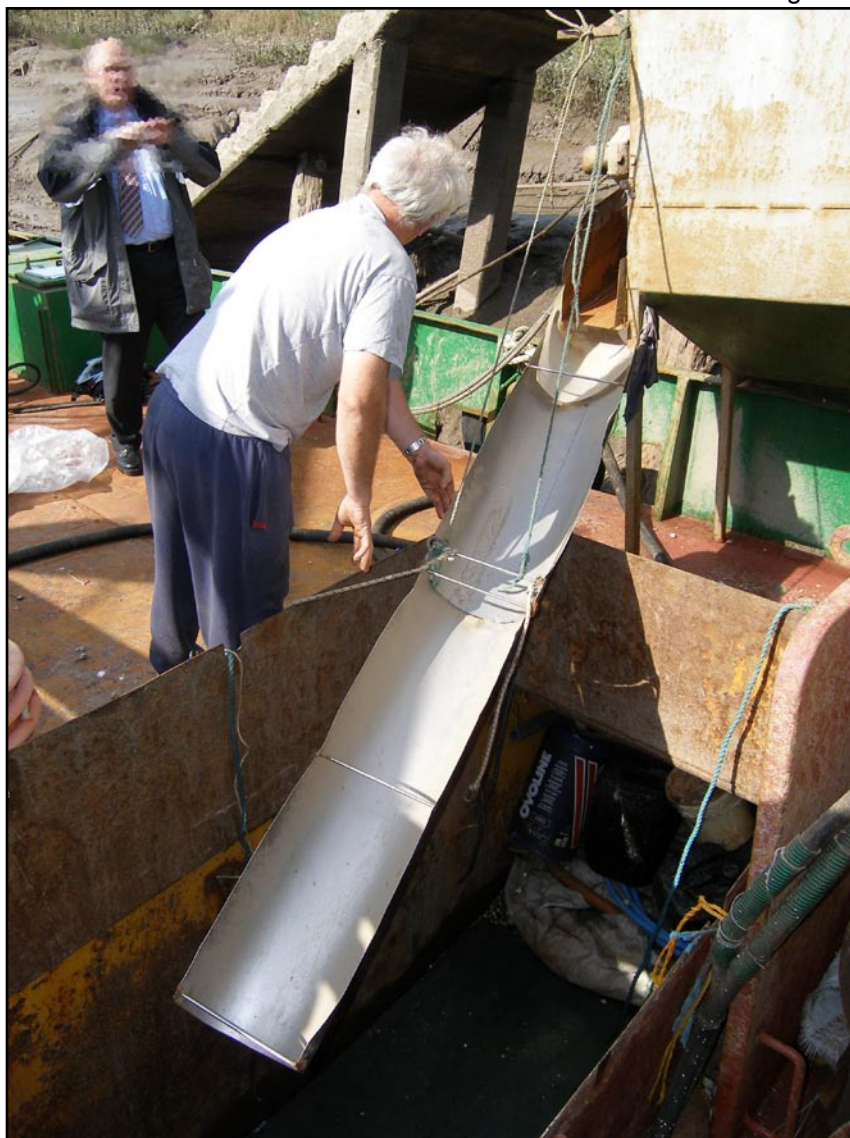
Figure 3

The skipper manoeuvred the vessel from the wheelhouse, turning the vessel in tight circles once a patch of cockles was found. The two men on deck initially directed the cockles from the end of the riddle, via a chute, into two bags stowed in the hold (**Figure 3**).

Clearing the chute by hand

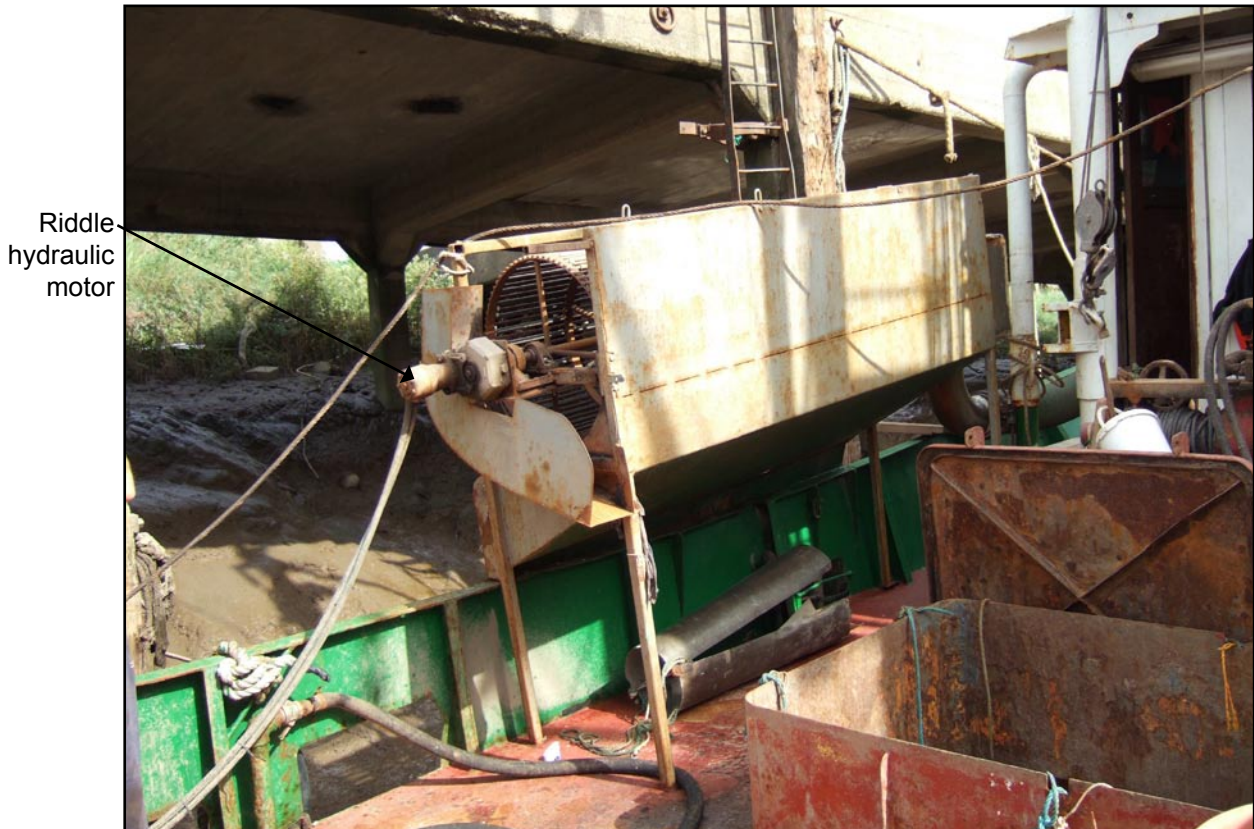
Figure 4

As the senior crewman directed the cockles from the end of the chute into the bags in the hold, the new crewman would ensure the cockles ran freely from the end of the riddle by scraping the chute by hand. The top of the chute at the end of the rotating riddle was susceptible to blockage with mud and cockles and required clearing, particularly when the hold was being filled. This was a right handed job and the new crewman's recollection was that he had been told that, if necessary, he could rest his left hand on the hydraulic motor which drove the riddle (**Figure 4**).

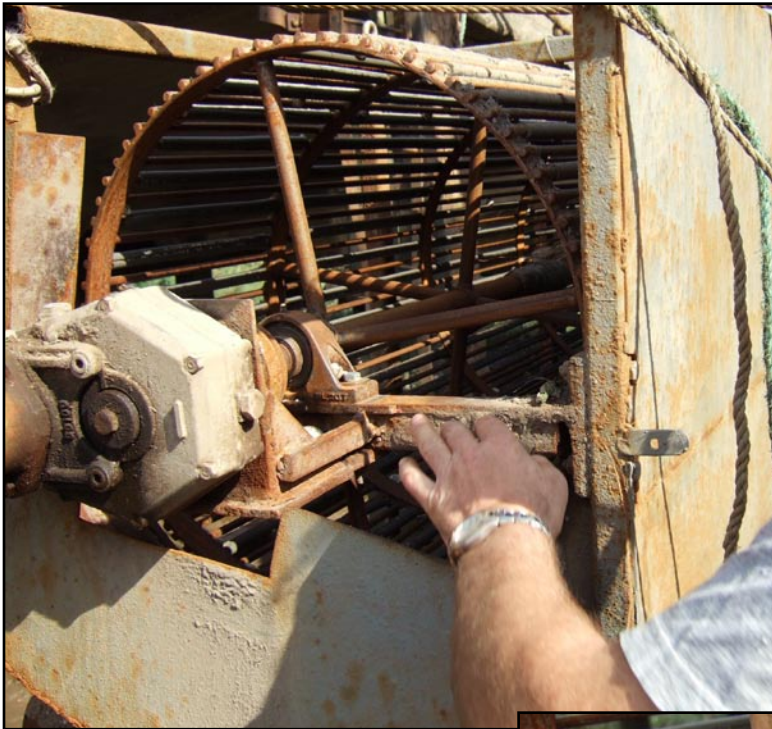
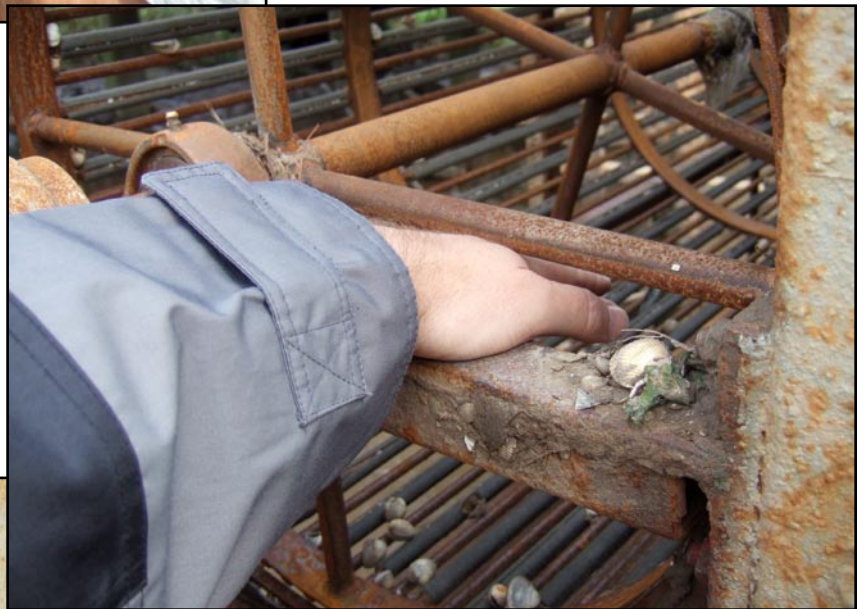
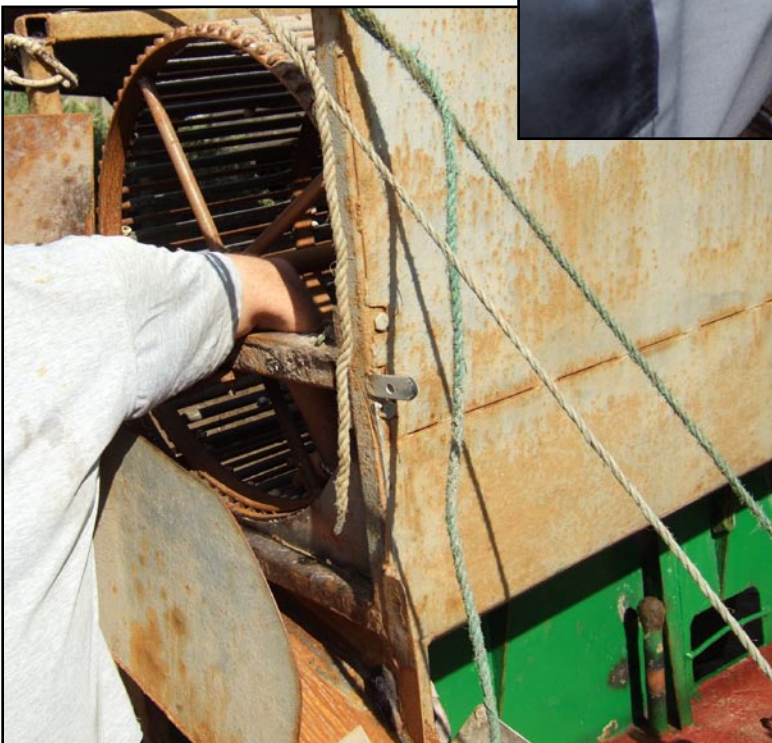
Figure 5

The unguarded riddle construction formed a shear trap that caught the crewman's left thumb and pulled his left arm into the riddle, causing serious injury.

Just before 1400, as the new crewman was scraping the cockles from the chute with his right hand, he moved his left hand to the structural cross member of the riddle, believing there was enough space for his hand to grip the support and be clear of the rotating inner drum (**Figure 5**). The rotating drum of the riddle caught his thumb, fracturing his wrist and pulling his arm into the riddle arrangement before fracturing his left elbow. The abrasion of the cross member also removed the skin from his inner left elbow.

Sequence showing how the crewman's arm was caught in the shear trap

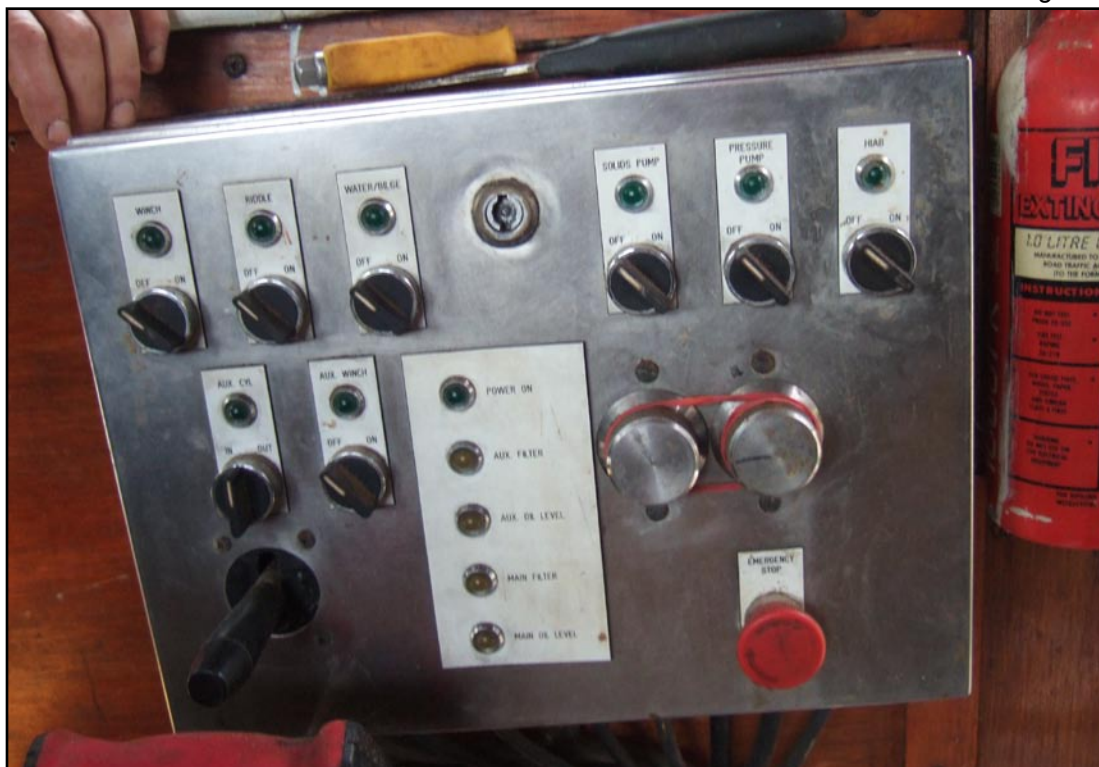
In the wheelhouse, the skipper heard a shout, and when he saw the injured crewman on deck he quickly stopped the hydraulic power using the stop button on the control panel on the aft bulkhead of the wheelhouse (**Figure 6**).

Hydraulic Control Panel
