Report on the investigation of the loss of the sailing yacht

***Ouzo***

20/21 August 2006

**Report No 7/2007  
April 2007**

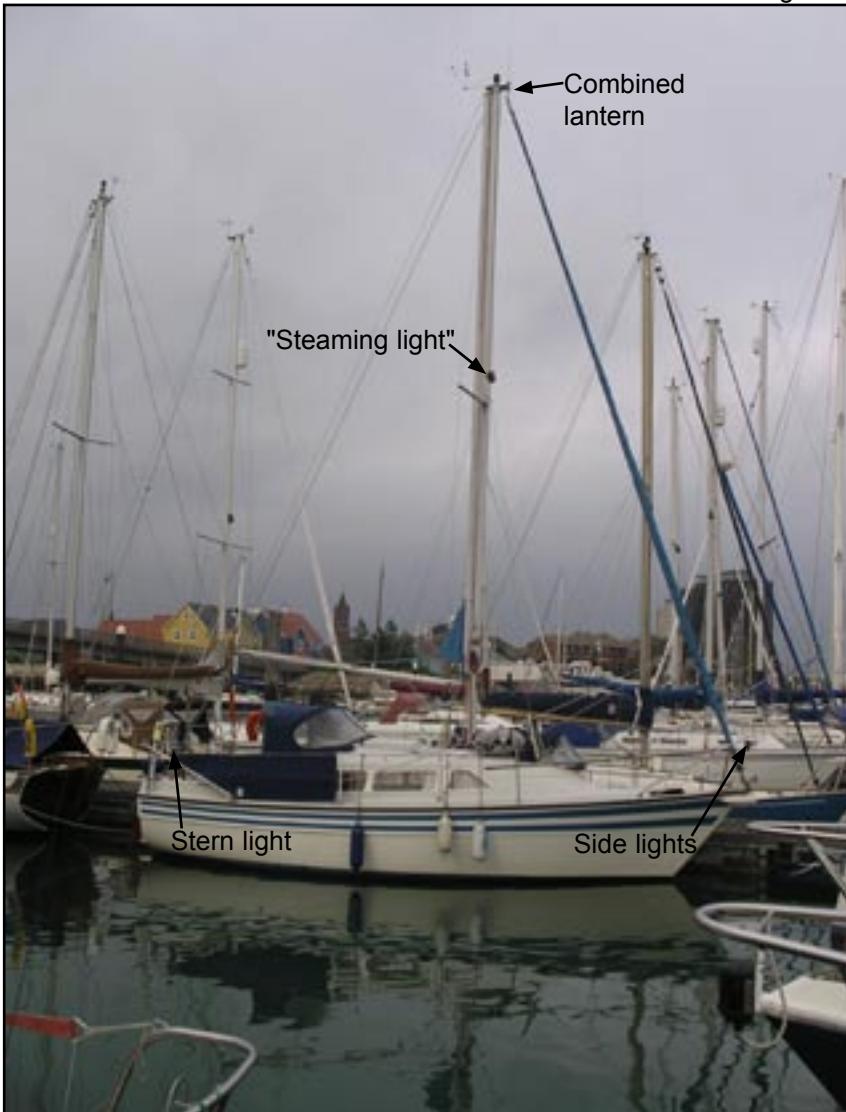
Figure 8

Navigation light arrangement

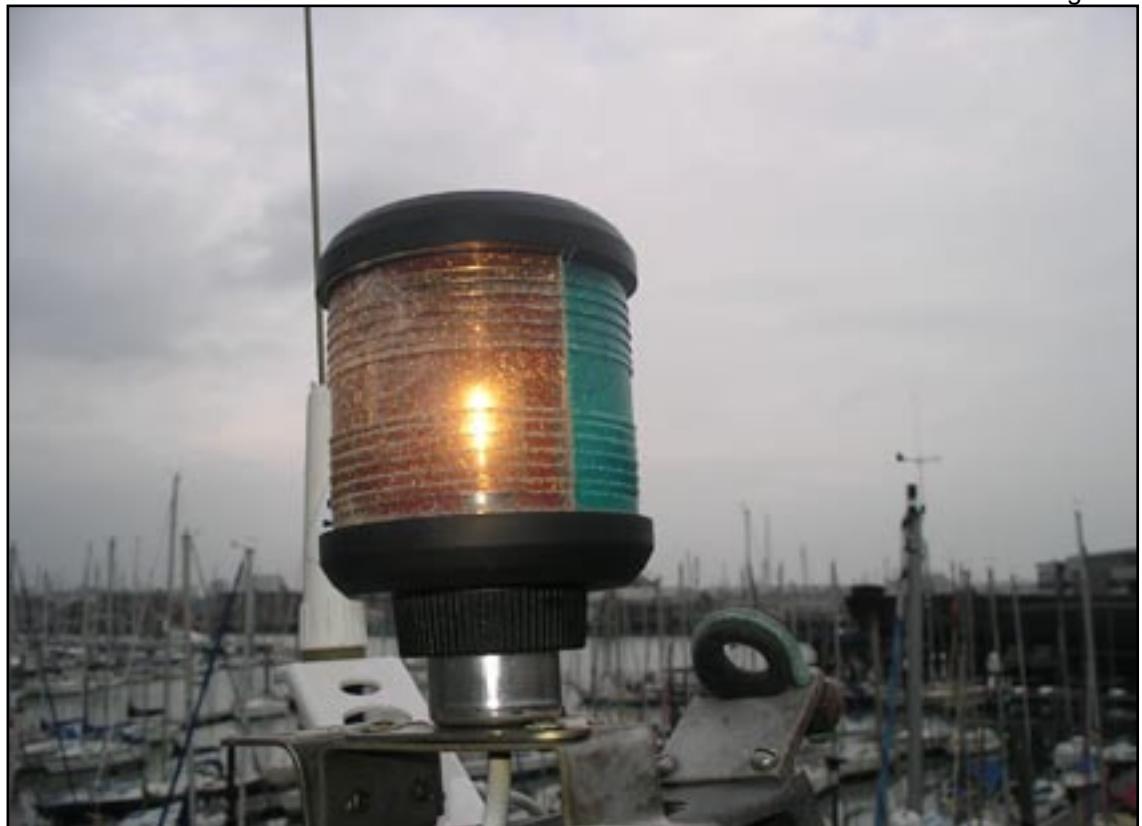
Figure 9

The investigation found that after a period of time, the lenses of combined plastic masthead units are prone to crazing as the plastic becomes diffuse due to heating from the lamp (bulb). This reduces the luminosity of the light (**Figure 9**).

The condition of the lights aboard is not known, but the unit had not been replaced since the boat was built. **Figure 9** shows a unit of similar age to the one on board *Ouzo*.

Combined top light

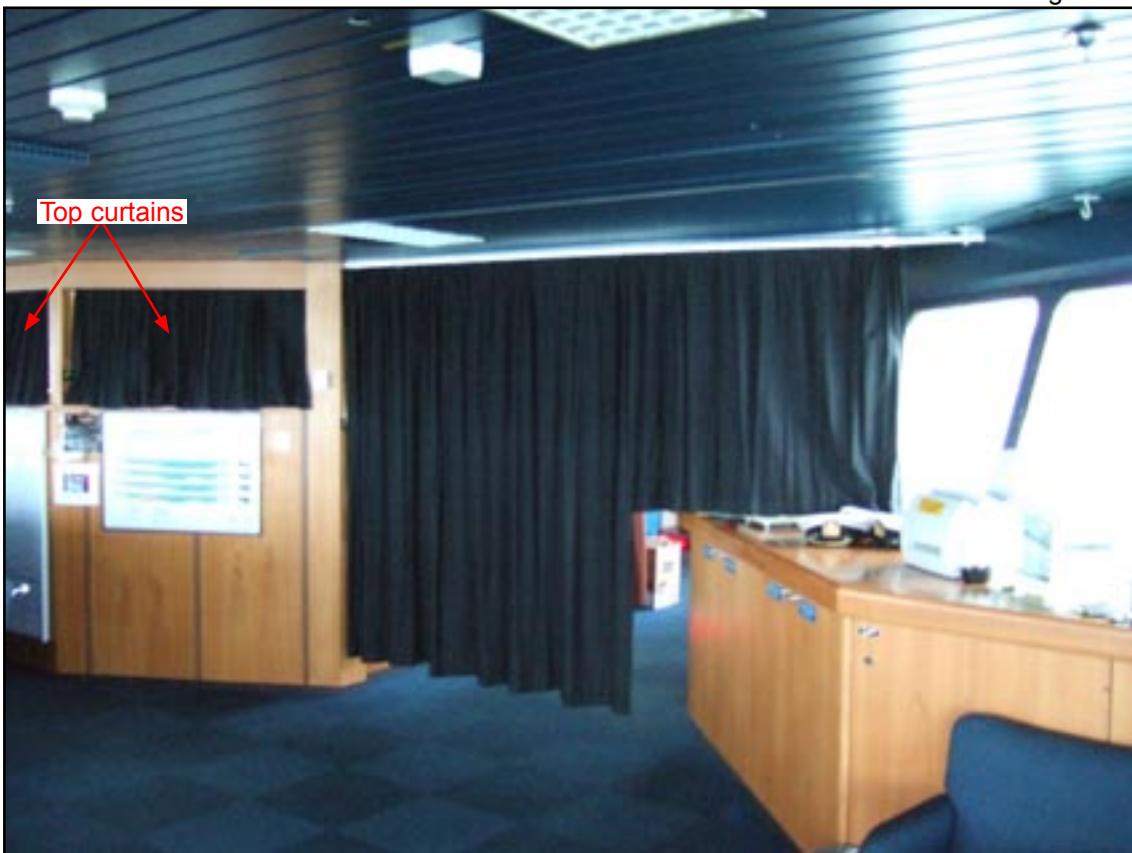
Figure 10

Port side chartroom black out curtains

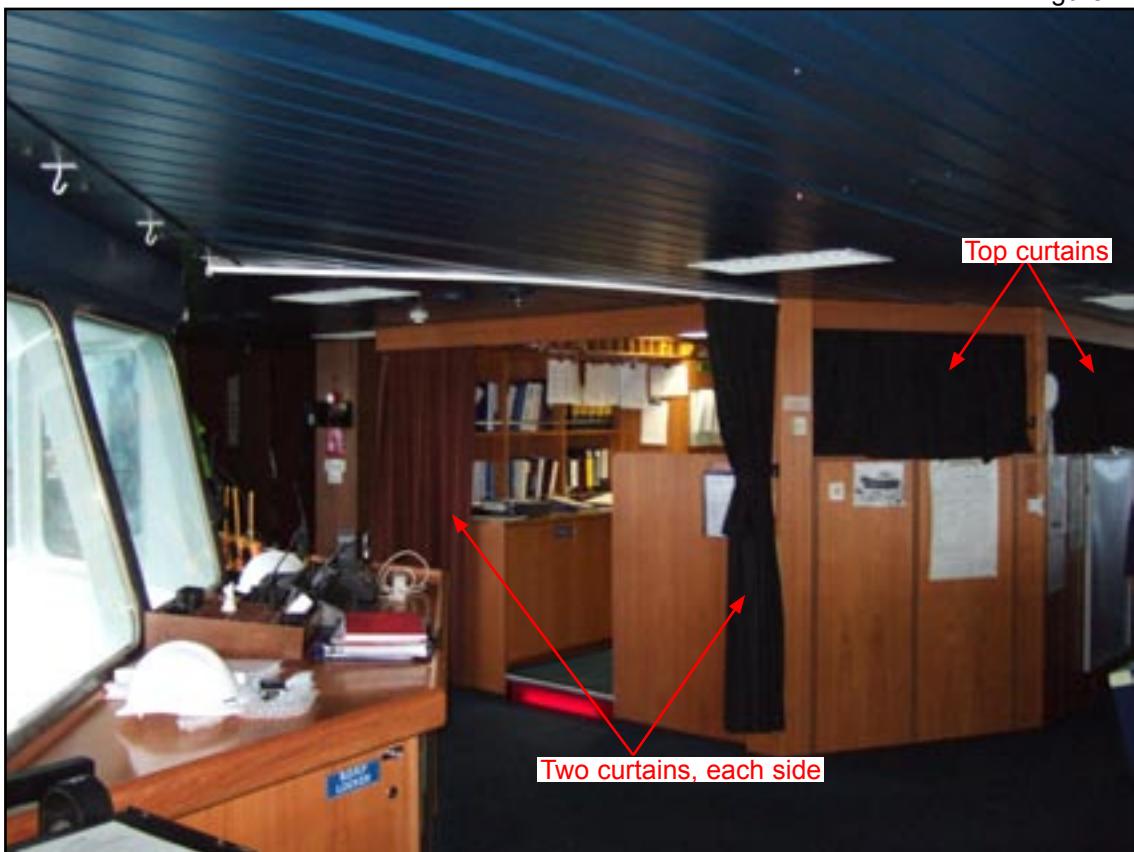
Figure 11

Starboard side curtains, and port side were in open position as shown

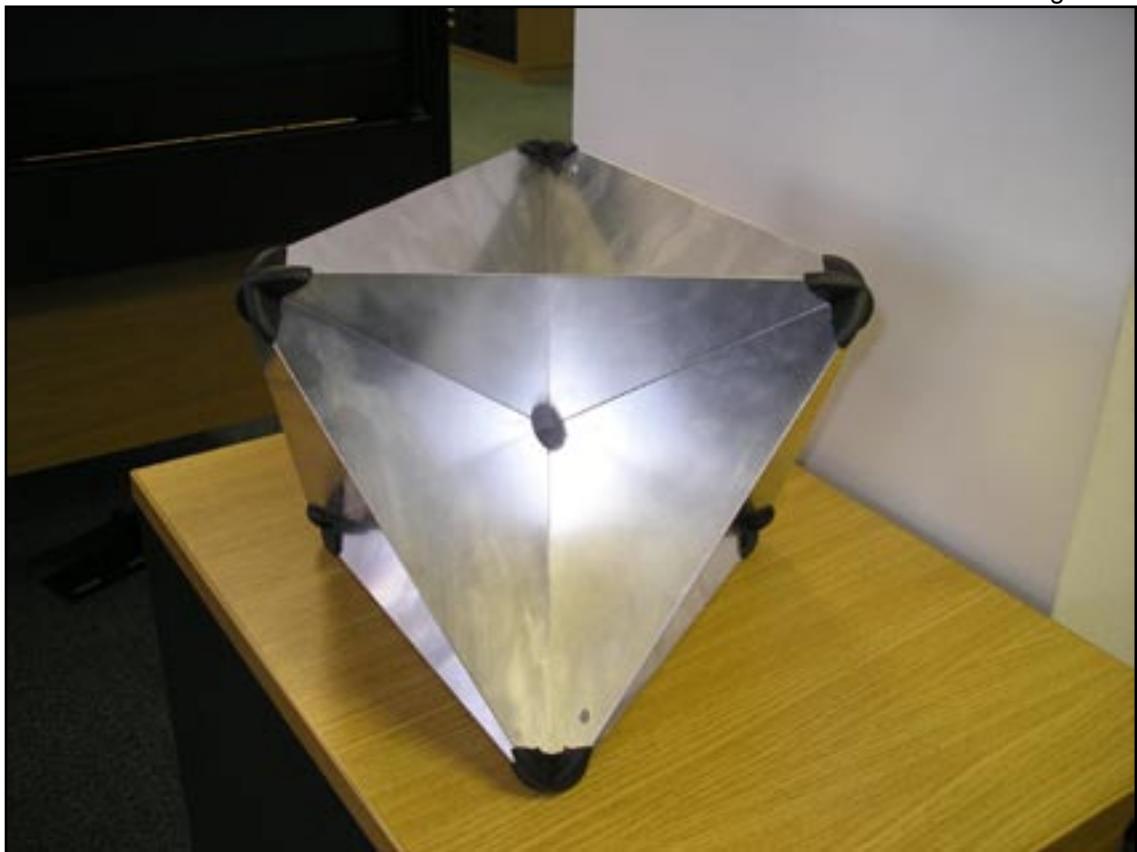
Figure 12

Octrahedral type radar reflector ("catch rain" position)

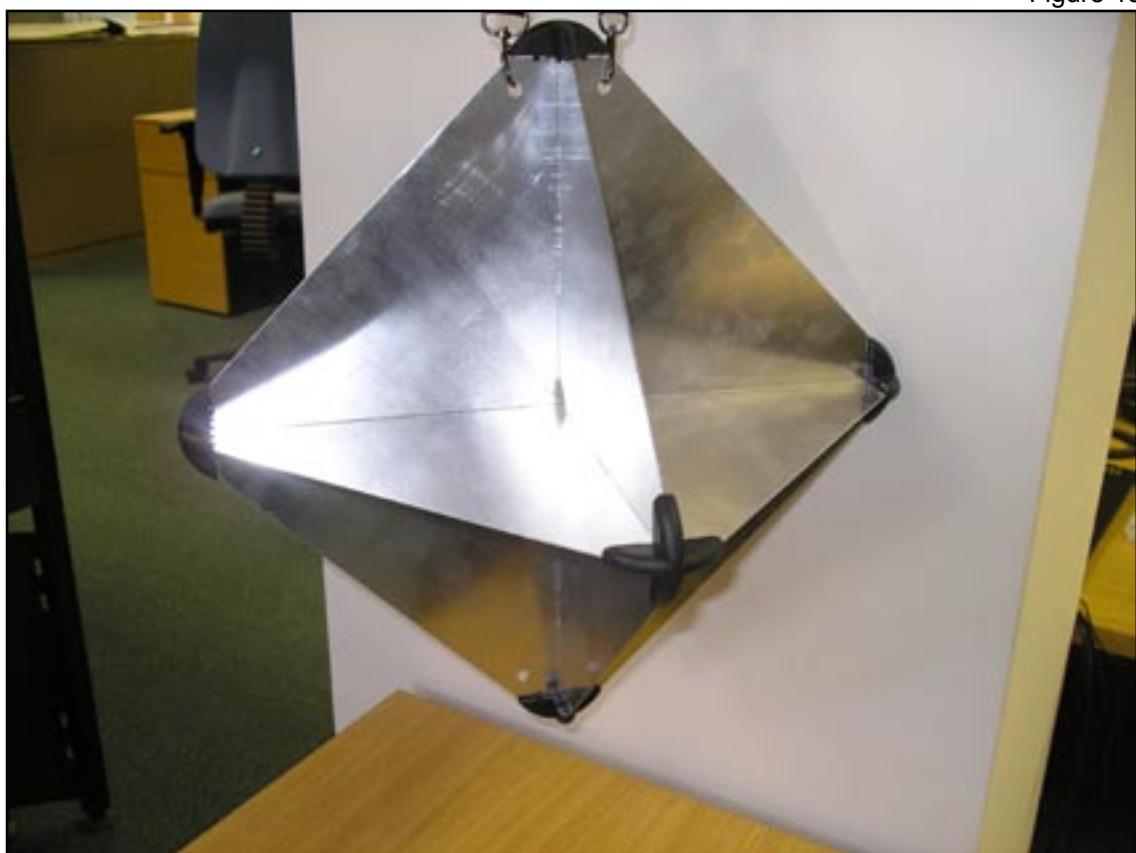
Figure 13

QinetiQ Funtington's report (**Annex 4**) concluded that, bearing the above factors in mind, it was unlikely that deployment of the radar reflector on *Ouzo* would have made very much difference to the RCS of the yacht.

Radar reflector (not in "catch rain" position) suspended from the fixing points

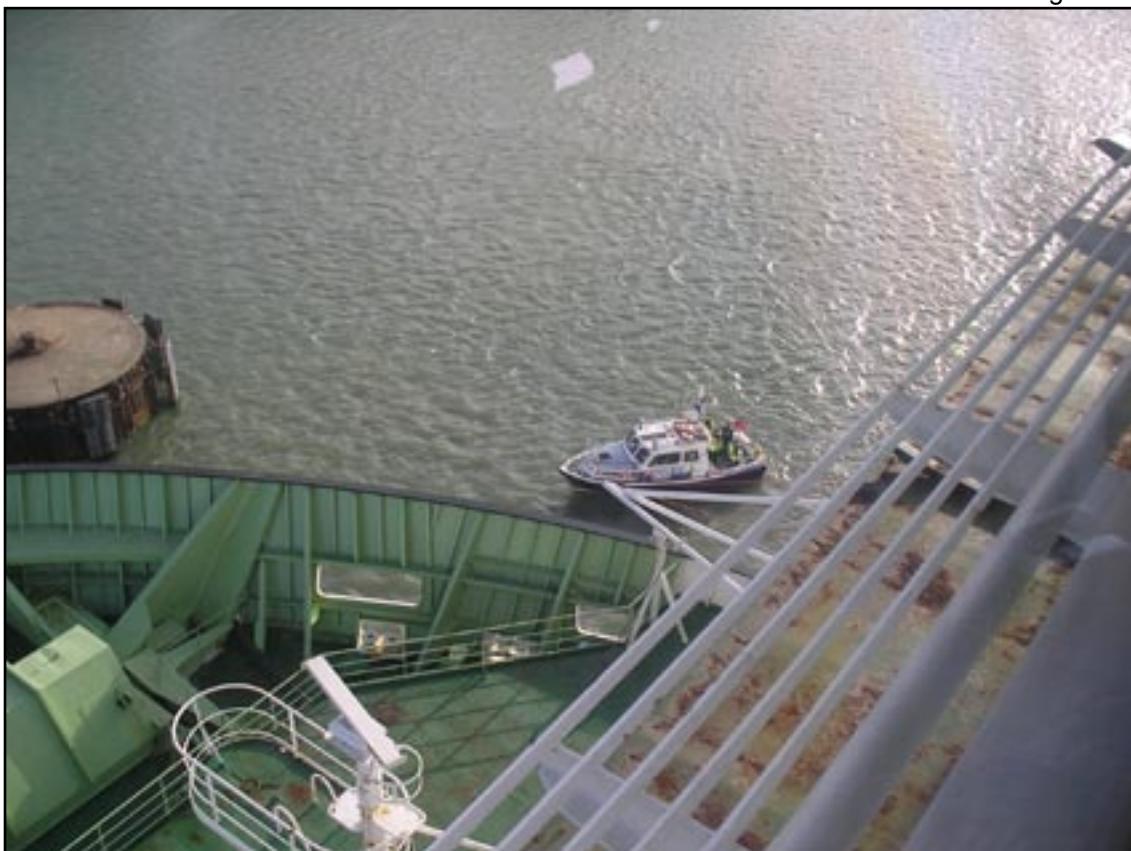
Figure 14

It is the firm view of the MAIB that a passing distance of 30 metres or less was unsafe for a small yacht in this situation.

Approximate position of Ouzo as she passed by

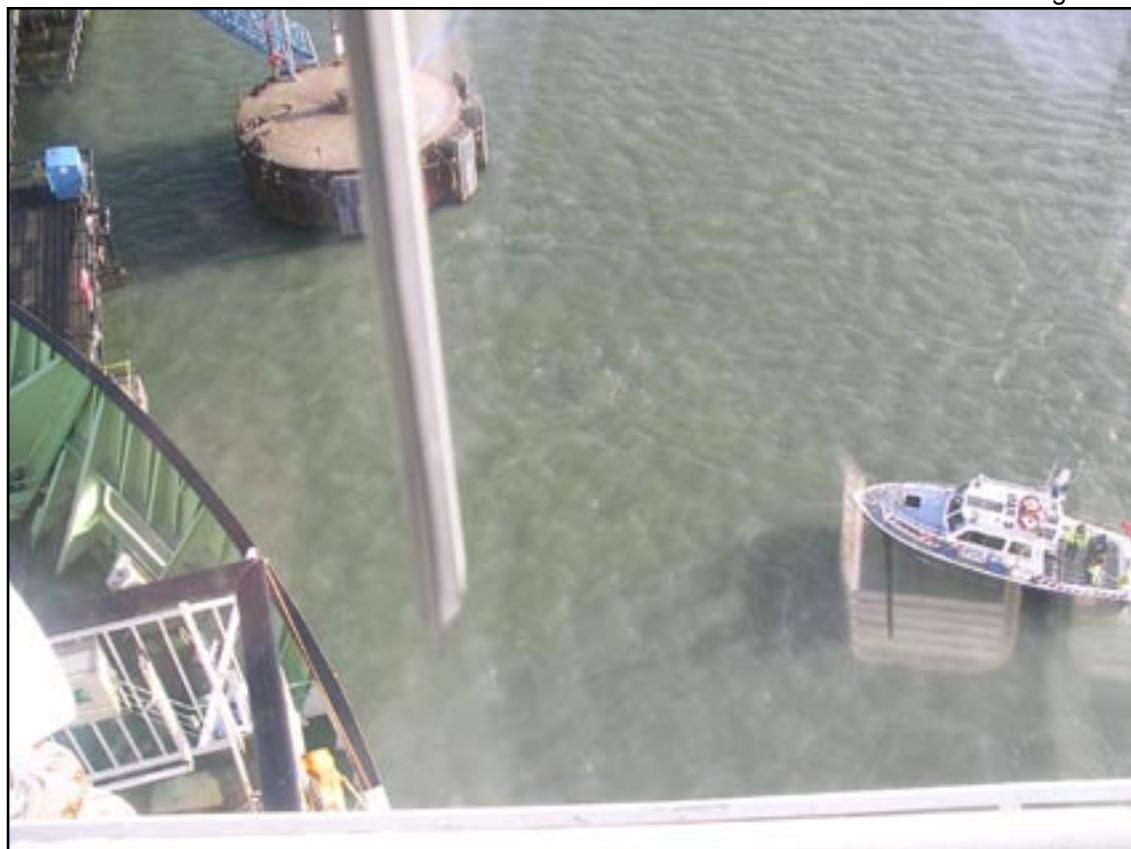
Figure 15

Approximate position of Ouzo looking down from starboard side of bridge

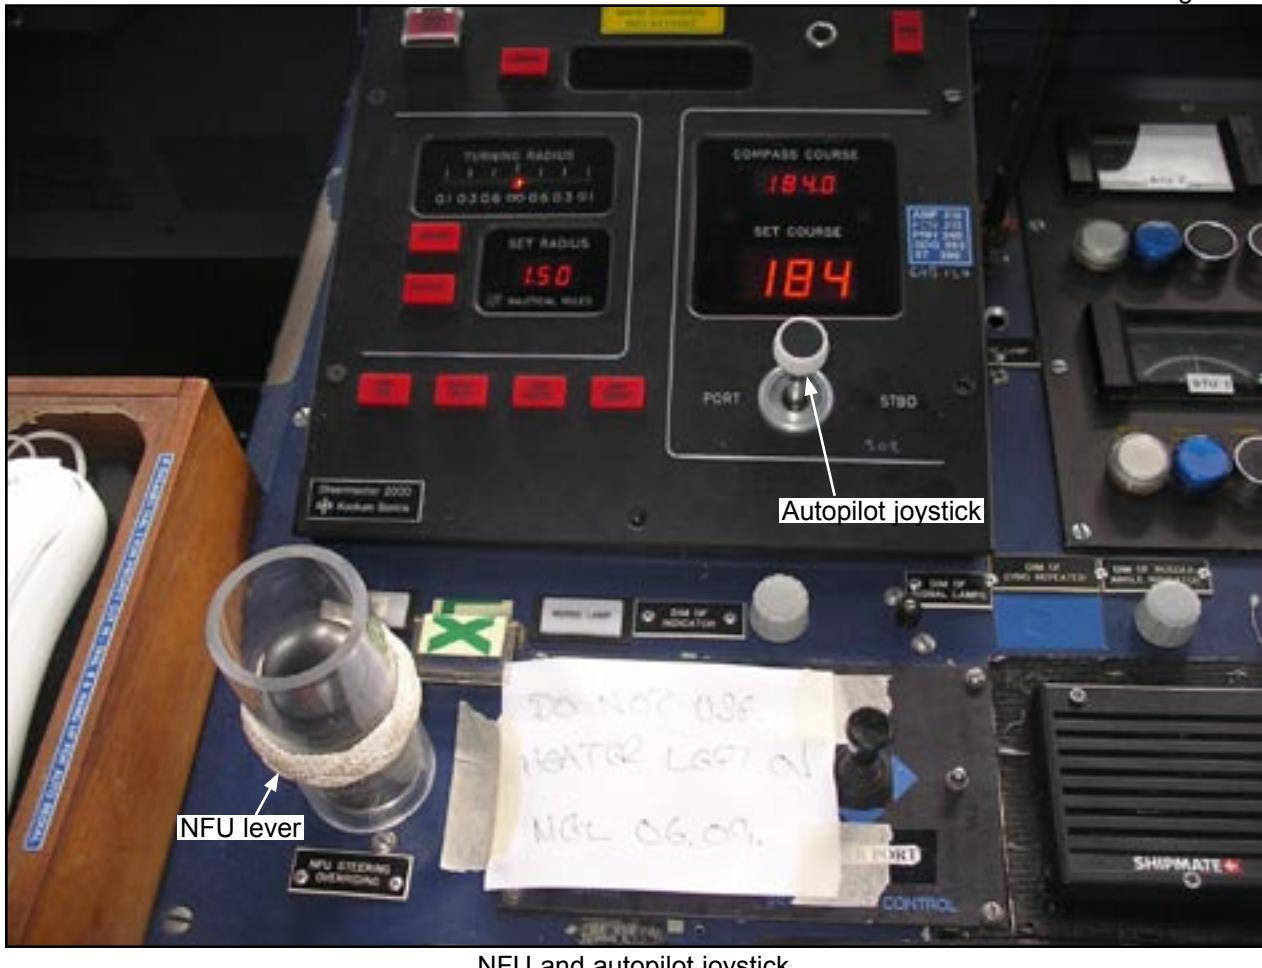
Figure 18

The second officer elected not to use either of these two steering modes, despite the fact that he considered that he urgently needed to turn the vessel quickly to port. Instead, he opted to keep the vessel in autopilot steering mode and adjust the course using the autopilot course input joystick (Figure 18).

NFU and autopilot joystick
