Report on the investigation of the grounding of

mv Thunder

at the approaches to the Dee Estuary

**Report No 12/2007
June 2007**

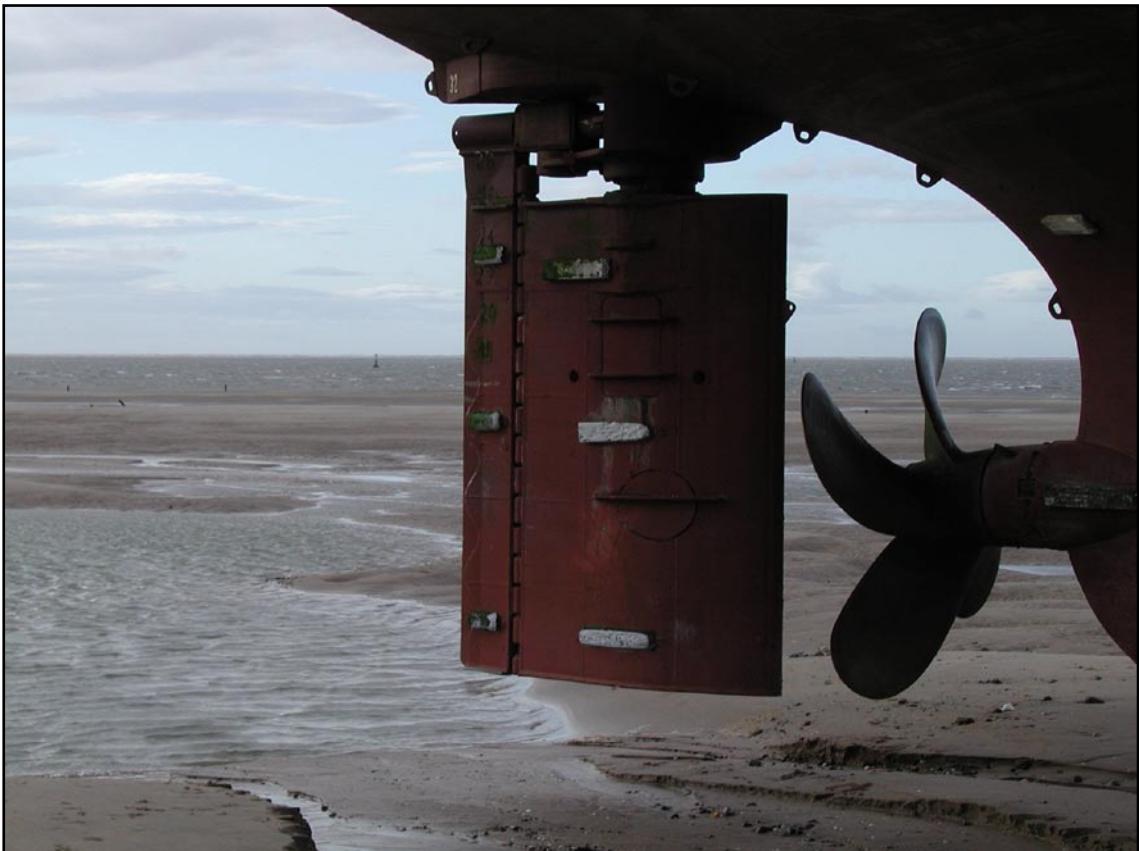
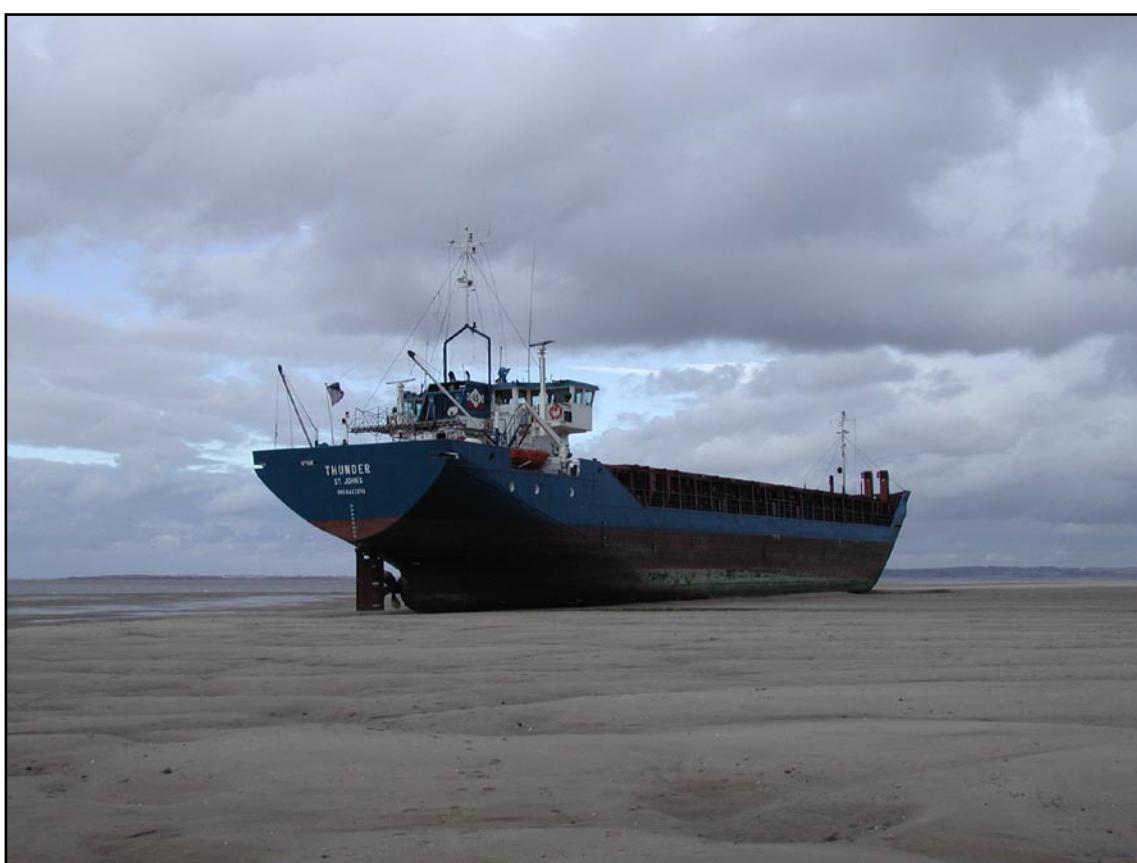
Thunder aground pm 10 August on the Mostyn Bank
