Chart BA 1953 showing positions of Thunder between 9 and 10 August

Table of accidents and incidents at Mostyn, drawn from Mostyn and Dee Conservancy records

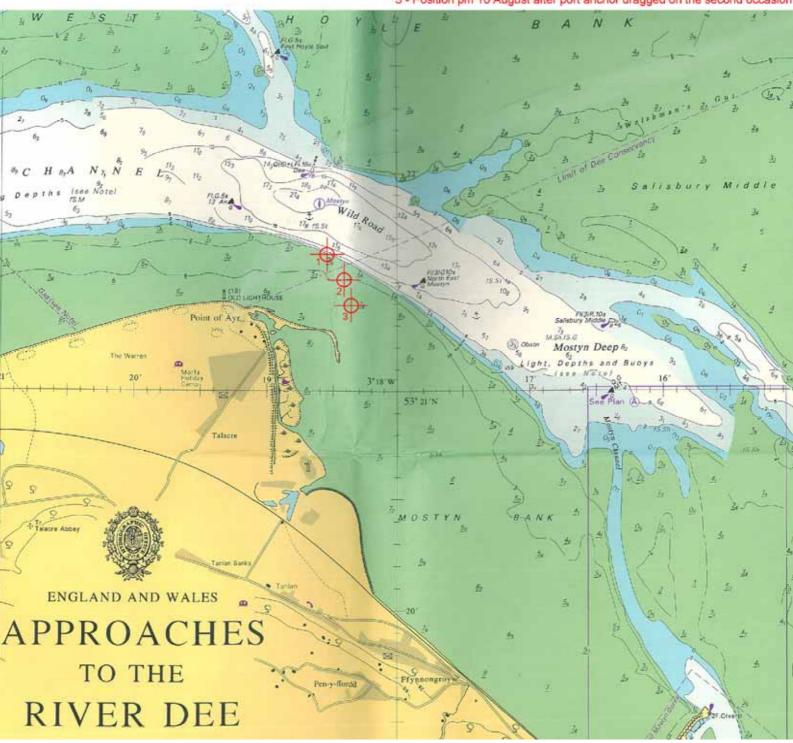
- 1 Initial anchor position 09 August (bridge)
 2 Position am 10 August after port anchor dragged on the first occasion
 3 Position pm 10 August after port anchor dragged on the second occasion
