SYNOPSIS

On 30 June 2005, the fishing vessel *Auriga* (**Figure 1**) capsized and sank about 6 miles north-east of Portavogie, Northern Ireland. The skipper and his crewman were both rescued from the stricken vessel's liferaft. Sea conditions at the time were slight with light SSE winds.

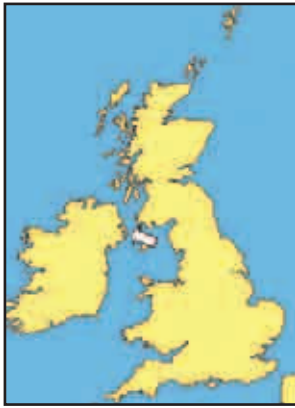
Auriga capsized because of a heavy weight in her net which she was hauling over the top of a high gantry. This created a capsizing lever on the vessel. The small vessel carried a lot of top weight; her deck layout included deck shelter, gantry, fish hopper, net drum and a trawl winch containing a large quantity of wire, which were all instrumental in jeopardising her stability.
