Report on the investigation of  
the capsized and foundering of

**fv *PAMELA S*, IH 308**

in Carmarthen Bay

**Report No 32/2006  
December 2006**

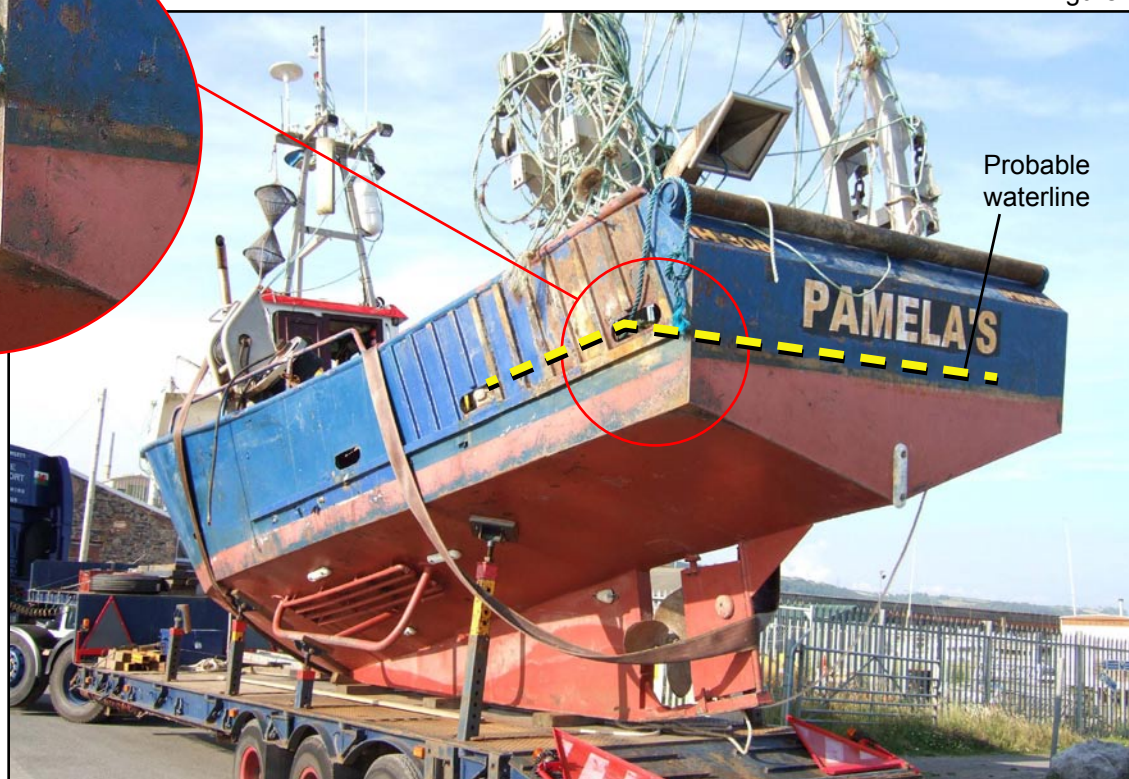
Figure 3

The vessel left its mooring at 1030, with their tender on board. A fisherman on a vessel at an adjacent mooring saw *Pamela S* depart, and he observed that she was trimmed by the stern with a list to port, and that the waterline was approximately level with the bottom of the letters of the vessel's name on the stern (**Figure 3**).

Probable waterline level as vessel left its moorings on 17 June 2006

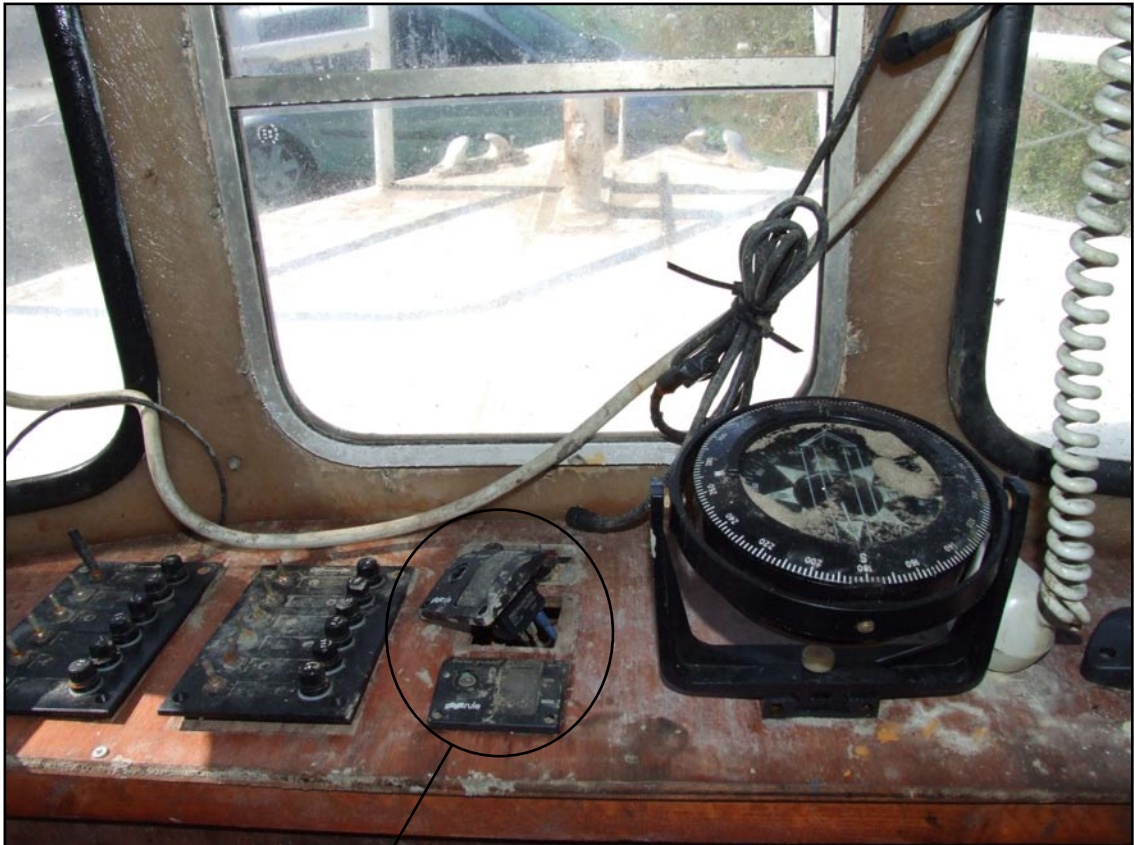
Figure 5

The vessel's electrical bilge system consisted of 3 *Rule* 12 volt, 2275 litres per hour (500 gallon per hour), electric bilge pumps which were controlled via three switch panels in the wheelhouse (**Figure 5**). The switches for the fish hold and aft compartment were 3-way rocker panel switches with manual off and automatic positions. A feature of these panels is that the switch is spring-loaded in the manual position such that it will return to the off position if released. The third switch controlled the engine compartment bilge pump, which had no automatic position as the pump required a float switch installation to be operated automatically. No float switch was fitted to this pump; therefore automatic operation was not possible.

Bilge pump switches

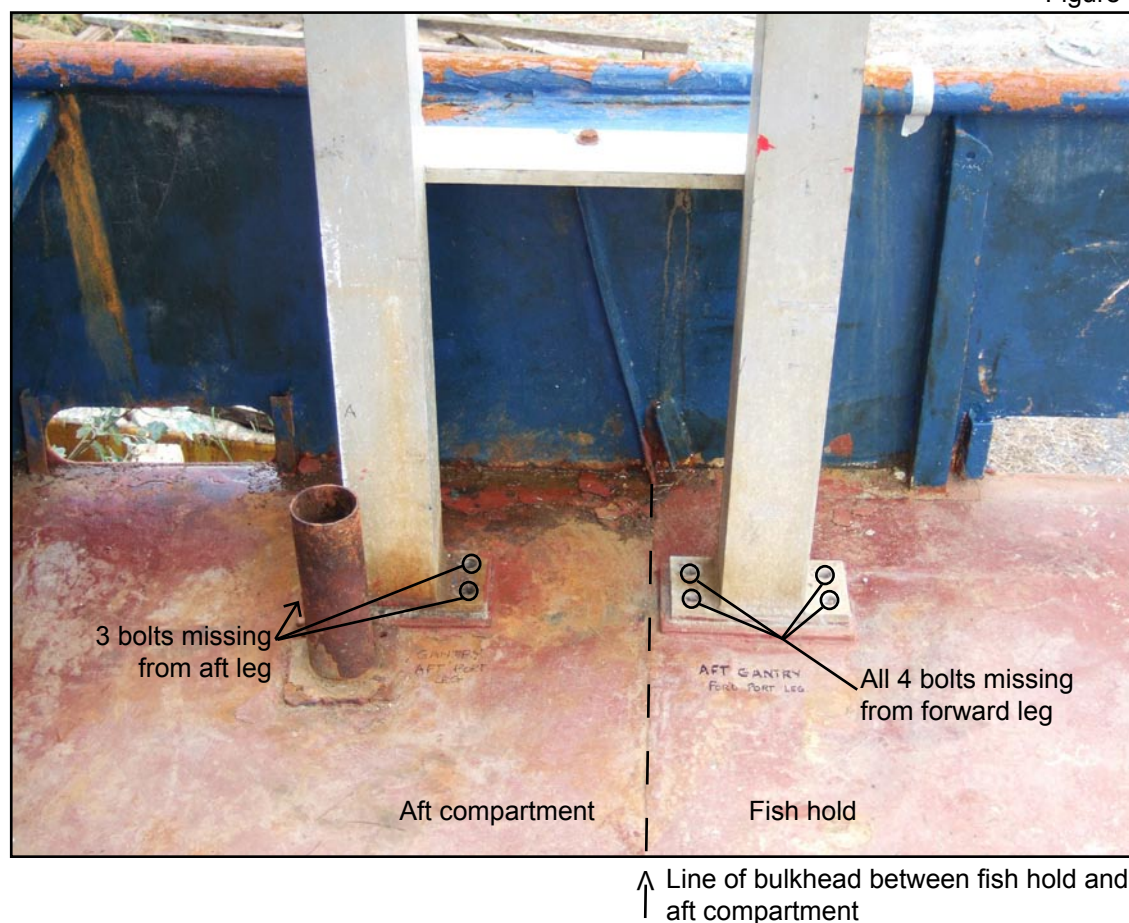
Figure 9

Nine bolts were missing from the stern gantry securing points, seven from the port side and two from the starboard side. The gantry, made of aluminium alloy, had been installed in 2003 by the then owner to replace a steel gantry. The bolt holes were 18mm in diameter.

The gantry was secured to the vessel's deck with through deck bolts, and was positioned such that the forward legs were located over the fish hold and the aft legs were over the aft compartment (Figure 9).

*Pamela S* - stern gantry securing arrangements, port side

The vessel was found with exposed bolt holes in the main deck. Nine bolts, 18mm in diameter, were found to be missing from the base of the stern gantry. Significantly, seven of the nine bolts were missing from the port side of the gantry securing arrangements (**Figure 9**). These holes would have allowed sea water on deck to downflood into the vessel's aft compartment and fish hold.

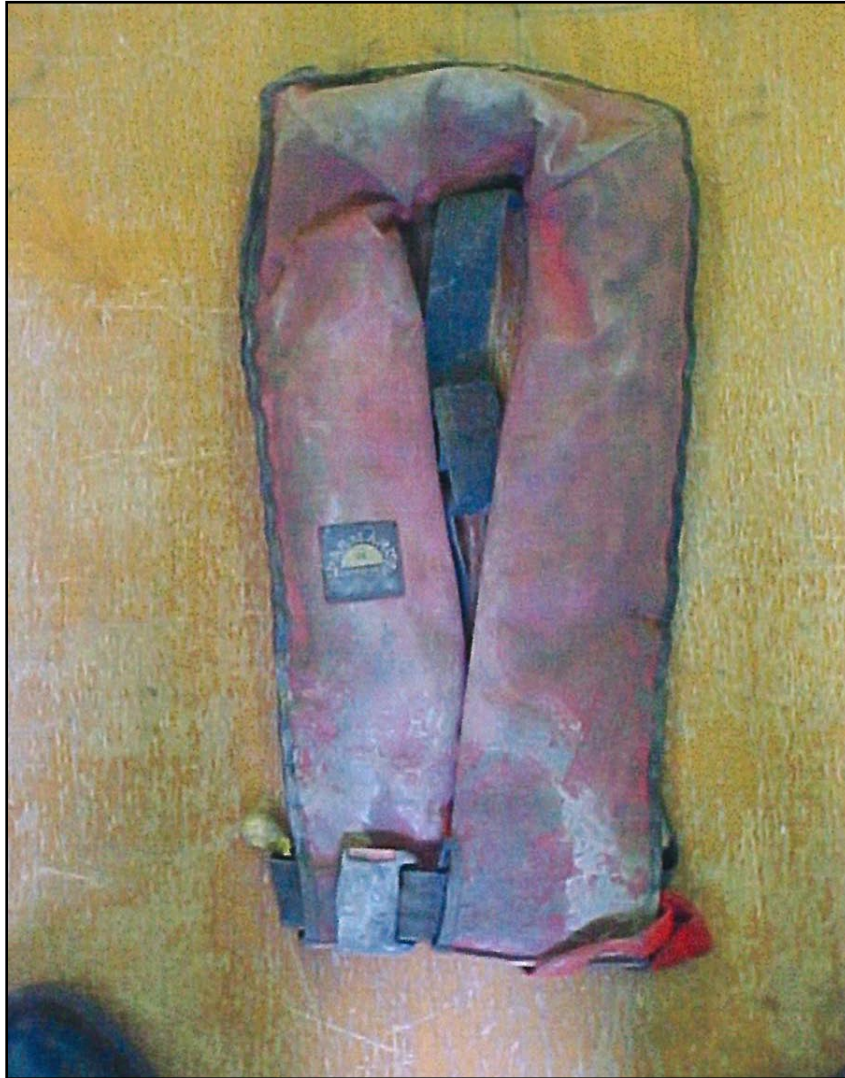
One lifejacket was found in the wheelhouse which appeared to be old and in poor condition. As the skipper had indicated that there were new, auto-inflation lifejackets on board the vessel, it was decided to send the lifejacket to an independent test house to verify its age and functionality.

A detailed inspection of the lifejacket was carried out by the Fleetwood Testing Laboratory, which ascertained that the lifejacket was dated September 2002 and was fitted with a manual inflation activator. During the test, the lifejacket was inflated and showed no sign of leakage. (Figure 10)

Lifejacket found on board *Pamela S*

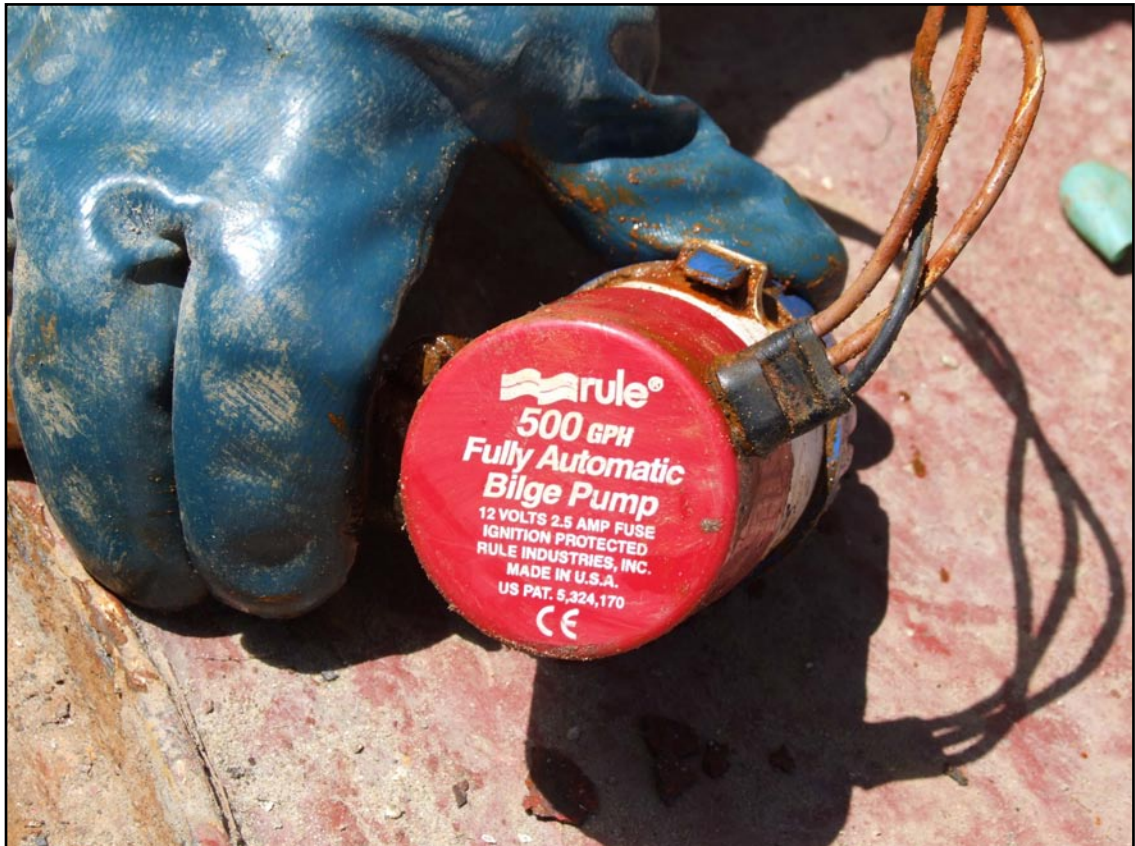
Figure 11

The bilge pumping system was inspected and it was found that three of the vessel's spaces were served by *Rule 500 gph* electric pumps (**Figure 11**). Each pump was rated at 2275 litres per hour. The pumps were removed and tested and were found to have the following outputs:

The discharge from each pump was via 18mm diameter plastic hoses to 12mm hull openings above the waterline on the starboard side of the engine space. Non return valves were fitted to each line. These were tested and it was found that the valve on the line from the fish hold was not working. The remaining valves were found to be functioning correctly.

A hand pump was also fitted to pump from the engine compartment; this was found to be non operational at the time of the inspection.

Bilge pumps

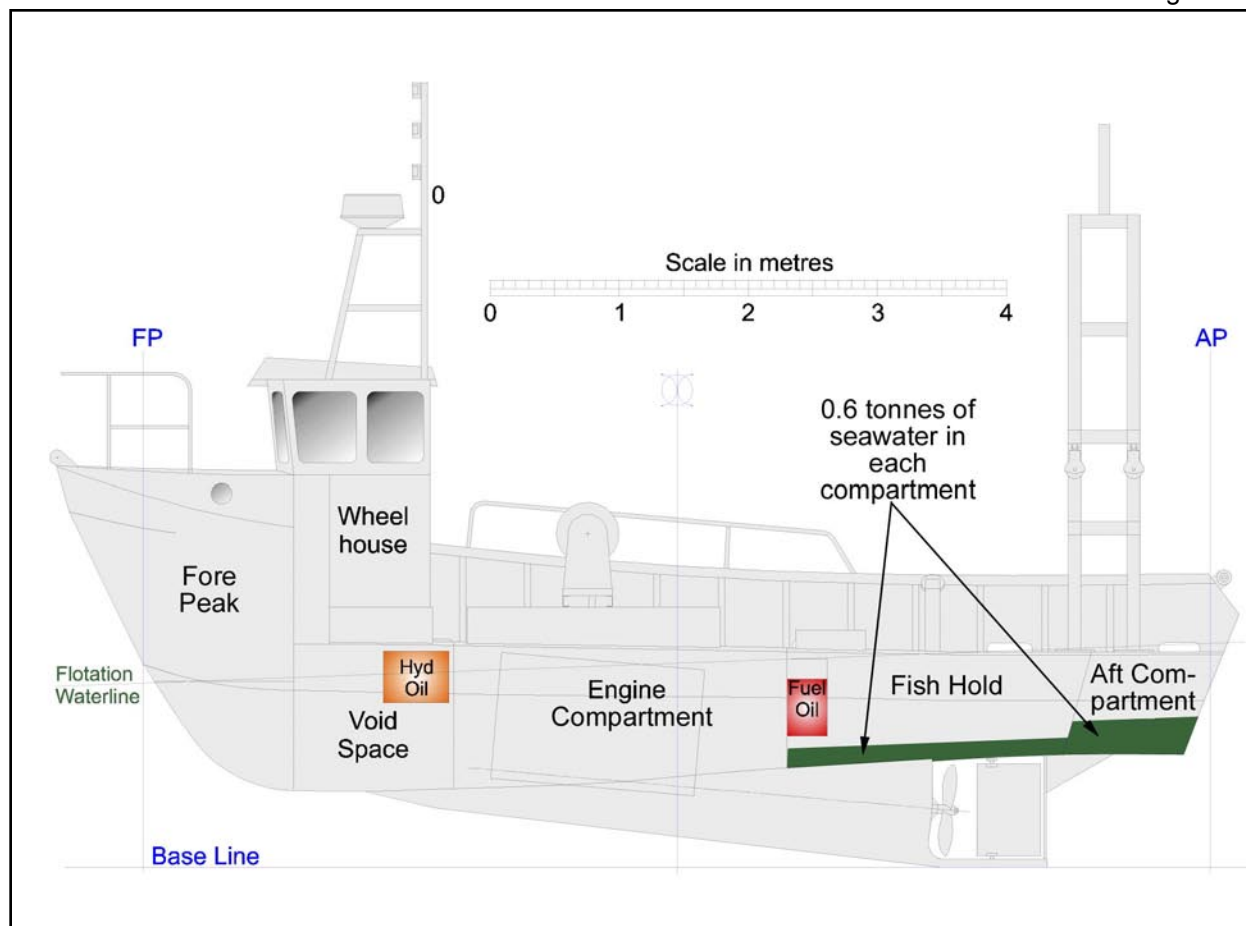
Figure 12

The report notes that nine bolts were missing from the base of the stern gantry, and calculates the effect which water in the spaces below these holes would have had on the vessel's freeboard and stability. If 0.6 tonne of seawater had entered each of the two aft compartments the vessel's deck would have been 26mm below the waterline (Figure 12).

Flotation waterline with 1.2 tonnes of seawater in aft compartments

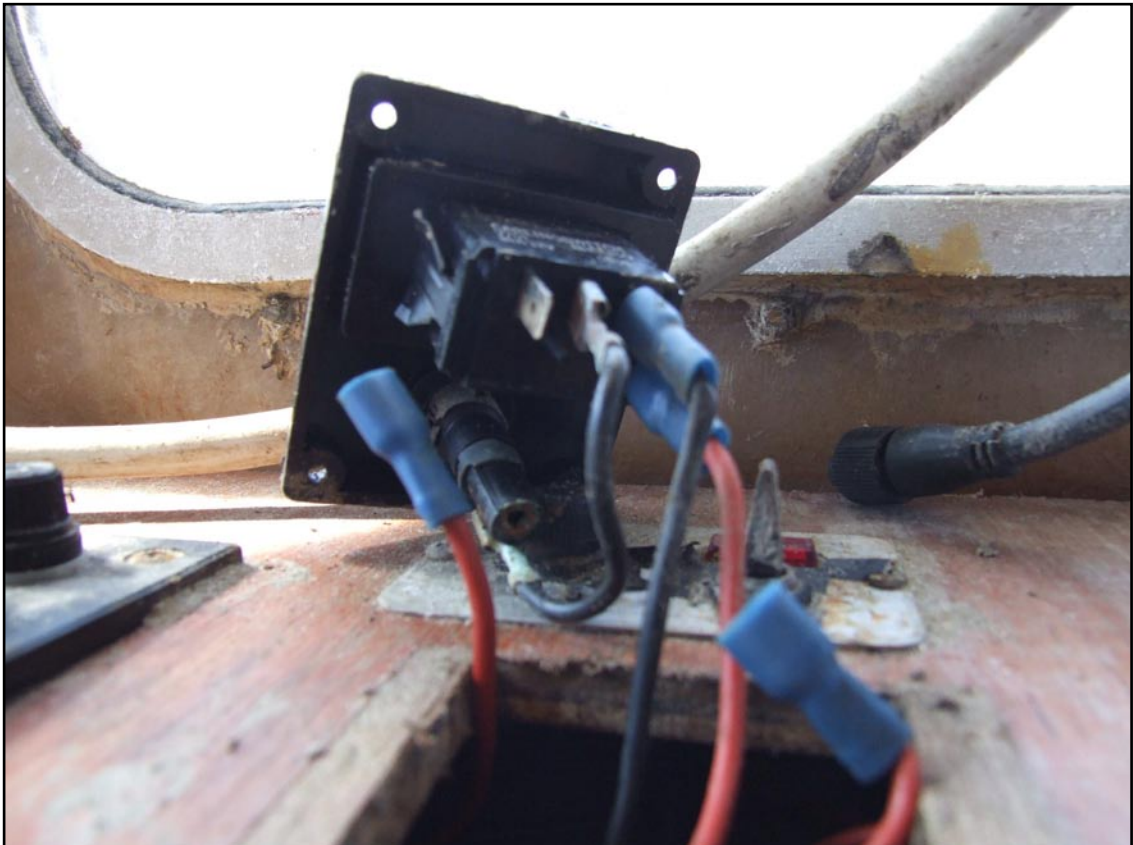
Figure 13

The pumps were controlled through three switches, located in the wheelhouse; the wiring on all three pumps was found with poor connections, and all three were found to be incorrectly wired.

The pump switch for the aft compartment was found to be incorrectly wired and would probably have operated in its manual setting only (**Figure 13**).

Wiring to bilge pump switch

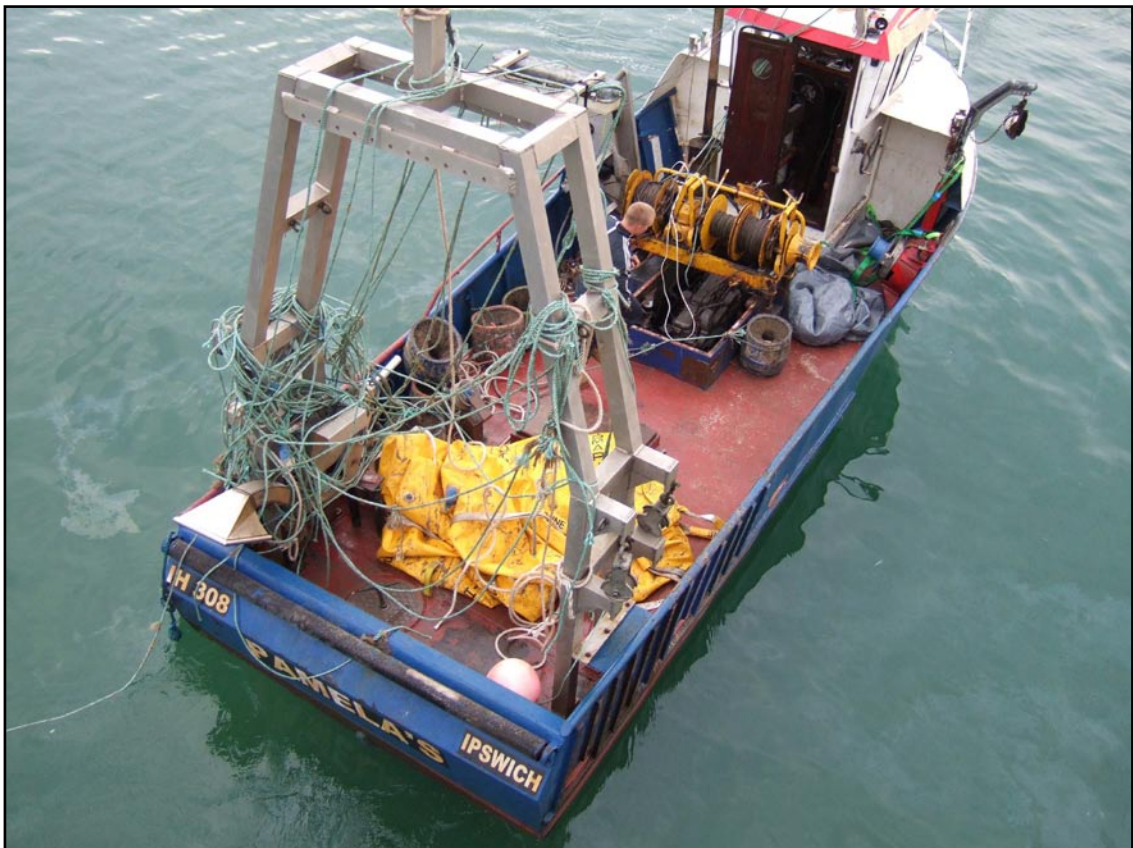
Figure 14

Before flooding, the vessel's mean freeboard aft was about 170mm, which is very low. In addition, there was a list to port, which would have further reduced the freeboard on this side. To support this fact, even with its compartments pumped out after the salvage operation, the vessel was observed by MAIB inspectors to have a low freeboard aft, and a list to port when it was towed from Tenby to Burry Port on 28 June 2006 (section 1.11) (**Figure 14**).

*Pamela S* being towed from Tenby to Burry Port with all compartments pumped dry

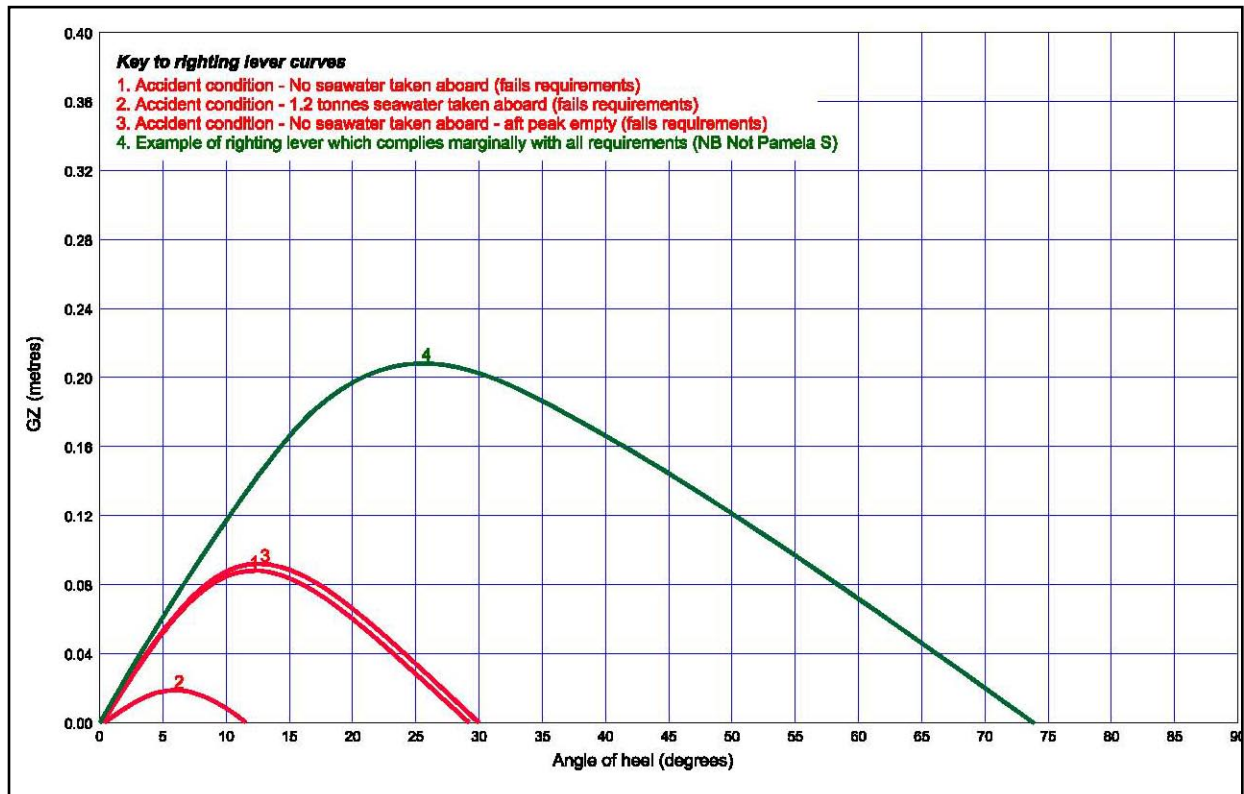
The vessel's righting lever in the intact condition before flooding and without a catch on deck (curve no 1) has about half the minimum righting lever required by a fishing vessel of 15m or more in length. The aft freeboard of 170mm was also insufficient.

*Pamela S* - Righting lever curves in accident conditions

With an assumption that there were 1.2 tonnes of sea water (curve no 2) in the two aft compartments just prior to the vessel sinking (section 1.12), the stability was further reduced, resulting in an extremely low righting lever of 20mm. This quantity of sea water produced a negative freeboard aft, and resulted in the vessel being unstable.
