ELECTRICAL REPORT FISHING VESSEL "PAMELA S"

Recovery of wreck of '*Pamela S*' diver's observations

Report on Stability Investigation - FV 'Pamela S'

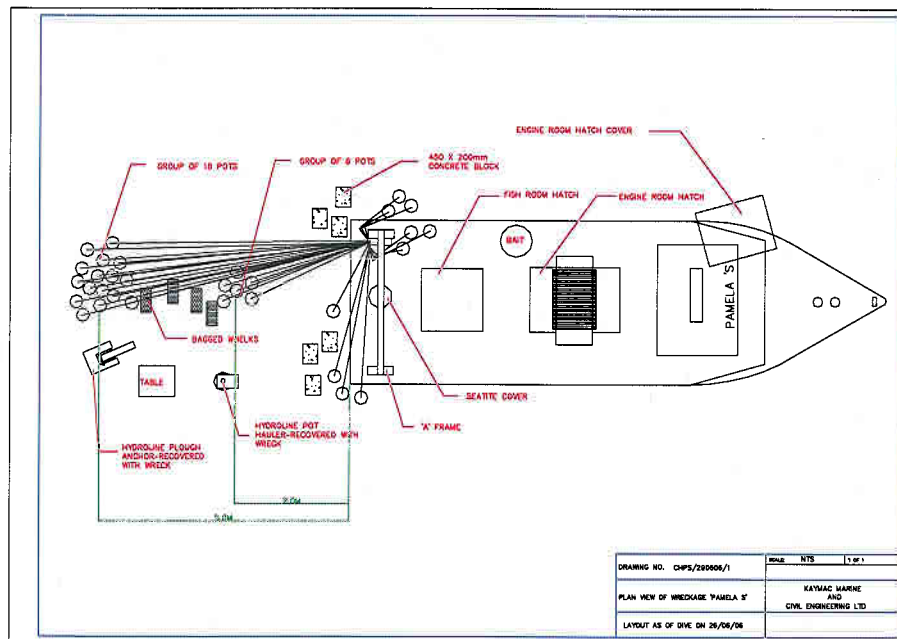
- The engine hatch cover was off and found on the sea bed under the portside of the vessel (see drawing CHPS/290606/1).
- A bait box made from the lower part of a plastic drum was found on the deck against the port gunwale between the engine and fish room hatches. The box was approximately 50% full of dead spider crabs, and a large number of crabs were also found scattered on the port side between the wheelhouse and engine room hatch, and in the engine room itself.
- The fish room hatch was in the closed position but not secured.
- The steatite cover was in site and secured.
- The 'A' frame was found to have a number of bolts missing at the base plates where secured to the stern decking.
- The port side aft pot hauler attached to the 'A' frame was intact, with a mass of lines steaming to aft of the vessel.
- A small number of pots were found on the deck just forward of the 'A' frame.

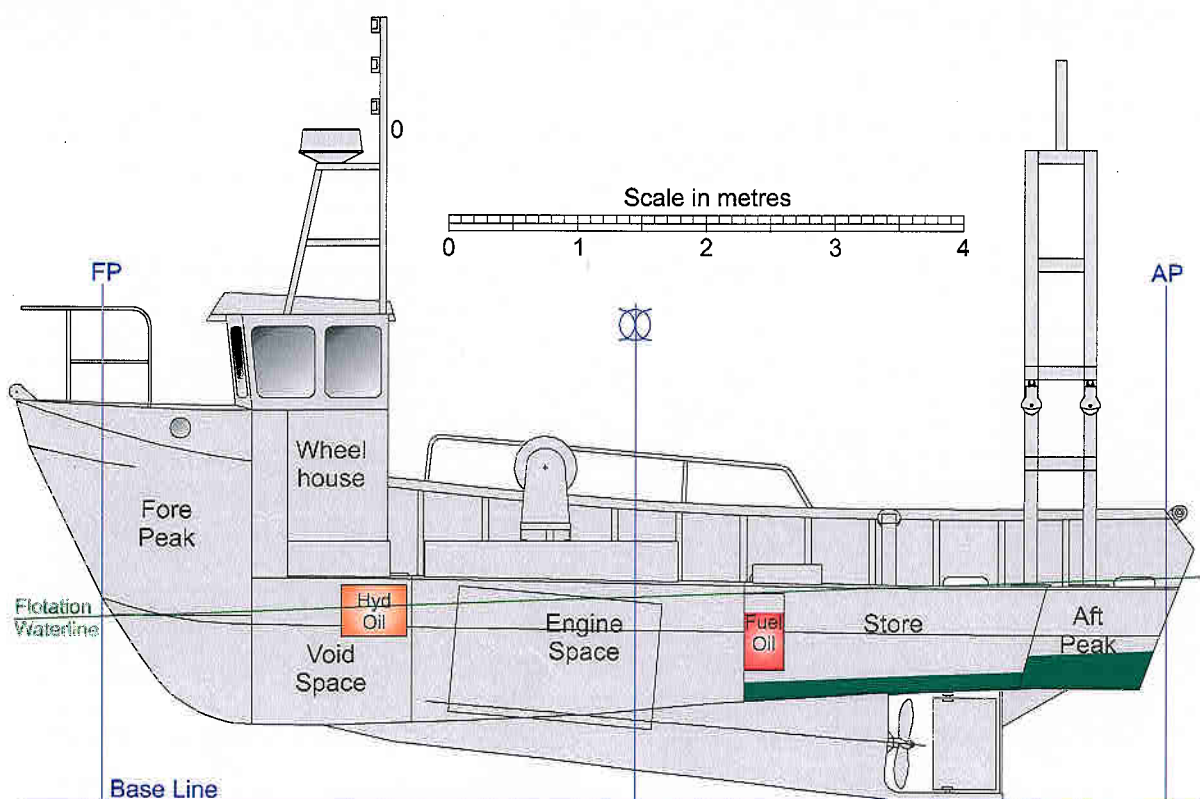
Diagram 5 – Flotation waterline with 1.2 tonnes of seawater in store and aft peak

It was noted that several of the attachment bolts for the aft gantry had not been fitted. The holes for these bolts were approximately 18mm in diameter and went through the gantry base plates and the deck, thereby giving water taken on deck through the scuppers access to both the store and the aft peak. Given this access and the very low freeboard, it is likely that seawater had been collecting in both these compartments for some time prior to the accident. Initially, the ingress of water would have been intermittent and at low pressure as the bolt holes were above the waterline. However, as more water was taken into the hull the stern was further depressed, further increasing the amount of water taken aboard as the boat rolled. Accident condition b. models the effect of 1.2 tonnes of seawater in the store and the aft peak (i.e. 0.6 tonnes in each compartment). It can be seen from the summary of results in Table 3 that this quantity of water aboard would have reduced the freeboard to minus 0.026 metres; in other words, a depth of water over the aft deck of 26 millimetres at the Aft Perpendicular. The flotation waterline with the vessel in this condition is shown in diagram 5 below.

It can be seen from the flotation waterline in diagram 5 that at around this level of flooding, the flow of seawater through the bolt holes into the two aft spaces and possibly the spaces forward (the bulkheads are not watertight) would have become continuous. Further, the water pressure would be increasing as the stern sank lower in the water. By now, the accident was probably unavoidable. Reserves of stability were extremely low at this point but sufficient to hold the boat upright at least until water started to flood continuously through the store access hatch. The data for accident condition b. indicates that subsequent severe flooding into the store would initiate sinking by the stern, which would immediately take the vessel from a marginally stable to an unstable condition. The vessel therefore capsized as it sank by the stern.

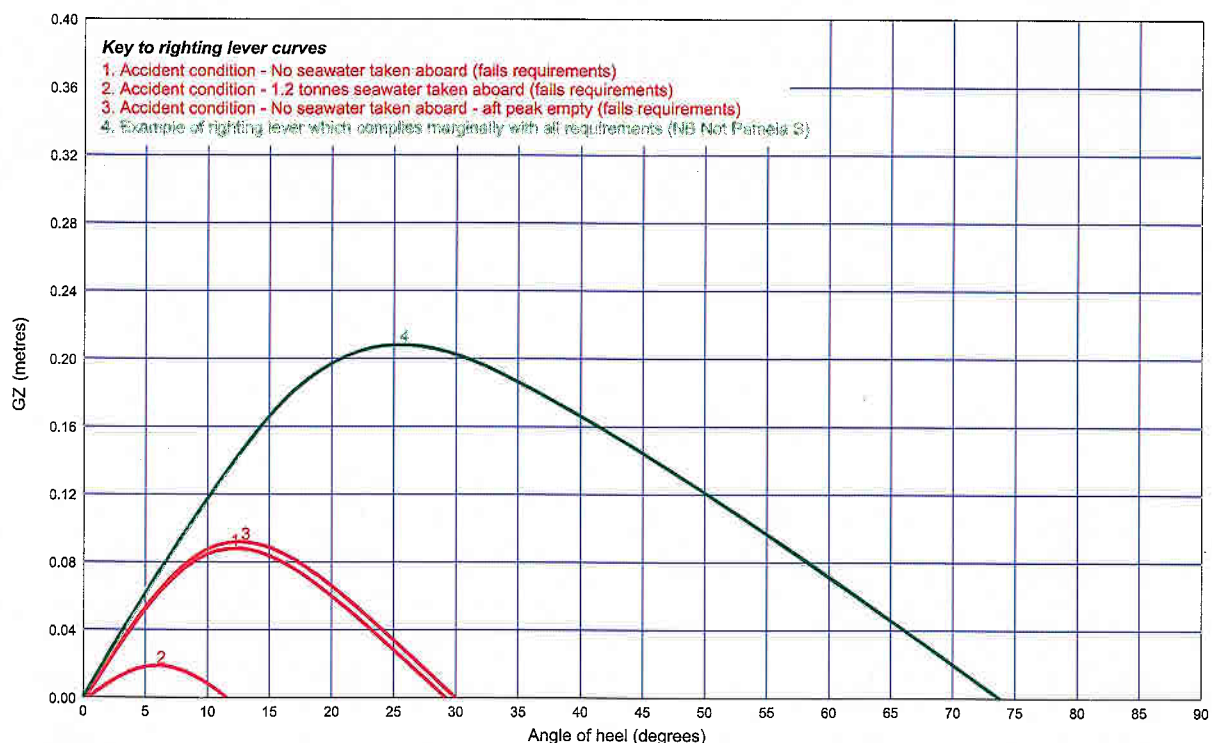
Diagram 6 – Righting lever curves in accident conditions

The accident was caused principally by a lack of freeboard, but emphasis is also placed on the extremely deleterious effect that this had on the stability. Diagram 6 below superimposes all three accident condition righting levers in red on the same plot. An example of a righting lever which complies, but only marginally, with all the requirements of MSN 1770(F) (see section 6 above) is also included, coloured green, to illustrate the very significant shortfall in the vessel's stability.
