## SYNOPSIS

On the evening of 7 June 2006, the general cargo ship *Skagern* and the container ship *Samskip Courier* collided in the Humber estuary in dense fog. Fortunately there were no injuries on either vessel. *Samskip Courier* sustained minor damage to her bow but was able to continue on her voyage to Rotterdam. *Skagern* was extensively damaged forward and required major repairs.

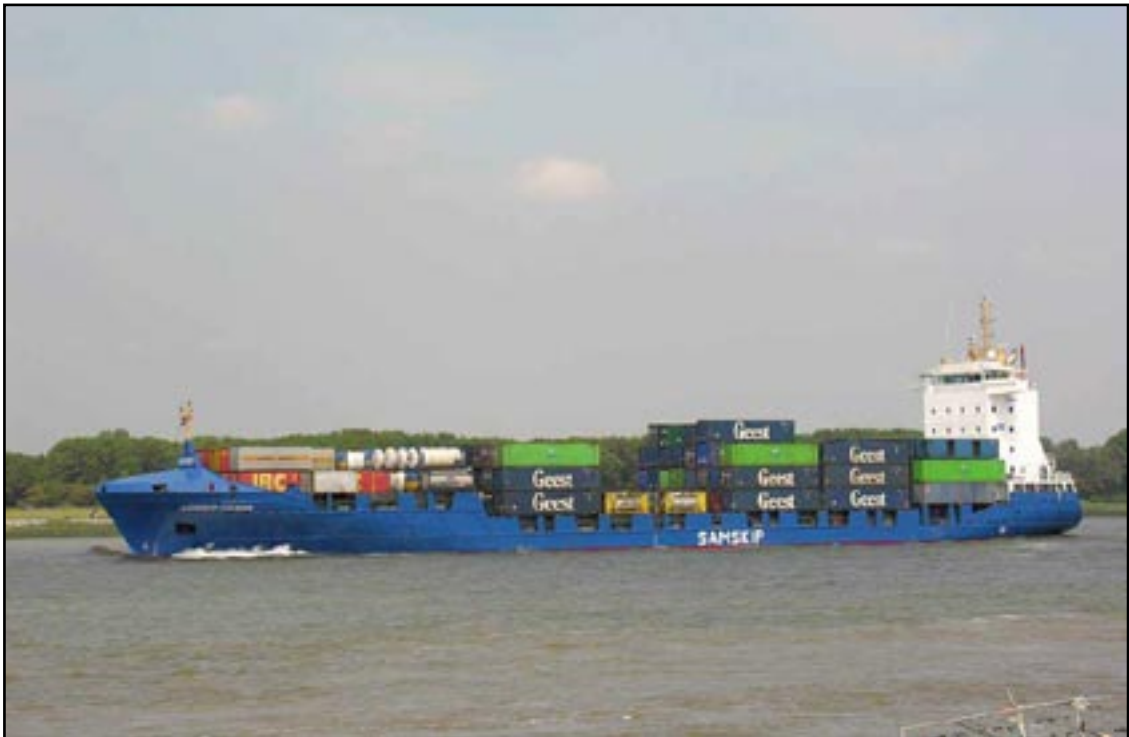
Figure 1

*Samskip Courier*

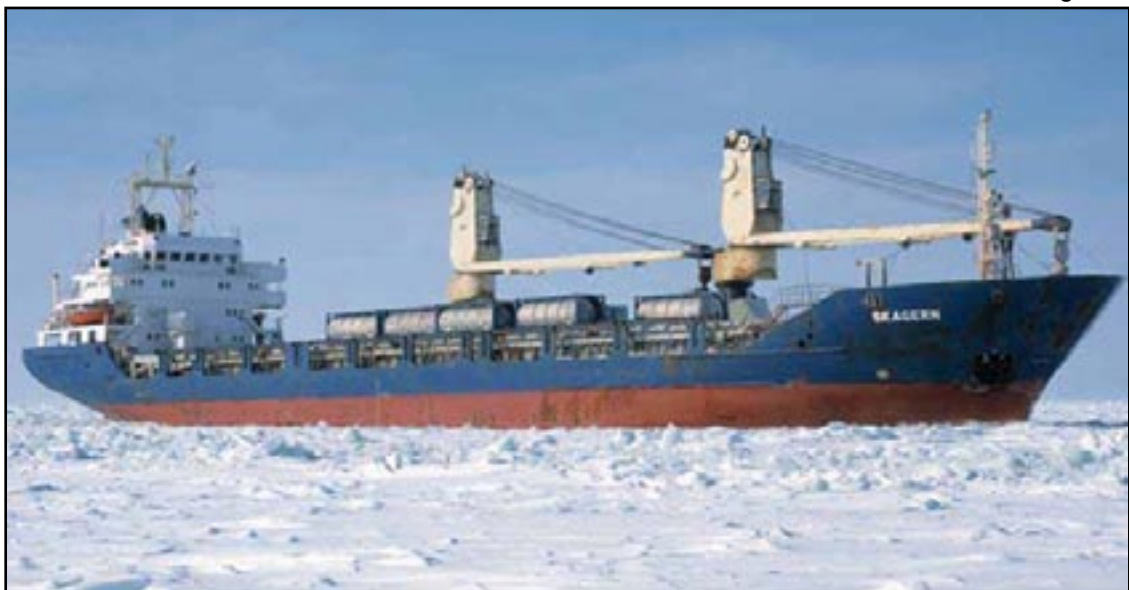
Figure 2

*Skagern*
